RE: Risk Management Plan
VIP Cleaners
3468 Sunset Avenue
Rocky Mount, Nash County, North Carolina
DSCA Site ID DC640005

**RISK MANAGEMENT PLAN
VIP CLEANERS
3468 SUNSET AVENUE
ROCKY MOUNT, NASH COUNTY, NORTH CAROLINA
DSCA SITE ID DC640005
JANUARY 28, 2022**

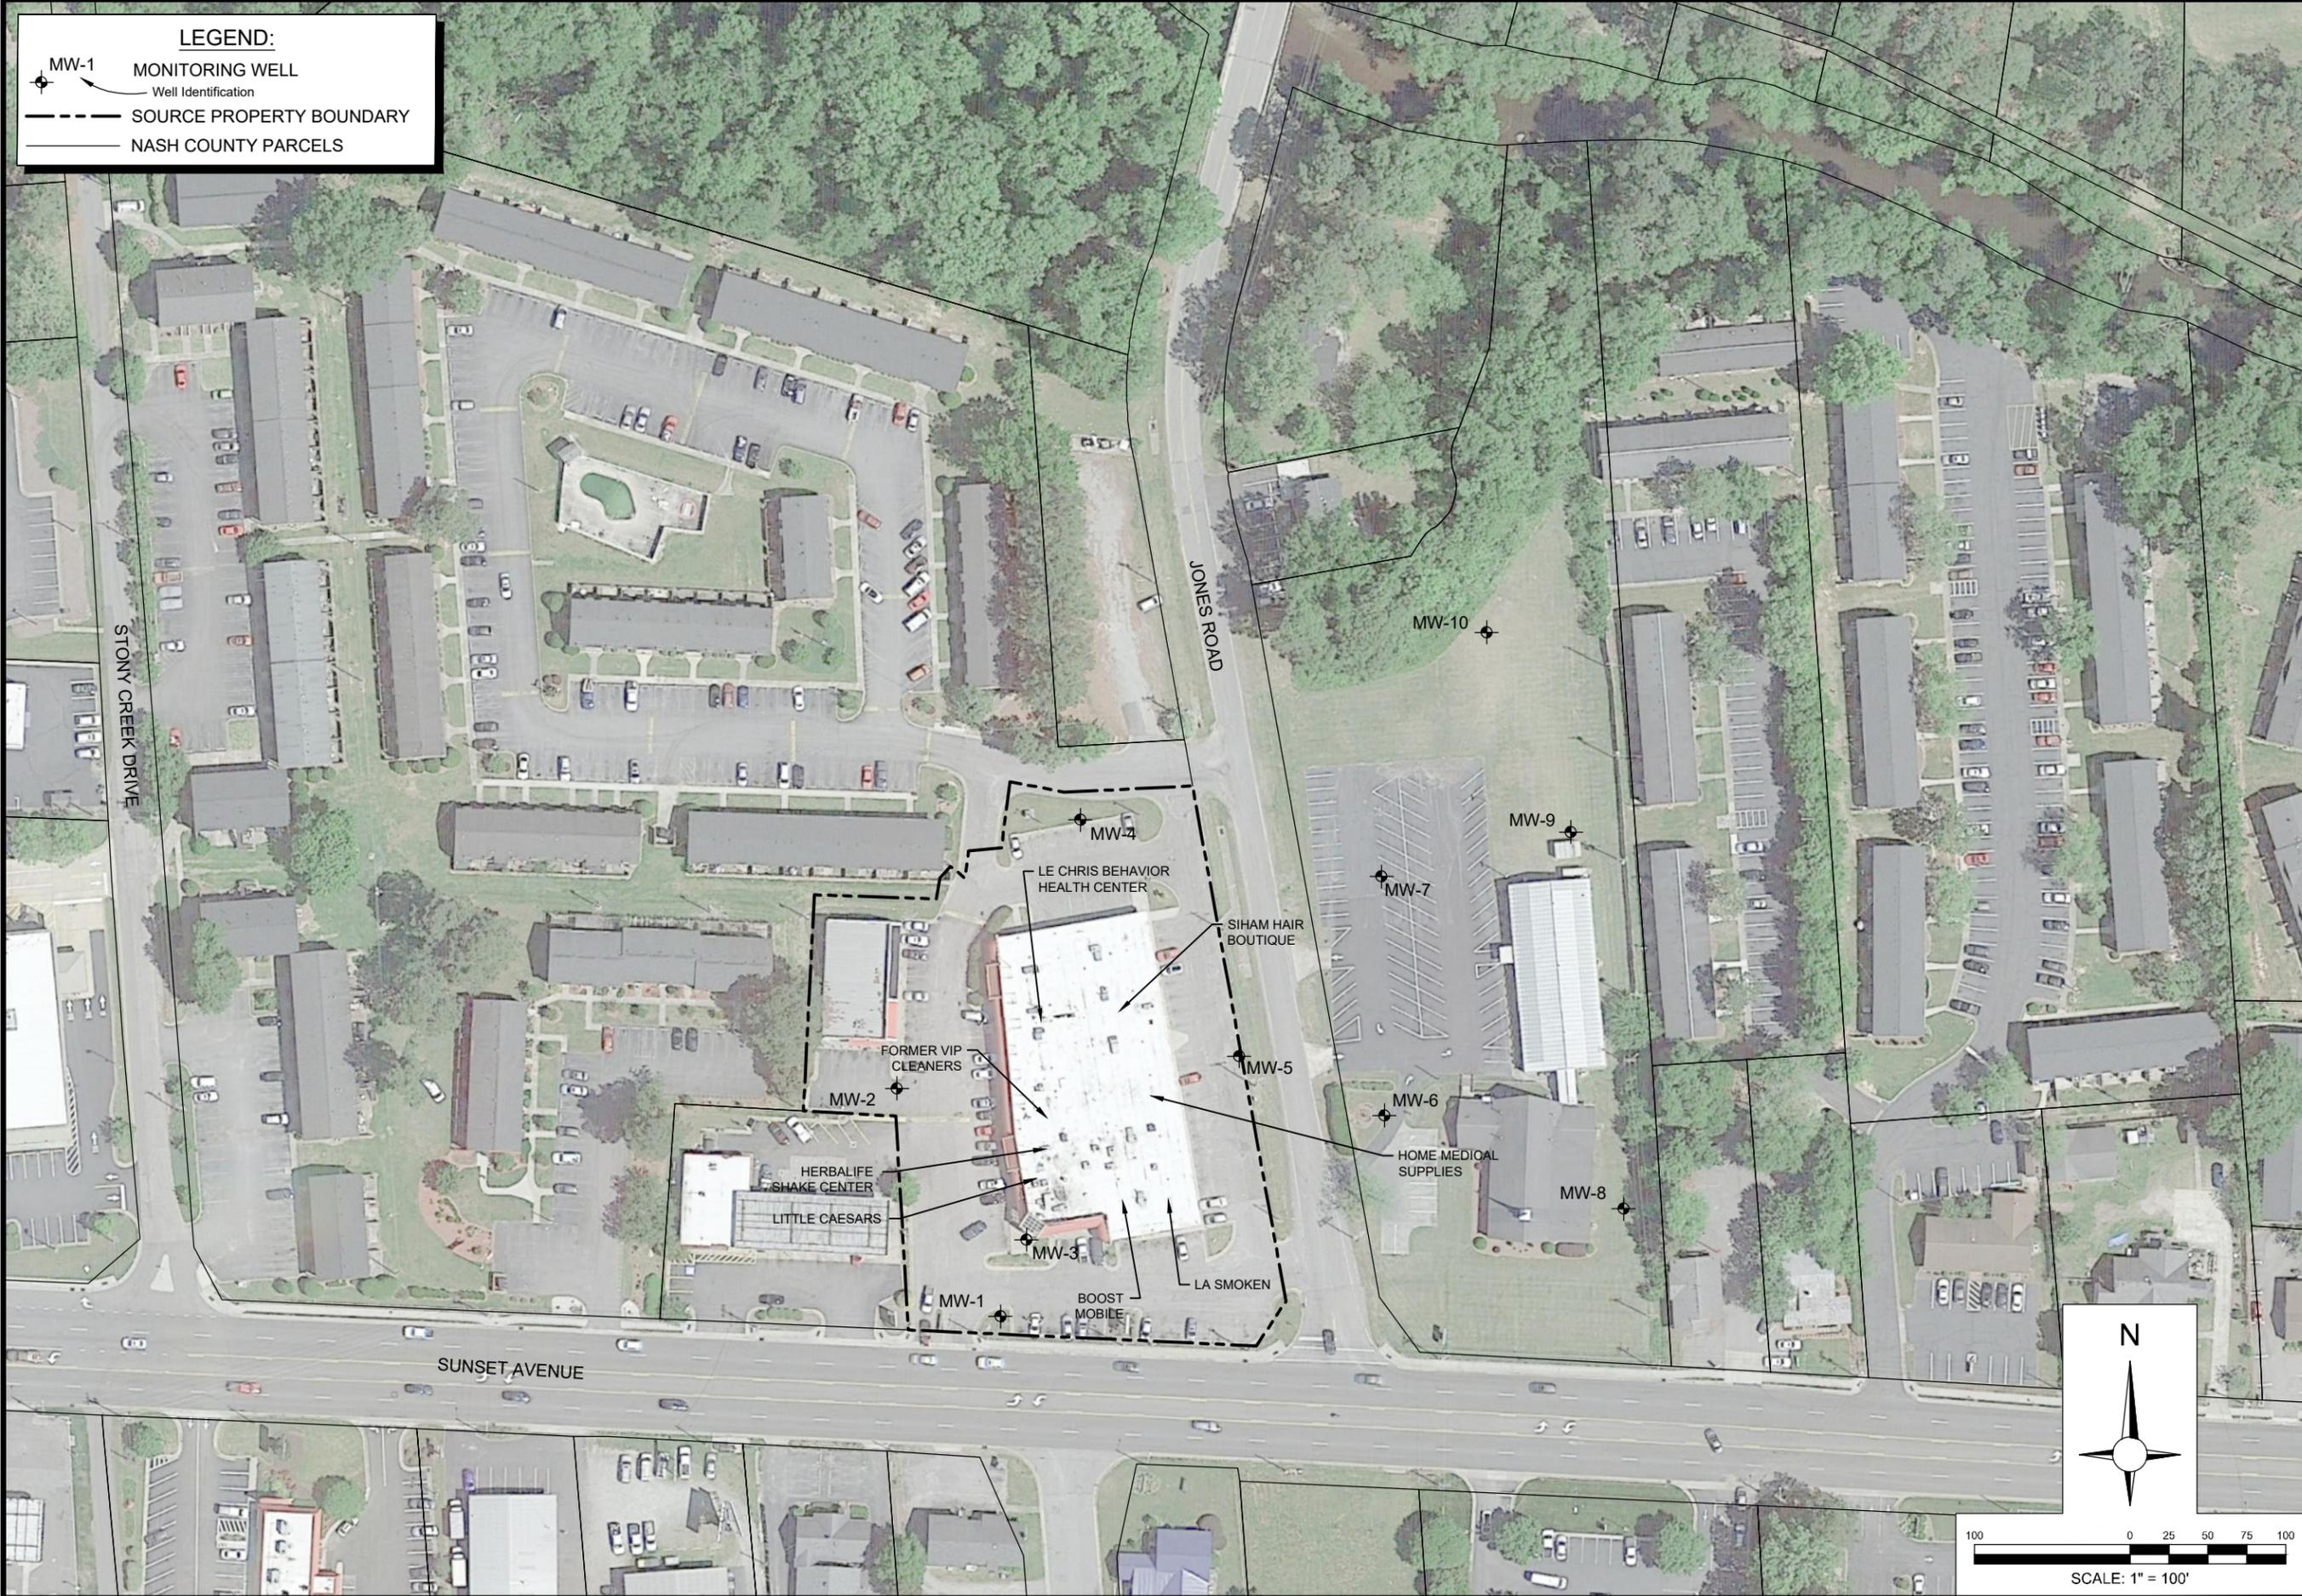
Date:
7/21
 Scale:
AS SHOWN
 Figure:
2

ATC completed a risk assessment for the site on April 17, 2019. The results of the risk assessment indicated that target risk levels are exceeded. However, the risks will be managed based on site-specific land-use conditions that have been selected as part of the evaluation and which require a RMP. Thus, the objective of the RMP is to ensure that those site-specific land-use conditions remain valid in the future. A site map which shows identifying features on the source property is included as *Figure 2*.

H:\2021\OTHER OFFICES\NORTH CAROLINA\NCDHQ-DWM-DSCA PROGRAM\64-0005 VIP CLEANERS\DC6405SL09-SITE.DWG, FIGURE 2

Overall, based on the results of recent and historical sampling events and the plume stability evaluation contained in this report, ATC concludes that the groundwater plume associated with the site is stable. Monitoring well locations are shown on **Figure 2**. Demonstration of the plume stability evaluation, including a table showing historical groundwater analytical data and the GSI Mann-Kendall Toolkit documentation, is included in **Appendix A**.

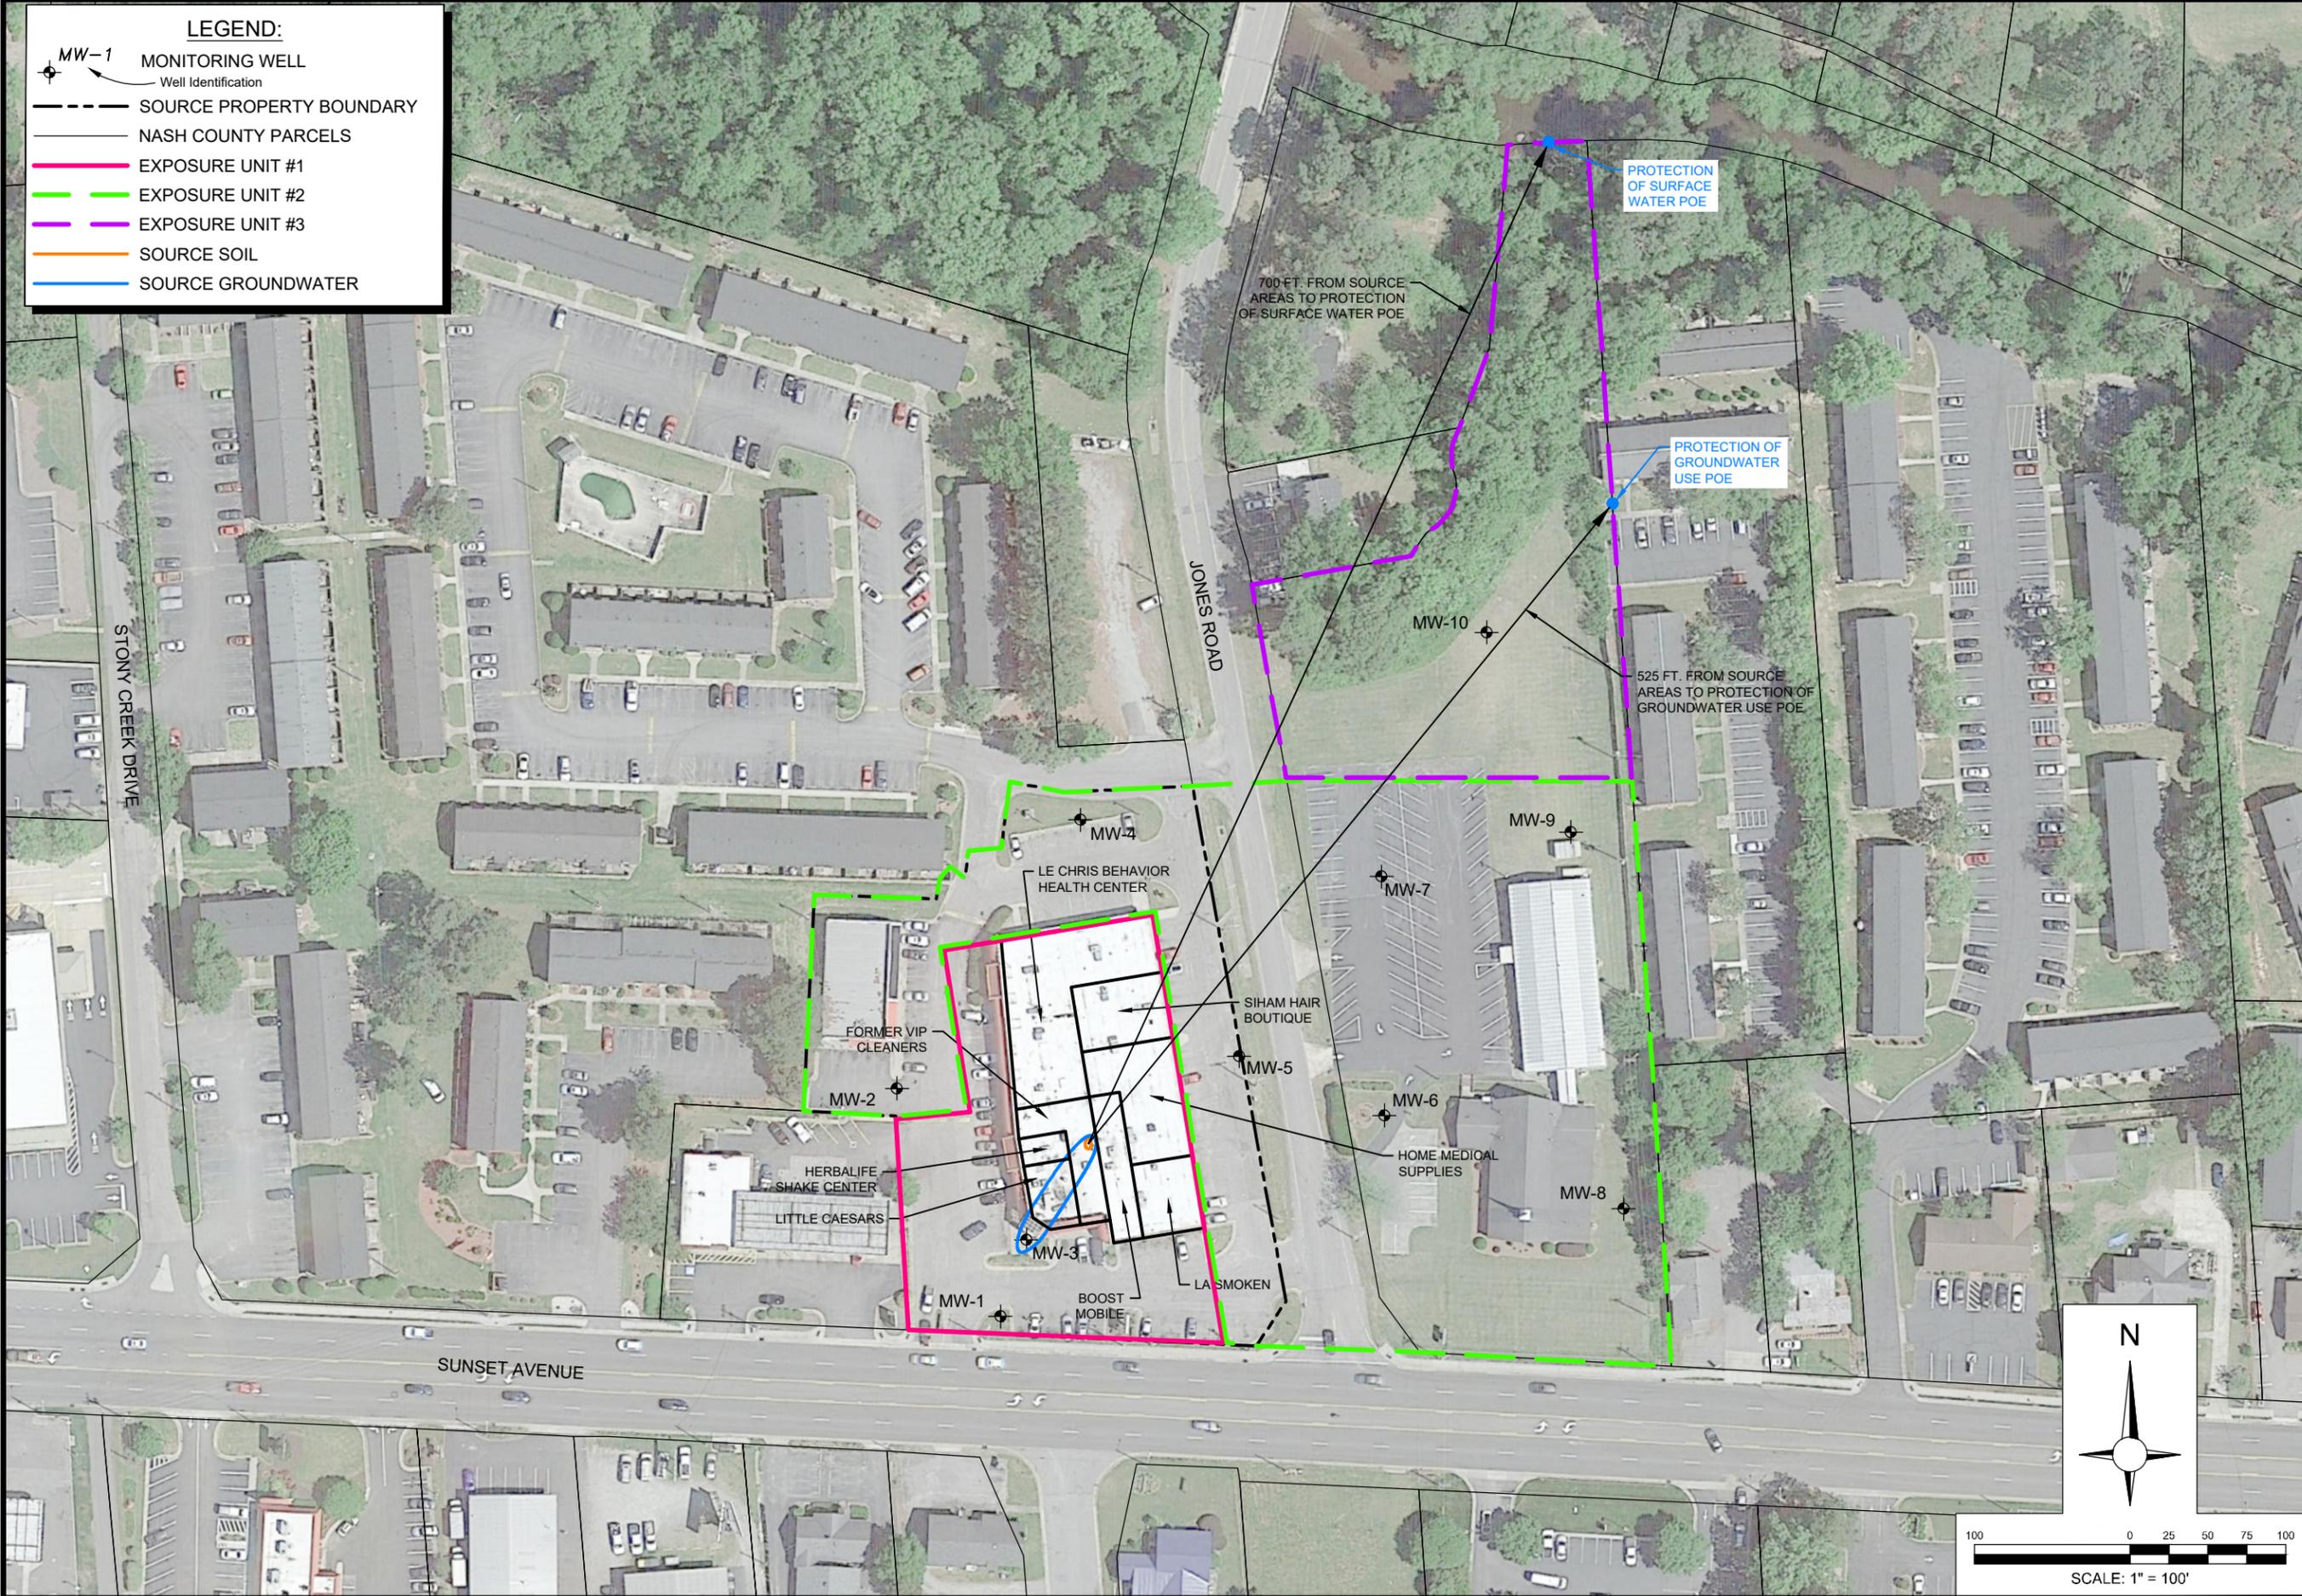
- MW-1 Well Identification
- MONITORING WELL
- SOURCE PROPERTY BOUNDARY
- NASH COUNTY PARCELS
- EXPOSURE UNIT #1
- EXPOSURE UNIT #2
- EXPOSURE UNIT #3
- SOURCE SOIL
- SOURCE GROUNDWATER

Exposure Unit #1

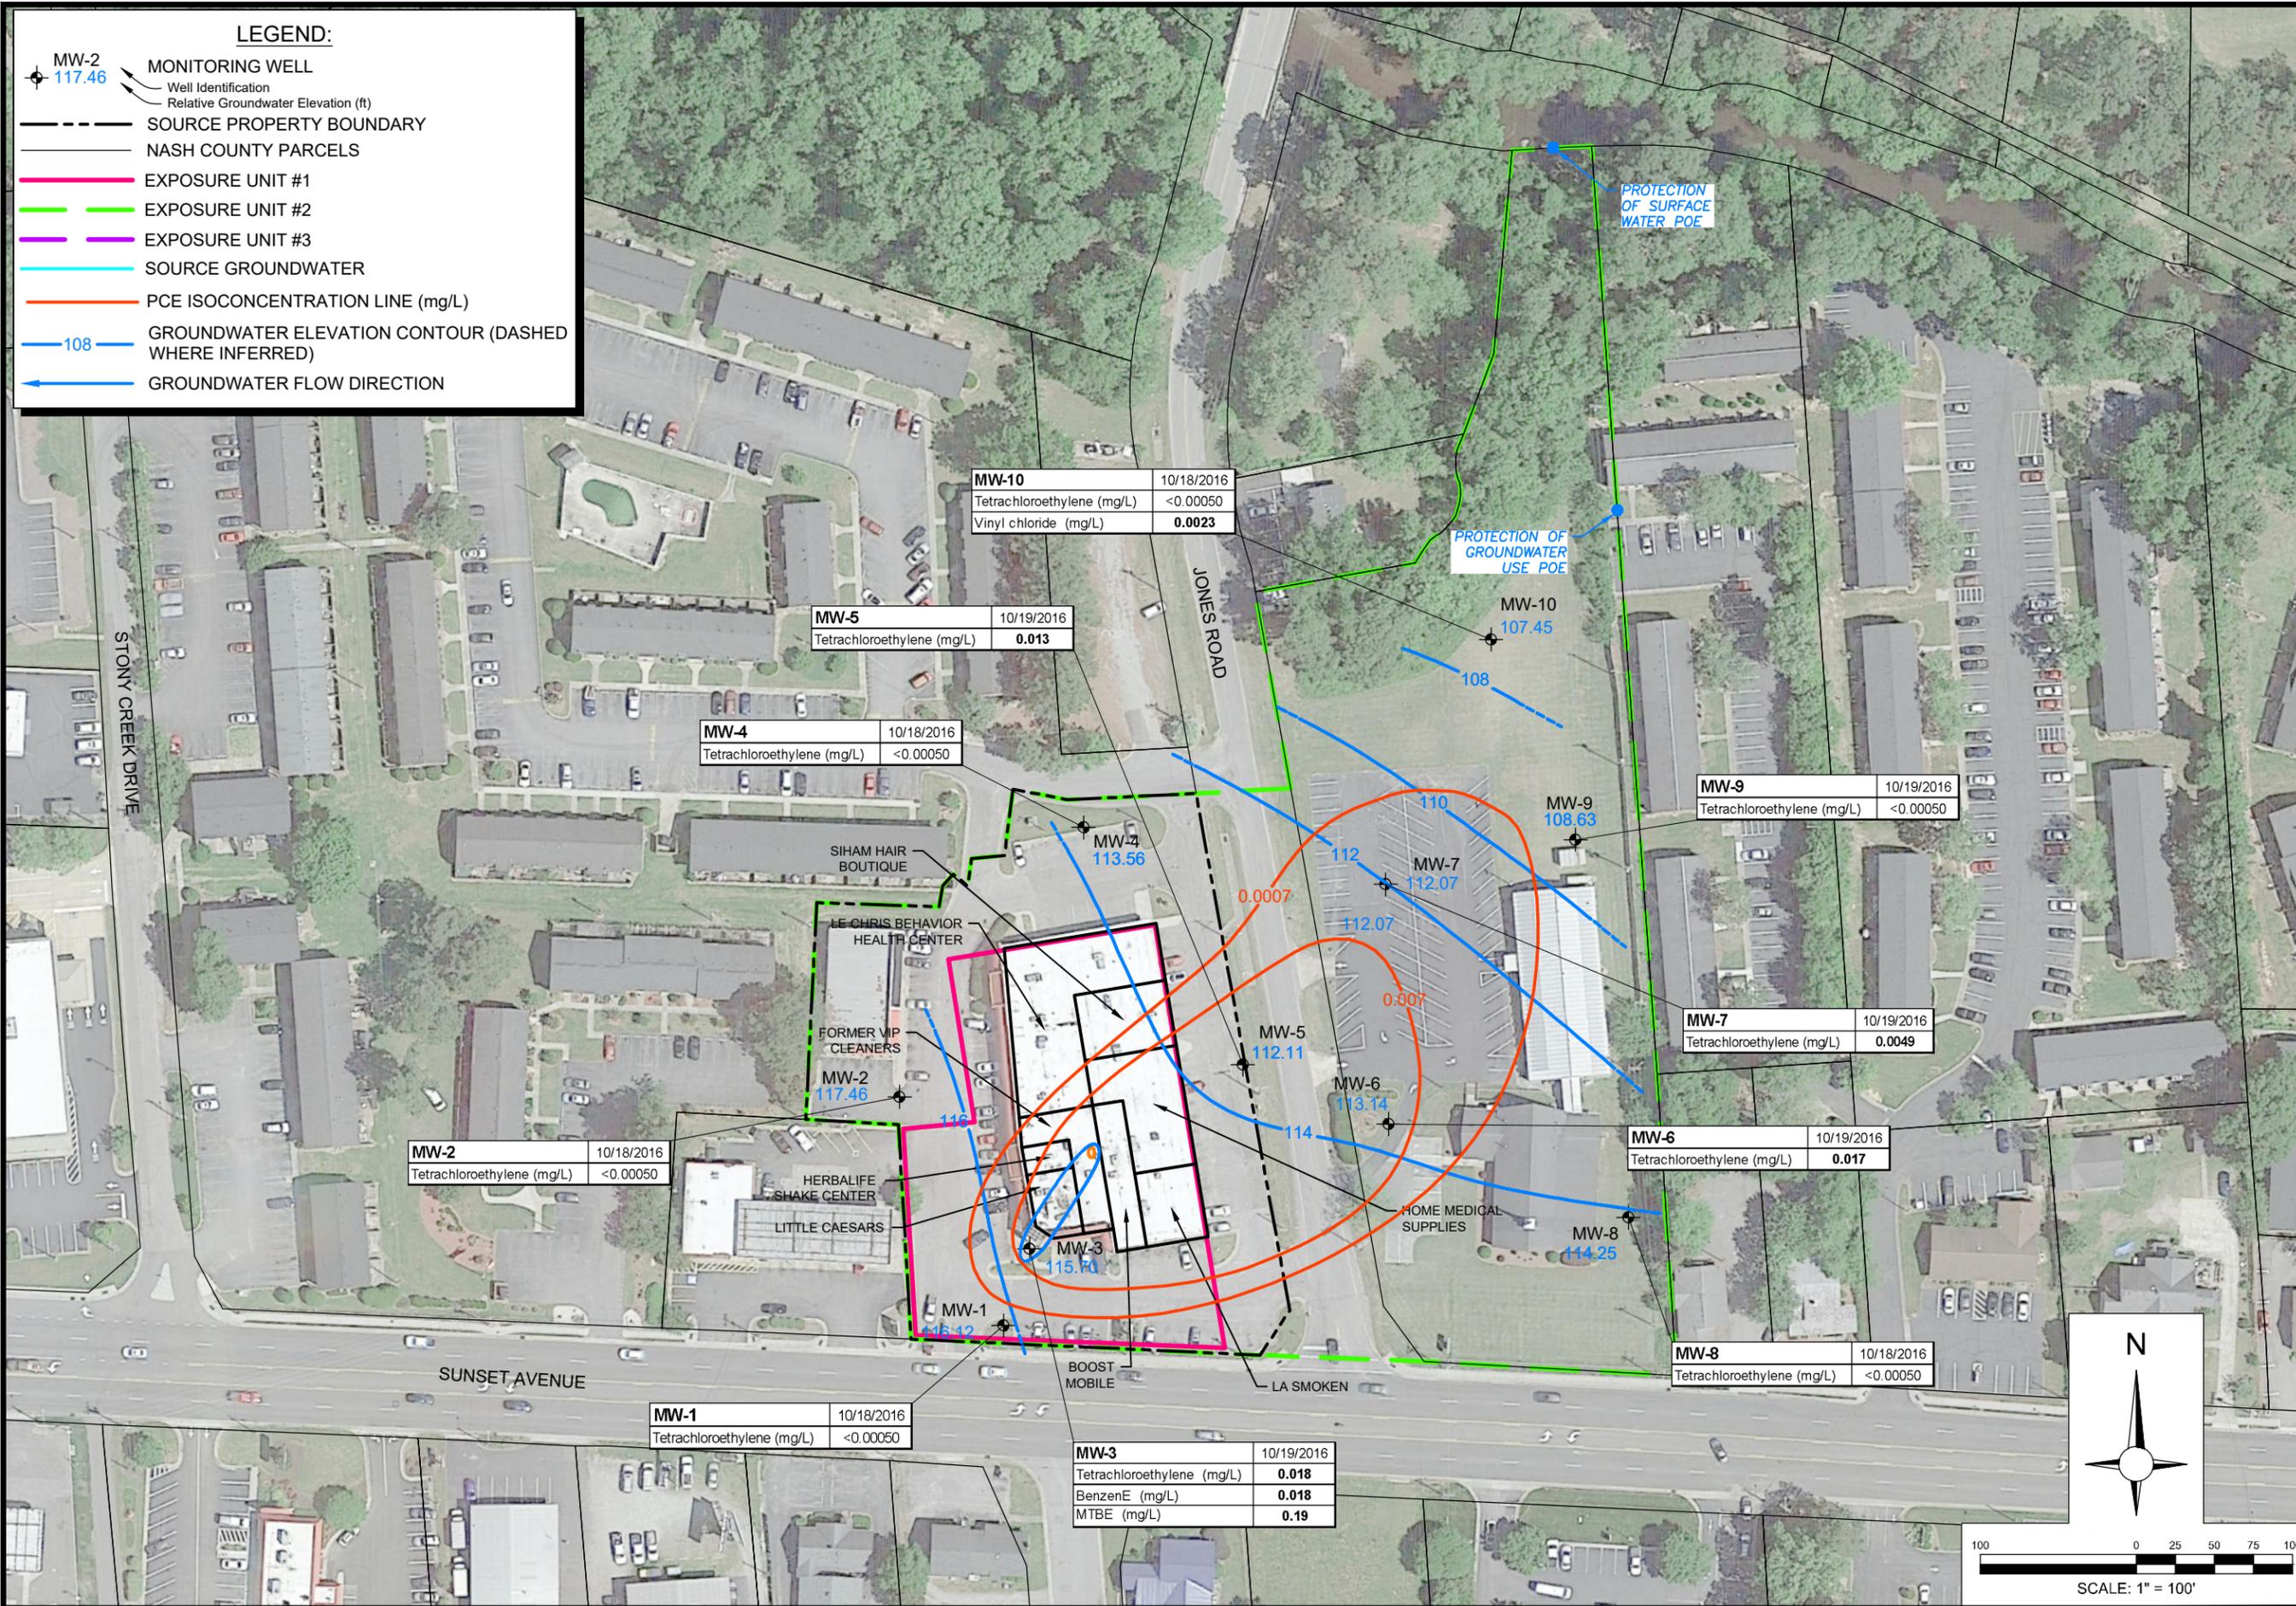
H:\2021\OTHER OFFICES\NORTH CAROLINA\NCDHEQ-DWM-DSCA PROGRAM\64-0005 VIP CLEANERS\DC6405SL09-GW.DWG, FIGURE 4

- MW-2 117.46 MONITORING WELL
 - Well Identification
 - Relative Groundwater Elevation (ft)
- SOURCE PROPERTY BOUNDARY
- NASH COUNTY PARCELS
- EXPOSURE UNIT #1
- EXPOSURE UNIT #2
- EXPOSURE UNIT #3
- SOURCE GROUNDWATER
- PCE ISOCONCENTRATION LINE (mg/L)
- 108 --- GROUNDWATER ELEVATION CONTOUR (DASHED WHERE INFERRED)
- GROUNDWATER FLOW DIRECTION

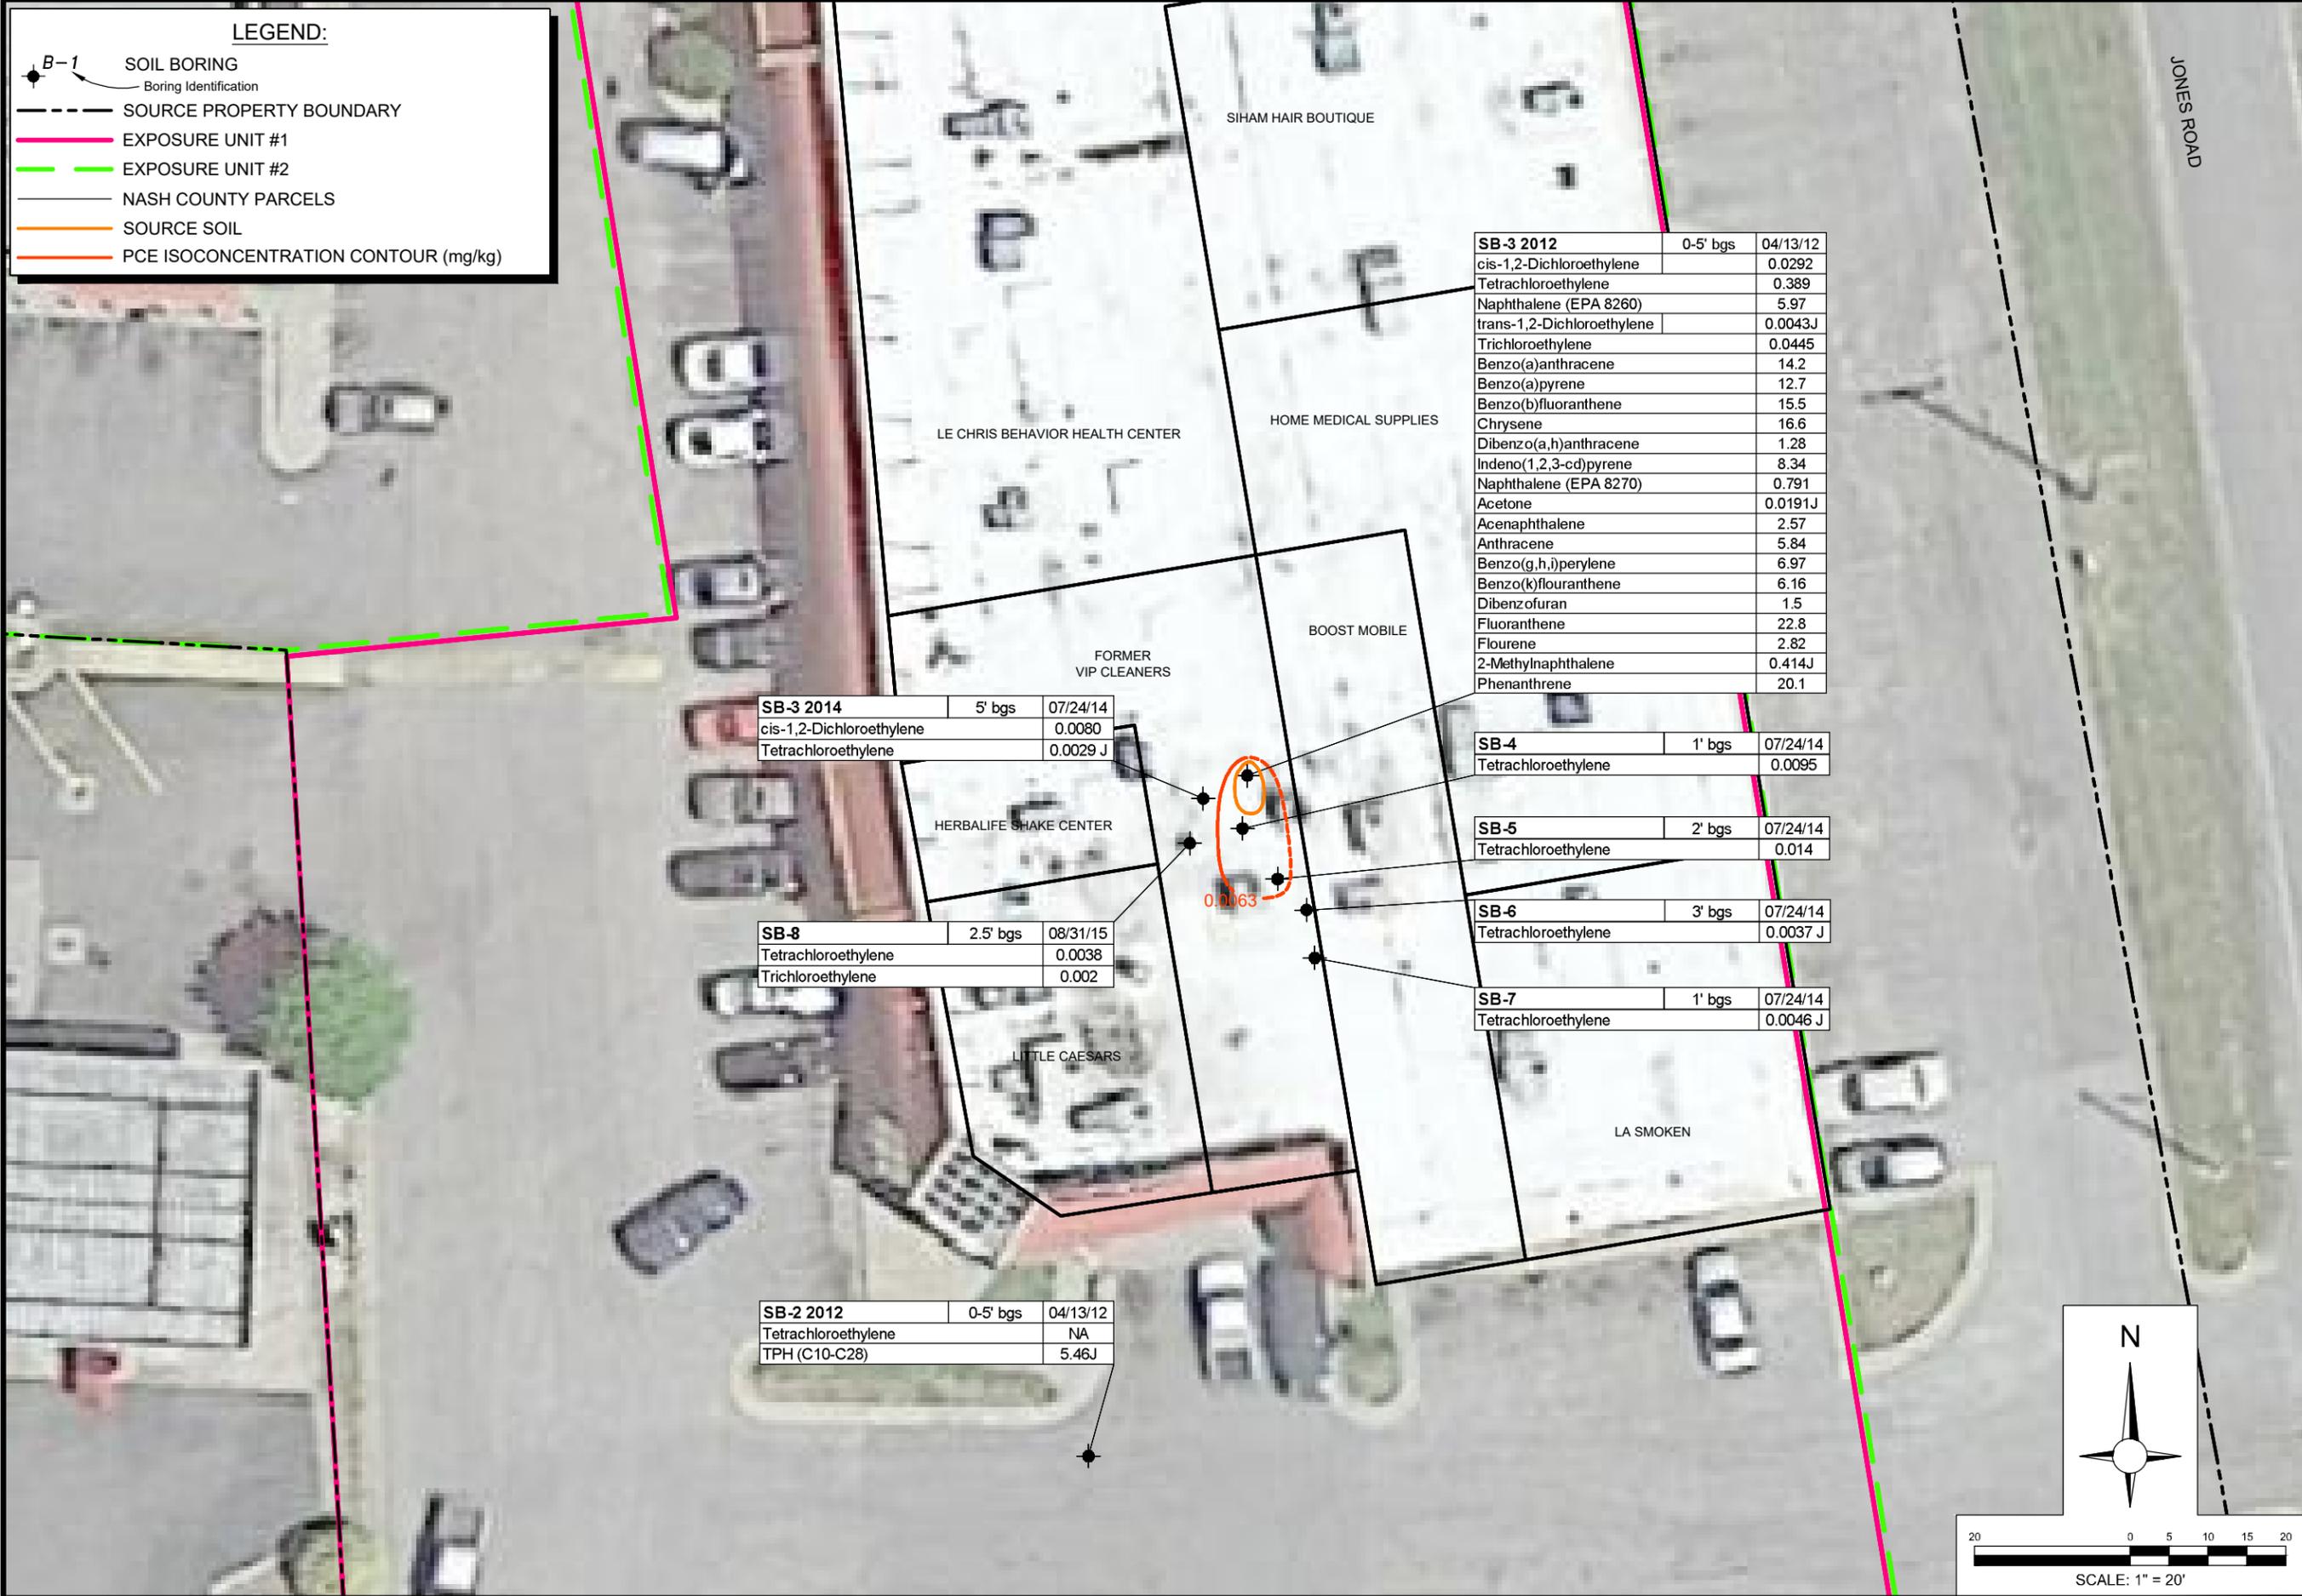
- B-1 SOIL BORING
- Boring Identification
- SOURCE PROPERTY BOUNDARY
- EXPOSURE UNIT #1
- EXPOSURE UNIT #2
- NASH COUNTY PARCELS
- SOURCE SOIL
- PCE ISOCONCENTRATION CONTOUR (mg/kg)

SB-3 2012		0-5' bgs	04/13/12
cis-1,2-Dichloroethylene			0.0292
Tetrachloroethylene			0.389
Naphthalene (EPA 8260)			5.97
trans-1,2-Dichloroethylene			0.0043J
Trichloroethylene			0.0445
Benzo(a)anthracene			14.2
Benzo(a)pyrene			12.7
Benzo(b)fluoranthene			15.5
Chrysene			16.6
Dibenzo(a,h)anthracene			1.28
Indeno(1,2,3-cd)pyrene			8.34
Naphthalene (EPA 8270)			0.791
Acetone			0.0191J
Acenaphthalene			2.57
Anthracene			5.84
Benzo(g,h,i)perylene			6.97
Benzo(k)fluoranthene			6.16
Dibenzofuran			1.5
Fluoranthene			22.8
Flourene			2.82
2-Methylnaphthalene			0.414J
Phenanthrene			20.1

SB-3 2014		5' bgs	07/24/14
cis-1,2-Dichloroethylene			0.0080
Tetrachloroethylene			0.0029 J

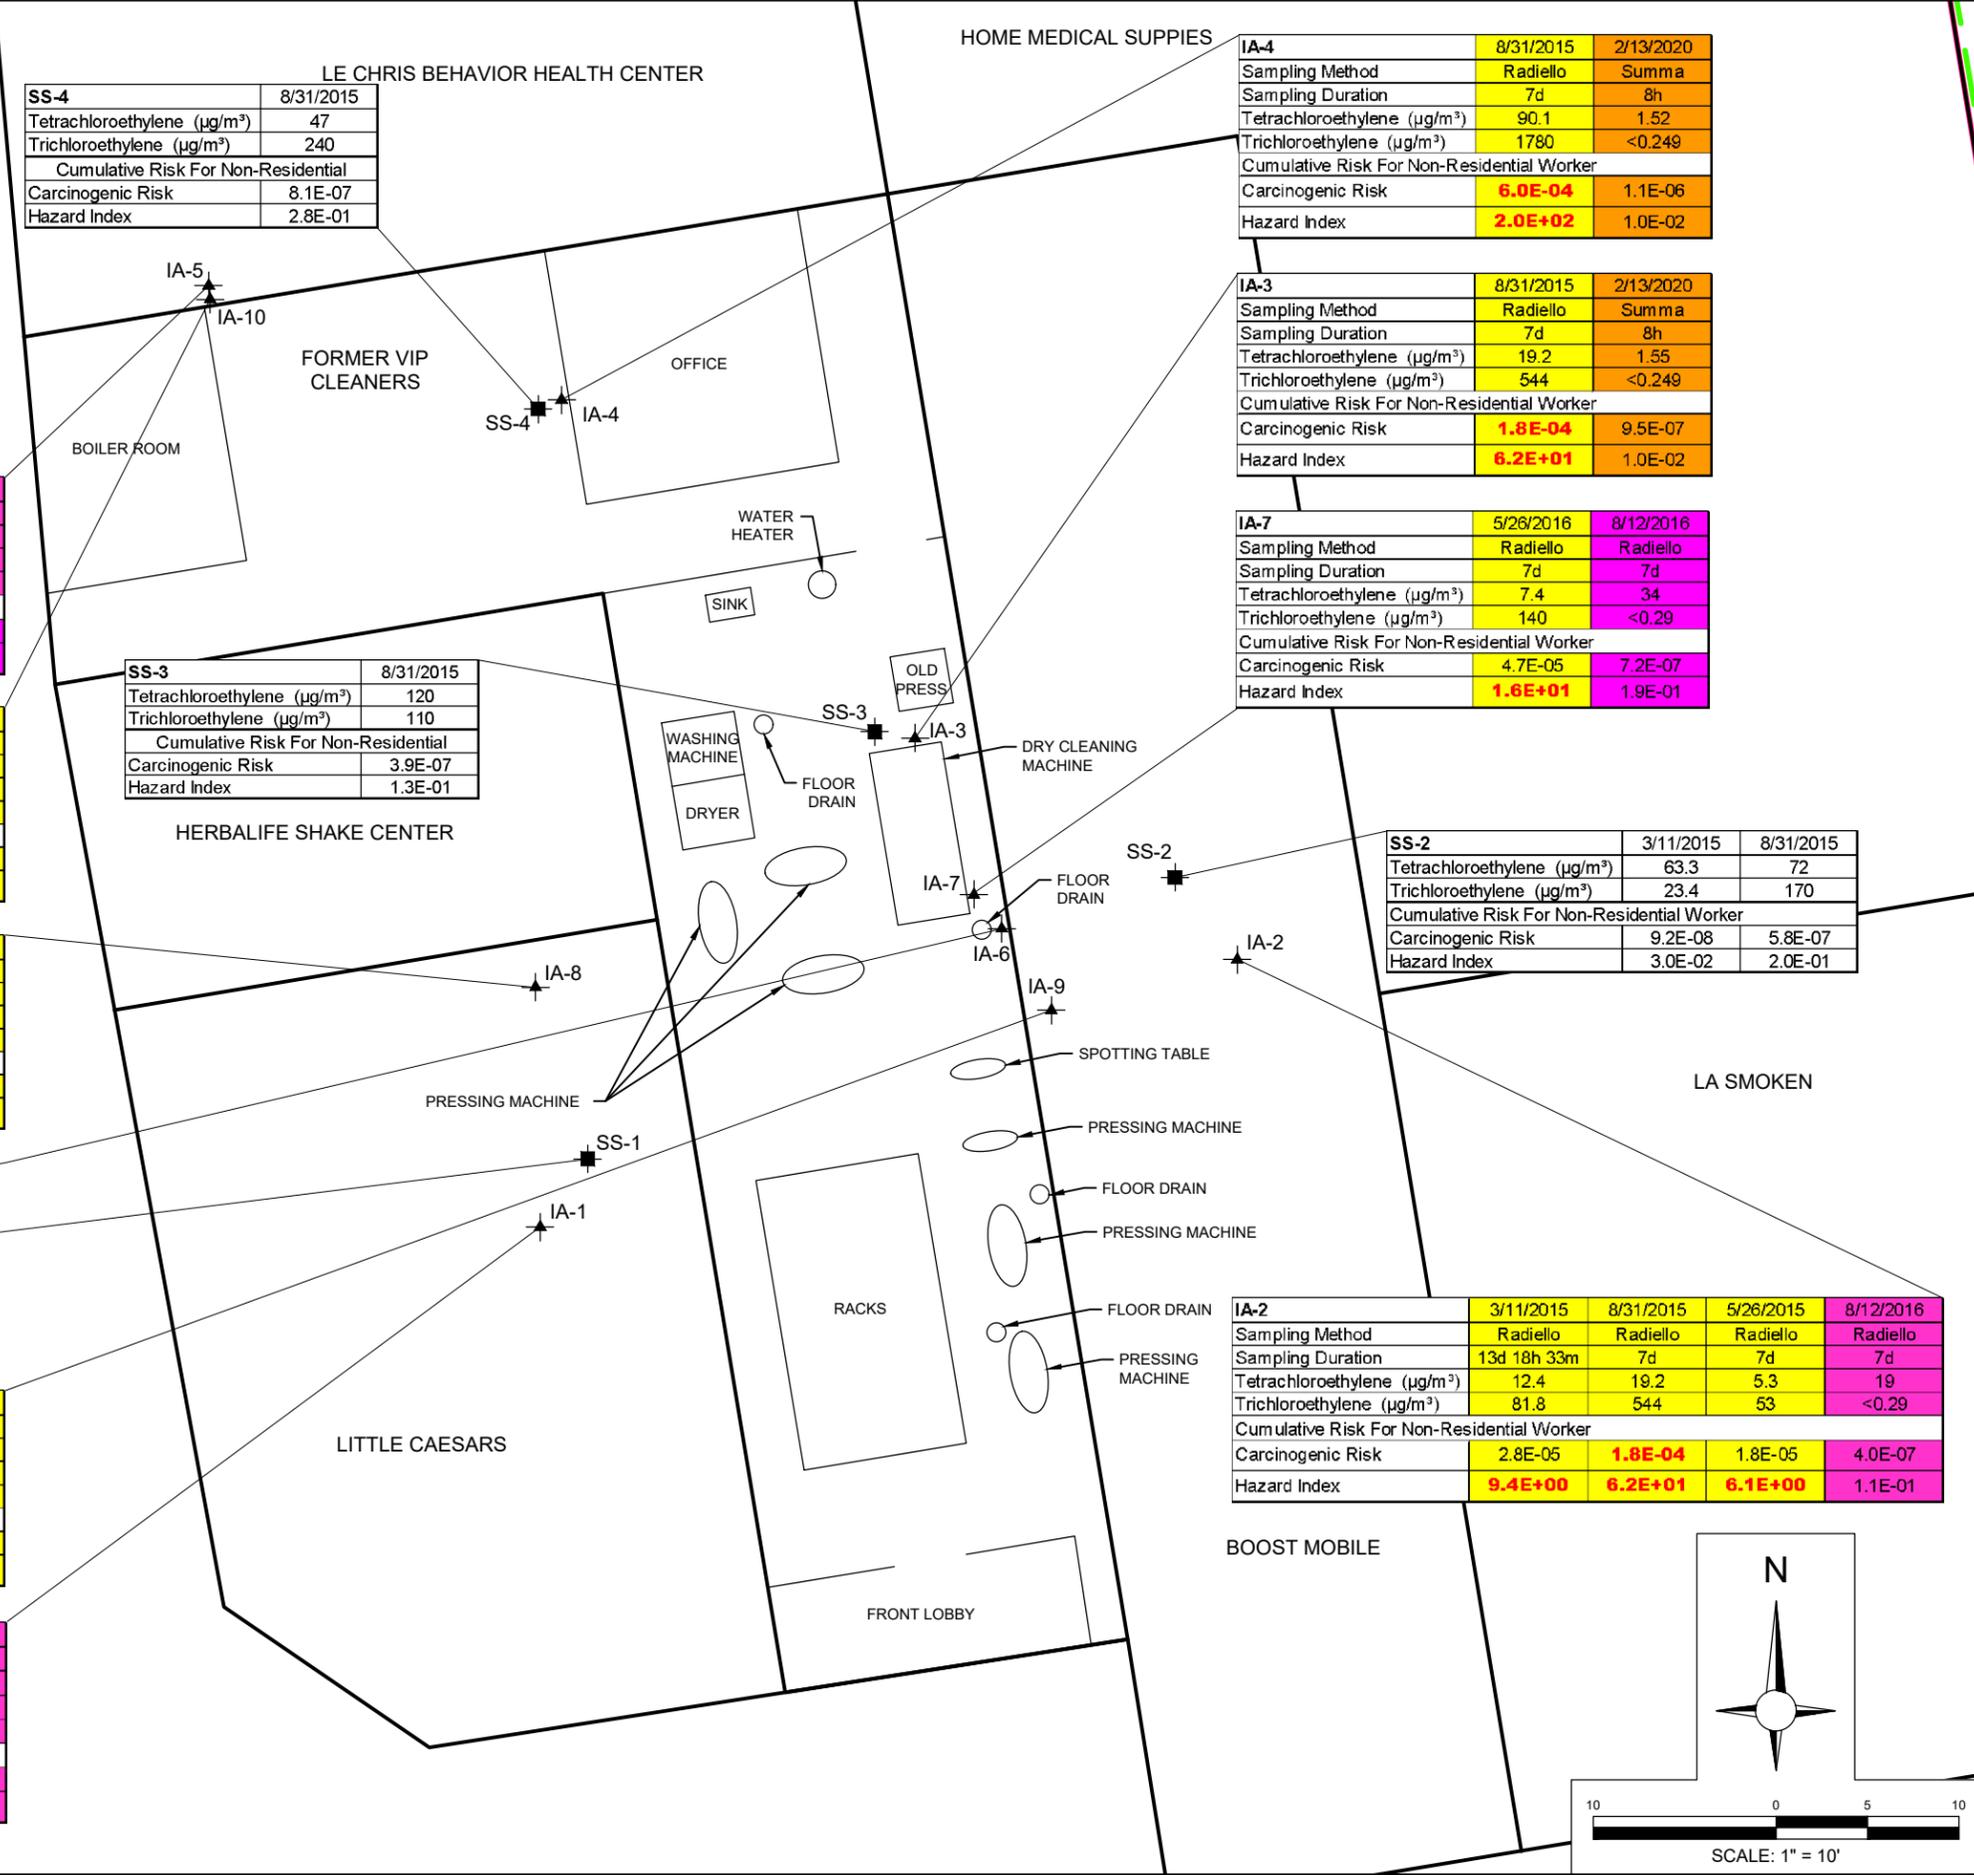
- IA-5 INDOOR AIR Sample Identification
- SS-1 SUB-SLAB Sample Identification
- SAMPLES COLLECTED DURING PICRIN USAGE
- SAMPLES COLLECTED AFTER PICRIN USAGE STOPPED
- SAMPLES COLLECTED AFTER VIP CLEANERS VACATED SPACE

Tetrachloroethylene (µg/m³)	47
Trichloroethylene (µg/m³)	240
Cumulative Risk For Non-Residential	
Carcinogenic Risk	8.1E-07
Hazard Index	2.8E-01

Sampling Method	Radiello	Summa
Sampling Duration	7d	8h
Tetrachloroethylene (µg/m³)	90.1	1.52
Trichloroethylene (µg/m³)	1780	<0.249
Cumulative Risk For Non-Residential Worker		
Carcinogenic Risk	6.0E-04	1.1E-06
Hazard Index	2.0E+02	1.0E-02

It should be noted that indoor air samples collected at the site in August 2015 and May 2016 indicated exceedances of acceptable risk levels for a non-residential worker; however, PCE and TCE concentrations were higher in indoor air samples than in sub-slab gas samples. Building materials in the dry-cleaning tenant space had detectable concentrations of PCE, as confirmed by an analysis of total concentrations in ceiling tile samples. Furthermore, it was determined the dry-cleaner was using Picrin, a TCE-based spotting agent. Exceedances of acceptable risk levels in indoor air appeared to be related to Picrin usage and off-gassing from the PCE-impacted building materials. In addition, confirmatory indoor air sampling was performed in February 2020, after VIP Cleaners
