RE: Risk Management Plan
VIP Cleaners
3468 Sunset Avenue
Rocky Mount, Nash County, North Carolina
DSCA Site ID DC640005

**RISK MANAGEMENT PLAN
VIP CLEANERS
3468 SUNSET AVENUE
ROCKY MOUNT, NASH COUNTY, NORTH CAROLINA
DSCA SITE ID DC640005
JANUARY 28, 2022**

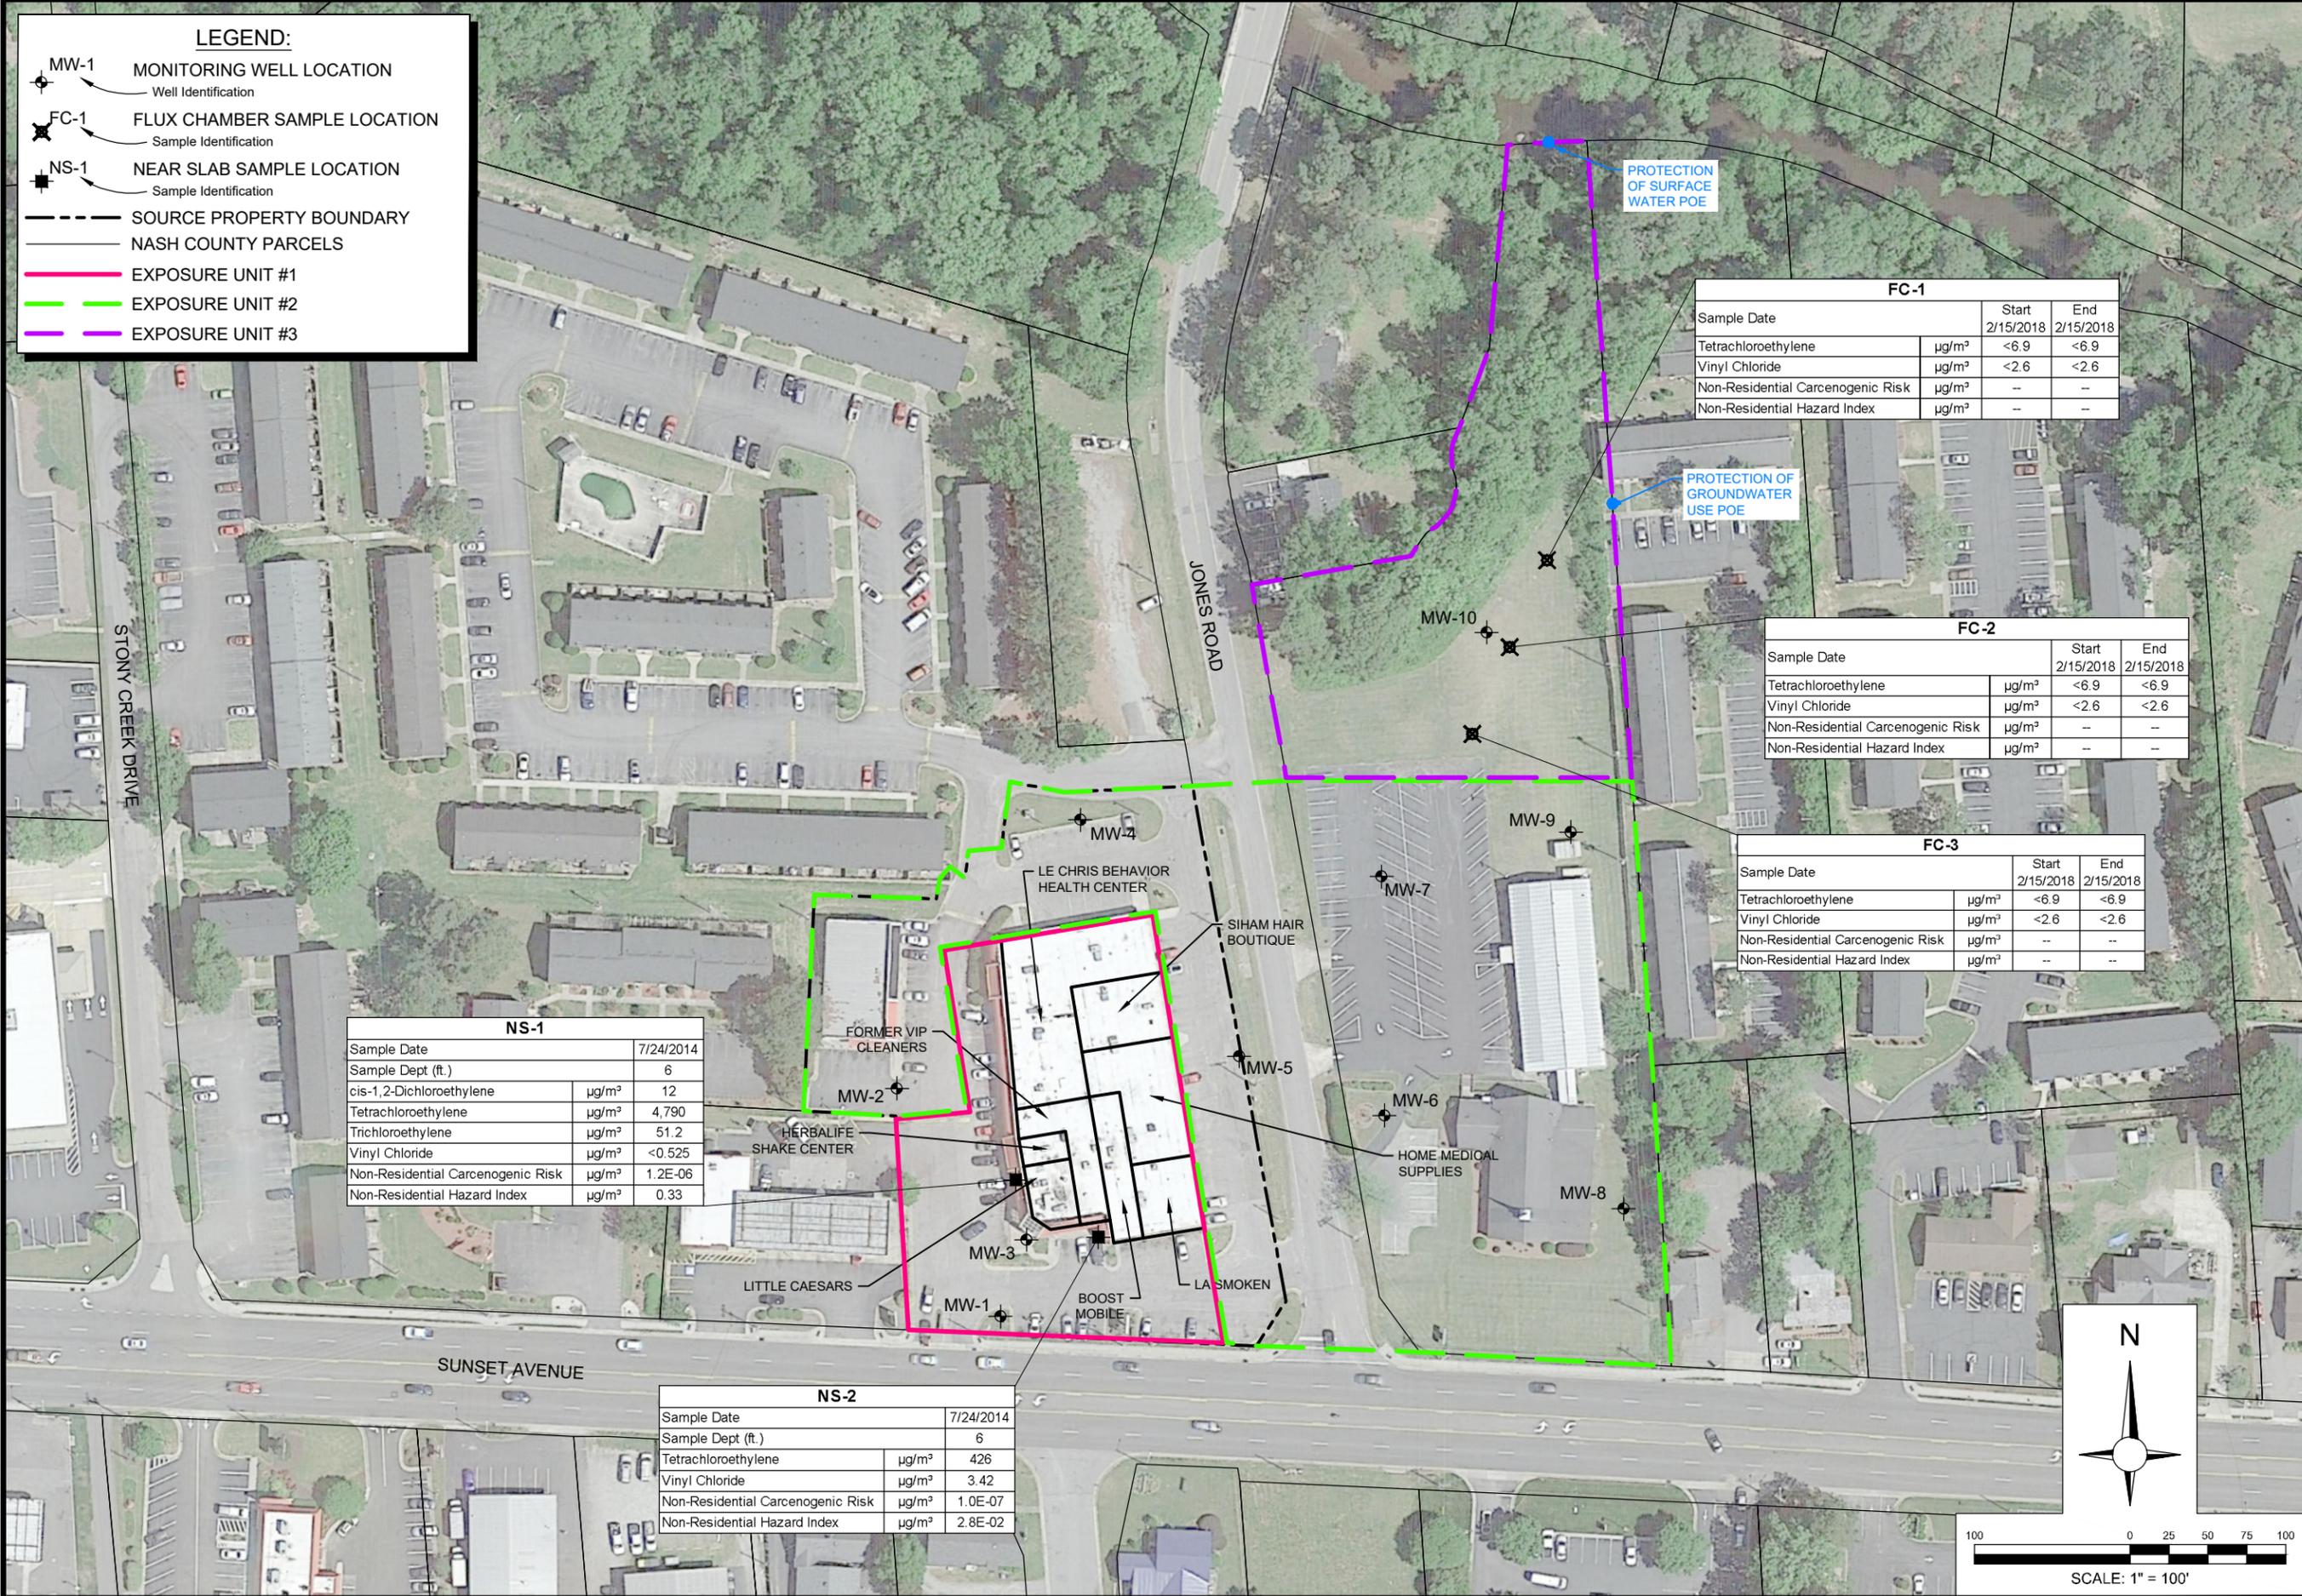
NS-1	
Sample Date	7/24/2014
Sample Dept. (ft.)	6
cis-1,2-Dichloroethylene	µg/m³ 12
Tetrachloroethylene	µg/m³ 4,790
Trichloroethylene	µg/m³ 51.2
Vinyl Chloride	µg/m³ <0.525
Non-Residential Carcenogenic Risk	µg/m³ 1.2E-06
Non-Residential Hazard Index	µg/m³ 0.33

NS-2	
Sample Date	7/24/2014
Sample Dept. (ft.)	6
Tetrachloroethylene	µg/m³ 426
Vinyl Chloride	µg/m³ 3.42
Non-Residential Carcenogenic Risk	µg/m³ 1.0E-07
Non-Residential Hazard Index	µg/m³ 2.8E-02

FC-1		
Sample Date	Start	End
	2/15/2018	2/15/2018
Tetrachloroethylene	µg/m³	<6.9
Vinyl Chloride	µg/m³	<2.6
Non-Residential Carcenogenic Risk	µg/m³	--
Non-Residential Hazard Index	µg/m³	--

FC-2		
Sample Date	Start	End
	2/15/2018	2/15/2018
Tetrachloroethylene	µg/m³	<6.9
Vinyl Chloride	µg/m³	<2.6
Non-Residential Carcenogenic Risk	µg/m³	--
Non-Residential Hazard Index	µg/m³	--

FC-3		
Sample Date	Start	End
	2/15/2018	2/15/2018
Tetrachloroethylene	µg/m³	<6.9
Vinyl Chloride	µg/m³	<2.6
Non-Residential Carcenogenic Risk	µg/m³	--
Non-Residential Hazard Index	µg/m³	--

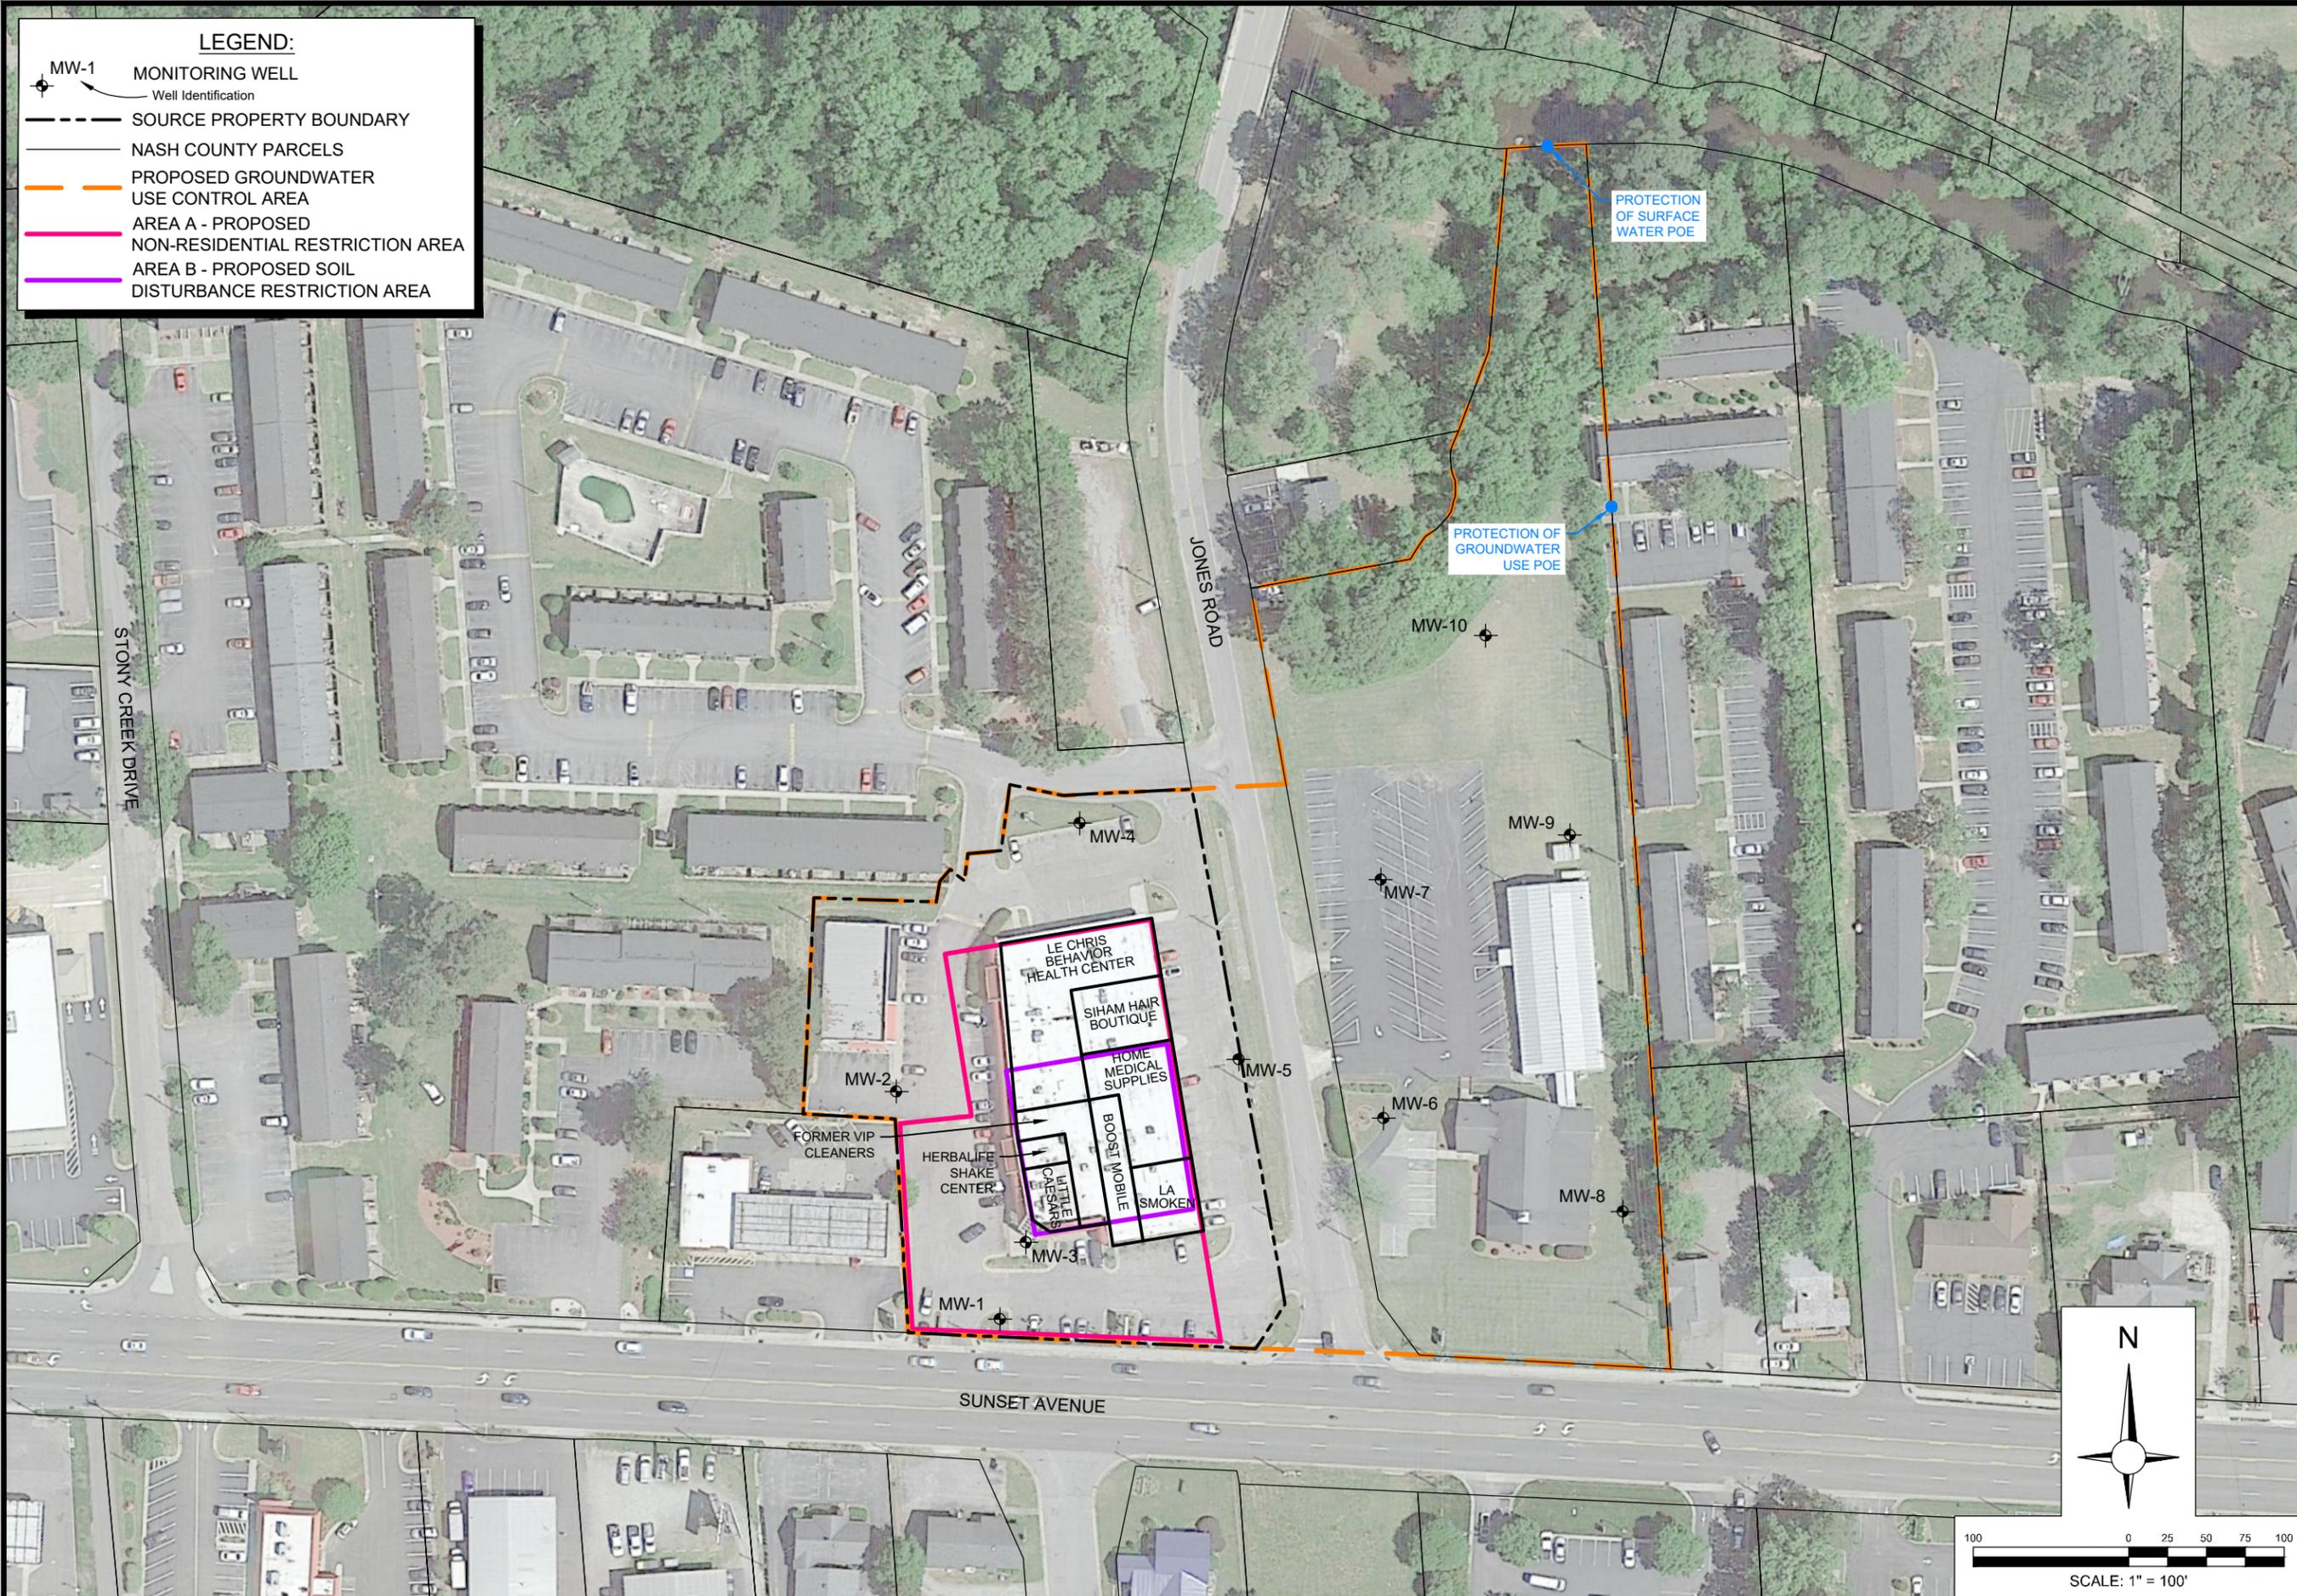
H:\2021\OTHER OFFICES\NORTH CAROLINA\DC64\DC64-0005 VIP CLEANERS\DC64\05SL09-LUCAREA.DWG, FIGS

- MW-1 MONITORING WELL
Well Identification
- SOURCE PROPERTY BOUNDARY
- NASH COUNTY PARCELS
- PROPOSED GROUNDWATER USE CONTROL AREA
- AREA A - PROPOSED NON-RESIDENTIAL RESTRICTION AREA
- AREA B - PROPOSED SOIL DISTURBANCE RESTRICTION AREA

Institutional controls will be implemented to ensure that land-use conditions are maintained and monitored until the land-use controls are no longer required for the site. A NDCSR was prepared for the source property to comply with the land-use control requirement. A NDCSR was also prepared for one off-source property to limit groundwater use. The NDCSRs for the source and off-source properties are included as *Appendix C*. Refer to the NDCSRs for the specific language to be incorporated to address each of the risk assessment assumptions detailed above. A plat showing the locations and types of dry-cleaning solvent contamination is included as an exhibit to the NDCSRs. The locations of dry-cleaning solvent contamination are where contaminants have been detected above unrestricted use standards.

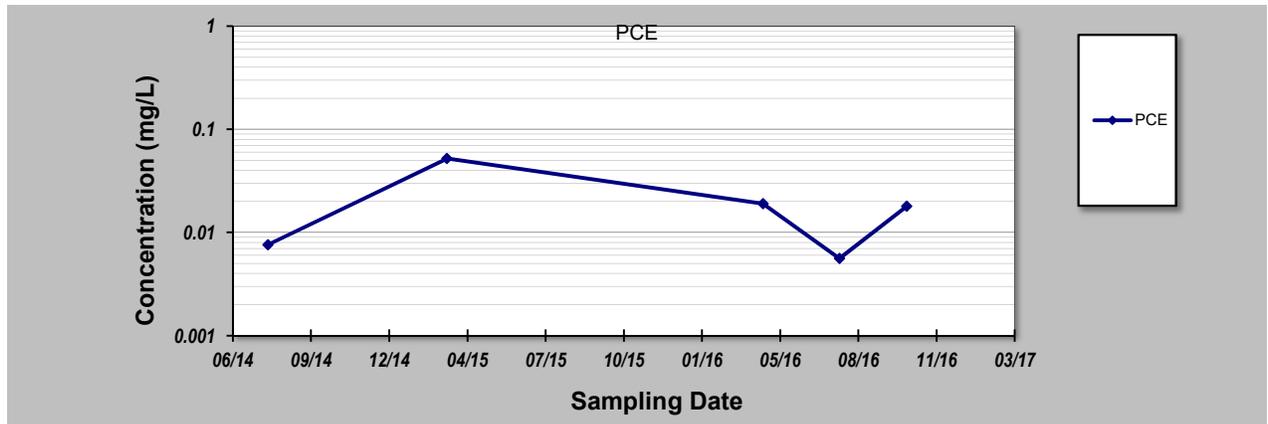
Sampling Event	Sampling Date	MW-3 CONCENTRATION (mg/L)							
1	07/25/14	0.0076							
2	03/11/15	0.0520							
3	04/18/16	0.019							
4	07/25/16	0.0056							
5	10/19/2016	0.018							
6									
7									
8									
9									
10									
11									
12									
13									
14									
15									
16									
17									
18									
19									
20

Coefficient of Variation:	0.91
Mann-Kendall Statistic (S):	-2
Confidence Factor:	59.2%
Concentration Trend:	Stable

ATC utilized the GSI Mann-Kendall Toolkit for Constituent Trend Analysis (Version 1.0, November 2012) to evaluate the stability of PCE and vinyl chloride concentrations. Monitoring wells MW-3, MW-5, MW-6, MW-7, and MW-10 were used to analyze trends for PCE and its degradation products. The results of this evaluation indicated "stable" trends for PCE in wells MW-3 and MW-5. Trends could not be calculated for wells MW-6 and MW-7 due to the limited number of monitoring events. There was no discernable trend for vinyl chloride in MW-10. Where a trend was not identified or unable to be identified, ATC manually reviewed the data. Based on the review, ATC concludes trends appear stable or decreasing for PCE in MW-6 and MW-7 and for vinyl chloride in MW-10.

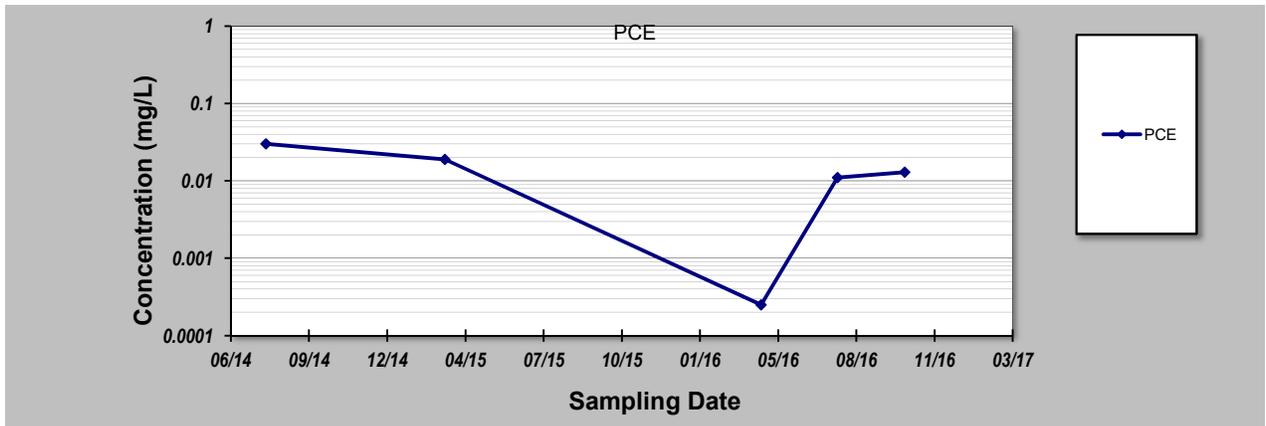
Evaluation Date: 31-Mar-20	Job ID: DC640005
Facility Name: VIP Cleaners	Constituent: MW-5
Conducted By: ATC Associates of North Carolina, P.C.	Concentration Units: mg/L

Sampling Event	Sampling Date	MW-5 CONCENTRATION (mg/L)							
1	07/25/14	0.03							
2	03/11/15	0.019							
3	04/18/16	0.00025							
4	07/25/16	0.011							
5	10/19/2016	0.013							
6									
7									
8									
9									
10									
11									
12									
13									
14									
15									
16									
17									
18									
19									
20									
Coefficient of Variation:		0.75							
Mann-Kendall Statistic (S):		-4							
Confidence Factor:		75.8%							
Concentration Trend:		Stable

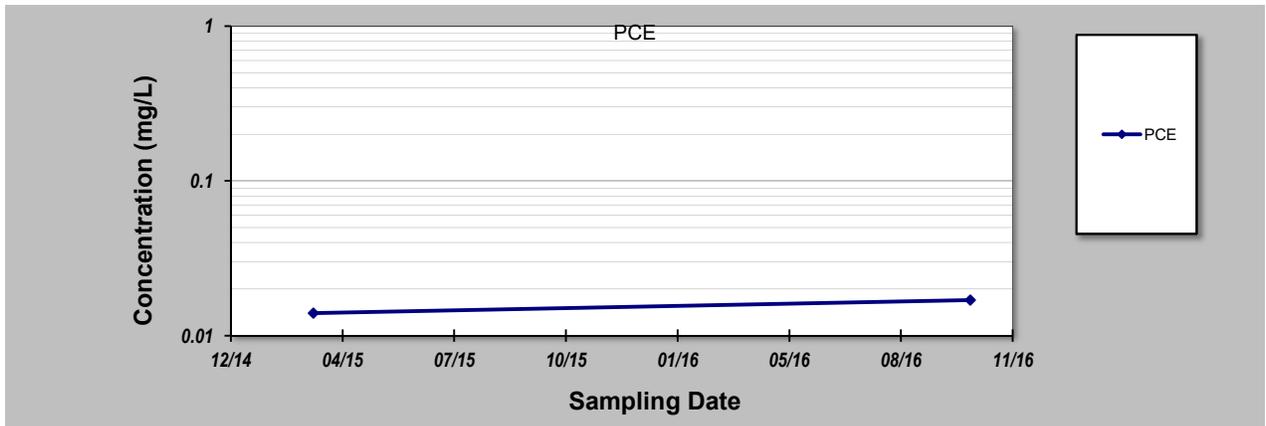
Evaluation Date: 31-Mar-20	Job ID: DC640005
Facility Name: VIP Cleaners	Constituent: MW-6
Conducted By: ATC Associates of North Carolina, P.C.	Concentration Units: mg/L

Sampling Event	Sampling Date	MW-6 CONCENTRATION (mg/L)							
1	03/11/15	0.014							
2	10/19/2016	0.017							
3									
4									
5									
6									
7									
8									
9									
10									
11									
12									
13									
14									
15									
16									
17									
18									
19									
20									
Coefficient of Variation:		0.14							
Mann-Kendall Statistic (S):		1							
Confidence Factor:									
Concentration Trend:

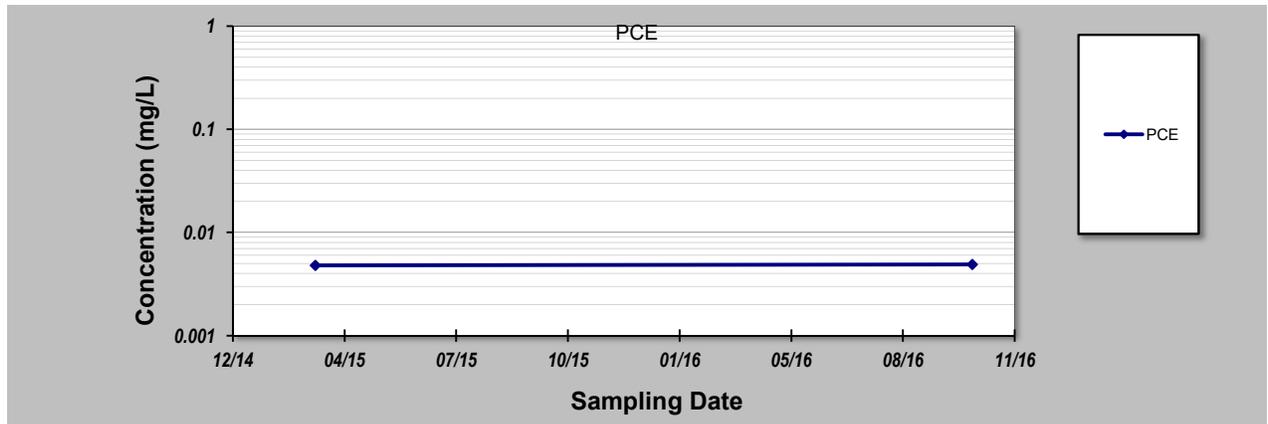
Sampling Event	Sampling Date	MW-7 CONCENTRATION (mg/L)						
1	03/11/15	0.0048						
2	10/19/2016	0.0049						
3								
4								
5								
6								
7								
8								
9								
10								
11								
12								
13								
14								
15								
16								
17								
18								
19								
20

Coefficient of Variation: **0.01**
 Mann-Kendall Statistic (S): **1**
 Confidence Factor:
 Concentration Trend:

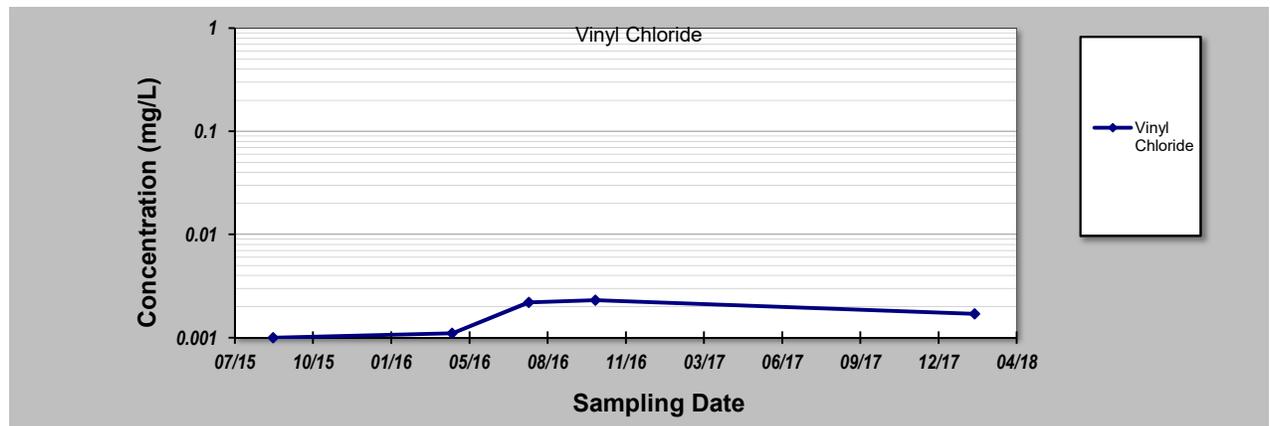
Sampling Point ID: **Vinyl Chloride**

Sampling Event	Sampling Date	MW-10 CONCENTRATION (mg/L)						
1	09/02/15	0.001						
2	04/18/16	0.0011						
3	07/25/16	0.0022						
4	10/18/2016	0.0023						
5	2/15/2018	0.0017						
6								
7								
8								
9								
10								
11								
12								
13								
14								
15								
16								
17								
18								
19								
20								
Coefficient of Variation:		0.36						
Mann-Kendall Statistic (S):		6						
Confidence Factor:		88.3%						
Concentration Trend:		No Trend

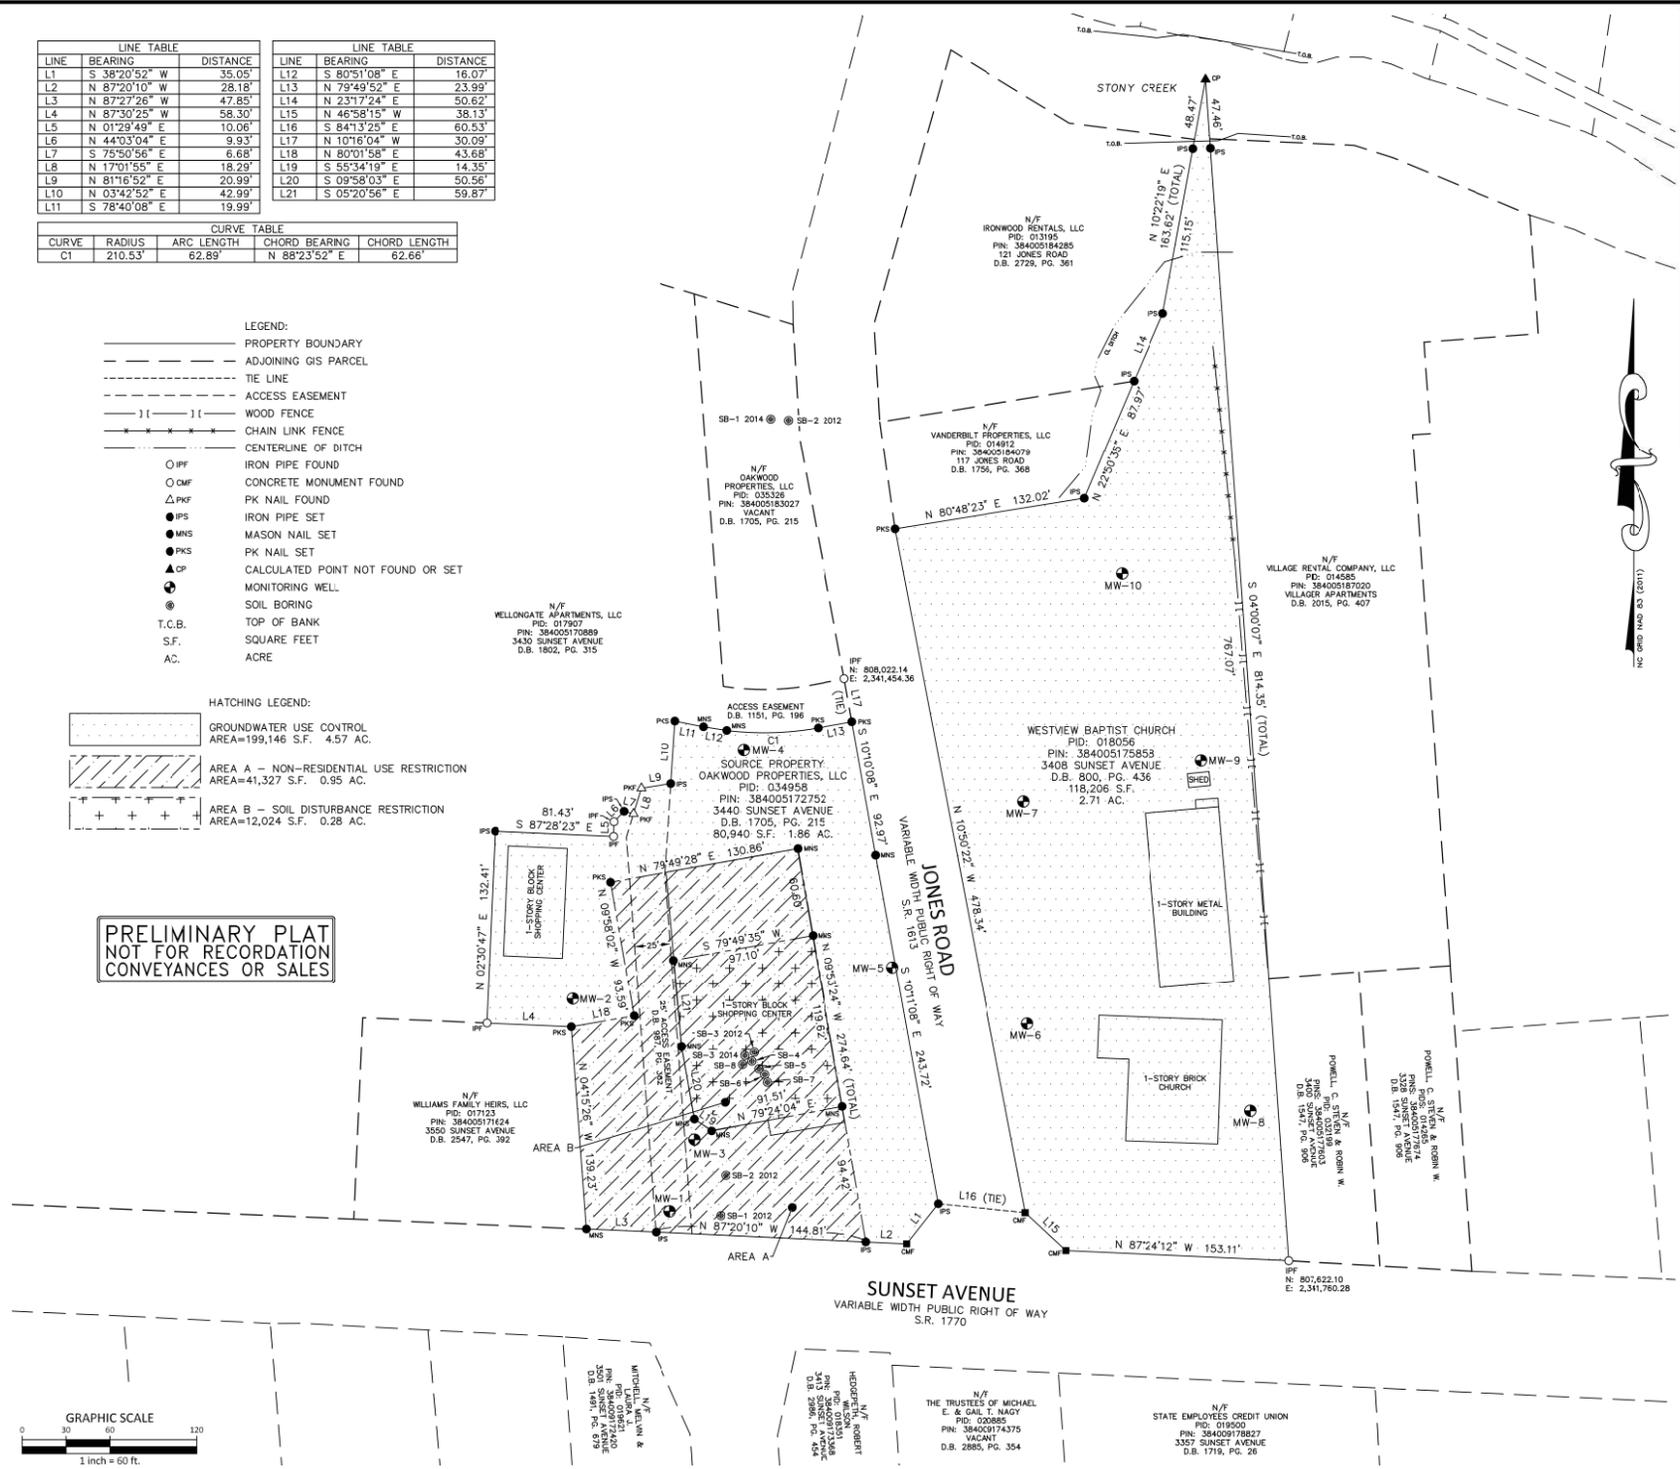
- HATCHING LEGEND:
- Groundwater Use Control
AREA=199,146 S.F. 4.57 AC.
 - AREA A - NON-RESIDENTIAL USE RESTRICTION
AREA=41,327 S.F. 0.95 AC.
 - AREA B - SOIL DISTURBANCE RESTRICTION
AREA=12,024 S.F. 0.28 AC.
