RE: Risk Management Plan
One Hour Koretizing
1691 Northern Boulevard
Rocky Mount, Nash County, North Carolina
DSCA Site ID DC640006

Risk Management Plan
One Hour Koretizing
1691 Northern Boulevard
Rocky Mount, Nash County, NC
DSCA Site ID DC640006

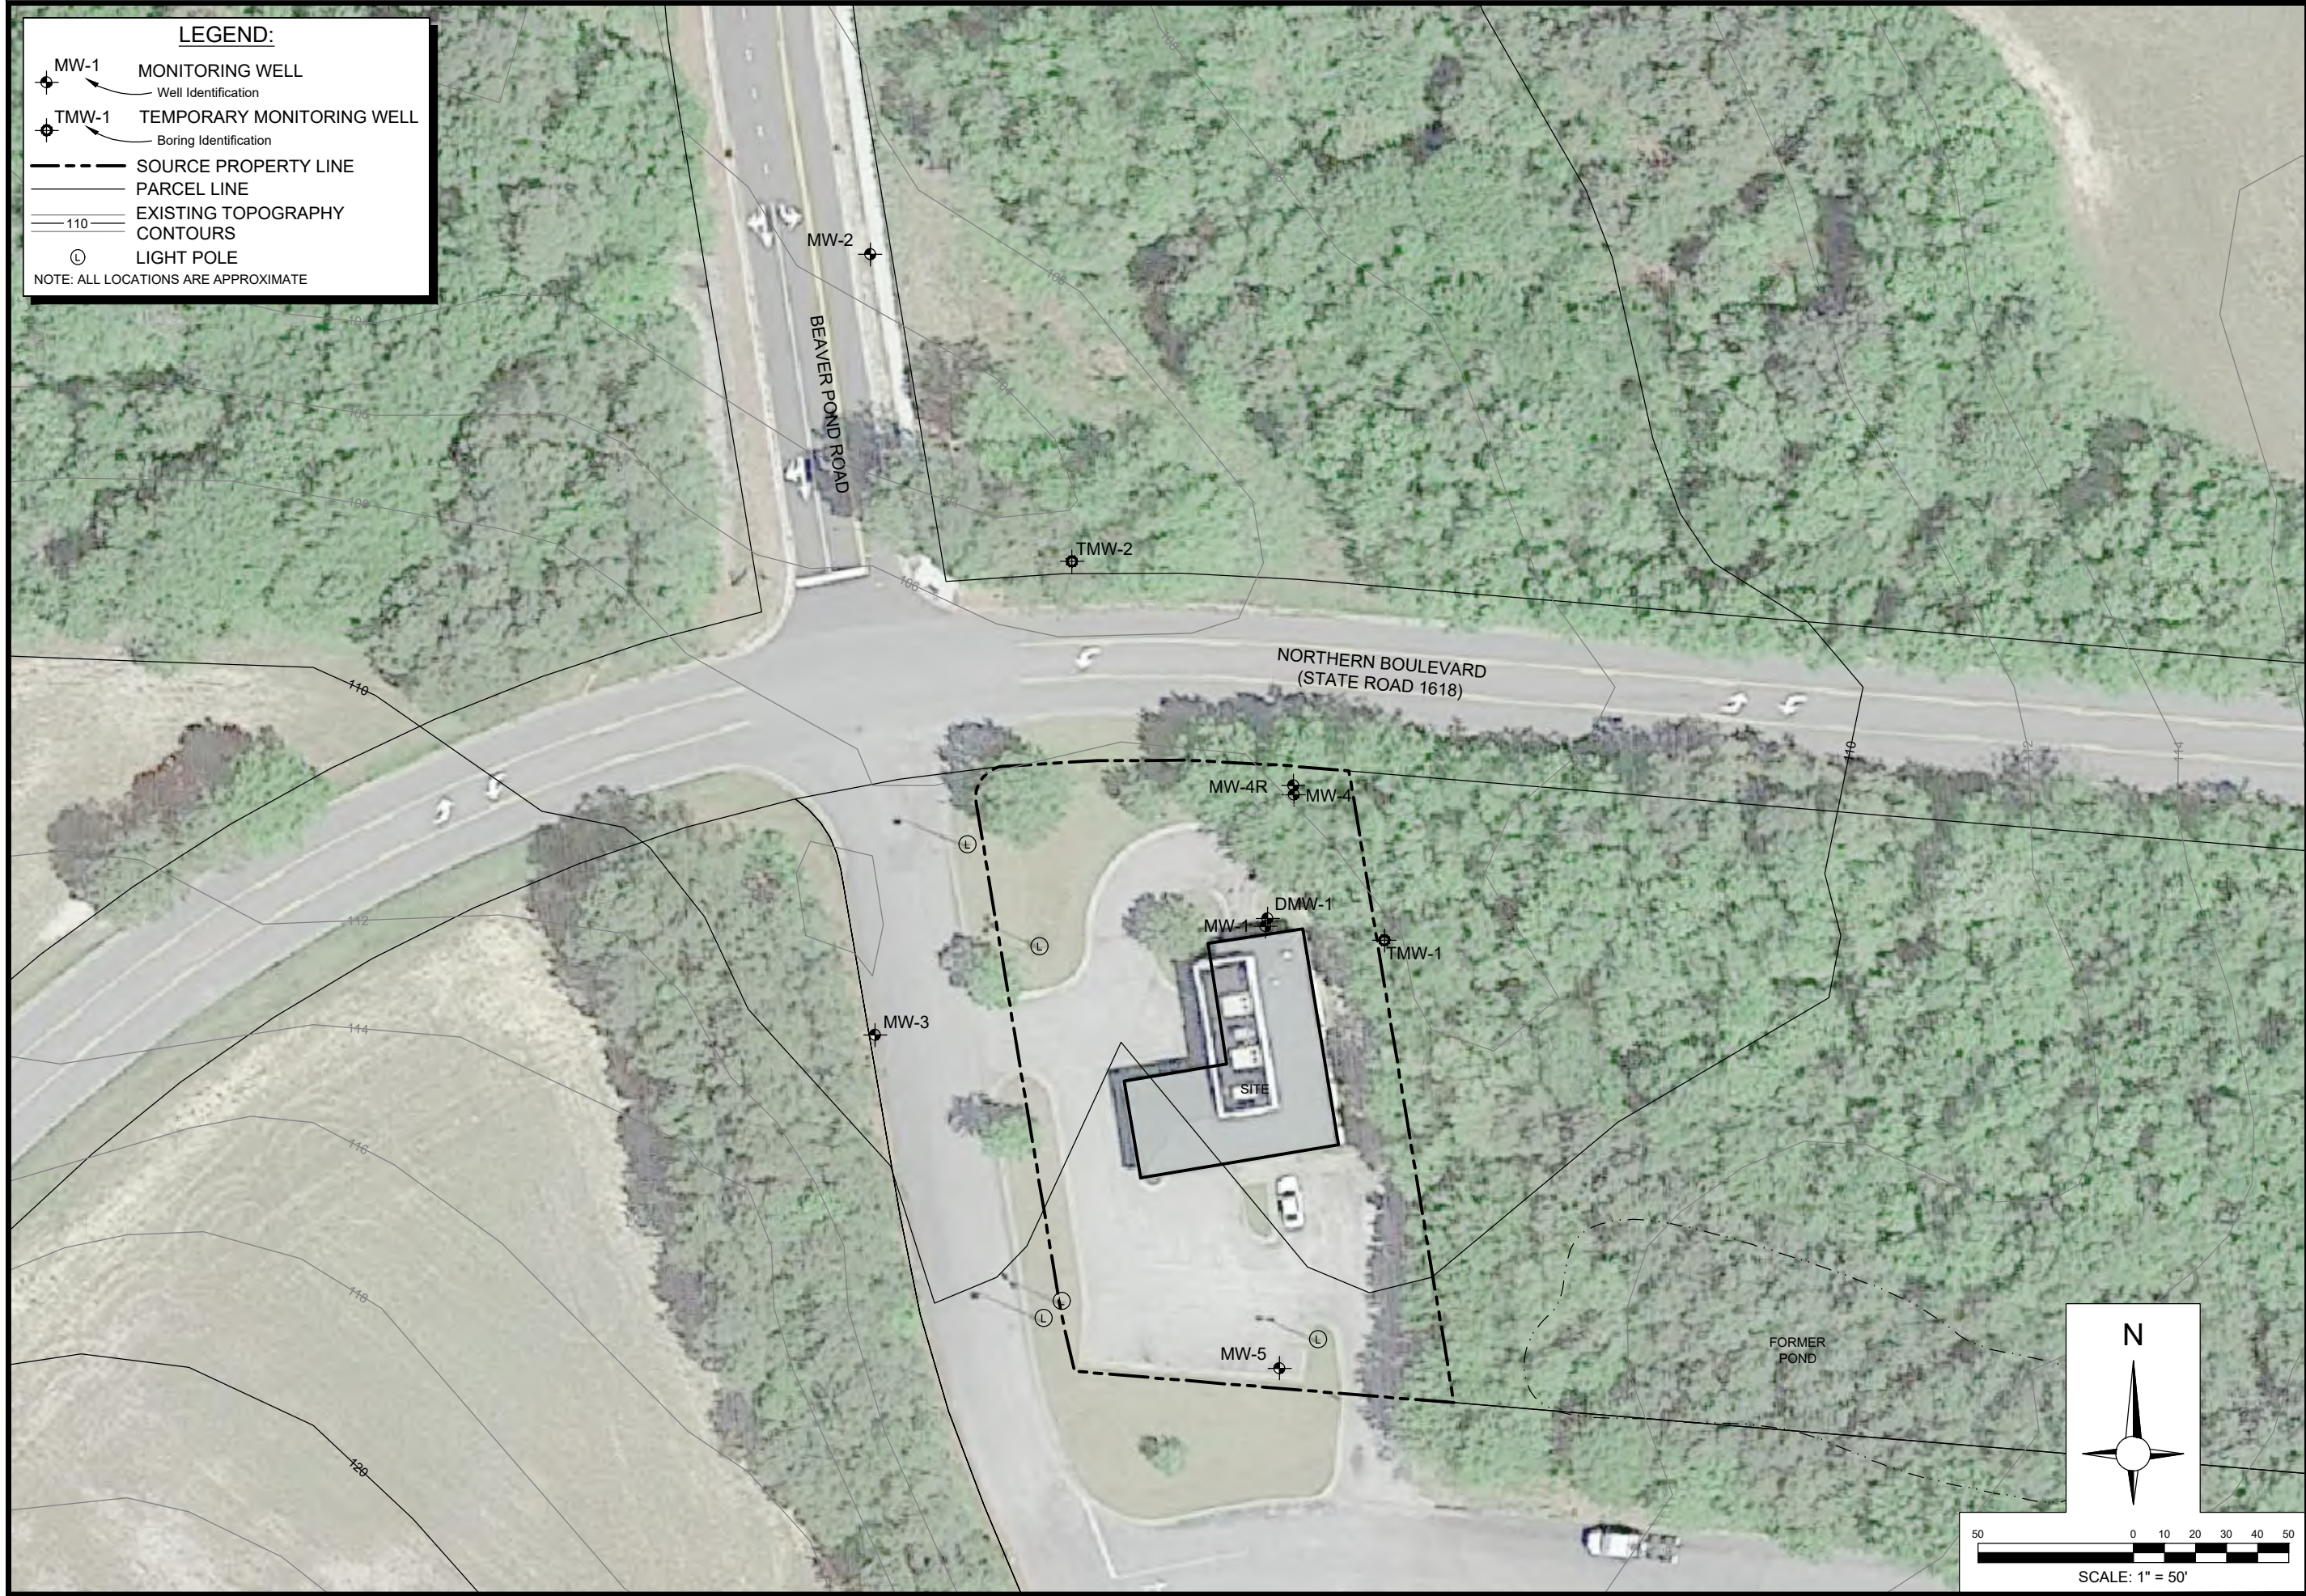
H:\2021\OTHER OFFICES\NORTH CAROLINA\NCDEQ-DWM-DSCA PROGRAM\64-0006 ONE HOUR KORETIZING\DC6406SL04-SITE1.DWG, FIG1

Project Number: DC6406SL04		DSCA ID: DC640006	Drn. By: DH
Drawing File: SEE LOWER LEFT			Ckd. By: AW
			App'd By: Ckd. Date:
NOTES: 1. Features shown are not an authoritative location, nor are they presented to a stated accuracy.			
COORDINATE SYSTEM: NAD 1983 NORTH CAROLINA STATE PLANE FIPS 3200, US SURVEY FEET			
SITE MAP ONE HOUR KORETIZING 1691 NORTHERN BOULEVARD ROCKY MOUNT, NASH COUNTY, NORTH CAROLINA			
Date: 4/21		Figure: 1	
Scale: AS SHOWN

A map showing the site location is included as **Figure 1**. This RMP is intended to comply with the requirements of the DSCA (N.C.G.S. 143-215.104A *et seqs*) and promulgated rules and follows the outline provided in the DSCA Program's risk-based corrective action (RBCA) guidance.

use conditions remain valid in the future. A site map which shows identifying features on the source property is included as *Figure 1*.
