Re: **Risk Management Plan**
Bowen Cleaners - DSCA Site ID DC740004
2480 Stantonsburg Road
Greenville, Pitt County, North Carolina

**Risk Management Plan
Bowen Cleaners - DSCA Site ID DC740004
2480 Stantonsburg Road
Pitt County
Greenville, North Carolina 27834**

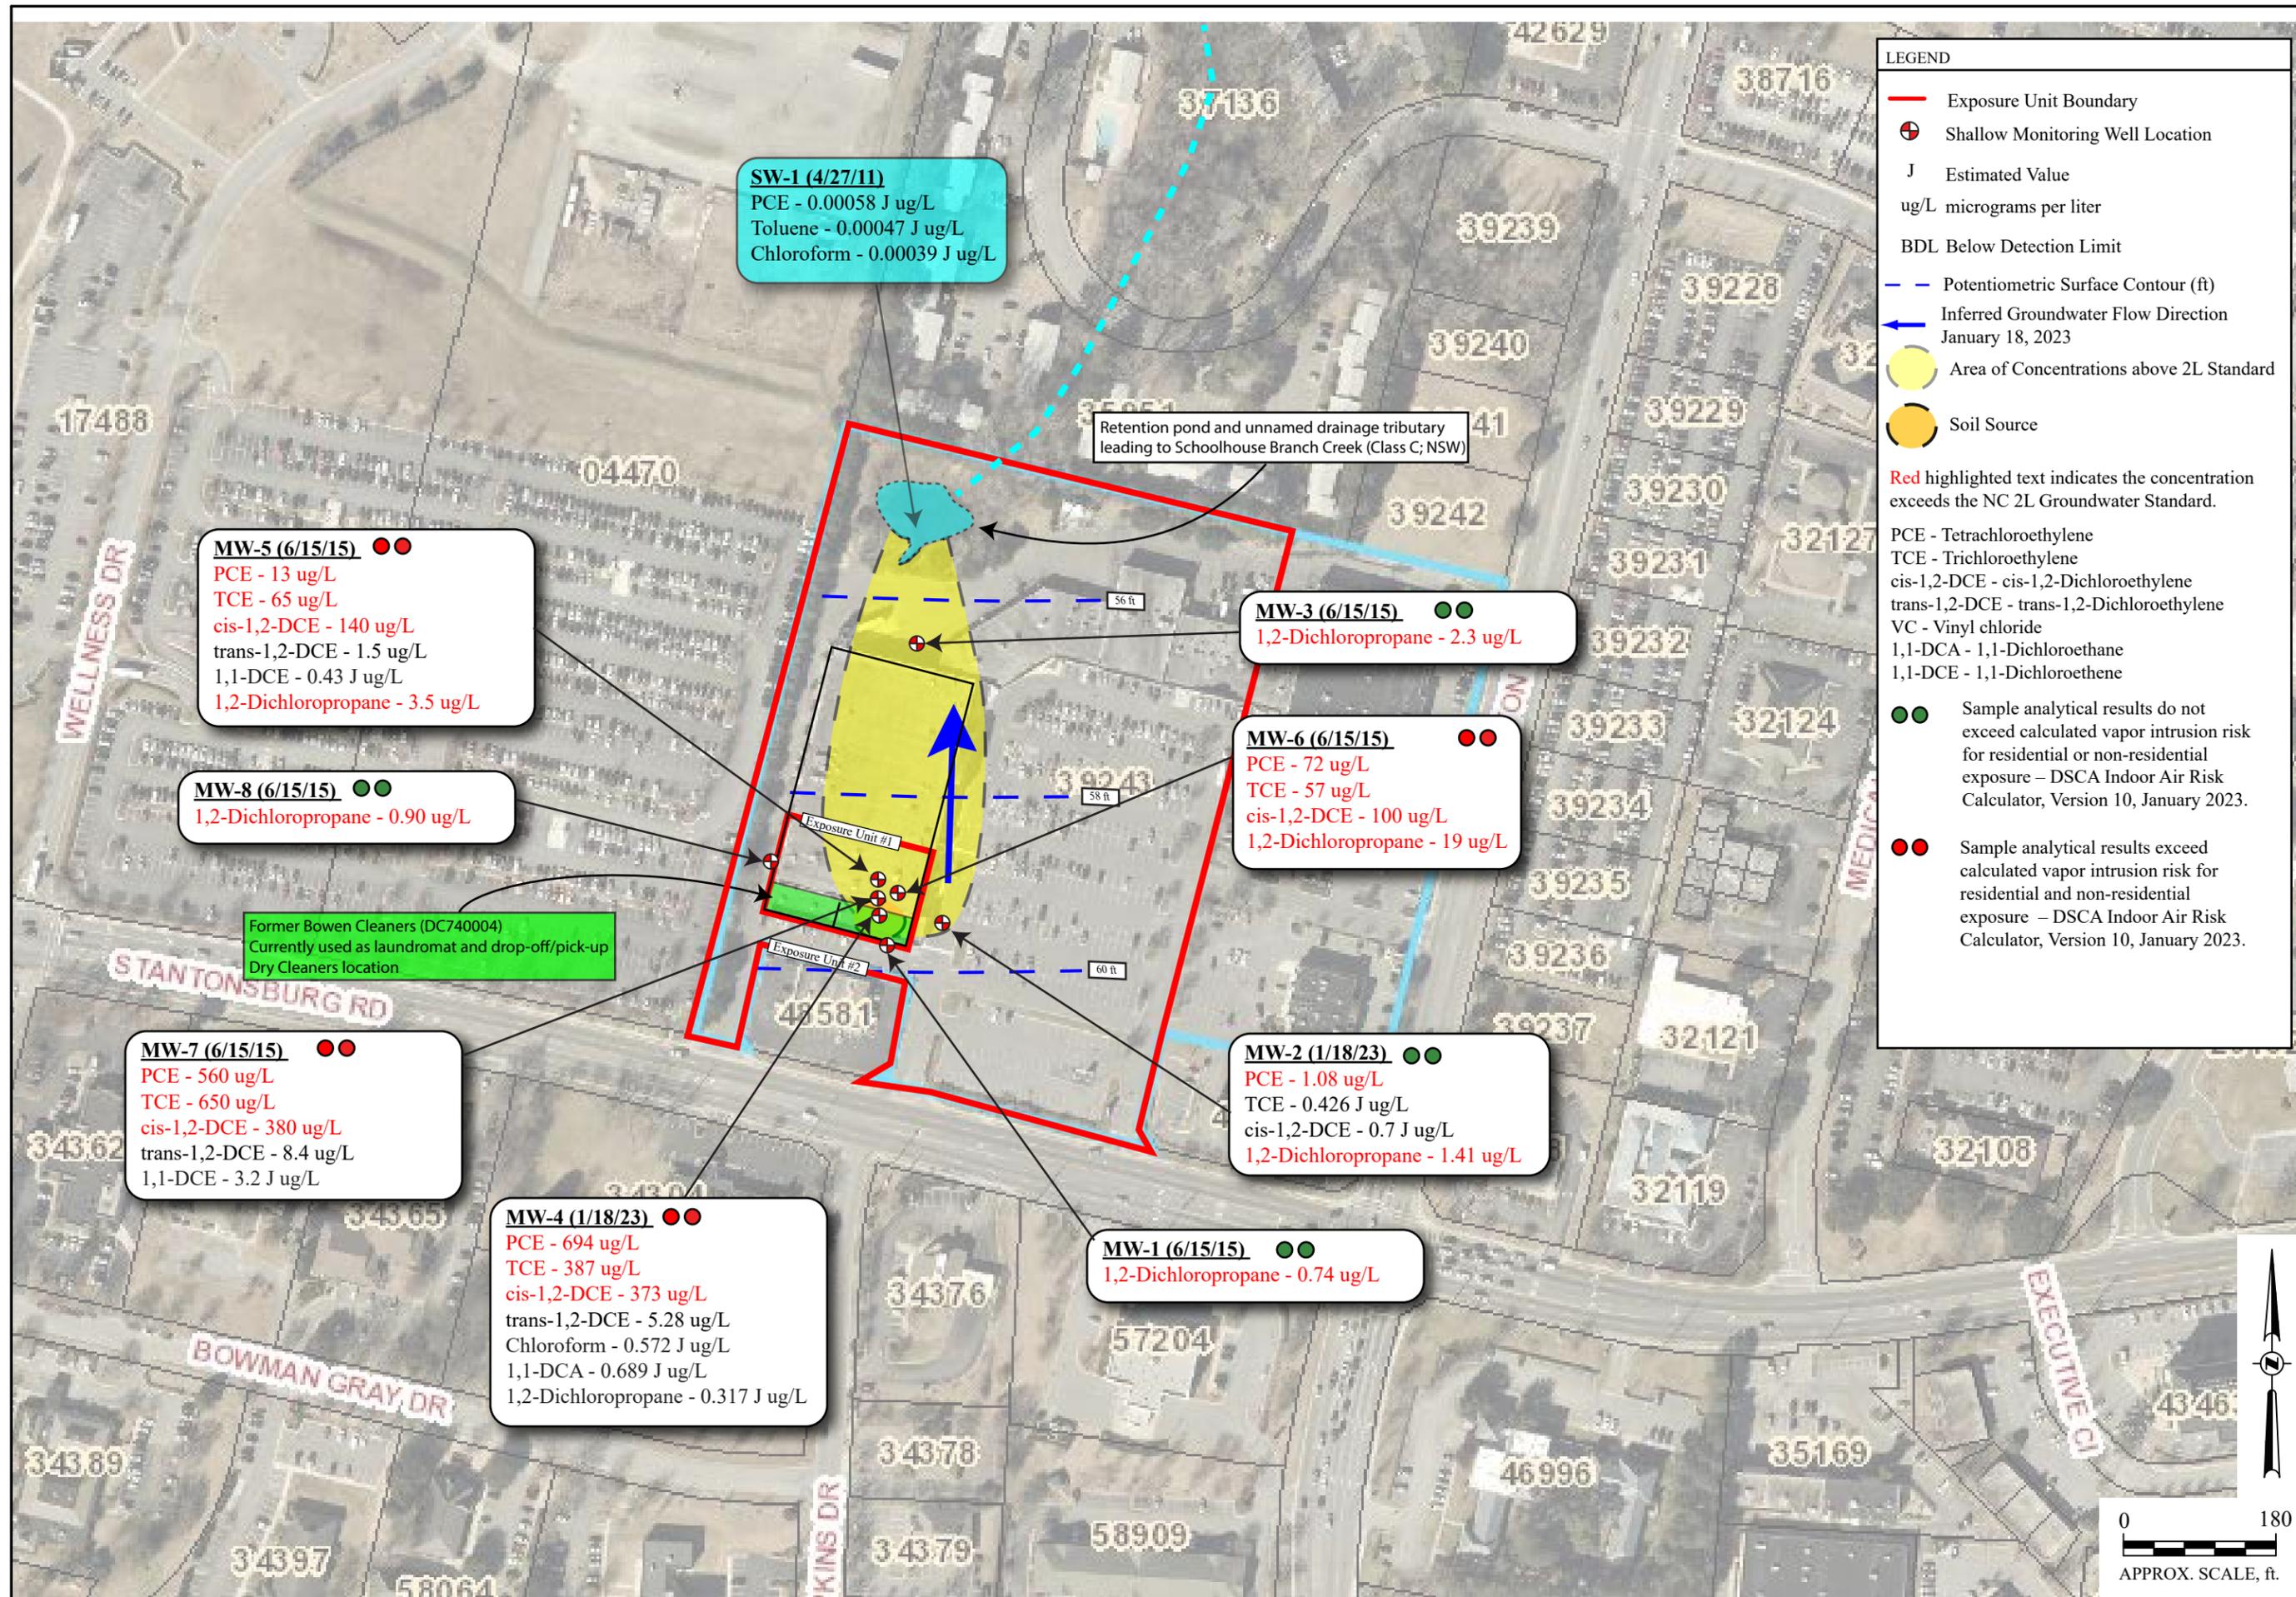
SHEET:
Figure 3

SW-1 (4/27/11)
 PCE - 0.00058 J ug/L
 Toluene - 0.00047 J ug/L
 Chloroform - 0.00039 J ug/L

MW-5 (6/15/15) ●●
 PCE - 13 ug/L
 TCE - 65 ug/L
 cis-1,2-DCE - 140 ug/L
 trans-1,2-DCE - 1.5 ug/L
 1,1-DCE - 0.43 J ug/L
 1,2-Dichloropropane - 3.5 ug/L

Although minor fluctuations in PCE concentrations have occurred during the 13 groundwater monitoring events (2008 to 2023), it appears that plume dynamics have been relatively stable over the last few monitoring events. It should be noted that although an increasing PCE and TCE concentration trend was calculated at monitoring well MW-5, while monitoring wells MW-4, MW-6 and MW-7 which are all located within close proximity to monitoring well MW-5, and which all exhibit significantly greater levels of PCE and TCE concentrations, did not indicate increasing trends. It is uncertain to the reason of the increasing contaminant concentration trend observed for low level contamination present at monitoring well MW-5. Based on the stable and decreasing trends observed at surrounding monitoring wells MW-4, MW-6 and MW-7 it is possible that the increasing trend observed at monitoring well MW-5 may just be a temporal minor fluctuation in a larger decreasing trend. However, in comparison to the decreasing or stable contaminant concentration trends observed in other monitoring wells at the site which

AECOM utilized the Mann-Kendall Analysis for the sampling events, which are included in Appendix A. As shown on the Mann-Kendall Analysis plots, groundwater impacts beneath the Stanton Square Shopping Center/Bowen Cleaners property are “Stable” for PCE concentrations with the exception of monitoring well MW-5. As documented in Section 4.1, it is uncertain to the reason of the increasing contaminant concentration trend observed for low level contamination present at monitoring well MW-5. Based on the stable and decreasing trends observed at surrounding monitoring wells MW-4, MW-6, and MW-7 it is possible that the increasing trend observed at monitoring well MW-5 may just be a temporal minor fluctuation in

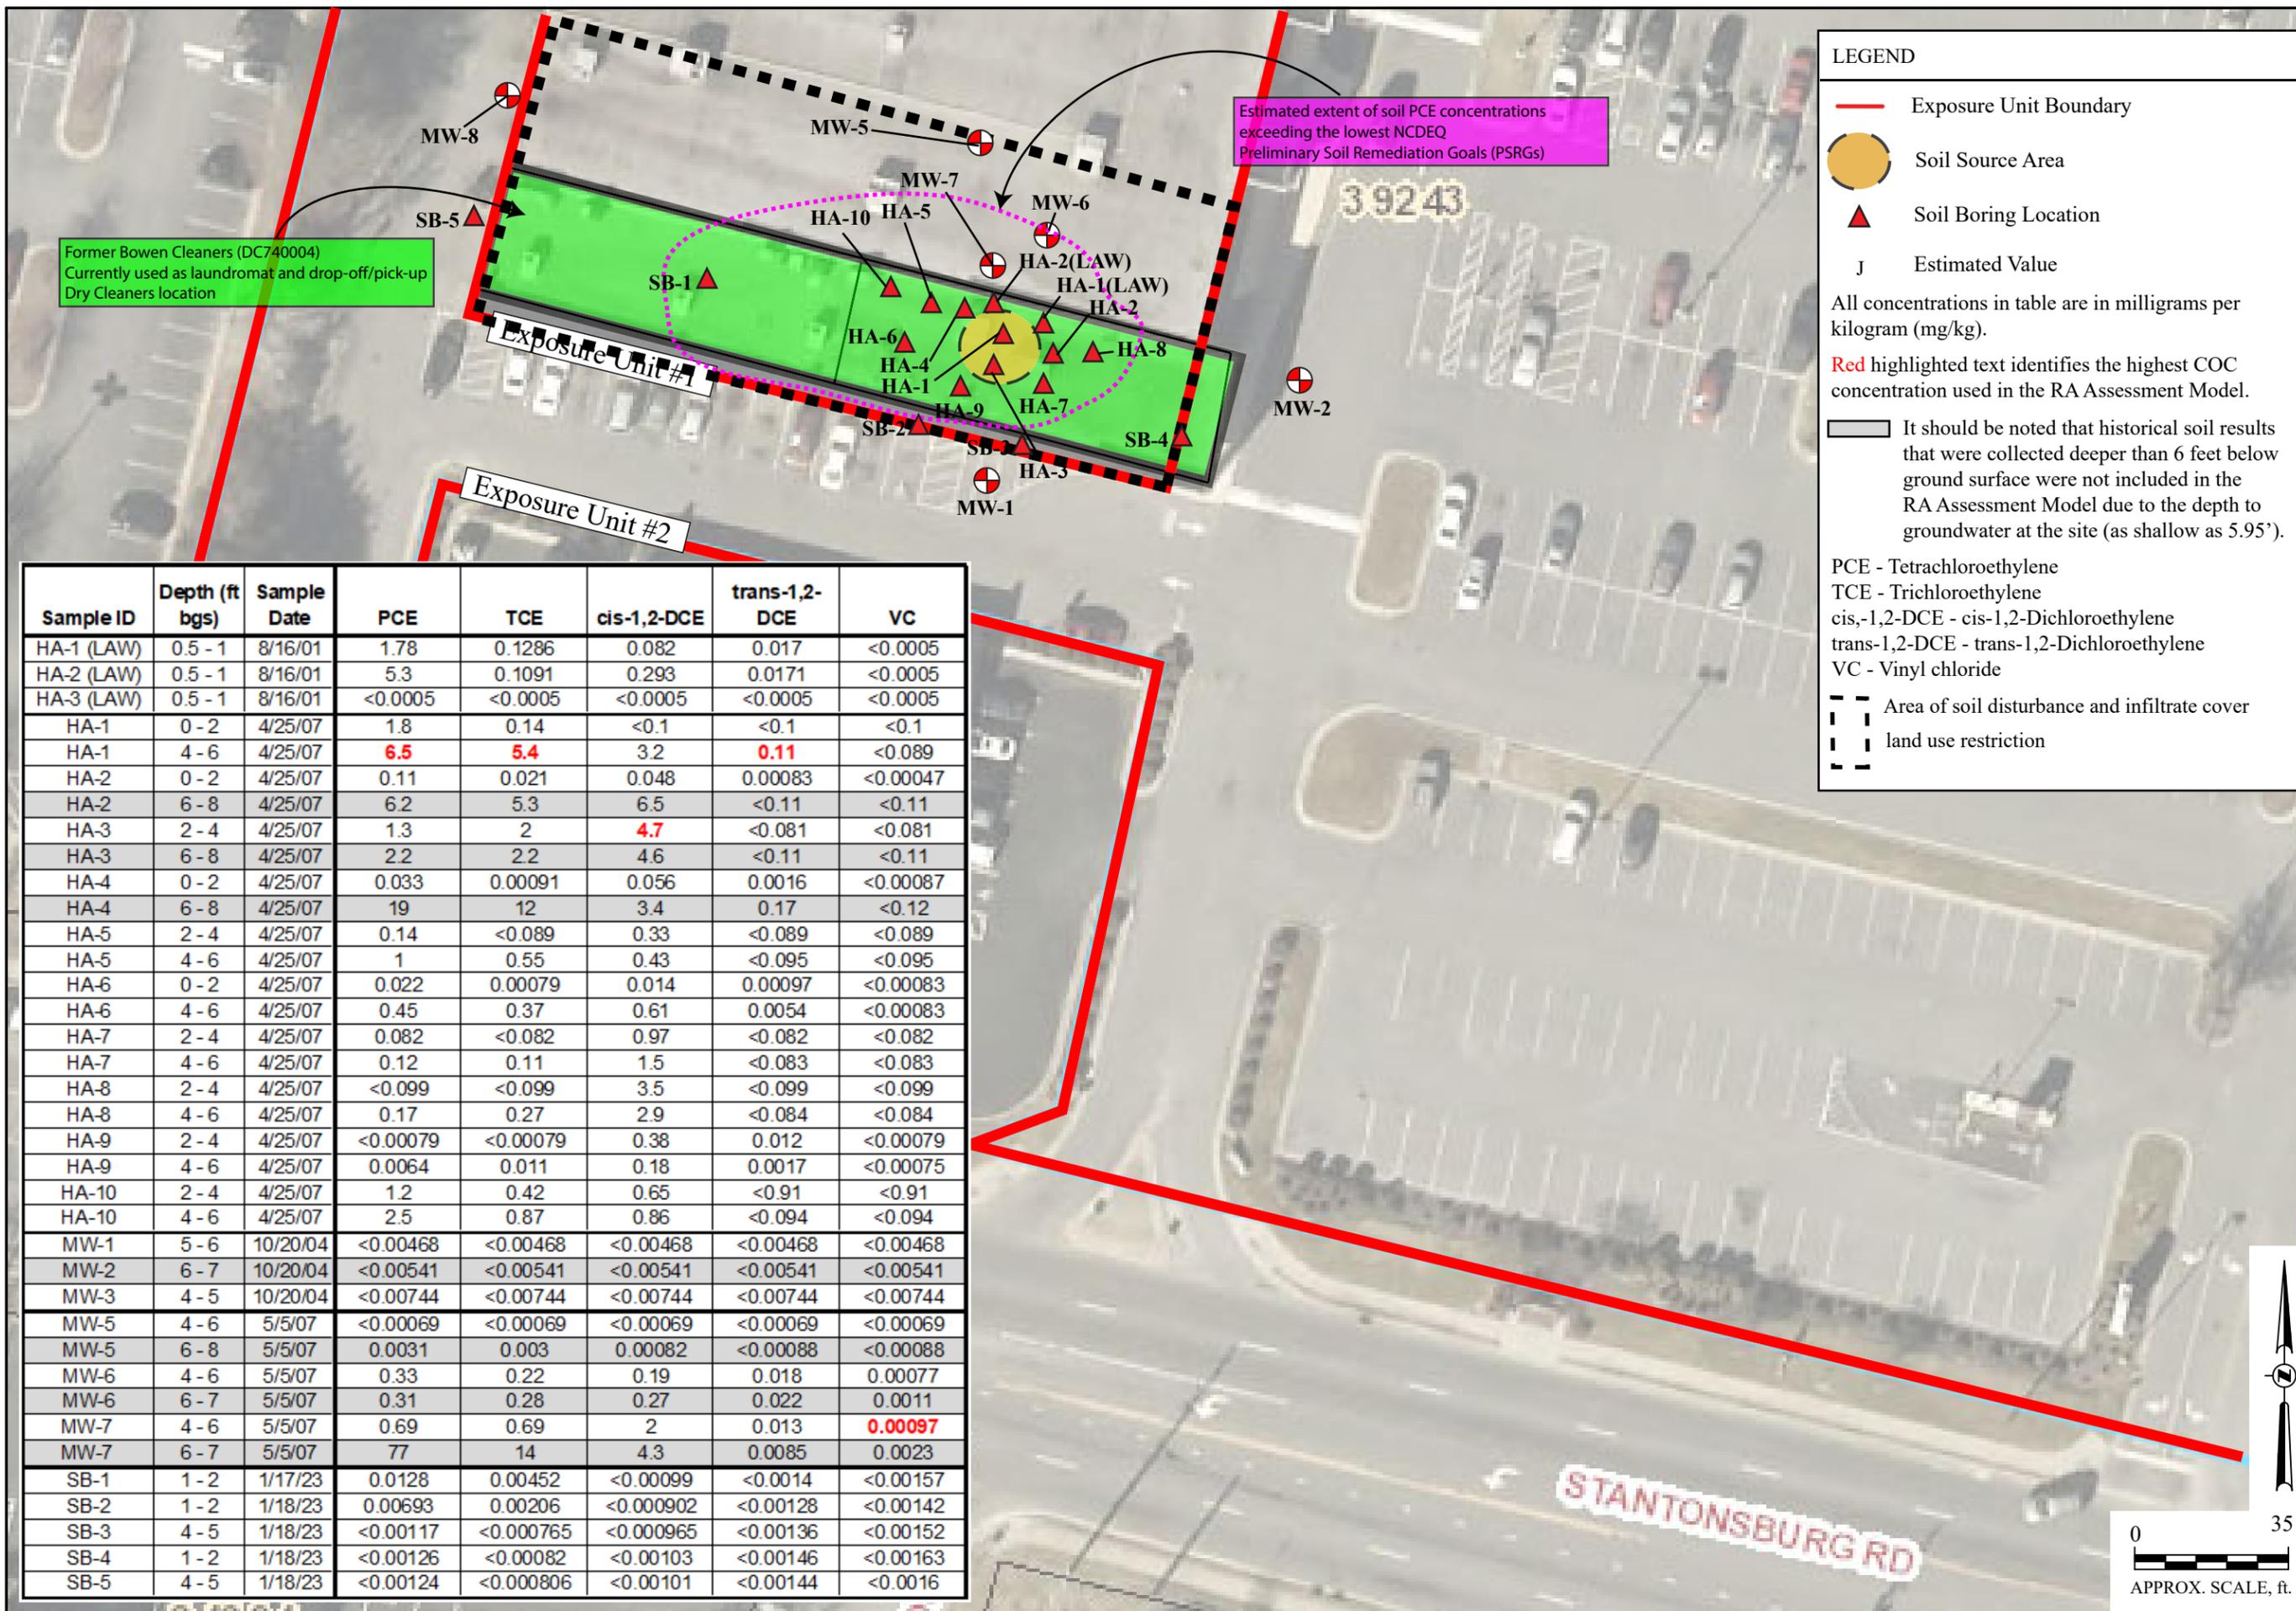
Figure 4

Soil Quality Summary Map
Bowen Cleaners
2480 Stantonsburg Road
Greenville, NC
DSCA Site ID DC740004

- **Soil Combined Exposure Pathways** – For the soil combined pathways evaluation, soil quality data was used to evaluate current and future risk. The maximum soil contaminant concentrations detected within EU#1 were conservatively used as EPC's for COC's. Soil combined risk was evaluated using the NCDEQ Risk Calculator (January 2023) for current and future conditions (residential and non-residential). Soil combined pathway risk levels did not exceed calculated acceptable risk for current or future residential and non-residential worker conditions. However, soil contamination concentrations exceed NCDEQ PSRGs in EU#1, as indicated on **Figure 4**. Therefore, this can be addressed through the imposition of a land-use control whereupon soil in **Area A** of EU#1 as indicated on **Figure 6C** may not be removed or disturbed unless approved in writing in advance by NCDEQ or its successor in function. No other land-use controls are necessary to address the Soil Combined Exposure Pathway in **Area A** of EU#1.

As soil contaminant concentrations in **Area A** of EU#1 exist at levels above the SSTLs for PCE and TCE, an infiltrate cover must be maintained over the source area to minimize infiltration of rain or water runoff unless approved in writing in advance by NCDEQ. As further detailed in **Section 6.0**, institutional controls will also be implemented to ensure that land-use conditions are maintained and monitored until the land-use controls are no longer required for the Bowen Cleaners (DSCA Site ID DC740004) site.

- Soil in **Area A** as shown on **Figure 6C** may not be removed or disturbed unless approved in writing in advance by DEQ or its successor in function, except for routine landscape maintenance and emergency utility repair. In the event of emergency utility repair, DEQ shall be given written notice of any such emergency repair no later than the next business day, and further related assessment and remedial measures may be required.

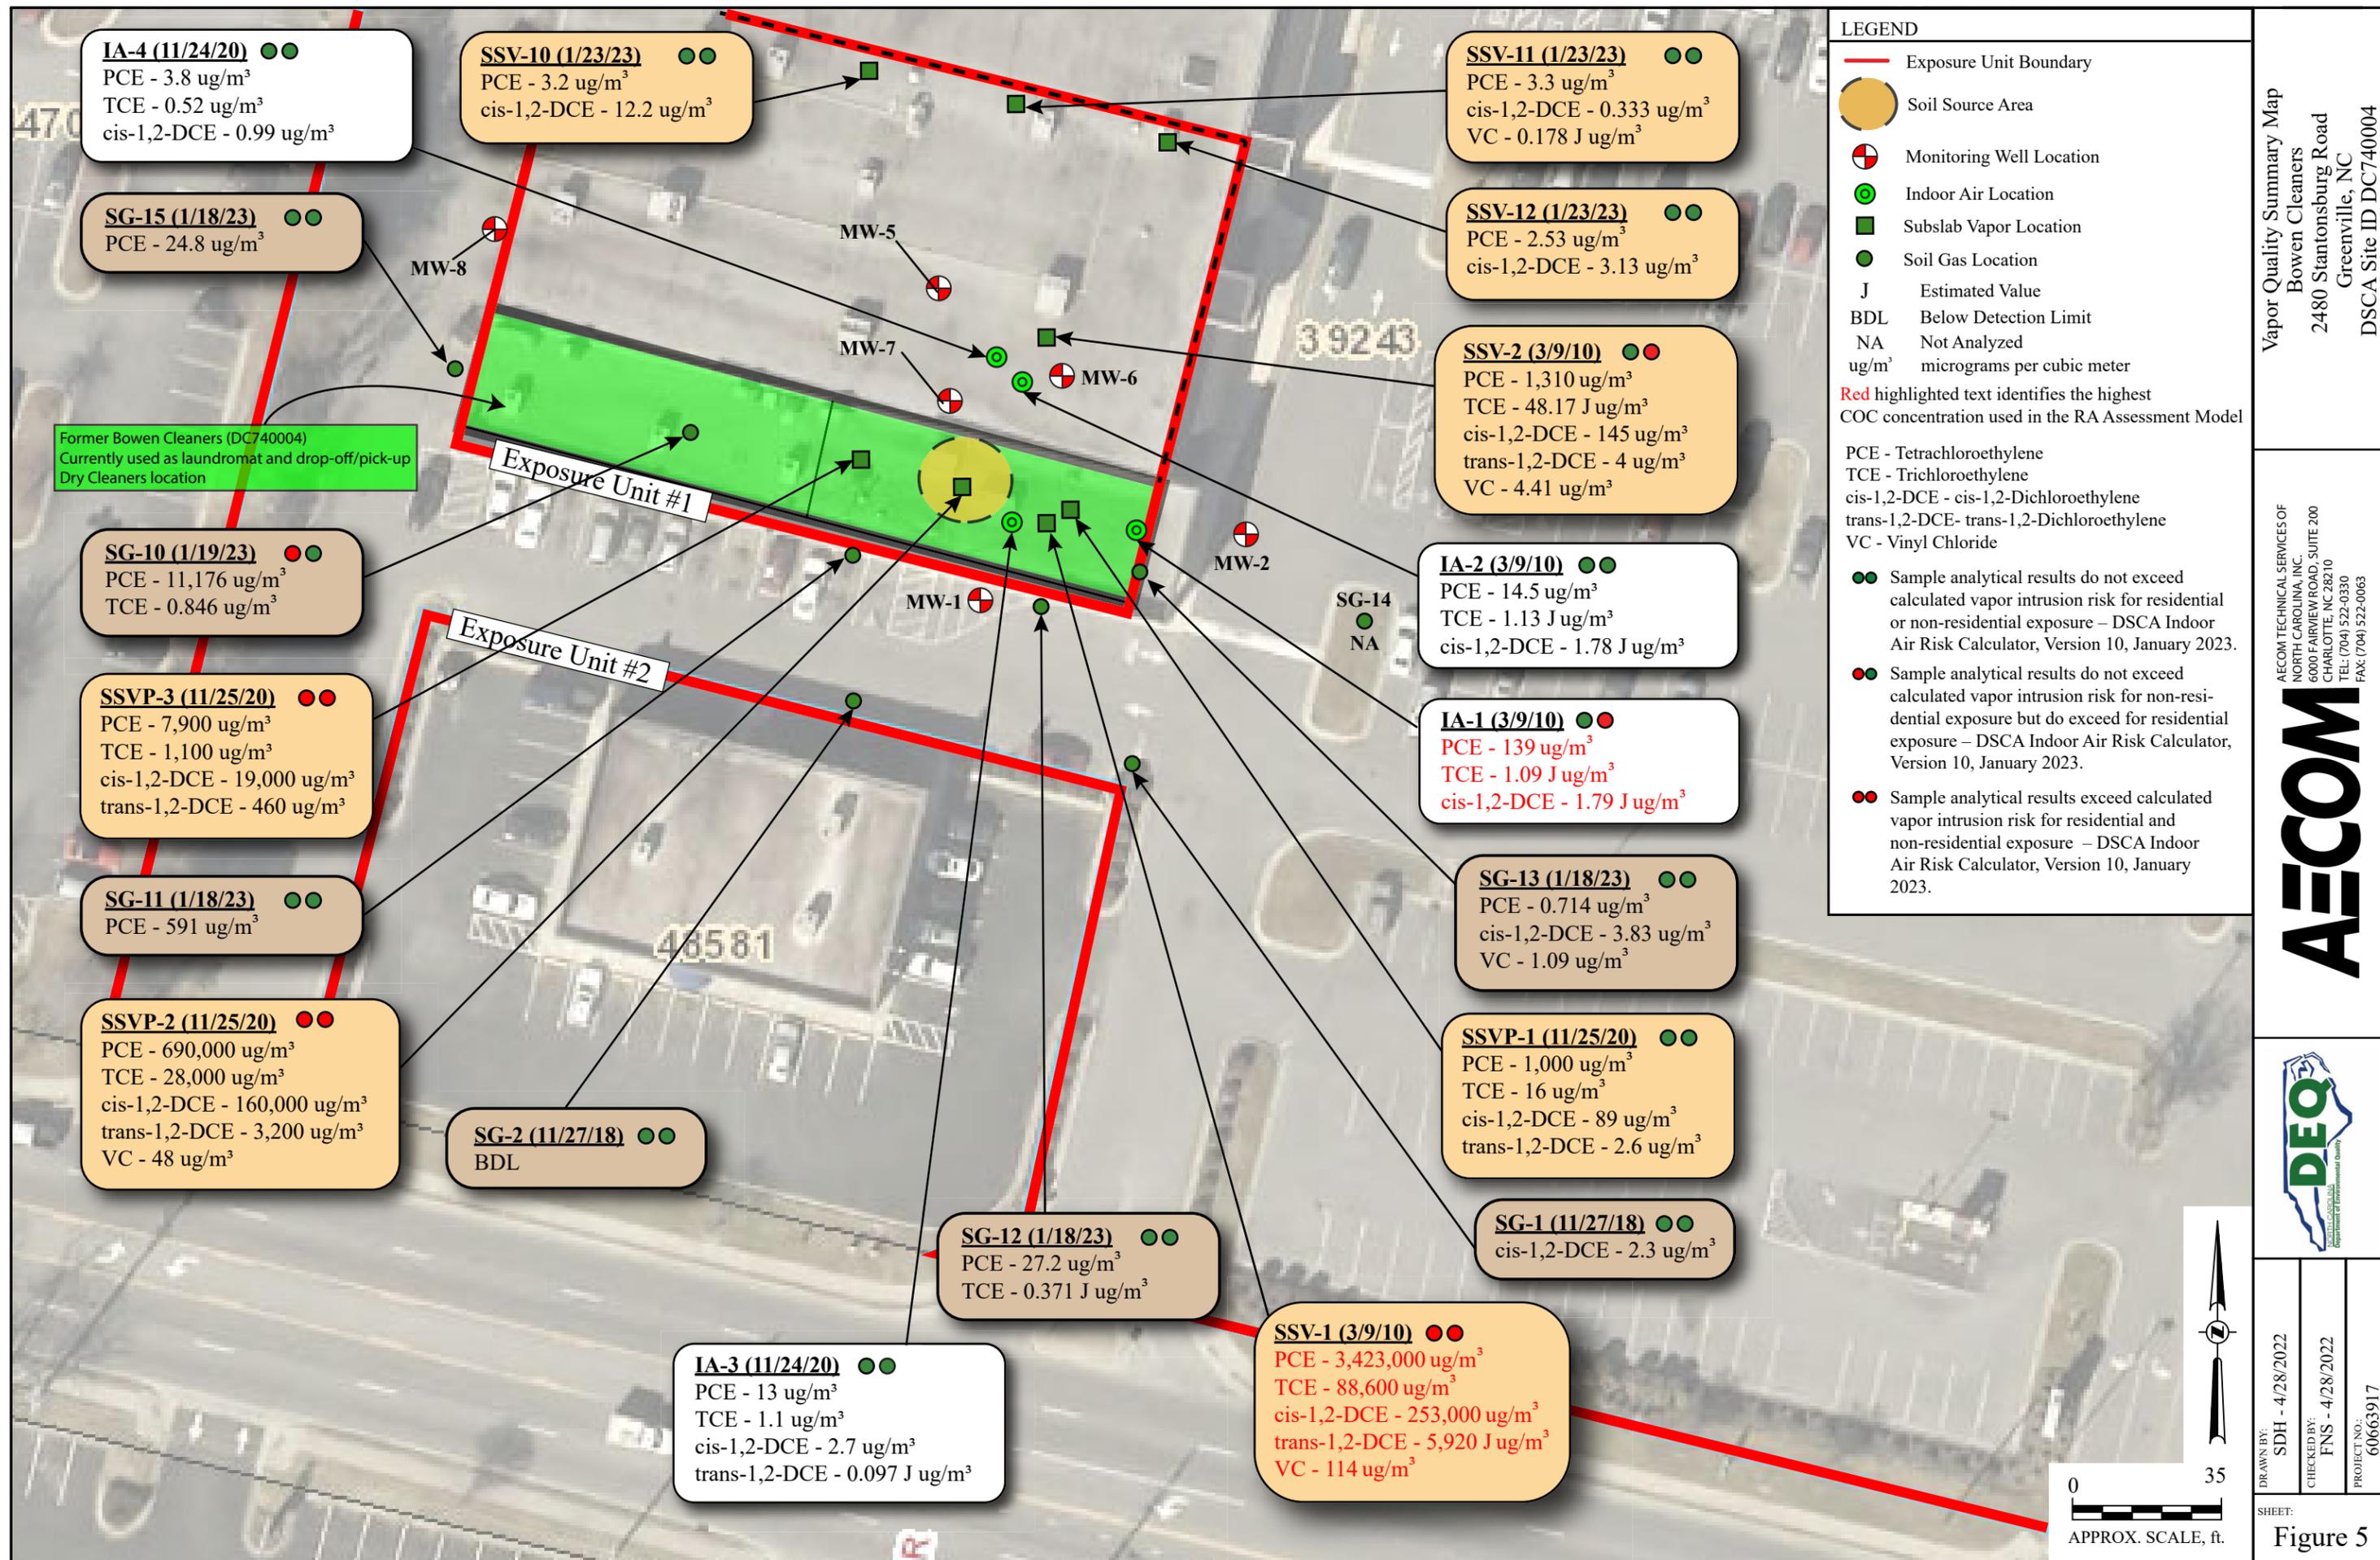
IA-4 (11/24/20) ●●
 PCE - 3.8 ug/m³
 TCE - 0.52 ug/m³
 cis-1,2-DCE - 0.99 ug/m³

SSV-10 (1/23/23) ●●
 PCE - 3.2 ug/m³
 cis-1,2-DCE - 12.2 ug/m³

- **Indoor Inhalation of Vapor Emissions** – For the indoor inhalation of vapor emissions exposure pathway, indoor air data was used to evaluate current risk and soil gas vapor data was used to evaluate future risk. The maximum indoor air and soil gas contaminant concentrations detected within EU#1 were conservatively used as exposure point concentrations (EPC's) for contaminants of concern (COC's) to evaluate the vapor intrusion pathway using the NCDEQ Risk Calculator (January 2023) for current and future conditions (residential and non-residential). As indicated on **Figure 5**, the risk assessment results were within acceptable risk levels for current non-residential worker land-use conditions based on indoor air contaminant concentrations. However, the risk assessment results were not within acceptable risk levels for the indoor air inhalation exposure pathway for residential or non-residential worker use under future conditions based on soil gas contaminant concentrations. The future indoor air inhalation exposure pathway in EU#1, designated on **Figure 6B** can be addressed through the imposition of

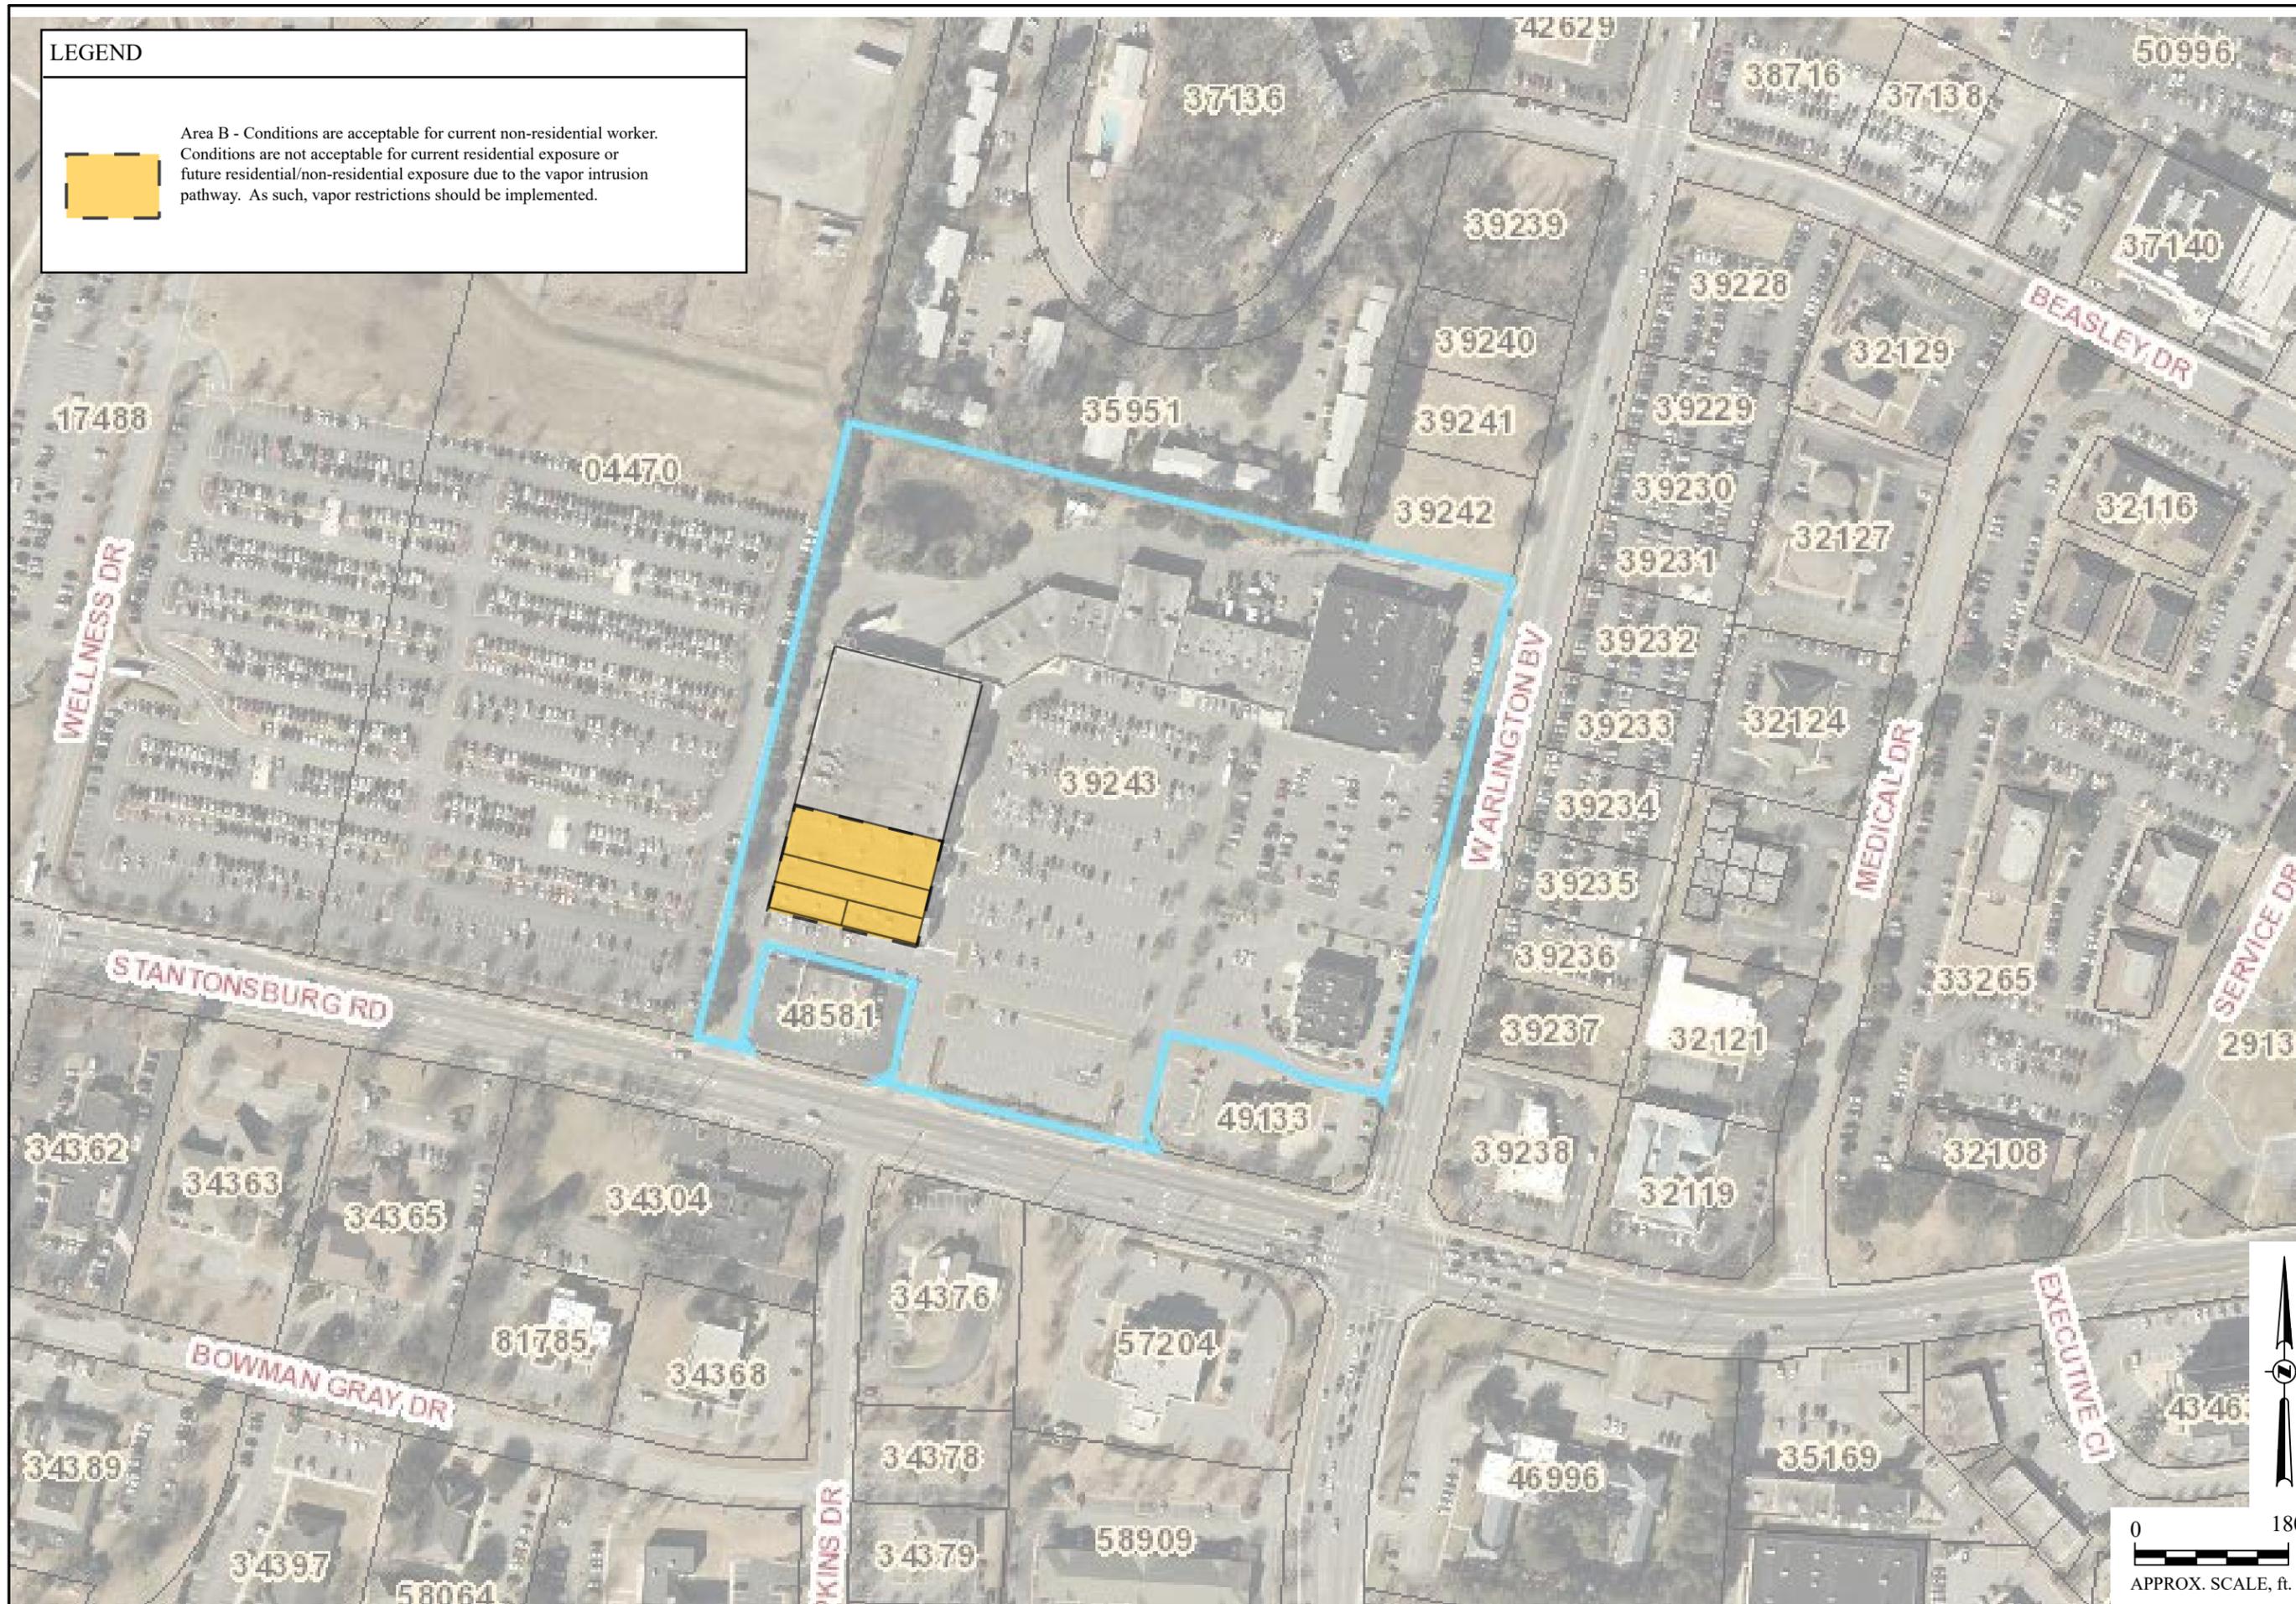
Land Use Restriction Map 2
Bowen Cleaners
2480 Stantonsburg Road
Greenville, NC
DSCA Site # DC740004

Area B - Conditions are acceptable for current non-residential worker. Conditions are not acceptable for current residential exposure or future residential/non-residential exposure due to the vapor intrusion pathway. As such, vapor restrictions should be implemented.

- Any activities within **Area B** of the source property as shown on **Figure 6B**, that cause or create a VI risk should not be completed without prior approval of NCDEQ, as detailed below:

- Except for routine maintenance, no construction activities or change in property use that cause or create an unacceptable human health risk from vapor intrusion may occur on the Property without prior approval of the NCDEQ. These activities include but are not limited to: construction of new buildings, removal and construction of part of a building, construction of sub-grade structures that encounter contaminated soil or places building users in close proximity to contaminated groundwater, change from non-residential to residential property, change in tenant space usage, and addition of residential property use on higher floors.

- Structural modifications that may cause or create an increased risk from vapor intrusion require the property owner to demonstrate to the satisfaction of the NCDEQ that the indoor air in the structure does not pose an unacceptable risk to the occupants following modifications. These modifications include but are not limited to: modification or replacement of heating, ventilation or air conditioning (HVAC) systems, removal or replacement of the building slab, installation of multiple conduits or piping through the building slab, modifications to building walls or ceilings that may change air flow.

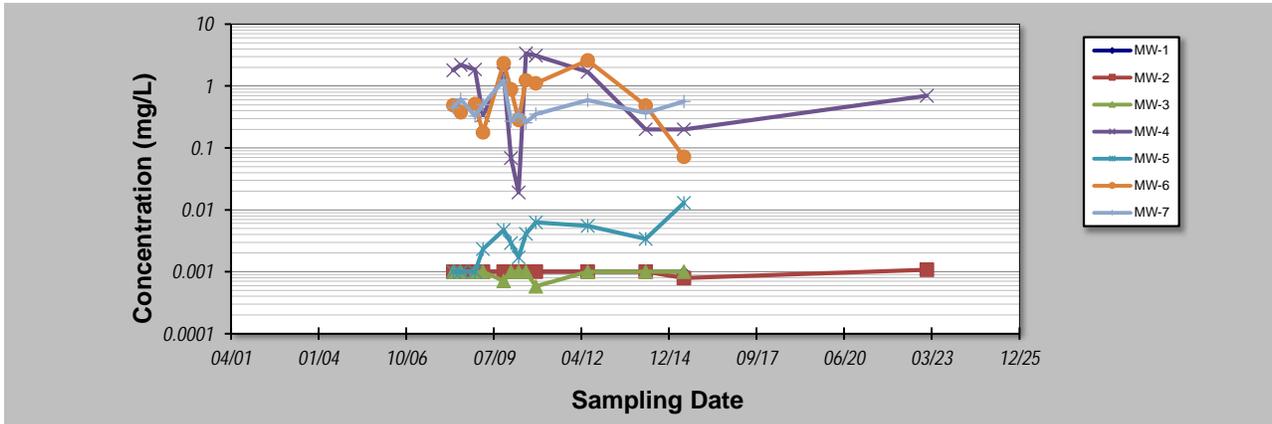
| Sampling Point ID: | MW-1 | MW-2 | MW-3 | MW-4 | MW-5 | MW-6 | MW-7 | |
|---|---|---|---|---|---|---|---|---|
| Confidence Factor: | 47.3% | 50.0% | 55.4% | 83.2% | 99.9% | 58.0% | 52.7% | |
| Concentration Trend: | Stable | No Trend | Stable | Stable | Increasing | No Trend | Stable | |

a larger decreasing trend. However, in comparison to the decreasing or stable contaminant concentration trends observed in other monitoring wells at the site which exhibit more significant contaminant concentrations, it is AECOM's opinion that the plume is stable.

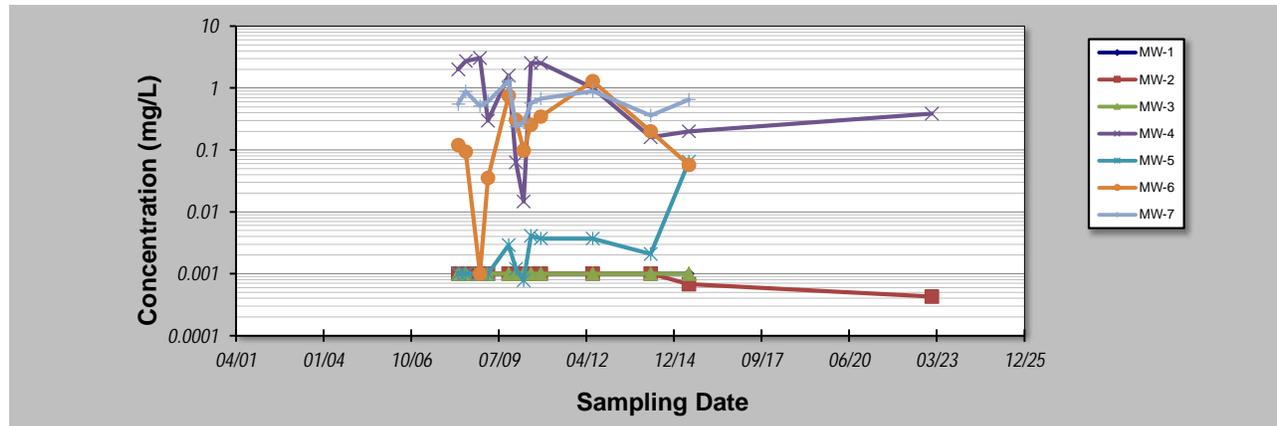
| Sampling Event | Sampling Date | TCE CONCENTRATION (mg/L) | | | | | | |
|---|---|---|---|---|---|---|---|---|
| Confidence Factor: | | 47.3% | 90.8% | 47.3% | 91.8% | 98.7% | 81.0% | 58.0% |
| Concentration Trend: | | Stable | Prob. Decreasing | Stable | Prob. Decreasing | Increasing | No Trend | No Trend |

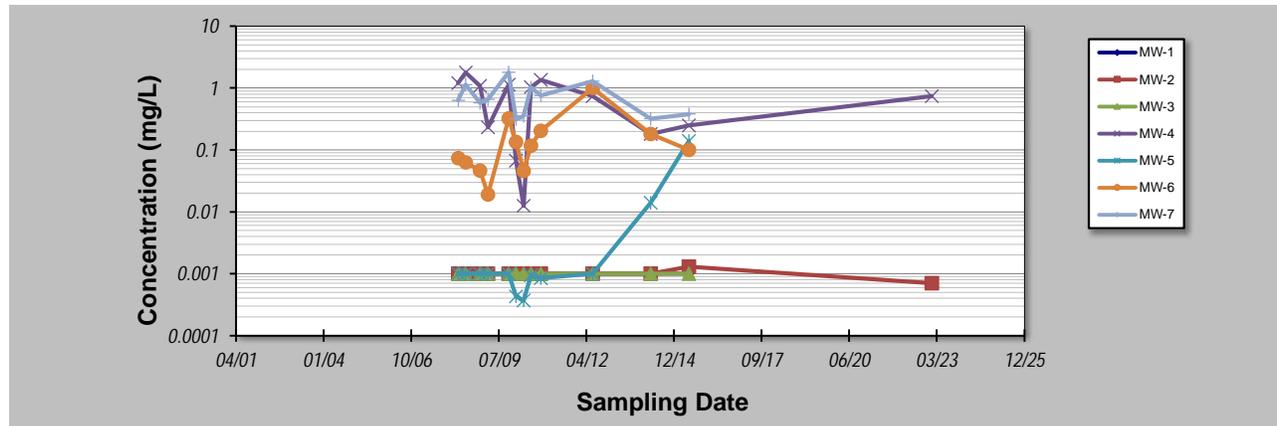
| Sampling Event | Sampling Date | CIS-1,2-DCE CONCENTRATION (mg/L) | | | | | | |
|---|---|---|---|---|---|---|---|---|
| Confidence Factor: | | 47.3% | 50.0% | 47.3% | 91.8% | 65.6% | 87.5% | 63.1% |
| Concentration Trend: | | Stable | Stable | Stable | Prob. Decreasing | No Trend | No Trend | Stable |

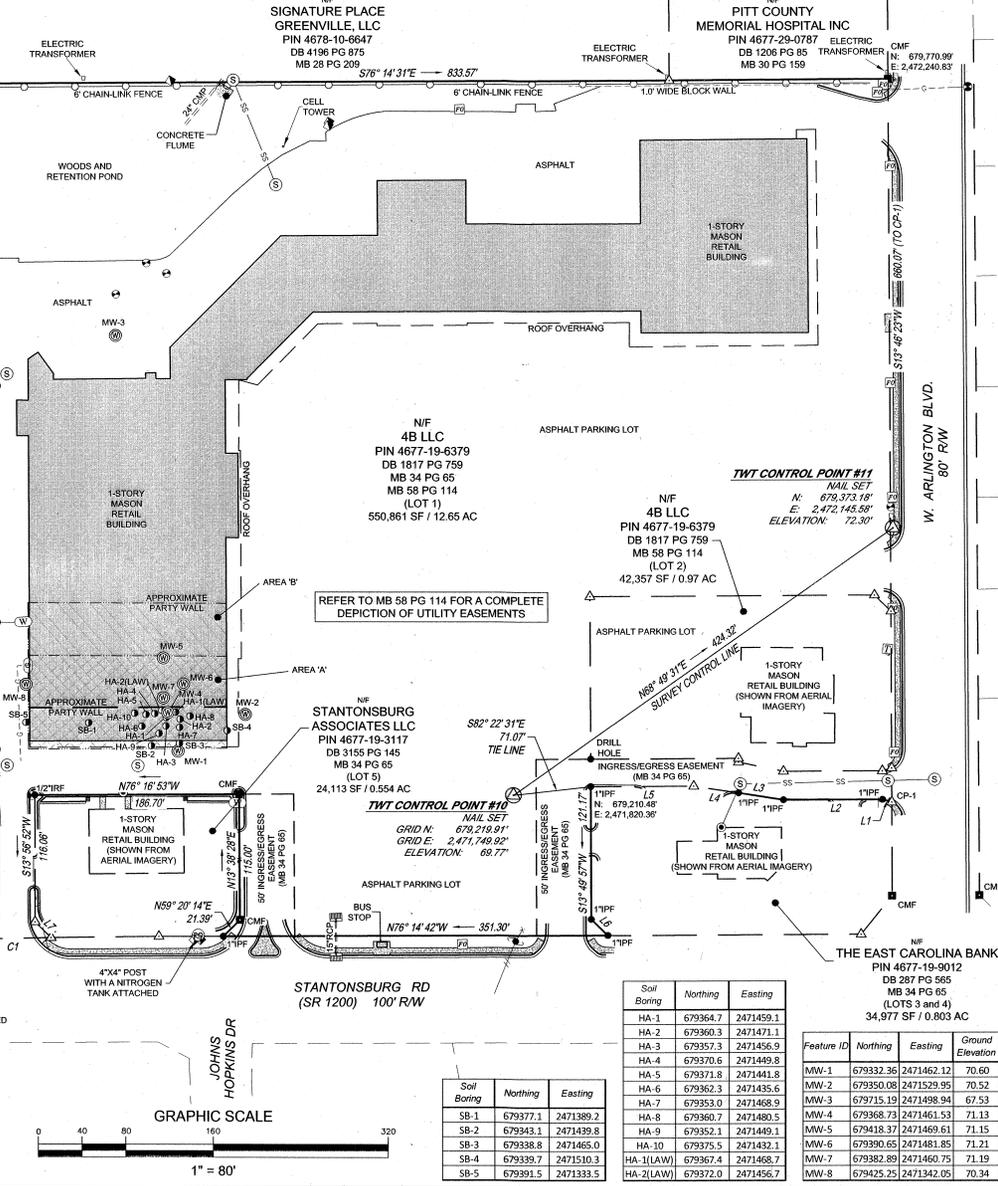
EXHIBIT A
REDUCTION OF SURVEY PLAT

- THE PURPOSE OF THIS PLAT IS TO PROVIDE A CURRENT BOUNDARY SURVEY FOR THE SUBJECT PROPERTY FOR USE WITH THE DRY-CLEANING SOLVENT REMEDIATION PROGRAM OF THE NORTH CAROLINA DEPARTMENT OF ENVIRONMENTAL QUALITY. THE SUBJECT PROPERTY IS IDENTIFIED AS LOT 1 HEREON. IT IS THE SOURCE PROPERTY FOR THE CONTAMINATION. THIS SURVEY IS NOT INTENDED TO REFLECT ALL PHYSICAL FEATURES SITUATED ON THE SUBJECT PROPERTY. ONLY PHYSICAL FEATURES THAT LIE WITHIN CLOSE PROXIMITY OF THE PROPERTY LINES WERE SURVEYED, IN ACCORDANCE WITH BOUNDARY SURVEYING LAW. PROPERTIES SHOWN HEREON ARE SUBJECT TO EASEMENTS AND RESTRICTIONS OF RECORD THAT WOULD BE REVEALED BY A THOROUGH TITLE SEARCH. THIS PLAT SHOULD NOT BE RELIED UPON AS A COMPLETE RECORD OF ALL EASEMENTS THAT MAY EXIST THESE PROPERTIES.

- Groundwater will not be used on the source property without prior approval of NCDEQ.
- No activities that cause or create an increase in infiltration (for example, removal or demolition of materials such as asphalt, concrete, buildings, or other structures that by their use and nature minimize infiltration of rain or water runoff into potentially contaminated soil) may occur in **Area A** of the Property, as shown on **Exhibit A** of **Appendix C**, without prior approval of DEQ.
