Four Seasons Cleaners, DSCA Site DC600086

November 2, 2023

Preliminary Source Removal
Soil Excavation
\$2.50 Cleaners
1310 N. Centennial Street, High Point, North Carolina
DSCA Site ID DC410030
June 2023

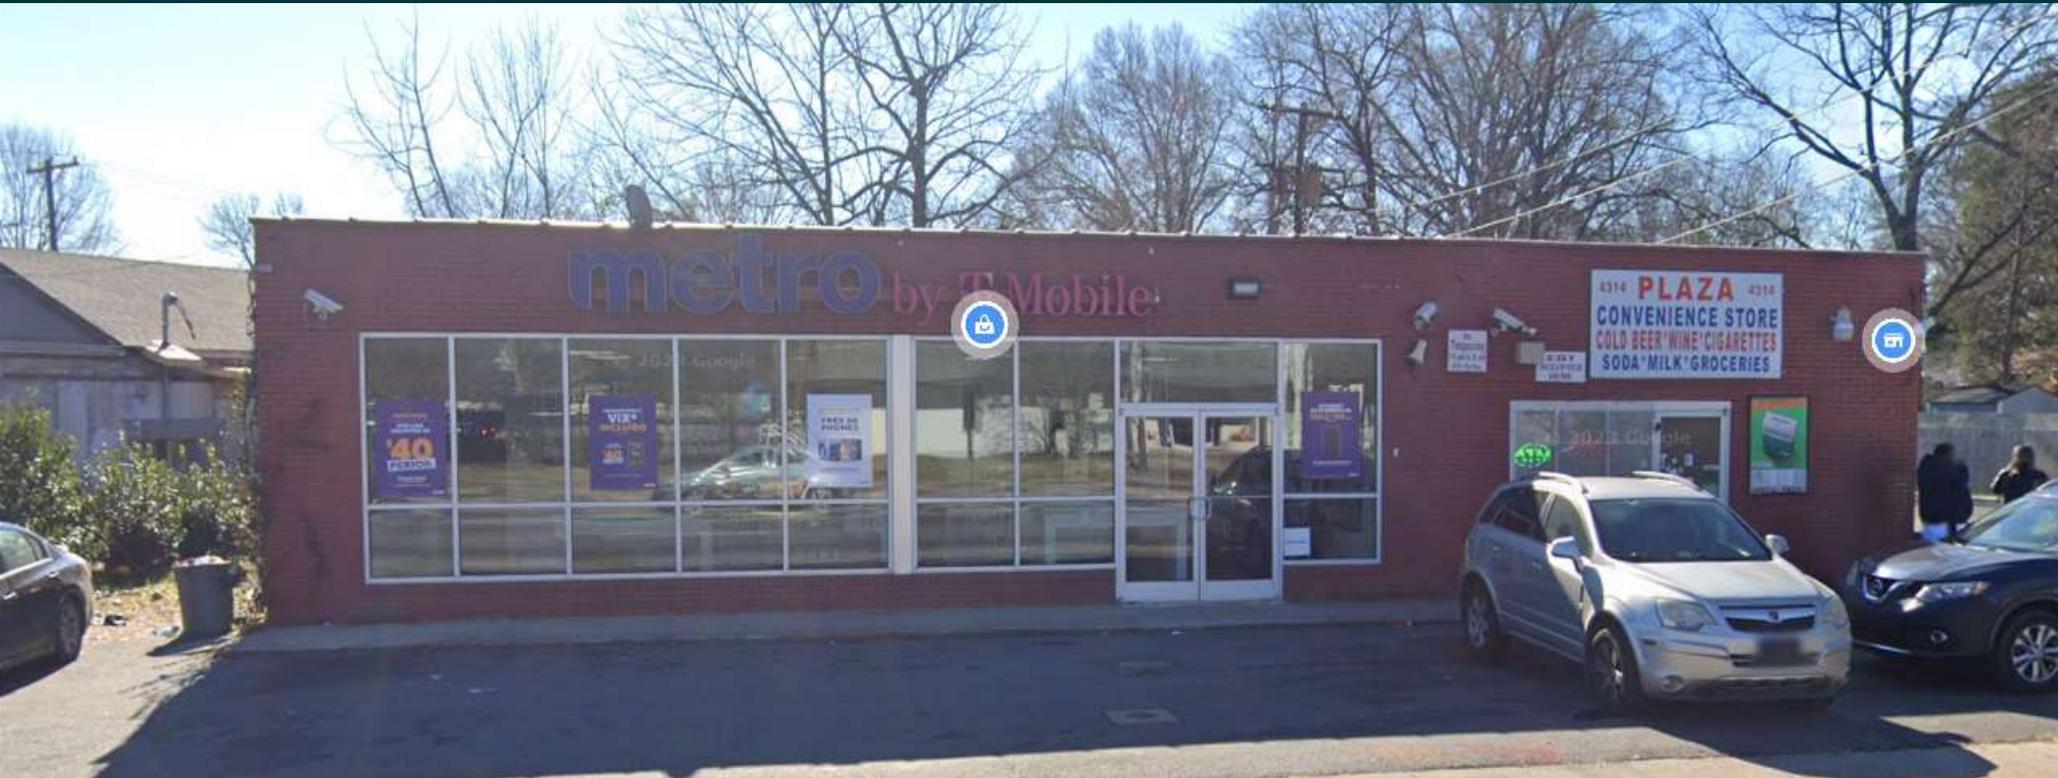
Introduction: Four Seasons Cleaners, DC600068

1. Here we have a view of the site building currently occupied by Metro by T-Mobile, a cell phone store, and the GEB Food Mart (now Plaza Convenience Store)
2. The former Four Seasons Cleaners operated as a full-service PERC dry-cleaning facility inside the Metro by T-Mobile between 1964 and 1979.

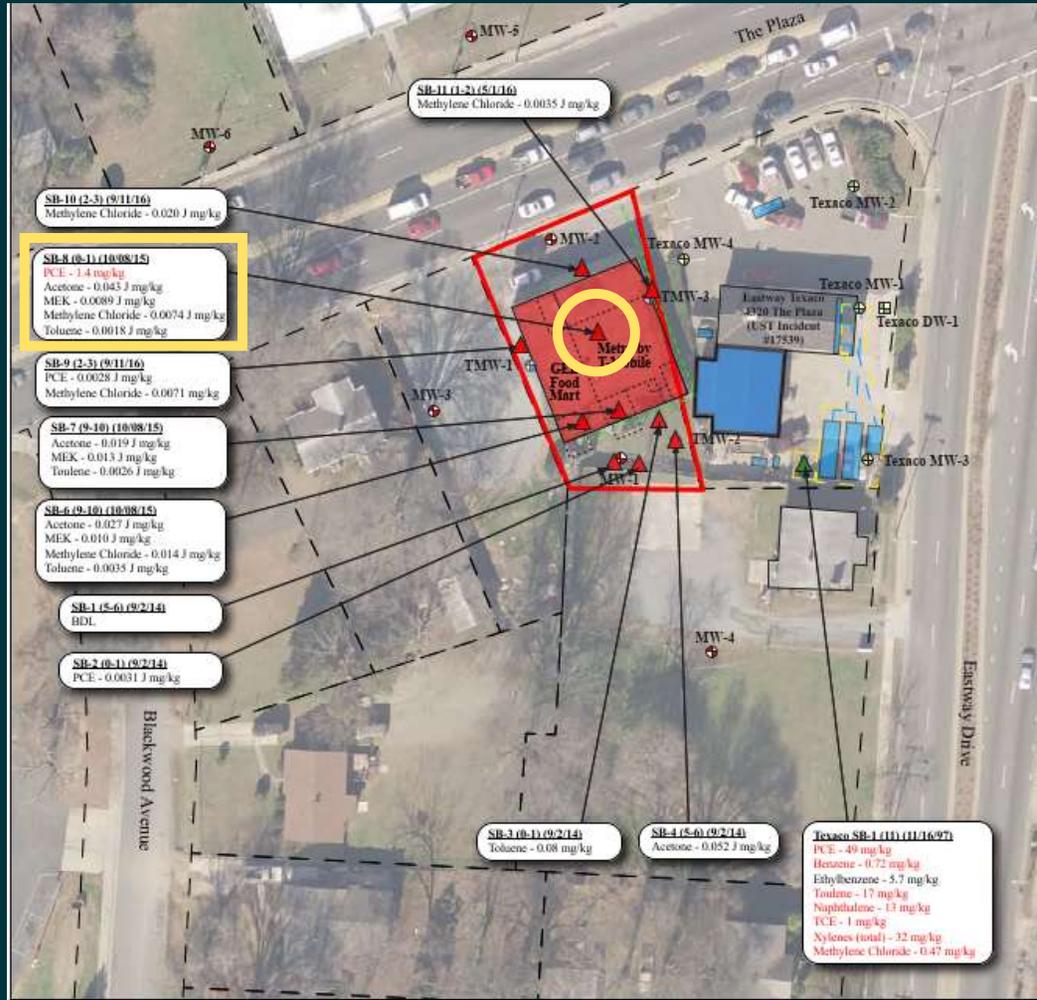
Site Assessment Activities - Soil

1. The first phase of developing our conceptual site model involved assessment of soil, groundwater, vapor, and indoor air.
2. This slide shows our shallow source soil impacts exceeding the Preliminary Soil Remediation Goal which are generally defined and located directly beneath the Metro by T-Mobile tenant space.

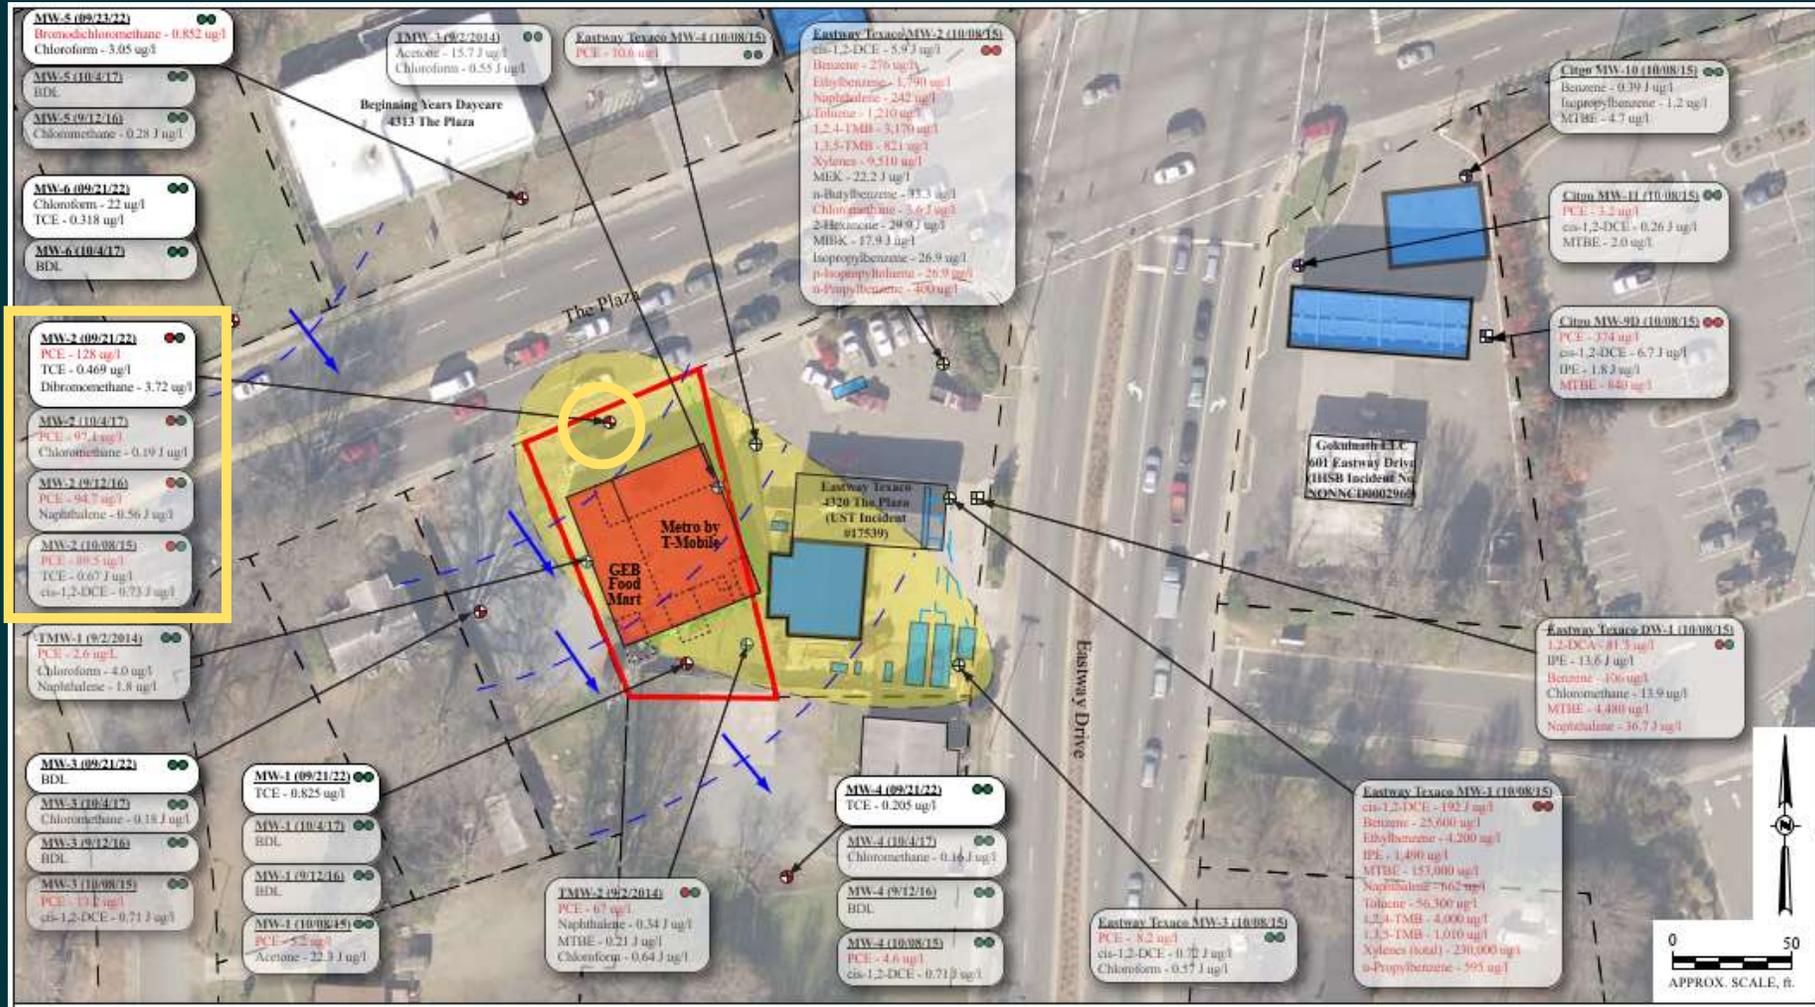
Site Assessment Activities - Groundwater

1. This slide shows our groundwater impacts exceeding the NC 2L Groundwater Quality Standard for PCE
2. The site is located on topographic high and groundwater flow direction varies from southeast to northwest but groundwater exceedances of the 2 L standard are adequately defined
3. As shown, the groundwater impacts from the Four Seasons Cleaners site are comingled with groundwater impacts associated the former Eastway Texaco
4. For those not familiar with the red and green dots, they are graphic depictions of calculated vapor intrusion risk – which makes it easy to see where site conditions may create a vapor intrusion exposure pathway
5. Our highest vapor intrusion risk determined from DSCAs risk calculators correlates closely with our soil source findings.

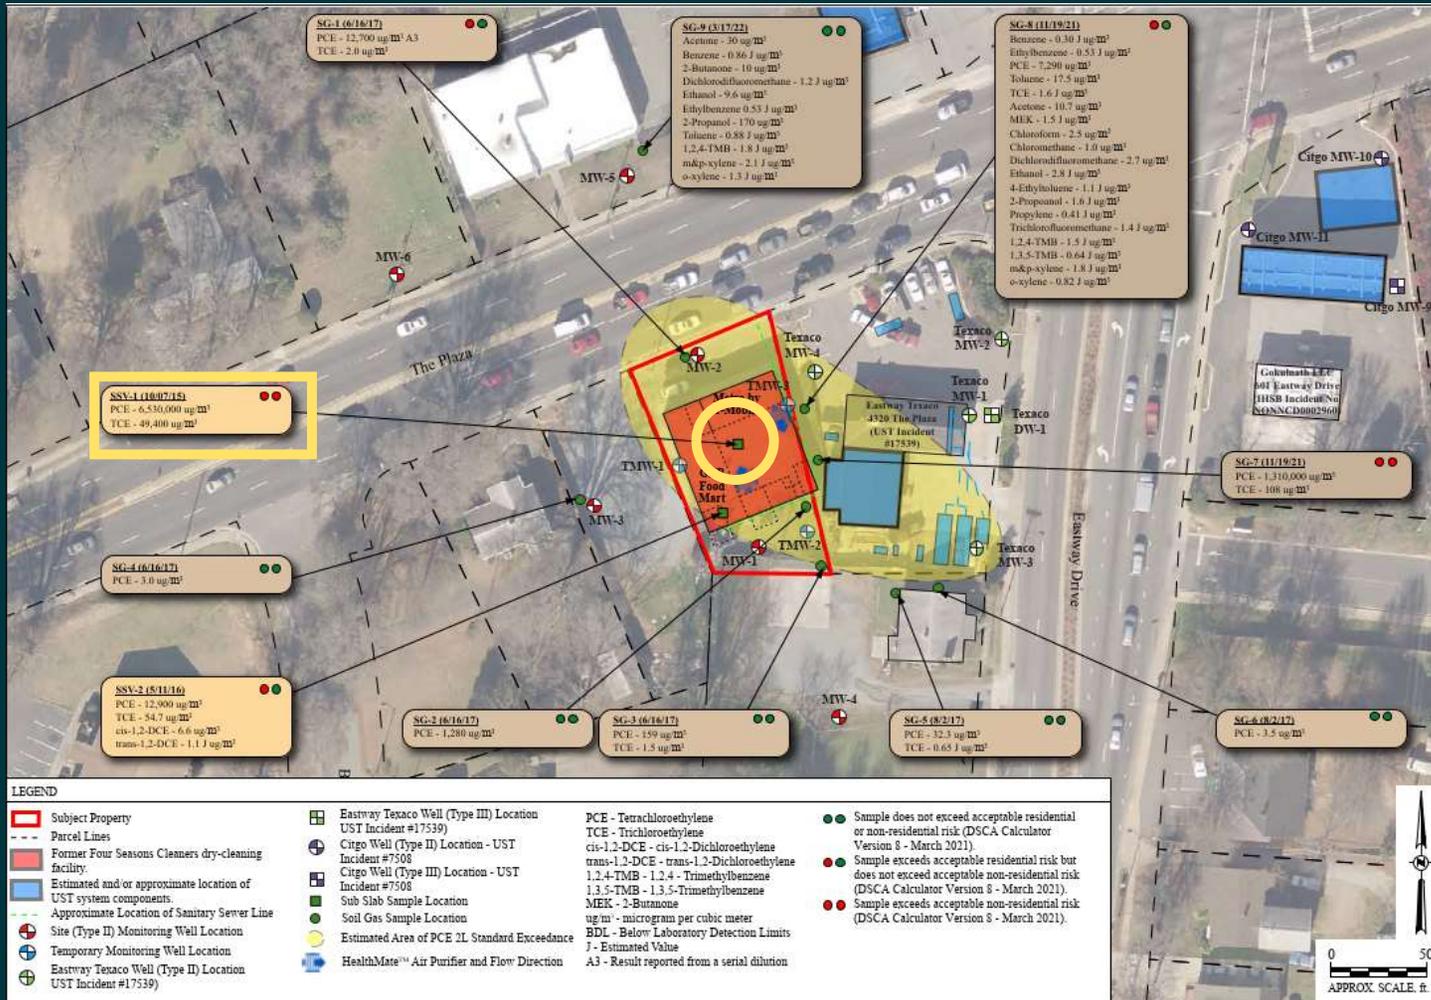
Site Assessment Activities – Soil Gas & Sub-slab Vapor (Pre-Mitigation)

1. This slide shows our sub-slab vapor and soil gas impacts collected to date
2. Of particular importance we have sub-slab vapor data indicating potential VI risk to the current occupants
3. I'd also like to point out that the sub-slab vapor quality data also correlates closely with our soil and groundwater source findings
4. In addition, there is a soil gas point along the eastern property boundary that fails both residential and non-residential exposure which does create potential offsite exposure issue
5. However as previously mentioned this site does have its own PCE impacts and is overseen by the UST program.

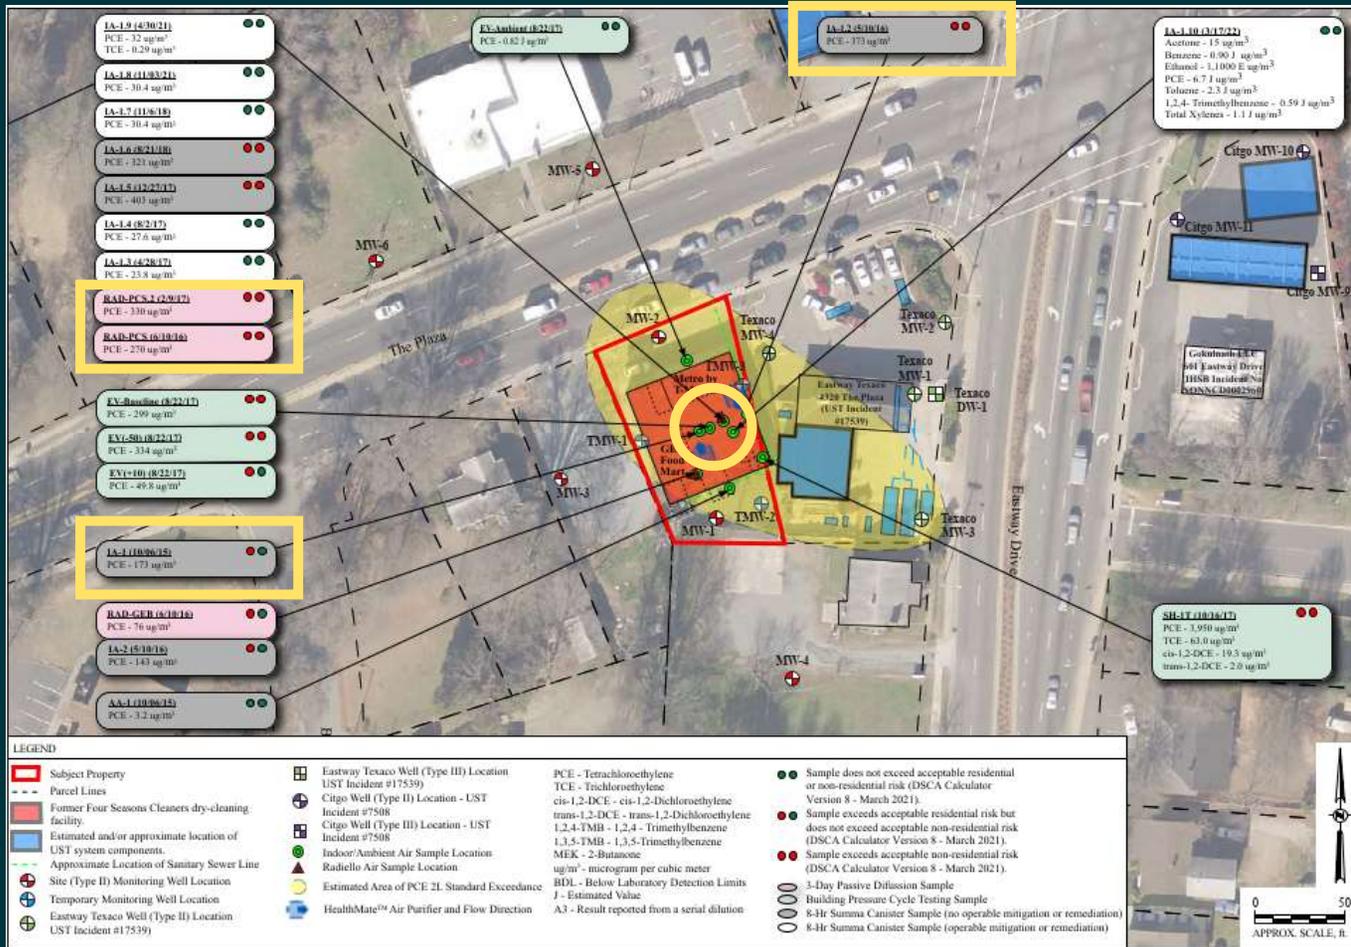
Site Assessment Activities – Indoor Air Quality

1. There is a lot going on with this slide, but it summarizes our indoor air quality data generated to date
2. Highlighted is the 2015, 2016, and 2017 data that prompted action due to unacceptable inhalation exposure risk to the current workers.

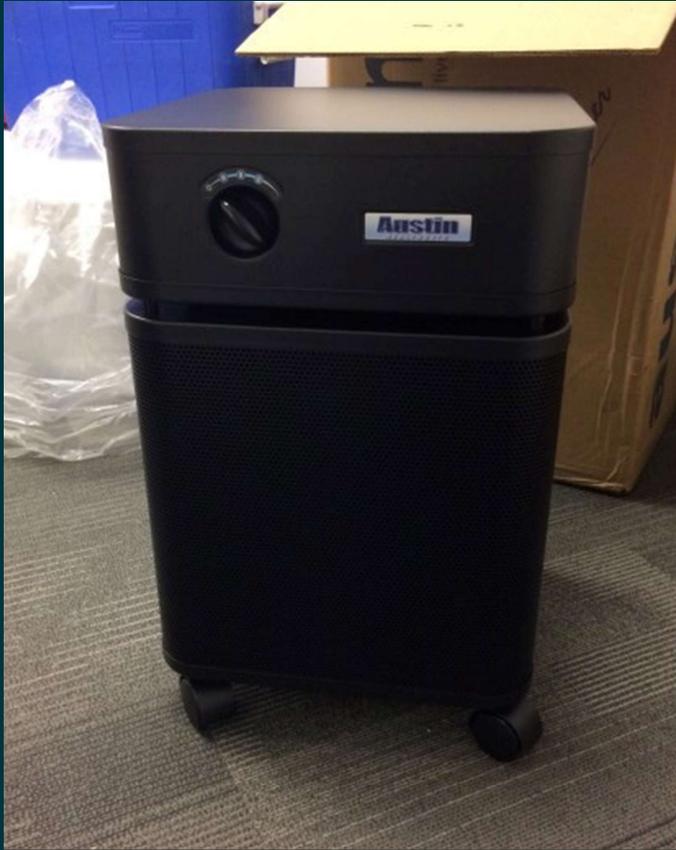
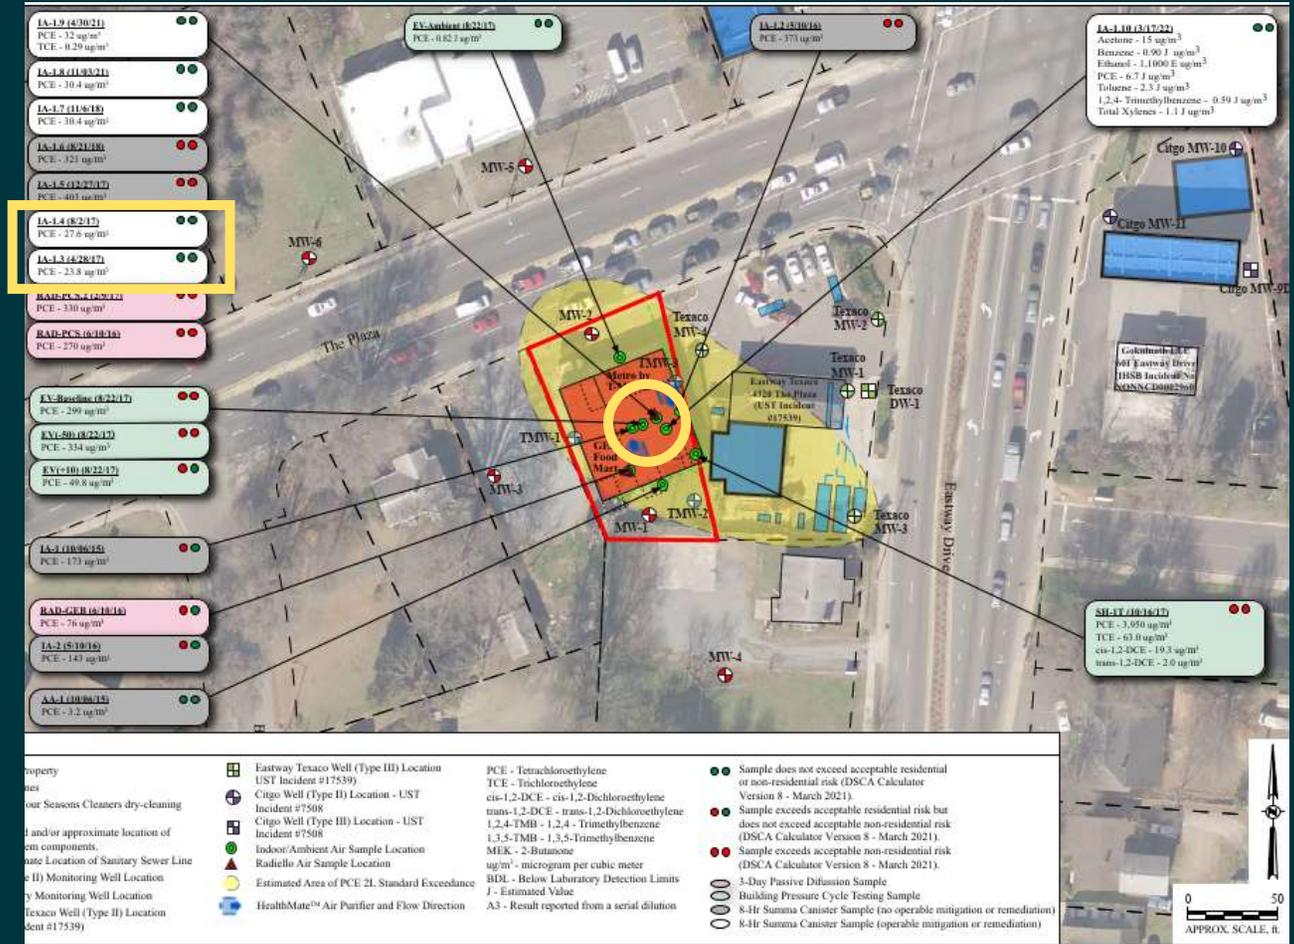
Source Evaluation and Mitigation – Other

1. As an interim measure, we installed Air Purifying Units (APUs) to filter IA concentrations to acceptable non-residential worker concentrations / risk
2. These are typically used for rapid response to TCE exposure, but we implemented them at this site to allow additional time to evaluate the cost/benefit of HVAC modifications, a sub-slab depressurization system, a soil vapor extraction system, and some other mitigation and remedial options.

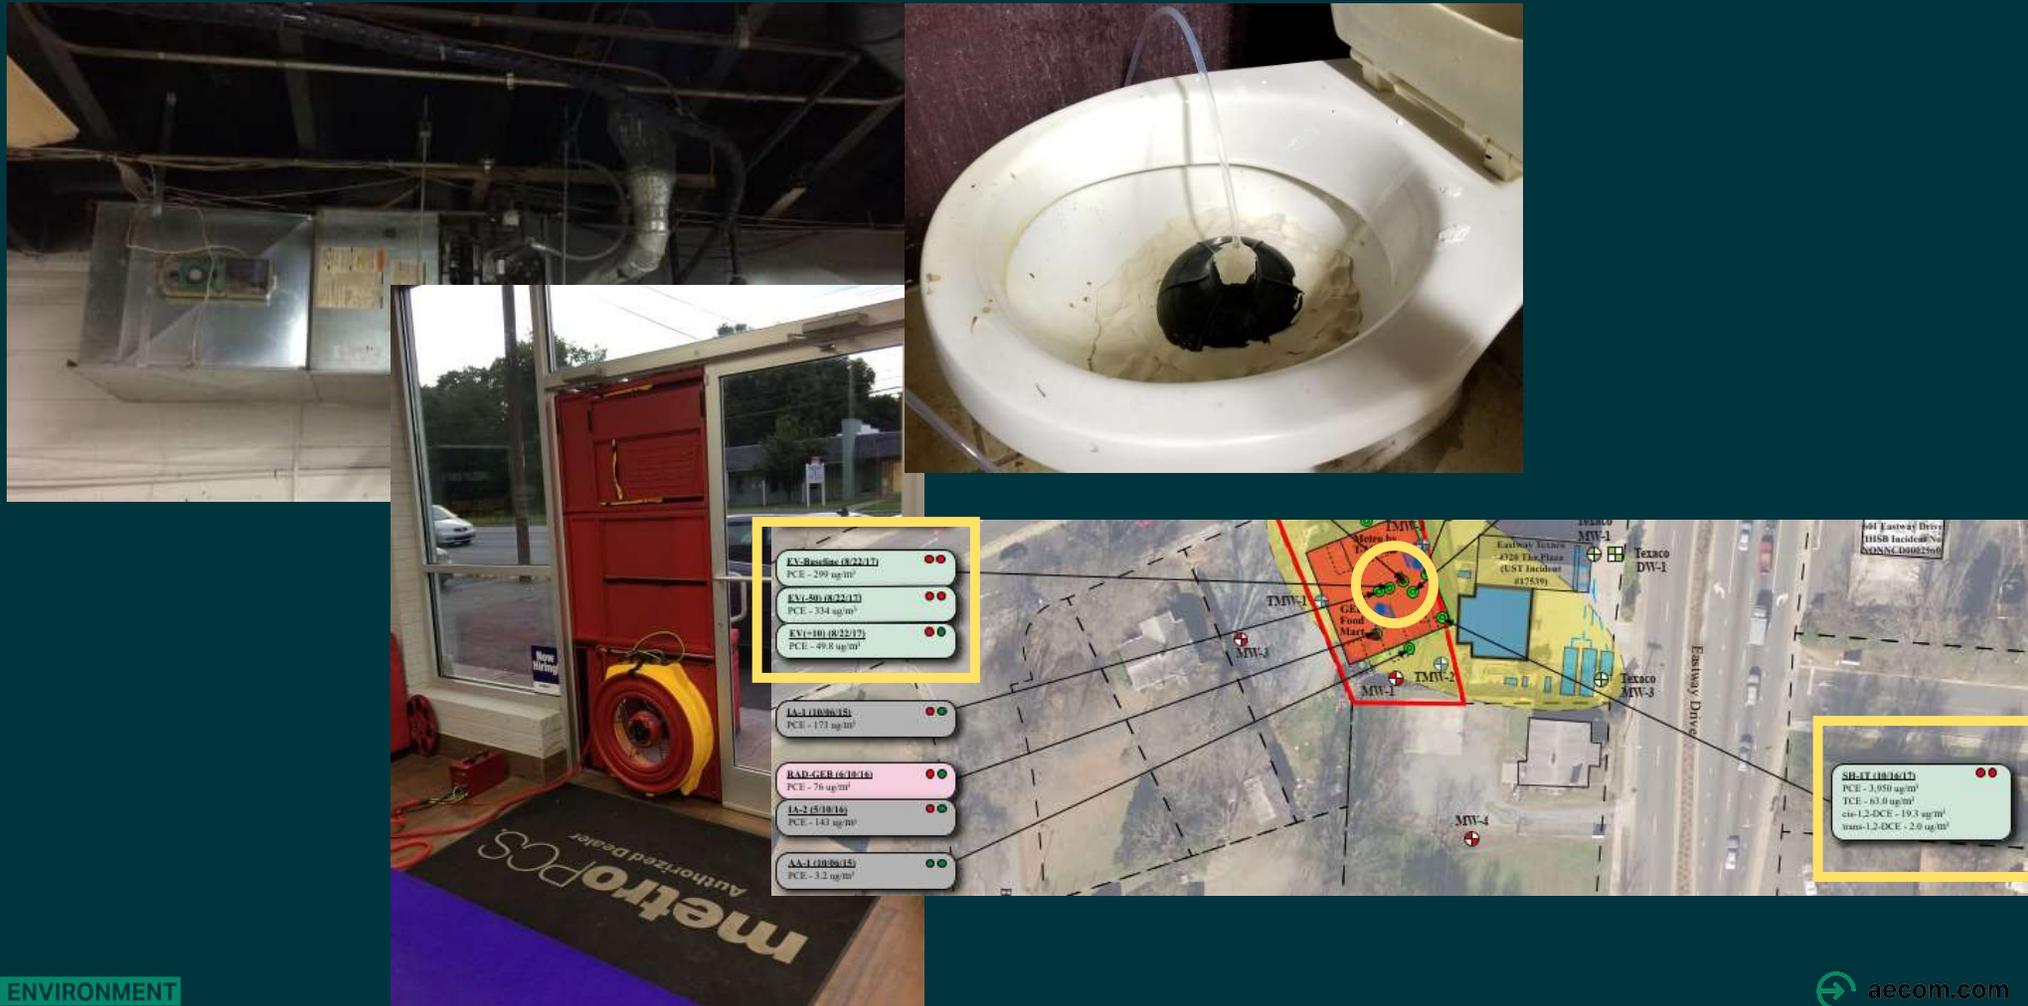
Source Evaluation and Mitigation – Other

1. With the interim remedial action in place, we:
 - Sealed up floor crack and patched holes in walls
 - Looked at altering the HVAC and finishing the floor and walls
 - And conducted “envelope” or building pressure cycle testing (BPCT)
2. Under positive pressure conditions, the indoor air quality was acceptable
3. However, under negative pressure, it was obvious that the dry traps in the unused restroom were a contributing factor to poor indoor air quality was observed, but it was not believed to be the only source.

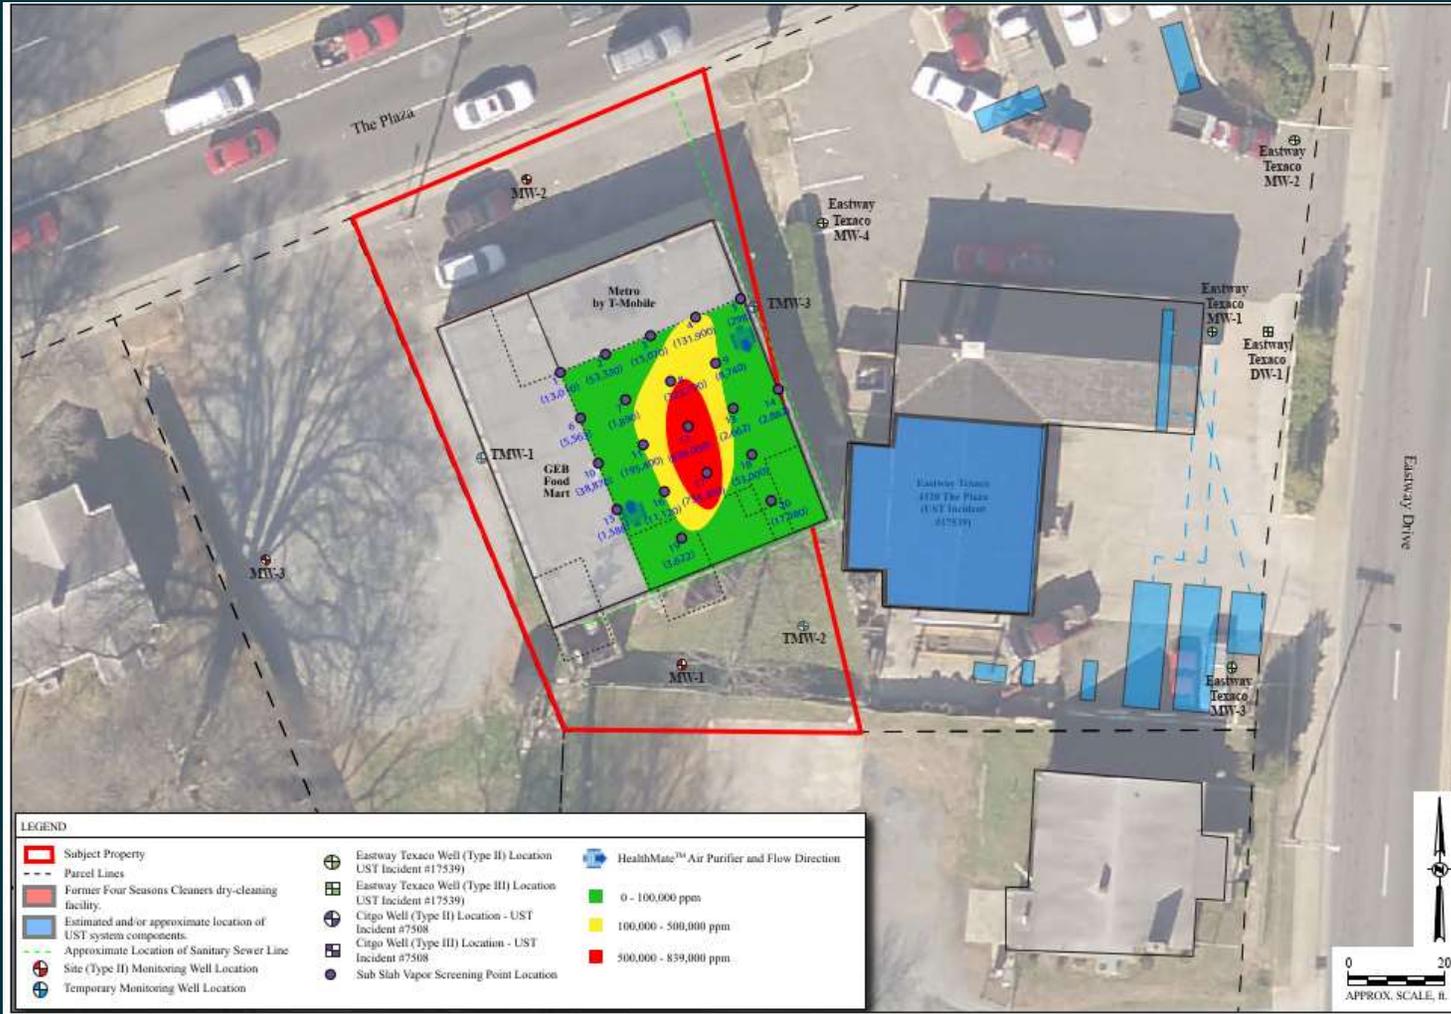
Source Evaluation and Mitigation – Heat Map

1. To further evaluate source areas at the site, we installed 20 temporary vapor monitoring points in a gridded array and screened total vapor concentrations beneath the slab
2. We used the vapor screening measurements to create the “heat” map you see here
3. The red shows the area of greatest impact which correlates well with the previously generated soil, groundwater, and other sub-slab vapor data
4. The soil, groundwater, and vapor data all pointed to a localized area for mitigation and remediation that could be targeted
5. Based on this configuration, as well as the results of a ROI influence test, it looked possible to not only mitigate but to possibly remediate and improve conditions enough that long term system operation would not be necessary
6. As such, a soil vapor extraction or SVE system was selected as our remedial approach.

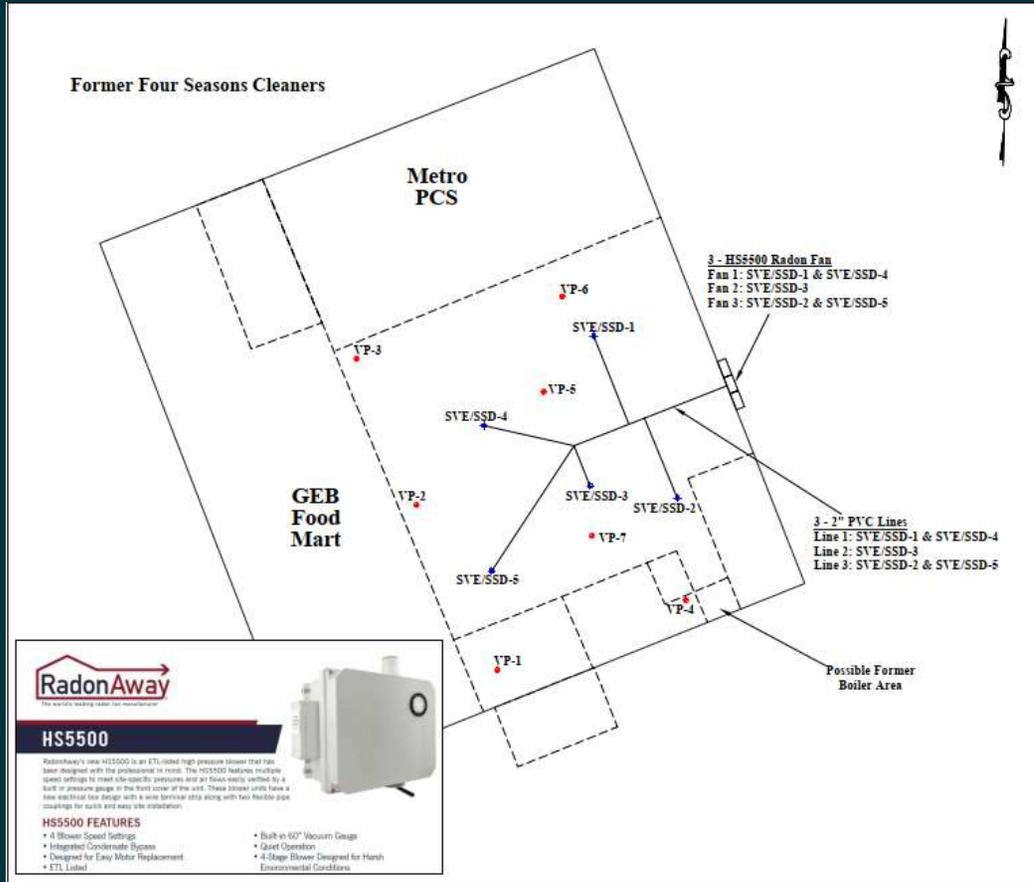
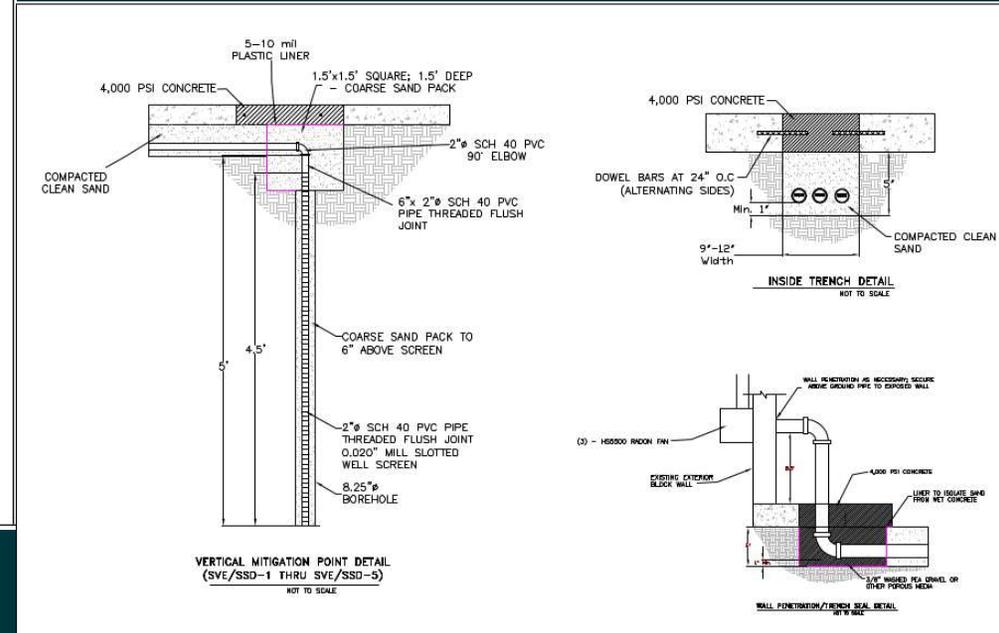
Soil Vapor Extraction/Sub-slab Depressurization System As-Built

1. This slide shows the SVE system layout and schematics
2. For remediation purposes, the SVE system design incorporated 5 vertical extraction points to perform mass removal from the shallow soil impacts
3. In addition, the extraction points were constructed so the system could act dually as a sub-slab depressurization system SSD system to mitigate vapor intrusion impacts if the system needed to be operational for a longer period of time
4. Theoretically, the dual functions would allow the system to aggressively strip and remove contaminant mass from the soil and reduce the available contaminant mass available to impact indoor air quality.

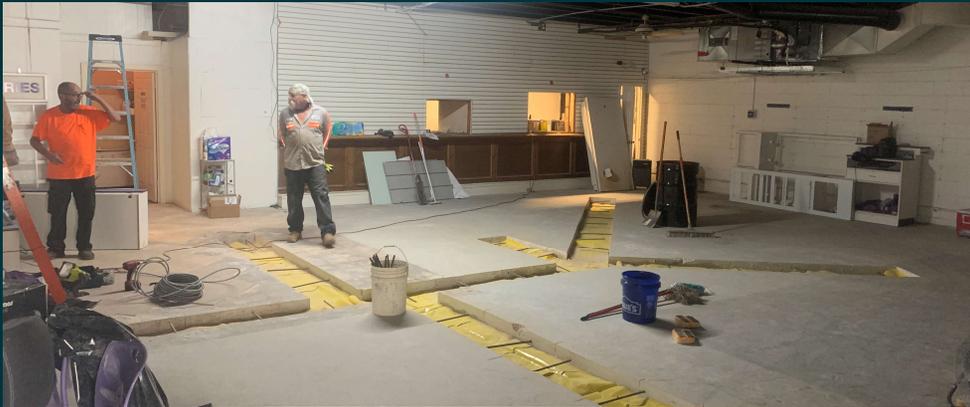
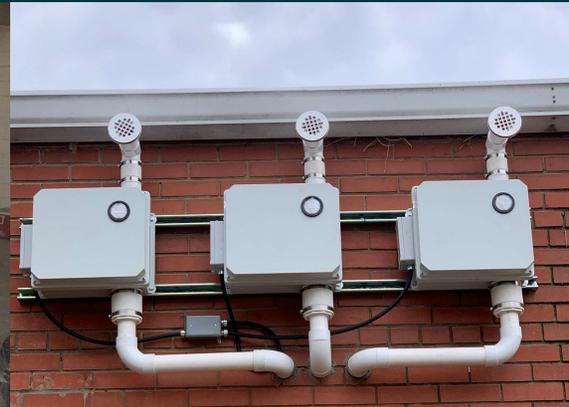
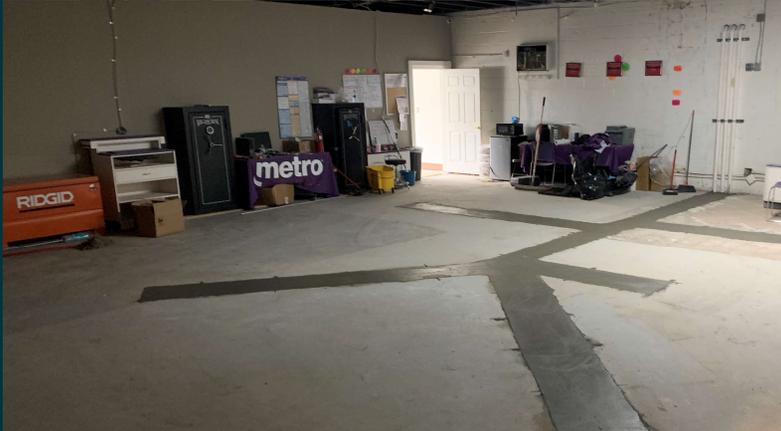
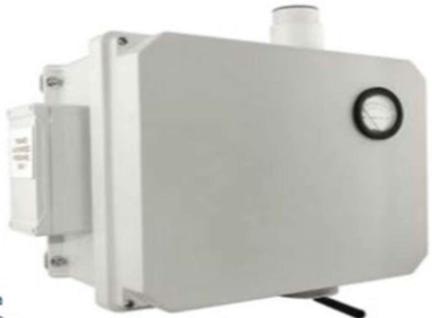
Sub-slab Vapor Extraction/Sub-slab Depressurization System

RadonAway's new HS5500 is an ETL-listed high pressure blower that has been designed with the professional in mind. The HS5500 features multiple speed settings to meet site-specific pressures and air flows easily verified by a built in pressure gauge in the front cover of the unit. These blower units have a new electrical box design with a wire terminal strip along with two flexible pipe couplings for quick and easy site installation.

1. This slide has a couple pictures of the system installation and the blowers that were selected
2. For our system, we opted to install some smaller high-powered radon fans to reduce costs, noise, and maintenance
3. Because the fans were much smaller, we were able to mount them up high on the exterior wall and eliminate housing
4. The reduced cost also allowed us to split the system up into 3 different legs so that in the case of a fan failure, the system would still be able to operate as intended using the other fans

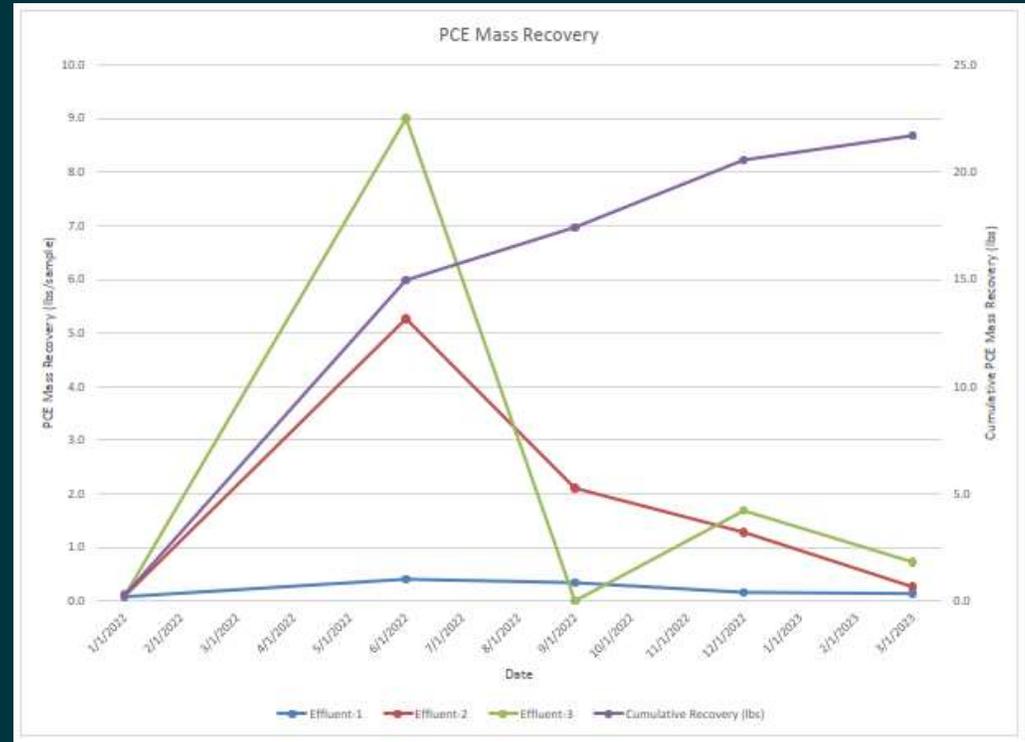
SVE/SSD System Effectiveness

1. As of March 2023, the system has removed approximately 22 pounds of PCE and is approaching asymptotic conditions.

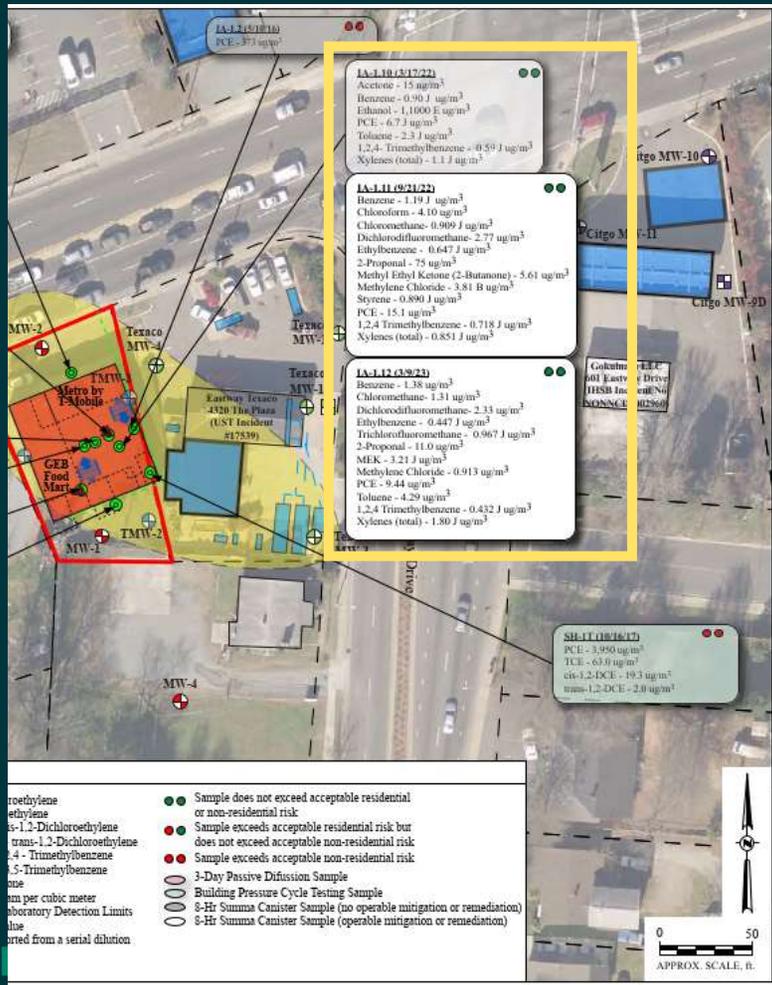
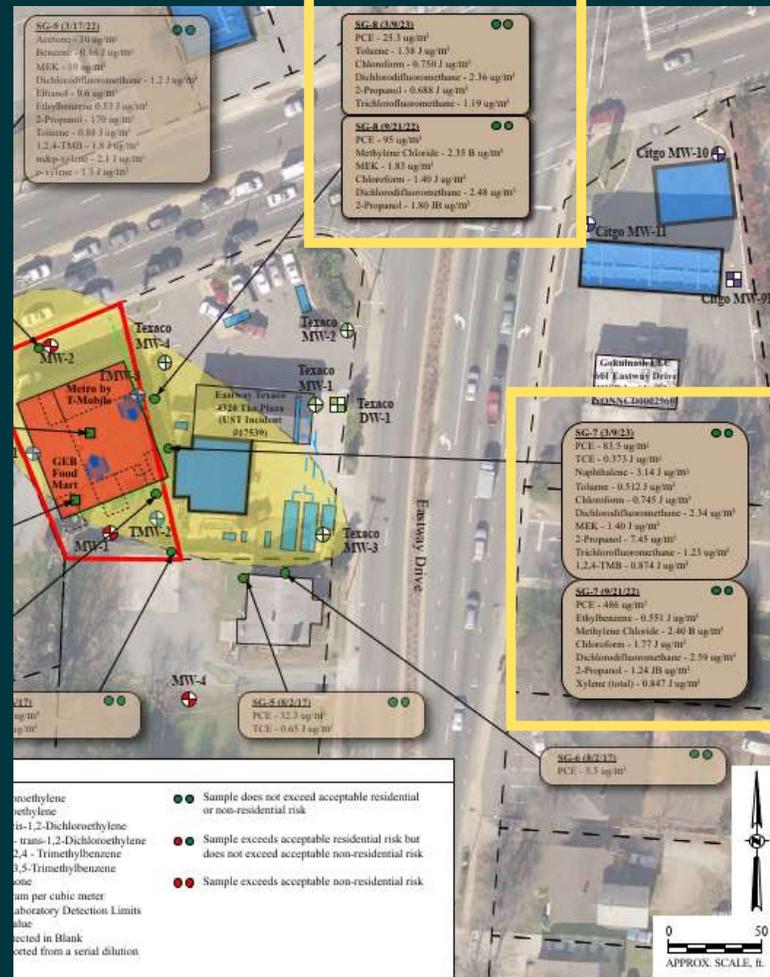
Updated Indoor Air and Soil Gas Quality Data

1. Finally, this slide shows the effect of the mass removal and mitigation efforts have had on the indoor air quality and identified vapor intrusion risks
2. On the left, you can see indoor air quality has shown significant improvement while the system has been operational
3. On the right, we also see significant reduction in PCE impacted soil gas at the shared property boundary

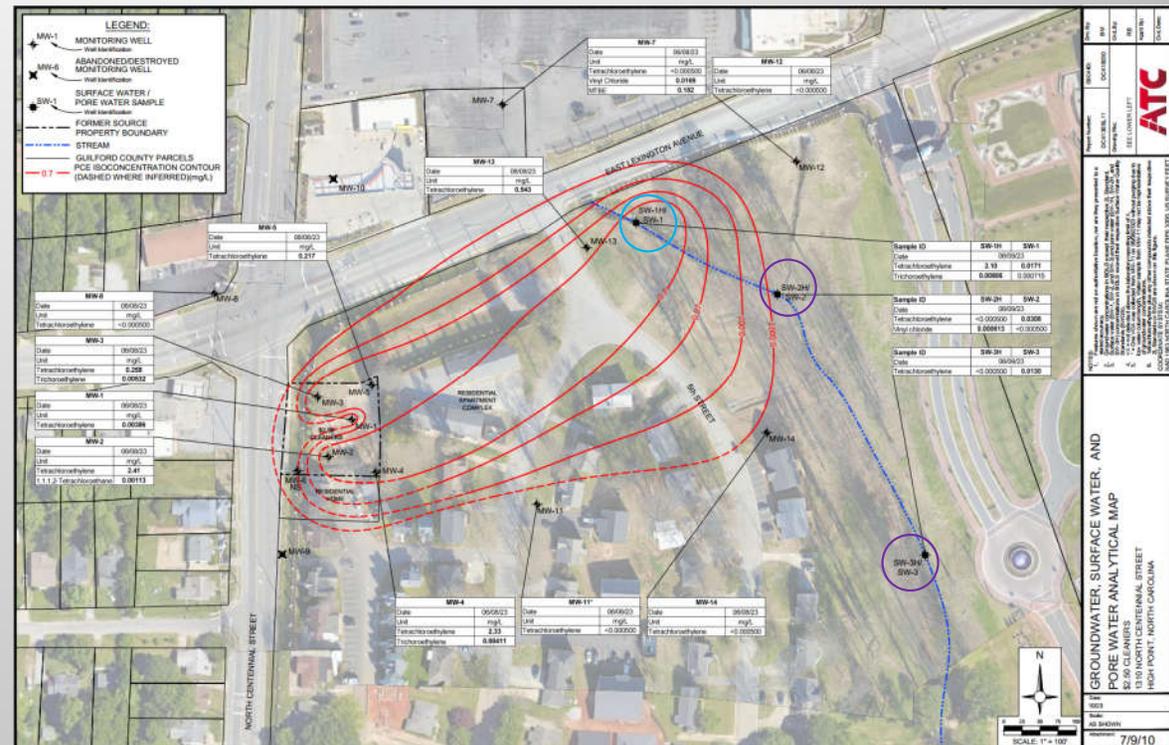
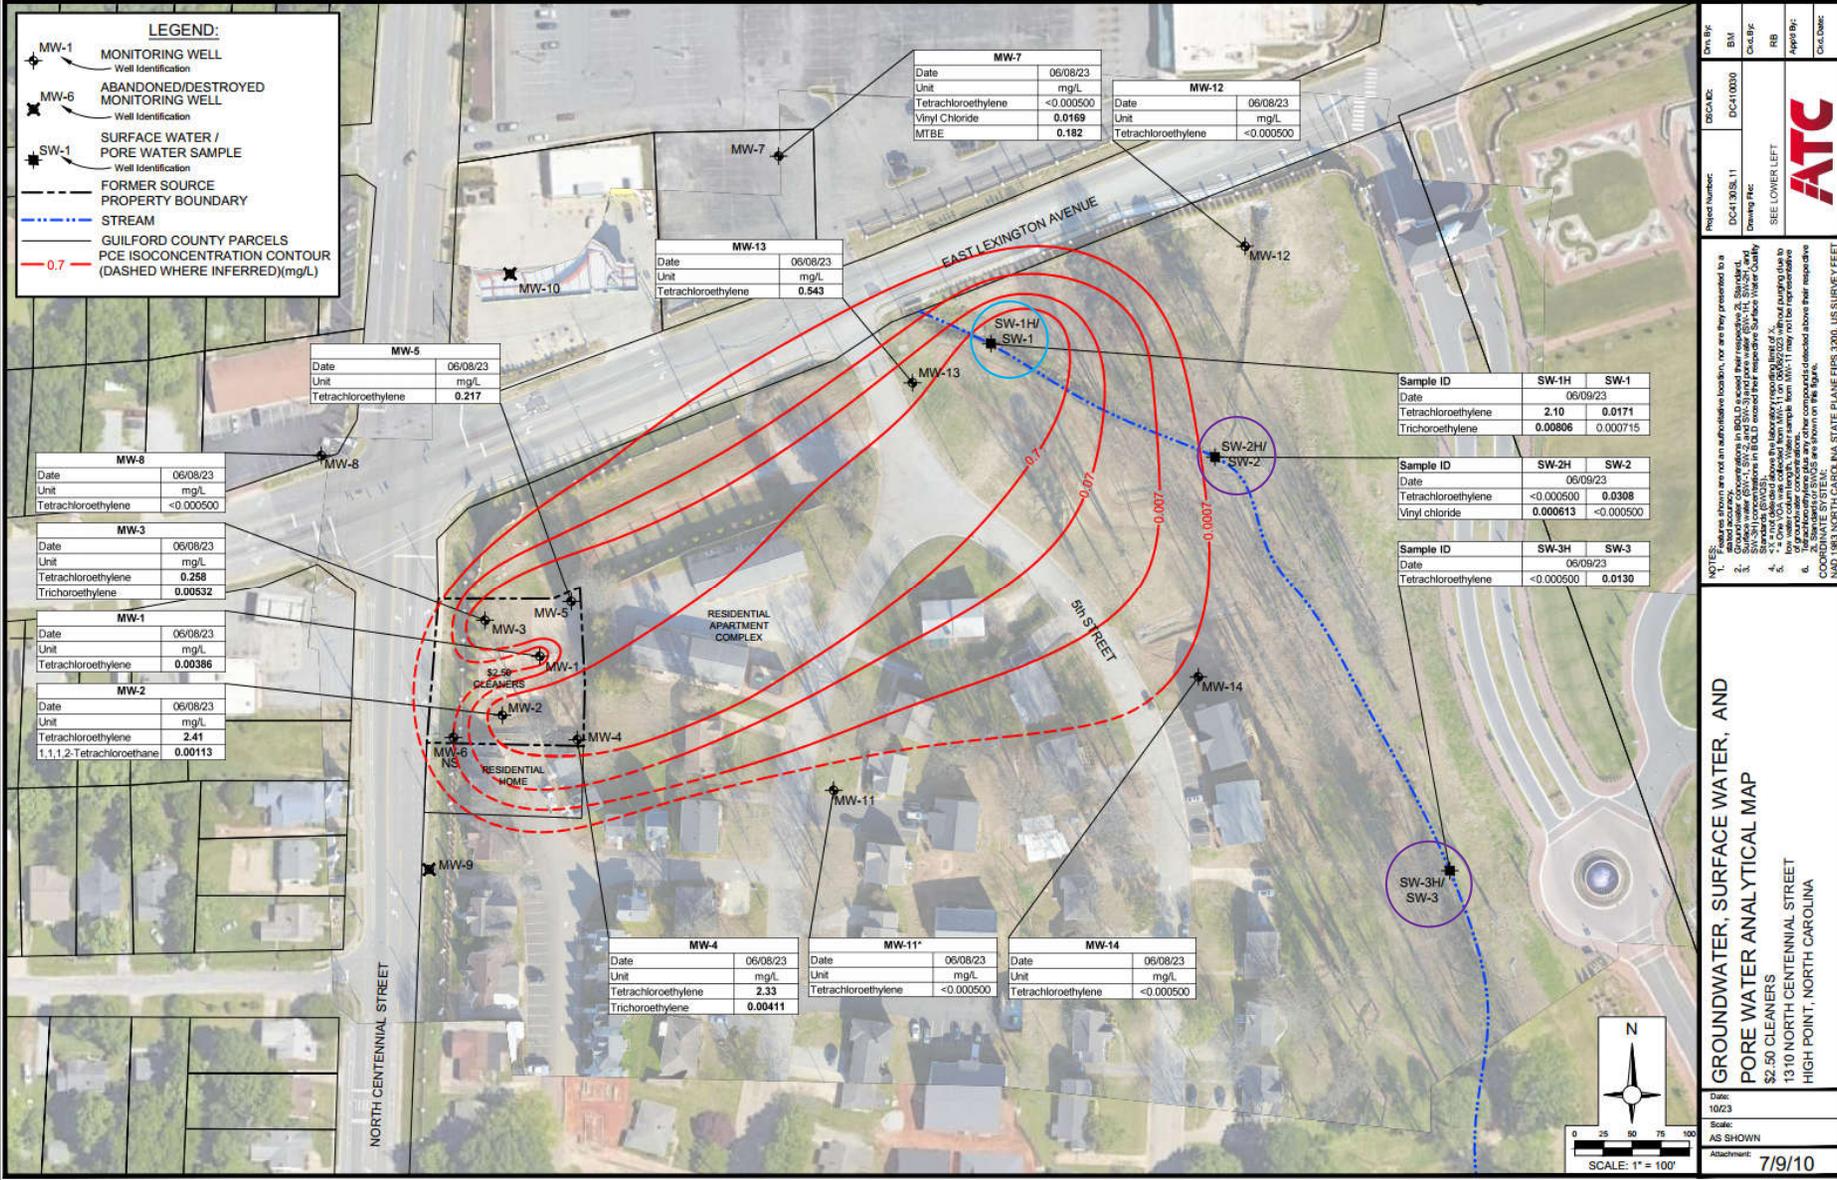
GROUNDWATER, SURFACE WATER, AND PORE WATER ANALYTICAL MAP
 \$2.50 CLEANERS
 1310 NORTH CENTENNIAL STREET
 HIGH POINT, NORTH CAROLINA

- Groundwater PCE plume is adequately delineated.
- The PCE plume underlies multiple residential structures.
- Surface water is impacted by PCE above 2B standards in **SW-1**, **SW-2**, and **SW-3**.
- Pore water is impacted by PCE in **SW-1H**.
