Four Seasons Cleaners, DSCA Site DC600086

November 2, 2023

Preliminary Source Removal
Soil Excavation
\$2.50 Cleaners
1310 N. Centennial Street, High Point, North Carolina
DSCA Site ID DC410030
June 2023

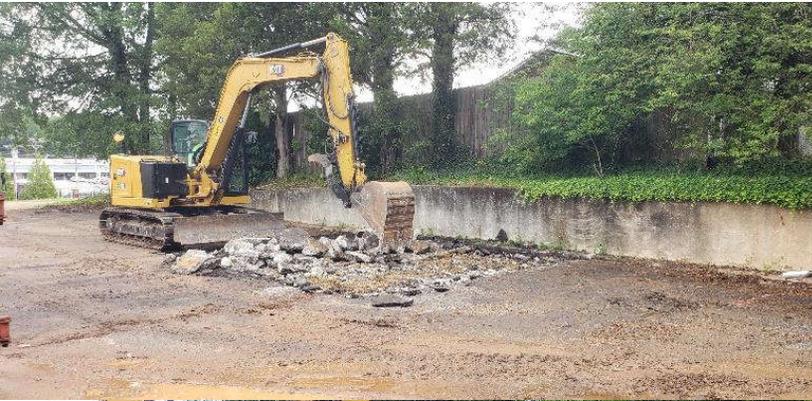
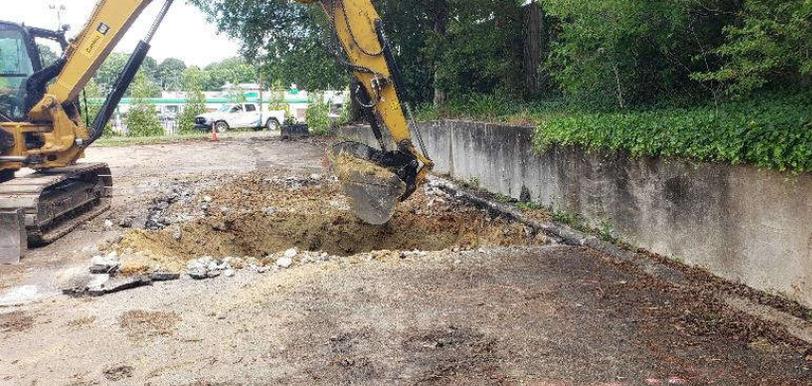
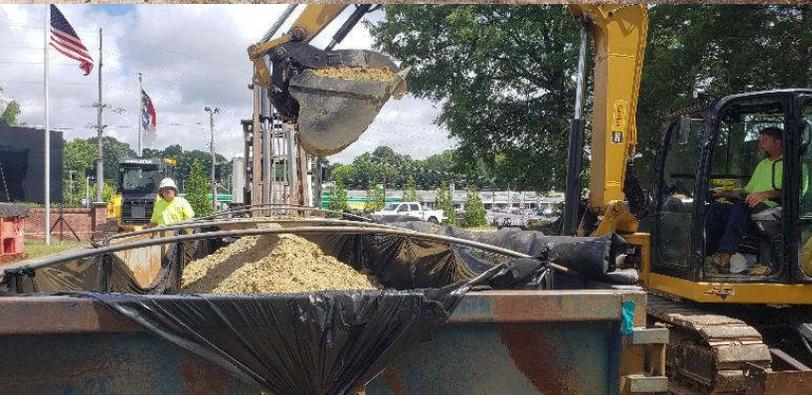
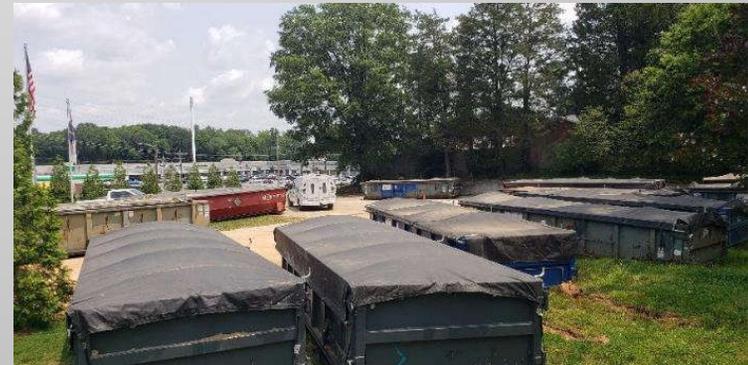
Excavation Performed in Compliance with the “Contained-in” Policy

- Removed 199.18 tons of soil and stored in 12 roll offs
- Sampled each roll off for proper waste characterization
 - 7 roll offs (119.94 tons) disposed as non-hazardous.
 - 5 roll offs (79.24 tons) disposed as hazardous requiring incineration.
- Removed 10.29 tons of asphalt/concrete is 1 roll off and disposed as non-hazardous

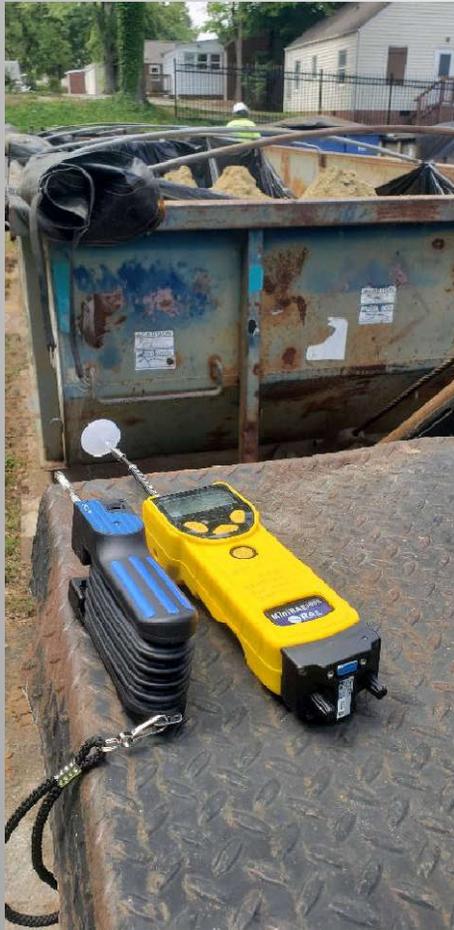
Health and Safety: Air Monitoring

- PID used to screen for organic vapor levels
- If a PID threshold concentration was exceeded, Dräger-Tubes (PCE and TCE) were to measure chemical specific concentrations.
- No Dräger-Tube measurements required implantation of additional PPE (respirators)

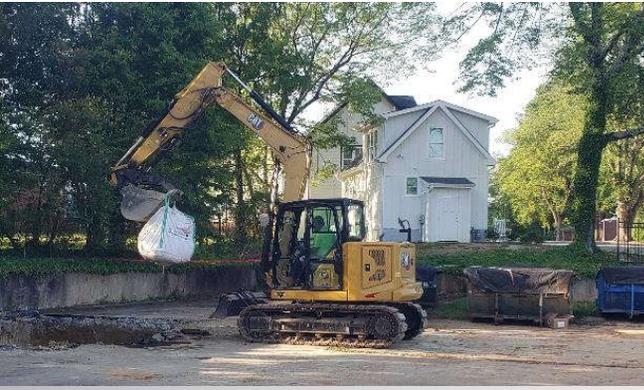
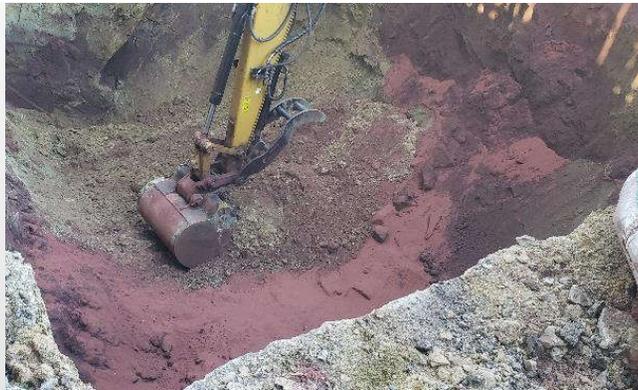
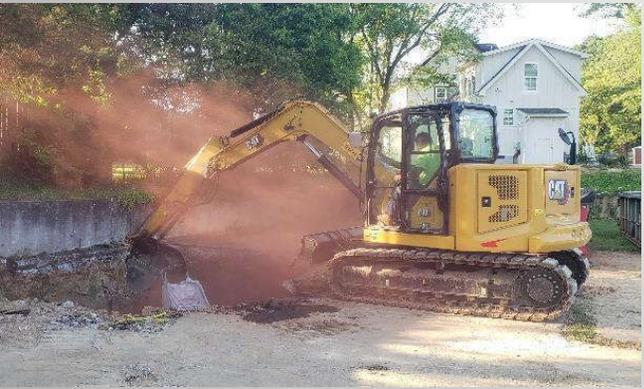
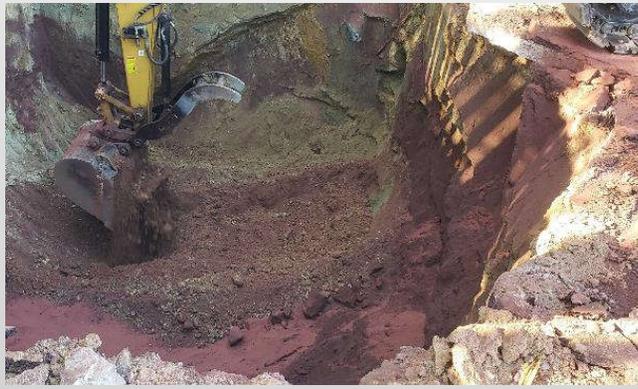
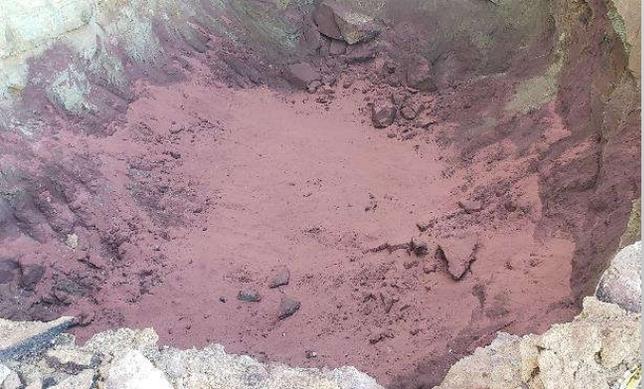
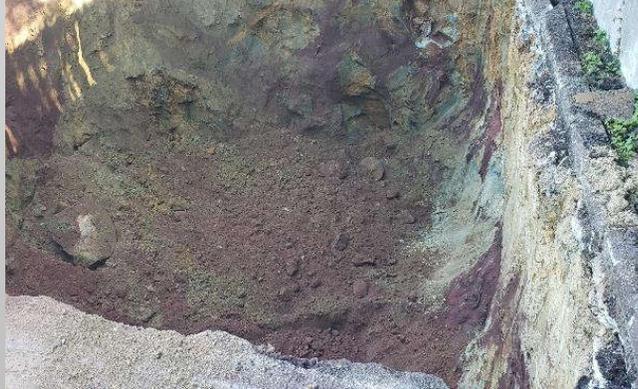
Implementation of Remediation Agent: Provect-OX2

- ATC emplaced 2,000 lbs of Provect-OX2 at the bottom of the excavation pit.
- Provect-OX2 is an extended release in situ chemical oxidation with an enhanced bioremediation reagent.
- Tilled it into the subsurface from ~10-12' bgs.
- Tilled zone is below the seasonal high water table, which targets reduction of sorbed and dissolved phase contaminants.
- Provect-OX2 mineralizes PCE to chloride. Therefore, vapor intrusion concerns from PCE breaking down to TCE is not expected.

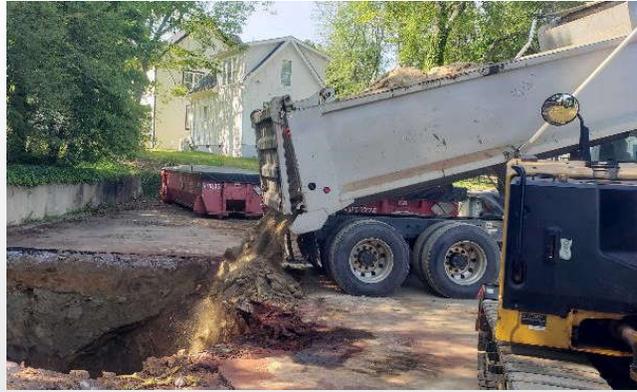
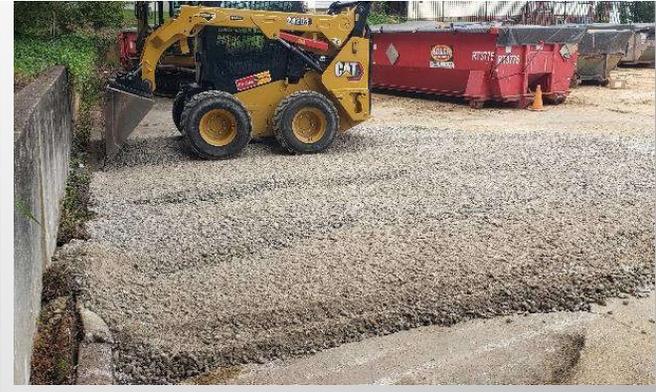
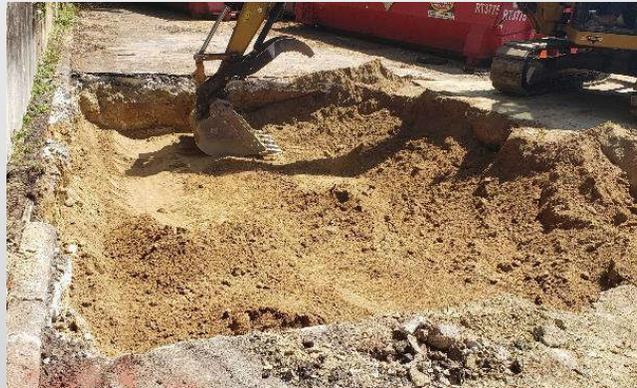
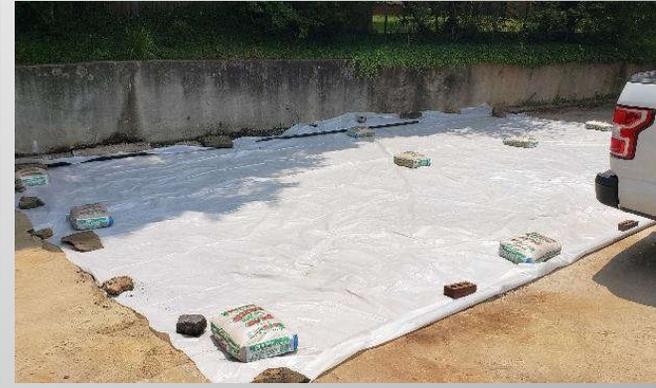
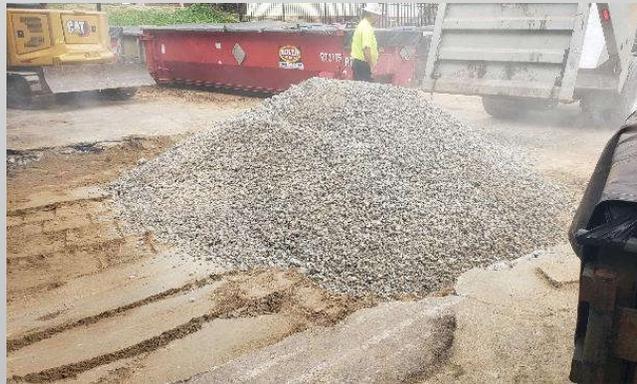
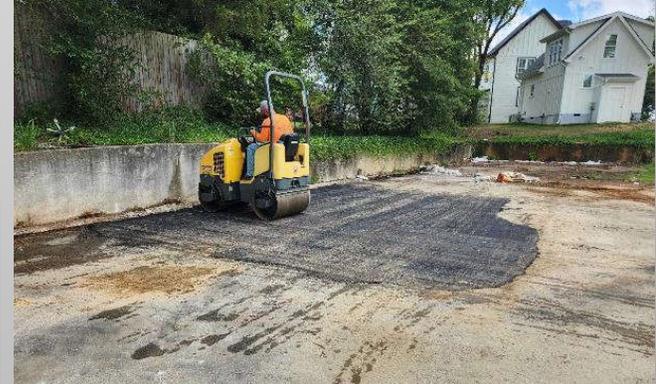
Backfilling The Excavation Pit

- ATC backfilled the pit immediately after the excavation was complete.
- Excavation surface was initially intended to be immediately covered with asphalt to prevent rainwater from entering the pit and extracting sorbed PCE from the soil into the groundwater.
- However, roll offs could not be removed until waste characterizations and arrangements for disposal were completed. ATC did not want to damage the fresh asphalt during roll off removal.
- A tarp was temporarily used to cover the surface until all roll off could be removed.
- After all roll offs were removed from the site, the excavation pit was finished at the surface with asphalt.
