# Upper Cullasaja River Watershed Strategy and Action Plan

**Upper Cullasaja Watershed Association**  
**Final 2004**

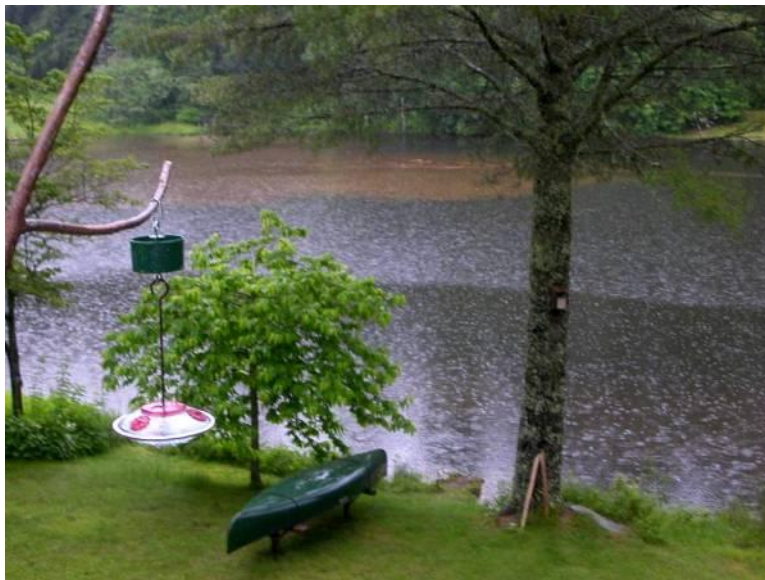
Figure 4. Sediment Plume from Lambert Creek in Mirror Lake, June 2003.

pollution are adequate to protect water quality. Sedimentation and removal of sediment accumulations in the lakes and streams, however, remain the highest priority water quality issues with the local watershed stakeholders. Sediment accumulations in local lakes prohibit the traditional uses of the waterbodies in several communities.

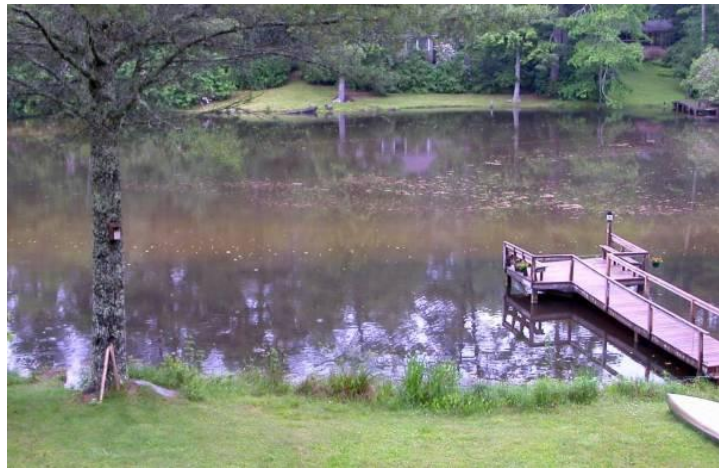
Mill Creek sediment plume in Mirror Lake, June 2003
