East Fork – South Fork New River

Watershed Plan

New River Conservancy

December 2017

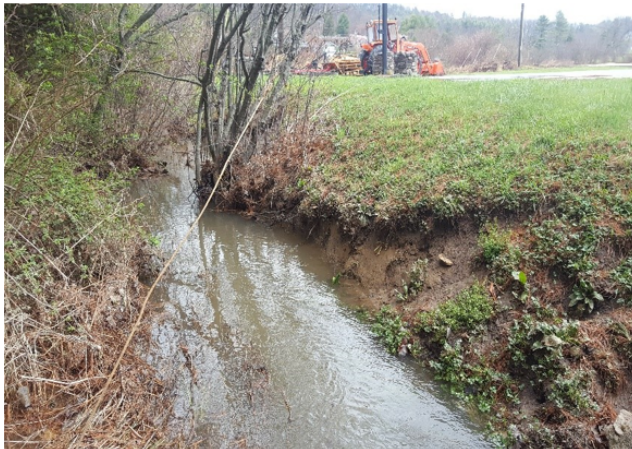
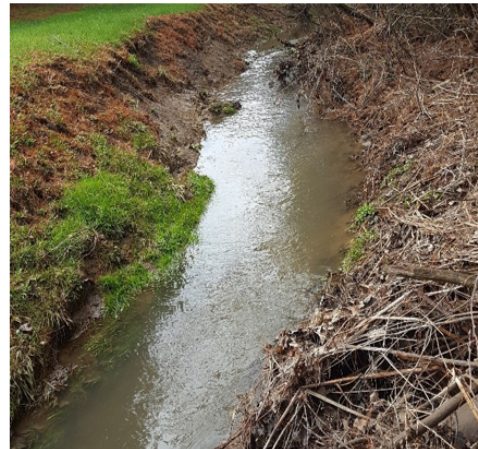
**Site 1: Unnamed tributary along western
Samaritan's Purse property boundary**

Right bank of the reach lacks riparian vegetation and is eroding. Left bank has a forested riparian buffer. A drain pipe placed perpendicularly to the direction of flow is causing further erosion on the right bank of the reach. Riparian vegetation planted along the right bank of the stream would decrease water temperature, bank erosion, and runoff into the stream.

Length of degraded reach: 225 ft

Issues: Bank erosion, lack of riparian buffer, poor pipe placement

Recommendations: Riparian buffer planting

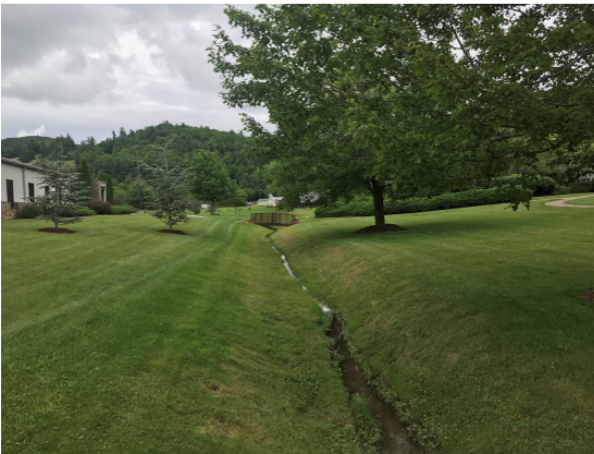
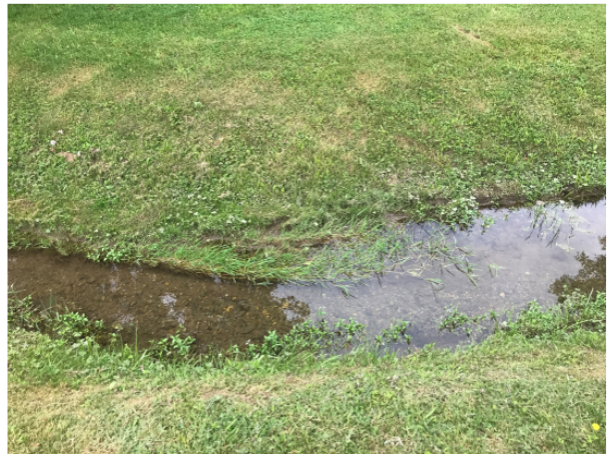
Site 2: Unnamed tributary on Samaritan's Purse property

Low volume tributary to the East Fork running through mowed grass on the Samaritan's Purse property. The reach lacks riparian vegetation and is exposed to direct sunlight as well as lawn clippings. Shrubs would provide shade.

Length of degraded reach: 1000 ft

Issues: Lack of riparian buffer

Recommendations: Shrub planting

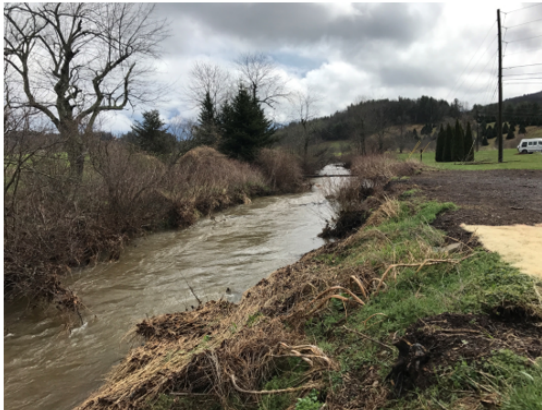
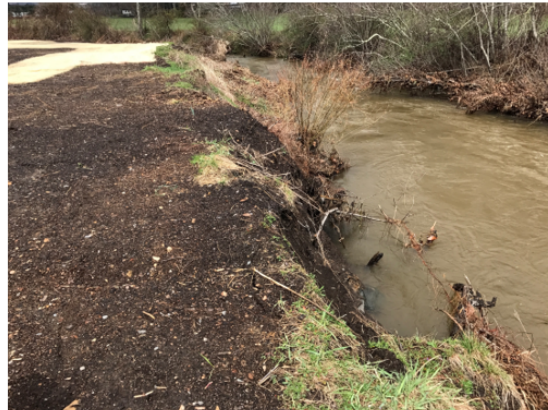
Site 3: East Fork along the north Samaritan's Purse property boundary

Both banks of the reach are incised. Some discontinuous riparian buffer with invasive species present. Piled dirt/mulch placed along the reach is contributing sediment to the river. Bank stabilization and planting of added riparian vegetation would reduce sediment contributions.

Length of degraded reach: 150 ft

Issues: Bank incision, discontinuous riparian buffer, invasive species presence, sediment runoff into river

Recommendations: Bank stabilization, invasive species removal/riparian buffer planting

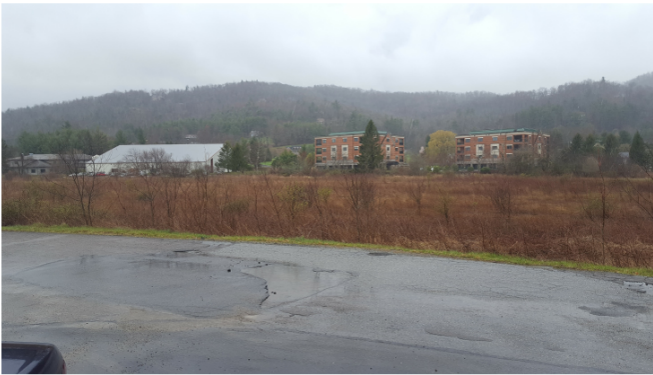
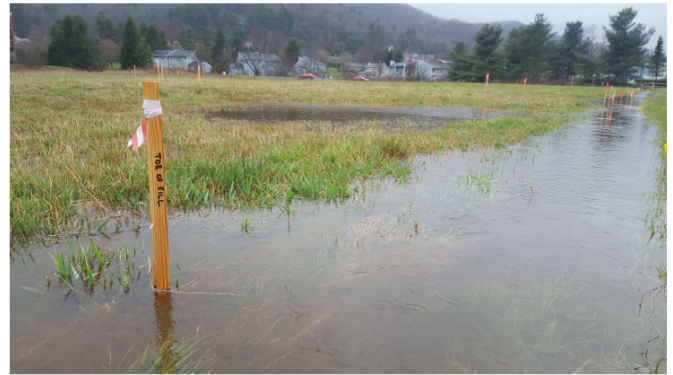
Site 4: Wetland on the north bank of the East Fork on Bamboo Road

Site has been surveyed for development but appears to act as wetland. NRC has reached out to the town of Boone and is continuing to monitor the situation.

Issues: Possible development on sensitive floodplain

Recommendations: Continued monitoring of the site

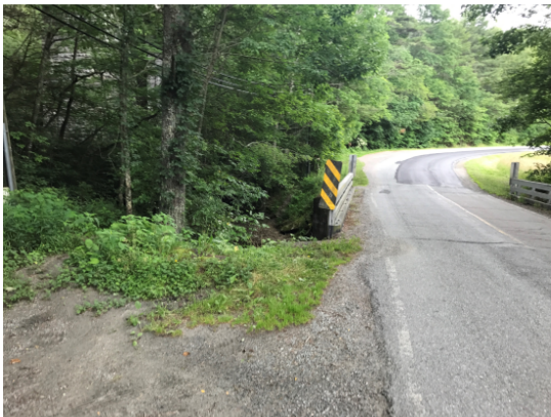
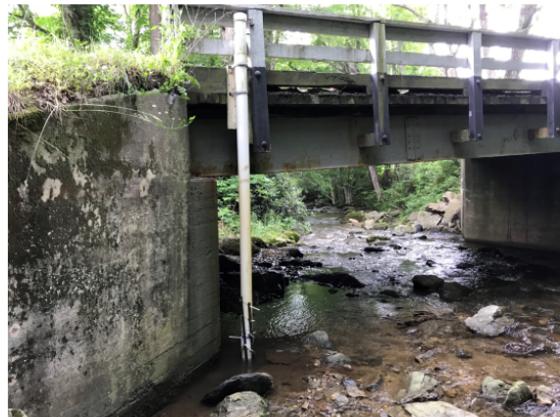
**Site 5: East Fork at intersection of
George Hayes Road and Bamboo Road**

Runoff from Bamboo Road is directly conveyed into the East Fork at the bridge above the river. Sediment traps and planted vegetation would greatly reduce the amount of runoff making it into the river.

Issues: Road runoff conveyed into river

Recommendations: Plant vegetation and install sediment traps

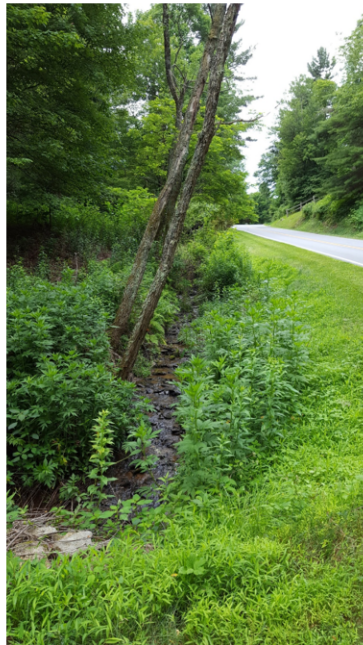
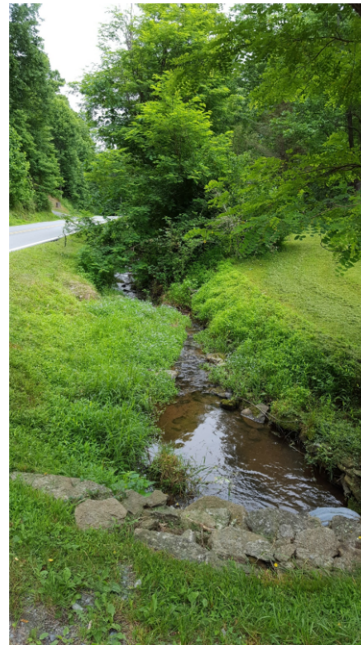
Site 6: Raccoon Branch along Friendship Church Road

Site has high potential for soil loss according to USLE, but hardscaping was observed in the channel. Riparian buffer is discontinuous; some planting is needed. Continue to monitor the reach for changes

Length of degraded reach: 200 ft

Issues: Discontinuous riparian buffer

Recommendations: Riparian buffer planting, continued monitoring

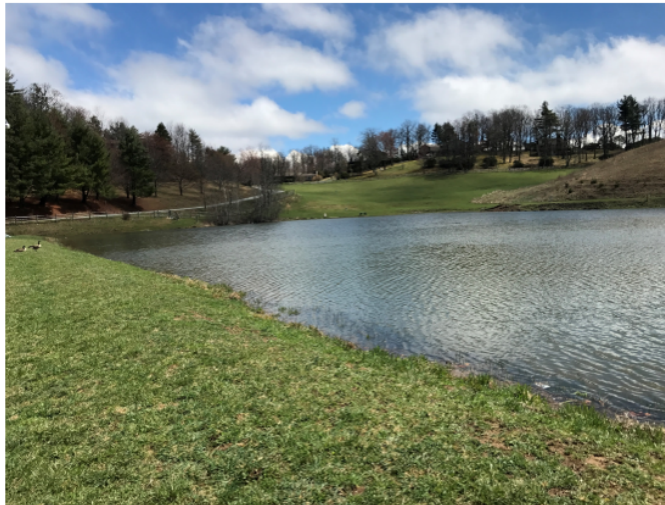
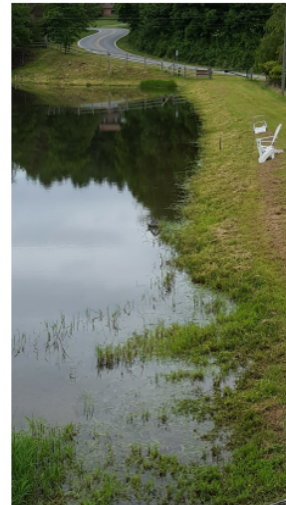
Site 7: Inline pond on Raccoon Branch

Large inline impoundment on Raccoon Branch lacks shade, elevating downstream water temperature. Grass surrounding pond is mowed up to the bank. Plant vegetation for shade and limit mowing to allow buffer to grow.

Degraded area: 2.6 acres

Issues: Lacks shade, mowed up to bank

Recommendations: Planting, limit mowing

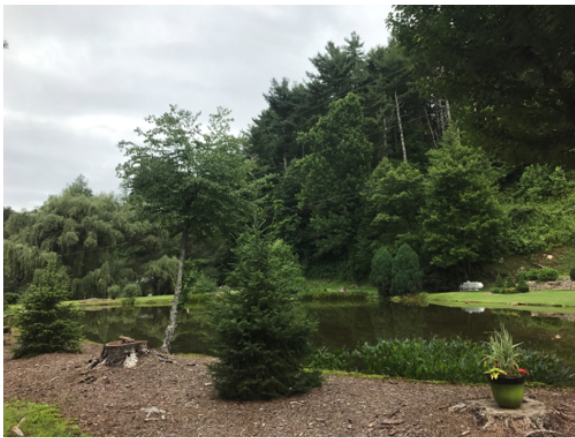
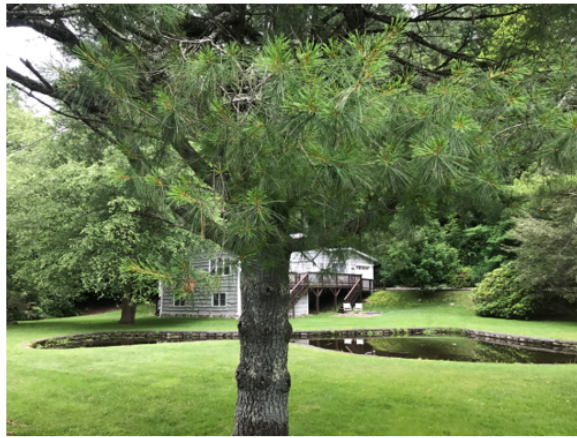
Site 8: Offline ponds along East Fork on Goshen Creek Lane

Flow from the East Fork is diverted to ornamental ponds, which may elevate downstream water temperature. Plant vegetation for shade and monitor water temperature.

Degraded area: 0.55 acres

Issues: Unshaded ponds

Recommendations: Plant vegetation, monitor water temperature

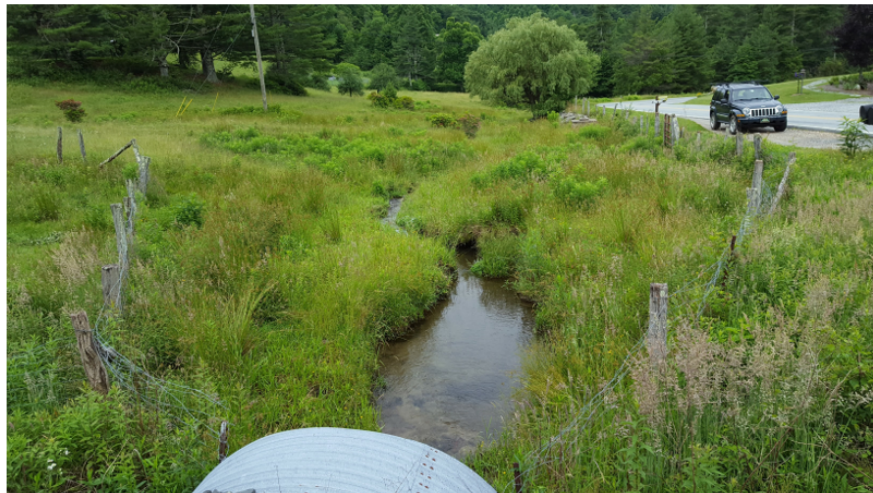
**Site 9: Days Creek downstream of the intersection of
George Hayes Road and Gordon Day Road**

Small tributary at high risk of soil loss according to USLE. Reach is unshaded and located on pasture. The reach is located under power lines, limiting options for planting riparian vegetation. Riparian vegetation and cattle fencing would reduce potential soil loss.

Length of degraded reach: 630 ft

Issues: High risk of soil loss, lack of shade, cattle access

Recommendations: Plant riparian vegetation, fence out cattle

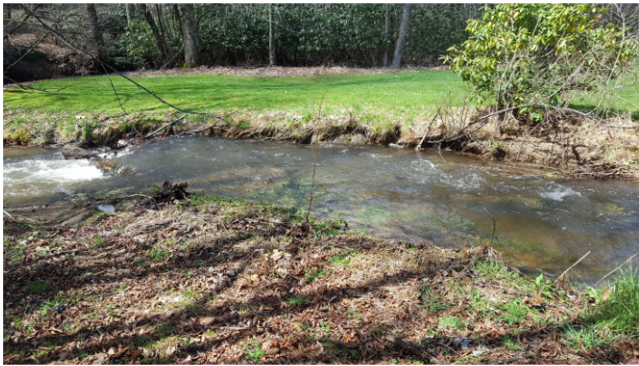
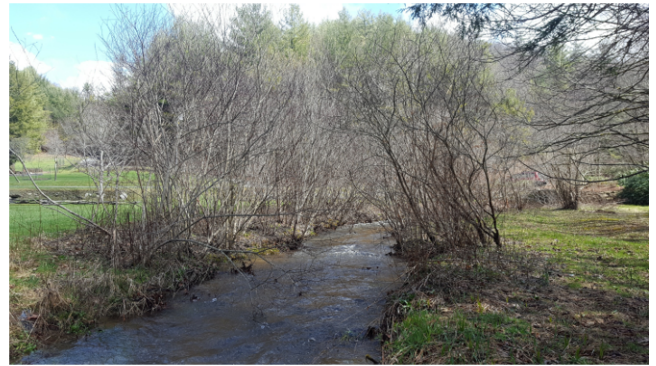
Site 10: Days Creek at Winding Creek Lane

Site where NRC has previously planted riparian vegetation. Not all vegetation on right bank was successful and the riparian buffer is discontinuous. Additional planting is needed.

Length of degraded reach: 175 ft

Issues: Discontinuous riparian buffer

Recommendations: Plant riparian vegetation

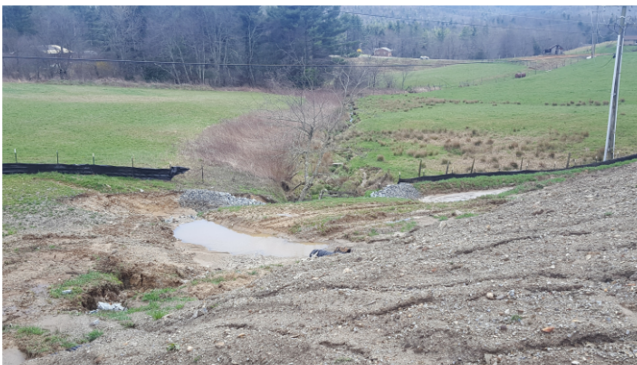
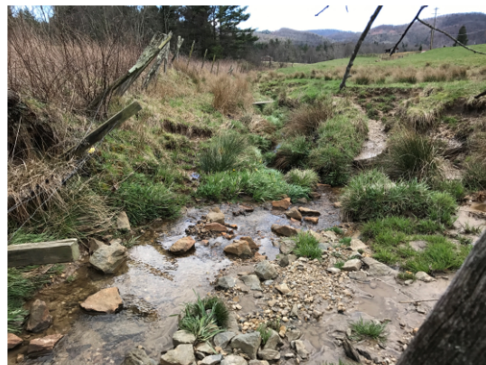
Site 11: Unnamed tributary at Mount Vernon Baptist Church

Small tributary downstream of construction activity. Sediment control and cattle fencing failing, evidence of sedimentation in the streambed. Reach lacks riparian vegetation . Cattle fencing will need to be repaired, continue to monitor sediment BMPs during construction. Plant riparian vegetation to reduce water temperature and intercept runoff.

Length of degraded reach: 290 ft

Issues: BMPs failing, sedimentation, lack of shade.

Recommendations: Monitor sediment BMPs during construction, repair cattle fencing, plant riparian vegetation for shade.

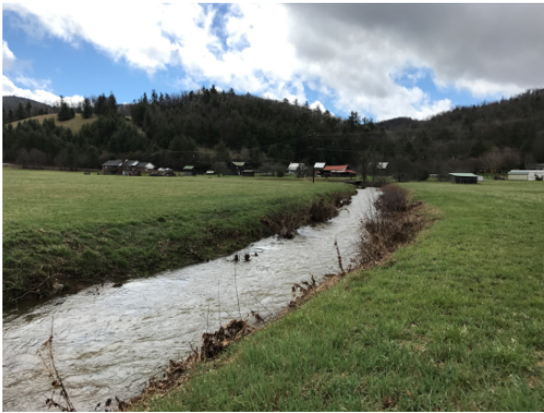
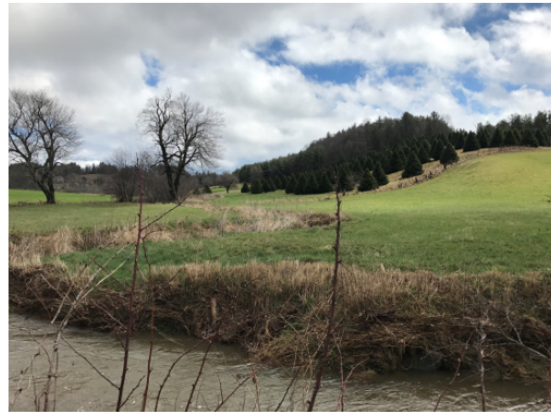
Site 12: East Fork upstream of Samaritan's Purse property

Reach lacks riparian vegetation and is mowed to the banks, but no bank erosion occurring. No shade. Recommend planting native woody vegetation.

Length of degraded reach: 1750 ft

Issues: No riparian vegetation

Recommendations: Plant native woody vegetation

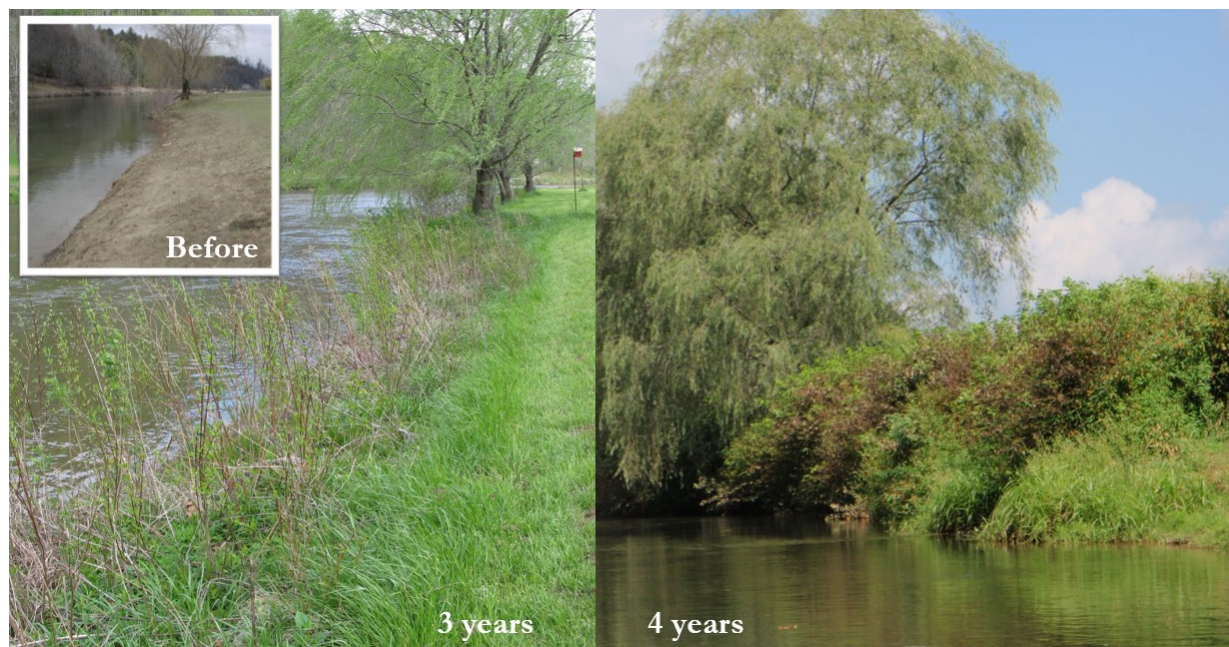
Figure 6: Example of past streambank enhancement planted by NRC

- Preserve streambank stability by planting riparian vegetation and protecting existing vegetation (Figure 6).
- In cases of severe bank erosion, the installation of engineered rock structures may be necessary to redirect flow away from streambanks.

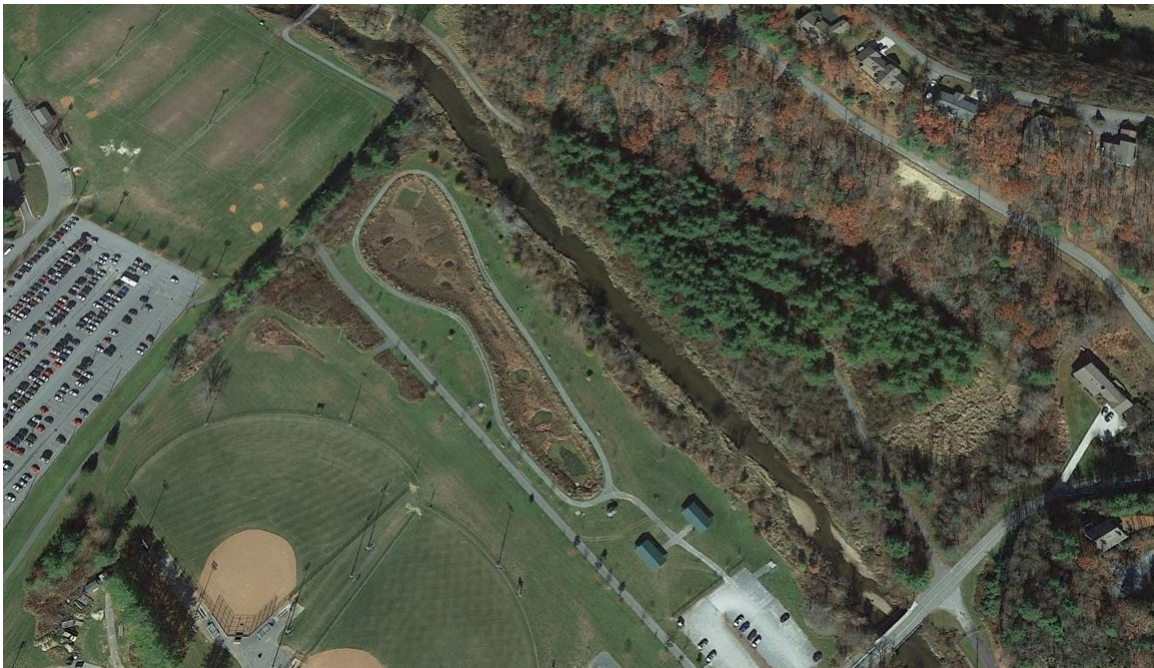
Figure 7: Designed urban streamwater capture located on the South Fork of the New River

- Install rain gardens, bioswales, and urban vegetation in order to slow stormwater and filter pollutants from runoff (Figure 7).
