Upper North Toe River Watershed Action Plan

Avery, Mitchell, and Yancey Counties
North Carolina

Effective January 1, 2015

Prepared by Equinox Environmental Consultation & Design, Inc.
37 Haywood Street
Asheville, NC 28801

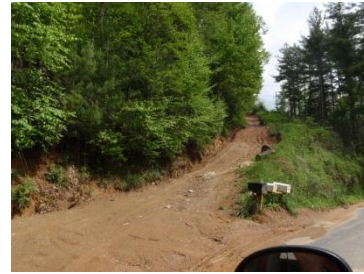
- Roads/driveways - most of these features paralleled the stream channel, with runoff flowing directly into the stream channel. Driveways were mostly unpaved; while many were graveled, those that were not often showed evidence of significant erosion. Public roads were generally paved, and those that were not had graveled surfaces. Surface and ditch erosion occurred in association with maintenance activities. In some cases, straw wattles were placed in ditches as check dams.

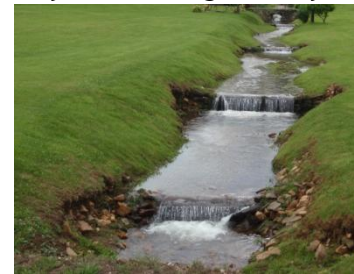
- Riparian areas of stream running through residential yards were generally kept clear of vegetation. Scouring often was observed at the toe of the bank; rock riprap was often used in places where significant bank failures had occurred. The worst erosion was seen in places where fill material was placed adjacent to streams and within areas that flood during high-flow events, of which there were many during 2013.

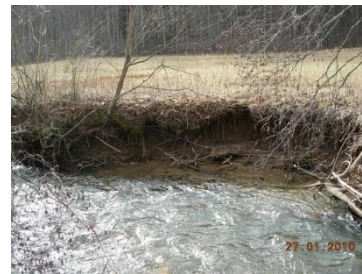
- Most hay fields were in excellent condition, with little or no erosion observed; however, some fields were mowed close to the top of the stream bank, limiting the regeneration of trees and shrubs in riparian areas. Stream banks at these locations tended to be undercut, less stable, and much more likely to be eroding as the stream channel tries to reestablish a meander pattern.

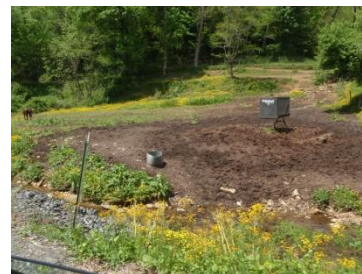
- Pastures were most often occupied by horses, not cattle. While some of the pastures were not overgrazed, the grass in most horse pastures was not in good condition, being overgrazed or trampled. At many sites, livestock were not fenced from the stream channels; the condition of the stream banks here was poor.

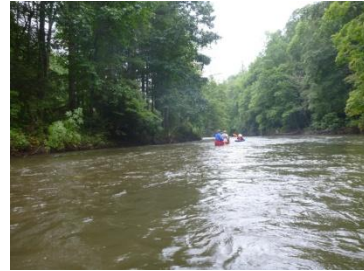
North Toe River - Approximately 20 miles of the North Toe River were surveyed. With the exception of the 2.7-mile portion of river between the Carpenters Island Road and NC 226 bypass bridges, the North Toe River channel is generally well vegetated or forested and very stable.

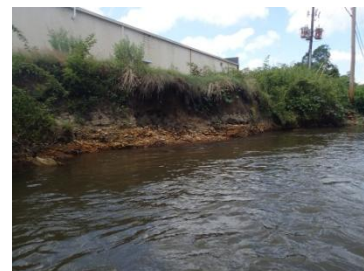
Grassy Creek - Streamwalks were conducted on 2.25 miles of Grassy Creek, from its confluence with East Fork Grassy Creek to the lower Carters Ridge Road (SR 1117) bridge. This portion of stream is heavily impacted by commercial development that has occurred within the last 25 years. In many places the stream channel has been straightened, armored with rock or both in order to accommodate the development of commercial properties. Constraints from this development will be a challenge to remediating the impacts from these conditions.

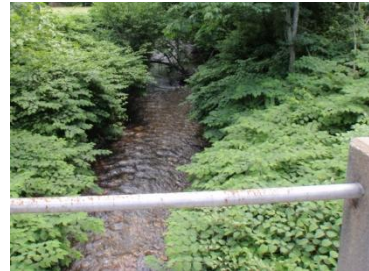
Impacts from 11 outfalls, 6 stream crossings, and 9 occurrences of utilities were documented within the stream corridor. The extensive infestations of multiflora rose and Japanese knotweed observed in the upstream portion of the watershed during the windshield survey extends through the streamwalk section. One area of kudzu was also observed.

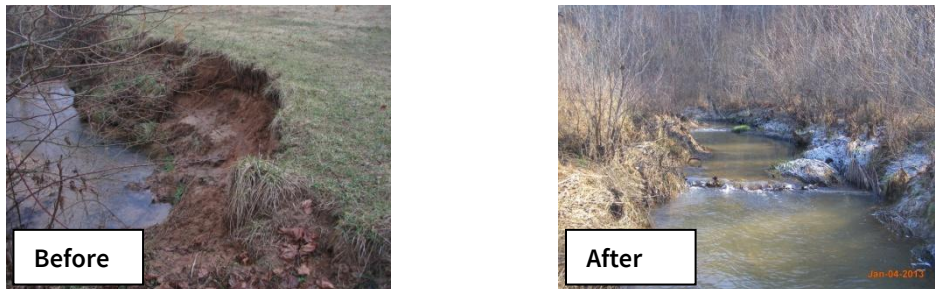
Figure 4.1 Functions of Woody Riparian Vegetation

Revegetation of the riparian area adjacent to the restored stream channel with native shrubs, trees, and herbaceous plants should be conducted in concert with stream restoration or enhancement to restore ecological function and to reestablish a riparian area's ability to filter sediment and other pollutants originating from upland areas (Figure 4.1).

scour during storm events by holding the soil in place (Figure 4.1). However, as shown in Figure 3.6 and Table 3.13, 57-70% of the riparian areas in the headwaters of the North Toe River, Whiteoak Creek, Plumtree Creek, and Threemile Creek subwatersheds have wooded riparian areas that are less than 30 feet in width. These areas present ample opportunity to reduce sedimentation while reestablishing native trees, shrubs, and herbaceous plants. The objective of this management measure should be to establish functioning riparian areas of at least 30 feet in width. Where nonnative invasive exotic plant species dominate, their control should also be carried out in conjunction with vegetation enhancement. The most common invasive exotic plants in the North Toe River watershed, Japanese knotweed and multiflora rose, create monocultures that exclude the establishment of native plant species and do not have the root structure necessary to hold stream banks in place or to filter pollution.

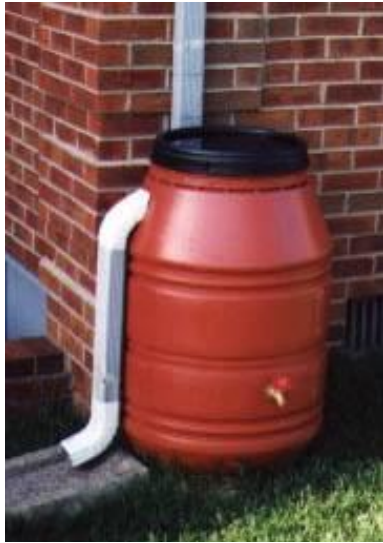
Figure 4.2 Rain Barrel and Cistern Setup

Rain Barrels and Cisterns - Rain barrels and cisterns (Figure 4.2) provide a storage device to capture rooftop drainage for later use on the site. Many people capture and reuse this water for their gardens and landscape plantings. Rain barrels come in a variety of sizes, shapes, and colors. It has become fairly commonplace to find 50- to 75-gallon barrels that make attractive additions to the landscape. A simple, 50-gallon plastic rain barrel will typically cost around \$100 or less to install. Users of this practice will need to make sure that they have screens over openings to keep mosquitoes from using the reservoir as a breeding ground. They will also need to direct the overflow to a suitable location to keep it from seeping into foundations and basements.

A rain barrel is attached to a downspout and collects rain water.

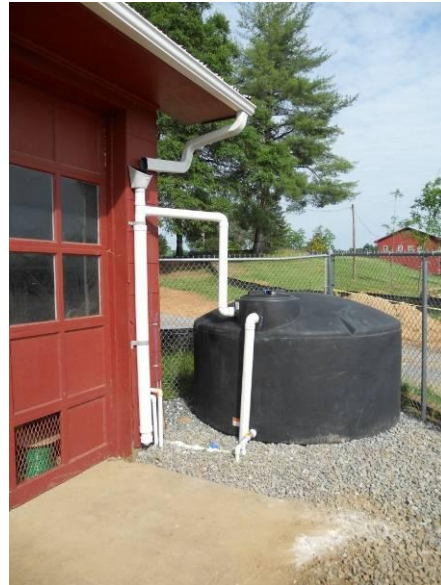
An above ground cistern located at the City of Morganton Parks and Recreation maintenance building catches runoff from the roof. The water is used to clean equipment.

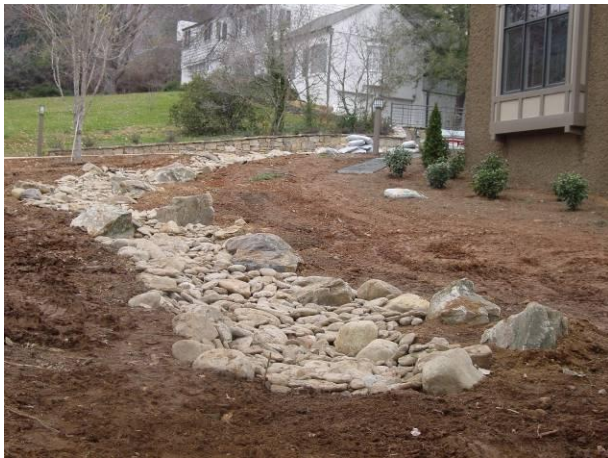
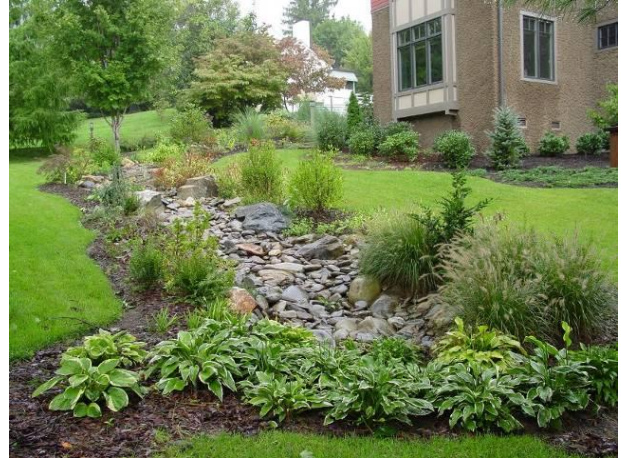
Figure 4.3 Dry Creek Beds in a Residential Setting

Dry Creek Beds - Dry creek beds (Figure 4.3) can be an attractive landscape amenity that can serve the function of re-routing storm runoff from impervious rooftops, driveways, and parking lots into a yard area where infiltration can occur.

The rough edges of the stones and the open spaces in between the rocks slow down runoff and allow it to be absorbed into the ground. Landscape plantings within and surrounding the dry creek bed also slow the water and promote infiltration. The stones and plants can also work together to create natural habitat for birds and small mammals.

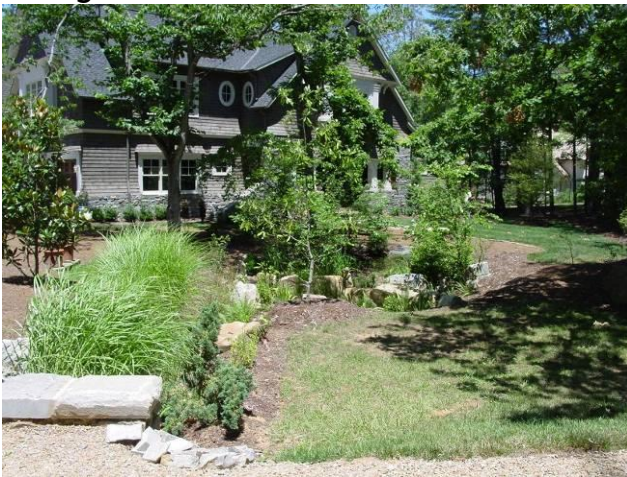
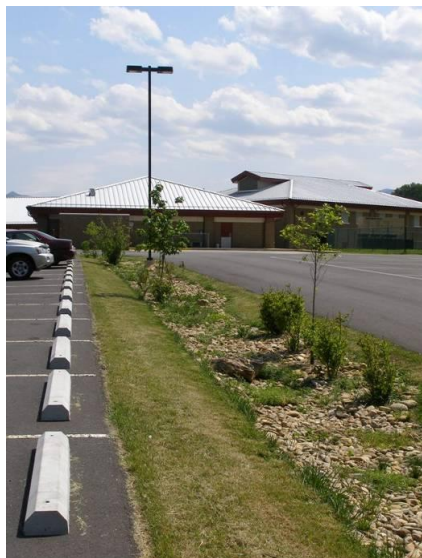
Figure 4.5 Bioretention Features in Residential and Commercial Applications

More simplified versions of bioretention features are known as rain gardens and are often utilized in residential applications (Figure 4.5). Rain gardens function like bioretention features by utilizing landscape depressions but do not normally include the infrastructure and soil mediums typical of bioretention cells. Because they lack drainage structures, soils in rain gardens need to be highly permeable in order to function correctly. Both methods are intended to "draw down" or empty within 48 hours following a rain event, alleviating stagnant water and mosquito-breeding concerns.

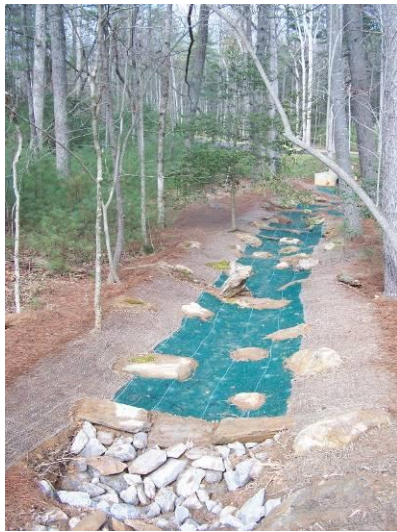
Figure 4.6 Examples of Regenerative Stormwater Conveyances

At Construction

Regenerative Stormwater Conveyances (RSC) - A new and more descriptive term for what have been known as swales, RSCs are essentially drainage ditches, but they do more than simply convey water from one point to another. They are designed to slow down water flow and allow infiltration. This innovative system utilizes open-channel, sand-seepage filtering systems that incorporate a series of shallow aquatic pools, riffle weir grade controls, native vegetation, and an underlying carbon-rich sand channel to treat and safely detain and convey storm flow (Figure 4.6, Brown et al. 2010). In the process, stormwater is converted to groundwater through infiltration. An RSC system combines the features and treatment benefits of swales, water infiltration, pollutant filtering, and wetland practices. Simple grass-lined swales have limited pollutant removal benefits, but are often utilized in conjunction with other SCMs.

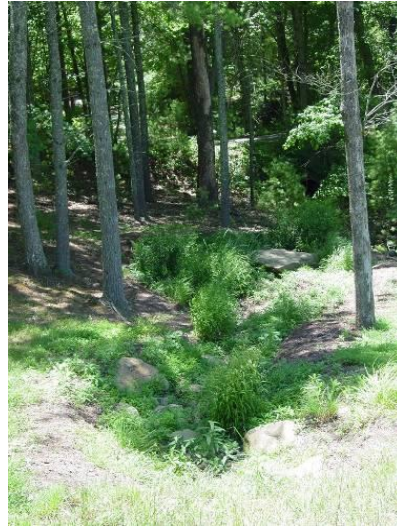
After One Growing Season

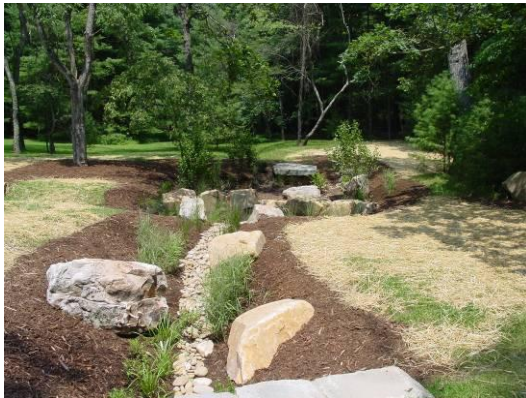
After Construction

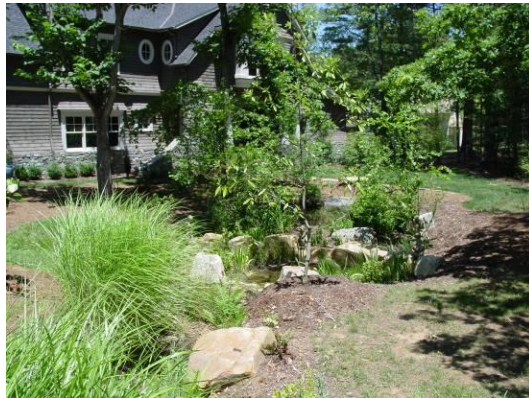
Three Years After Installation

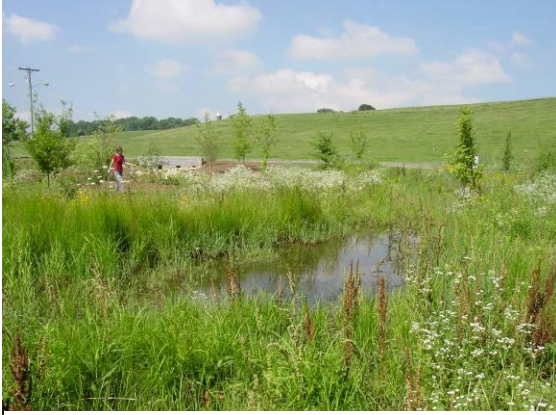
A constructed wetland at a city park captures stormwater runoff from a residential development and a parking lot. It also serves as a water feature in the park and provides wildlife habitat.

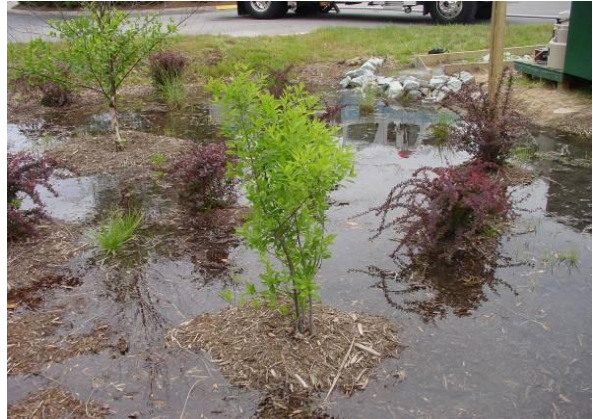
A bio-retention area effectively captures runoff, preventing large volumes of polluted runoff from entering a stream.

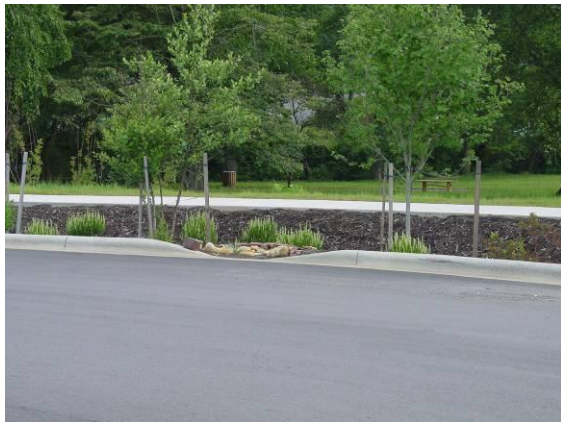
A small curb cut allows stormwater from a parking lot to enter into a bio-retention area bordering the parking lot.

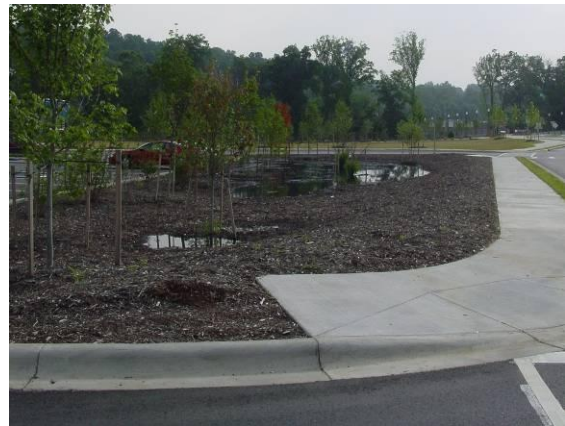
Following a rain event, stormwater enters the bio-retention area where it is absorbed by mulch and soil and is taken up by plants.

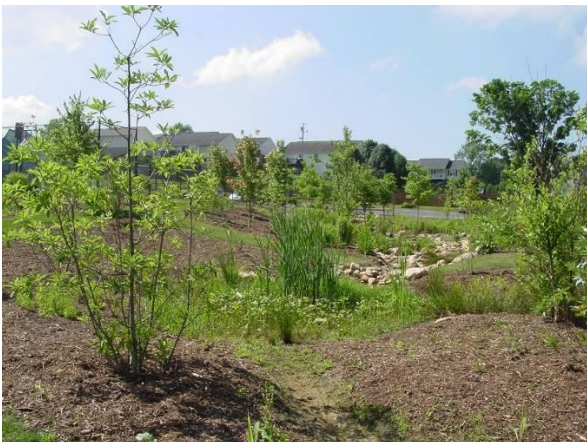
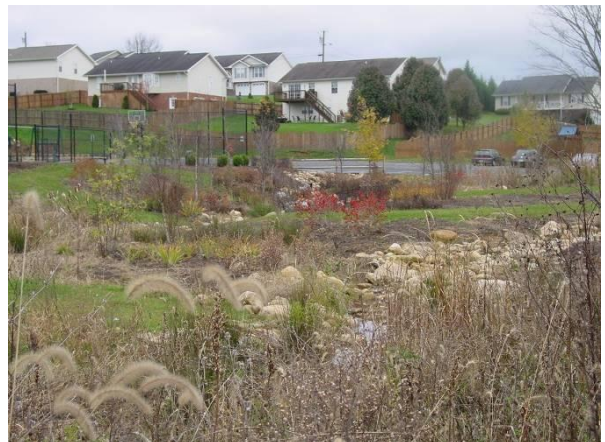
Figure 4.7 Examples of Constructed Wetlands

Constructed Wetlands (also known as stormwater wetlands) - Constructed wetlands are shallow depressional wetlands constructed to mimic the functions of natural wetlands (Figure 4.7). They temporarily store stormwater in shallow pools that contain diverse wetland vegetation. The wetland uses physical, chemical, and biological processes to filter pollutants. They can also be designed to provide stormwater volume control.

Examples of constructed wetlands.

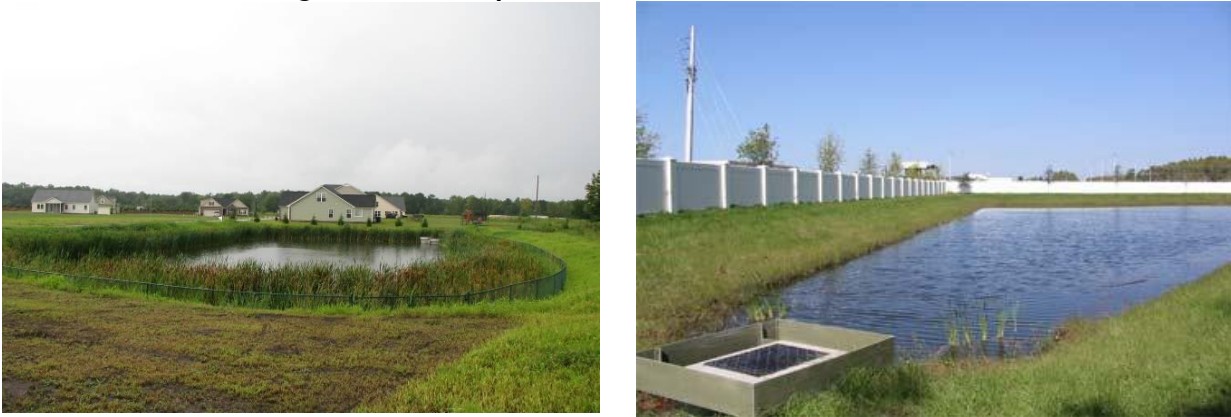
Figure 4.8 Examples of Wet Detention Ponds

Detention and Retention Ponds - Wet detention ponds act in a similar manner as stormwater wetlands, storing stormwater for 12-24 hours (Figure 4.8). During this time, sediment and other pollutants settle out or are absorbed on the lake bottom. Like wetlands, detention basins can handle runoff from large areas. In contrast, wet detention basins are usually deeper, are armored with concrete embankments, and do not utilize vegetation in the pollution treatment. While they may not require as much space to install as a wetland, they lack some of the aesthetic and functional qualities that are provided by wetlands. Because of the safety issues posed by the pond depth, fencing is often required around the perimeter. Since water temperature is a concern for trout streams in the North Toe River watershed, wet-pond use should be avoided. The lack of shading results in increased water temperatures that can affect stream life as water is released to receiving streams. Construction costs for wet-pond retrofits can be upwards of \$57,500 per impervious acre of treatment. Routine maintenance can be expected to cost about 3 to 5% of the construction cost.

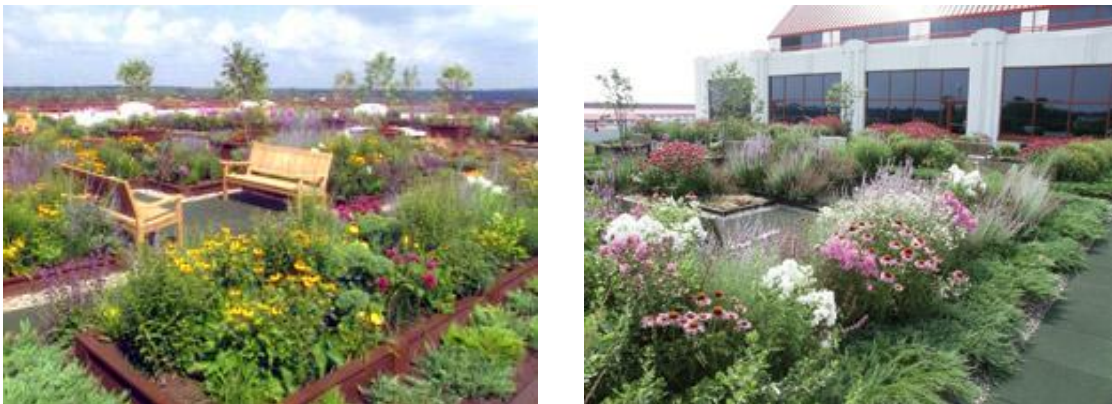
Figure 4.10 Examples of Green Roofs

Green Roofs - A green roof is a roof that has plants on it (Figure 4.10). While still a relatively novel concept in the southeastern United States, this engineered construction practice has been time tested throughout Europe and is beginning to show up in North America (Chicago's City Hall has a green roof). This practice is a great way to manage rooftop stormwater when space is limited for BMPs on the ground surrounding the building. Green-roof technology is not only a good way to manage stormwater runoff; these types of roofs provide greater insulation from heat and cold, soundproofing, and last up to two times longer than conventional roofing. Green roofs can also help moderate the "heat island" effect of urban areas.
