# **Goose Creek Watershed Management Plan**

**Completed by: Charlotte-Mecklenburg Storm Water Services  
Version 1  
October 31, 2009**

**Completed by:  
Charlotte-Mecklenburg Storm Water Services  
Water Quality Program Staff**

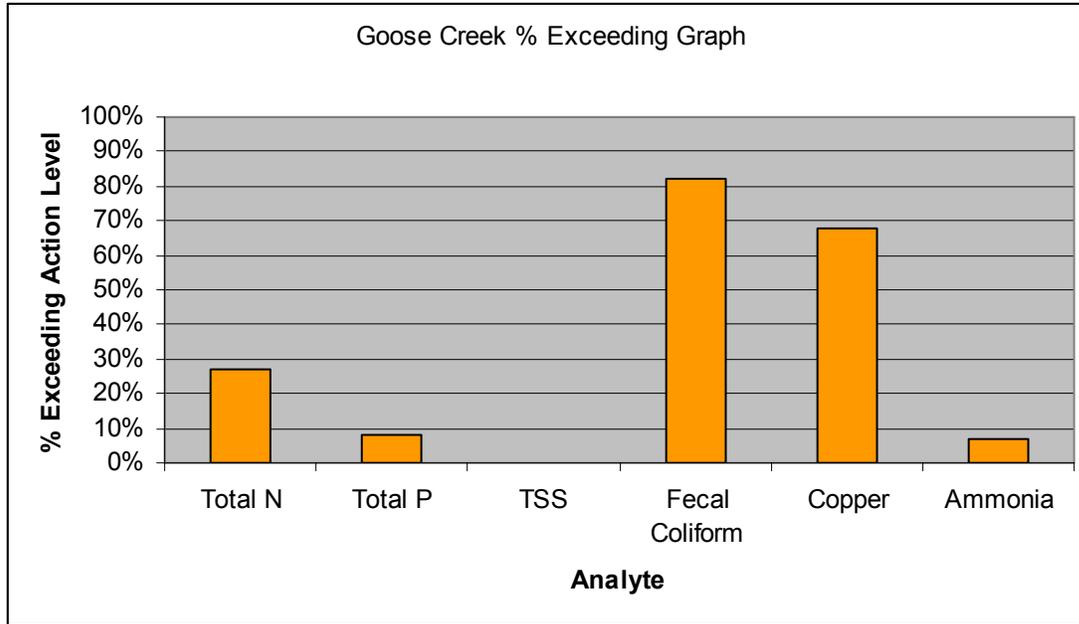
Figure 5: Percent Exceeding Graph for Goose Creek Samples.

All Goose Creek Monitoring Sites	Total N	Total P	TSS	Fecal Coliform	Copper	Ammonia
Action Level:	1.5 ppm	0.4 ppm	50	200 cfu/100MI	2.2 ug/L	0.5
Sample size	186	202	48	463	121	204
MIN	0.35	0.02	2	1	2	0.05
MAX	10.5	2.1	43	58000	36	2.5
MEAN	1.5	0.2	5.2	2398	6.2	0.22
MEDIAN	1.1	0.13	2.8	500	3.6	0.10
% samples over Action Level	27%	8%	0%	82%	68%	7%

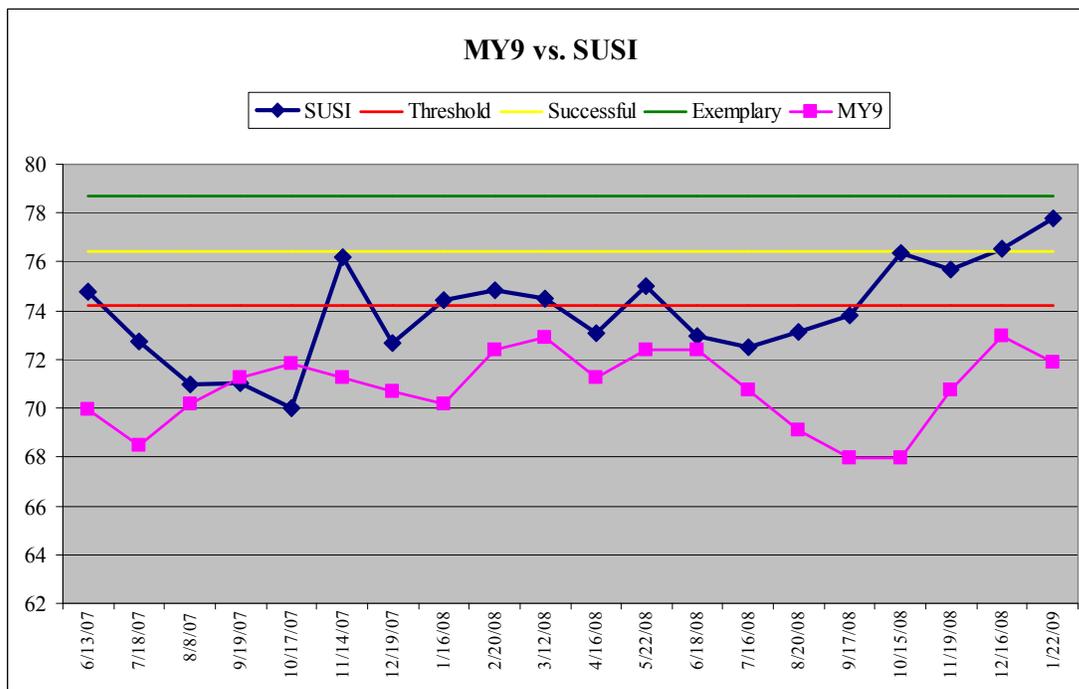
Figure 6: Historical SUSI Scores for Goose Creek

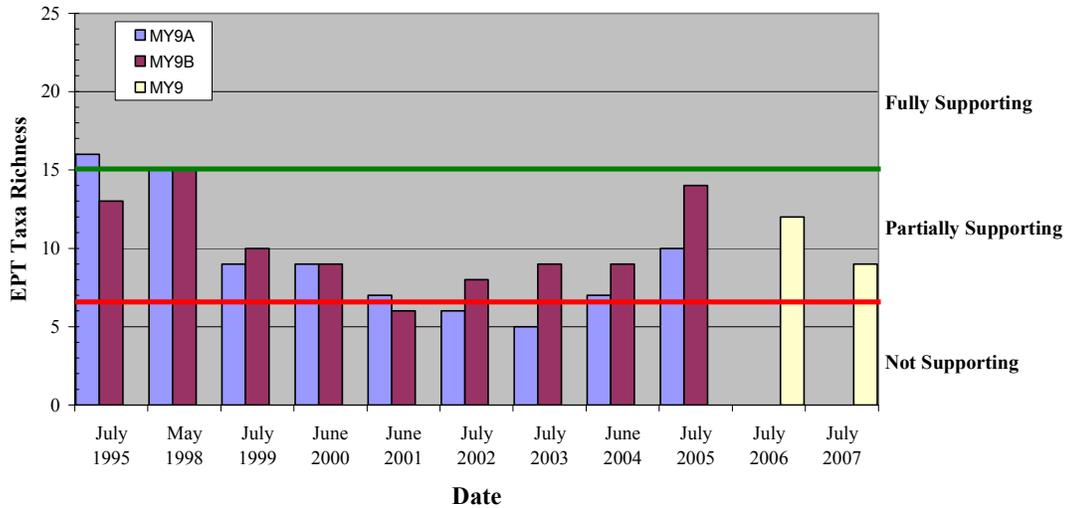
**Figure 7: Goose Creek Benthic Macroinvertebrate Scores.**

485 on Goose and Stevens Creeks respectively (Figure 2). The EPT taxa richness was generally below 10 species for all samples taken since 1999 in Goose Creek. Figure 7 presents the benthic macroinvertebrate scores for Goose Creek since 1995. As can be discerned from the graph, Goose Creek has exhibited a general decline in its macroinvertebrate population. However, it is important to note that the macroinvertebrate populations in Goose Creek are very sensitive to drought as Goose Creek tends to dry up more readily than other creeks with a similar drainage area. This is likely due to the drainage area being partially within the Carolina Slate Belt

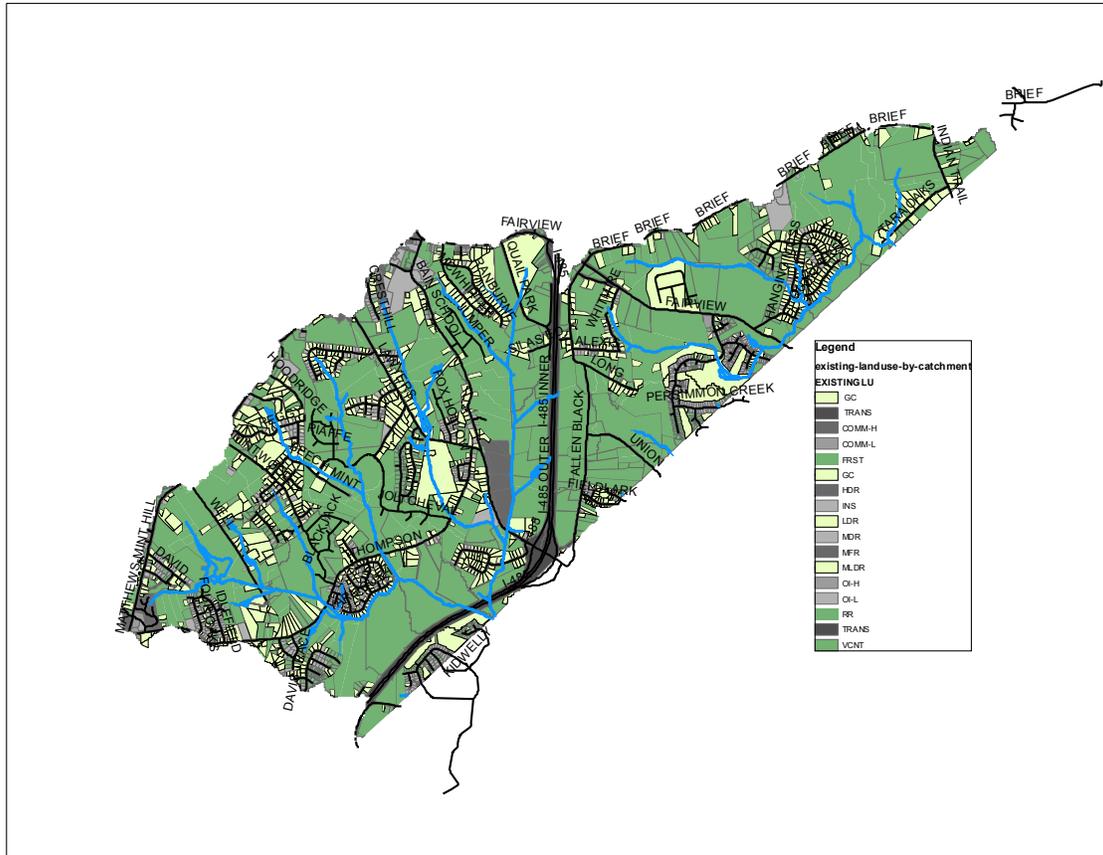
**Figure 8: Distribution of Land Uses in the Goose Creek Watershed.**

The distribution of the land-uses for the Goose Creek watershed is shown in Figure 8.

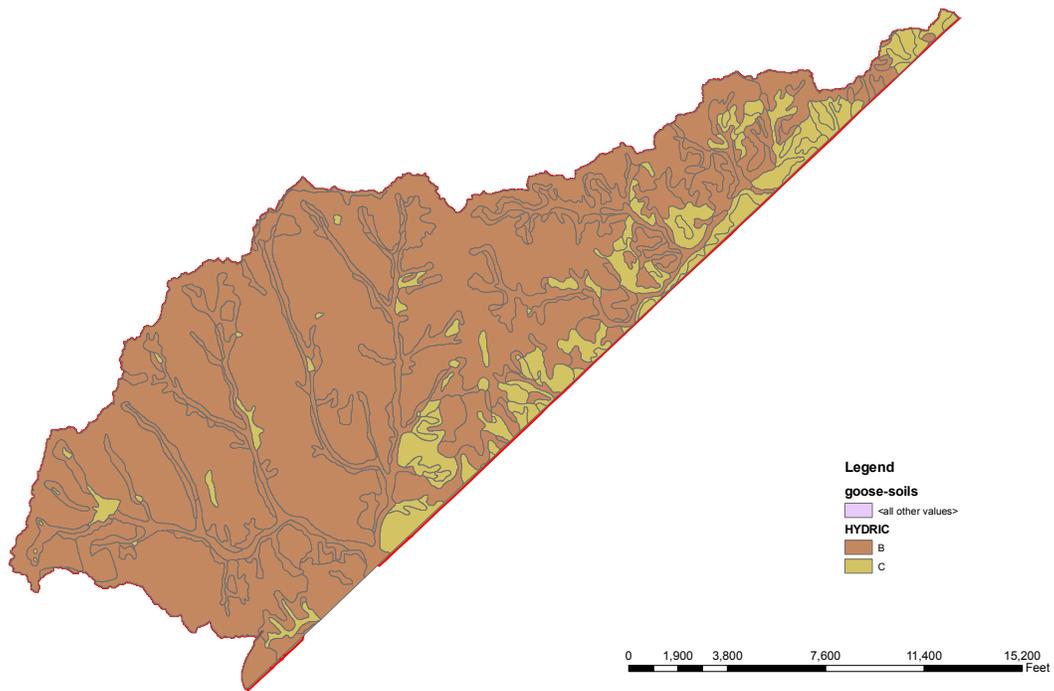
**Figure 9: Distribution of Hydrologic Soil Groups in the Goose Creek Watershed.**

The distribution of soils within the Goose Creek Watershed was determined through the Soil Survey of Mecklenburg County (USDOA – SCS, 1980). The hydrologic soil types found in the Goose Creek Watershed are B and C. A description of each soil type and distribution within the watershed are shown in Table 7. Figure 9 shows the location of the hydrologic soil groups in the Goose Creek Watershed.

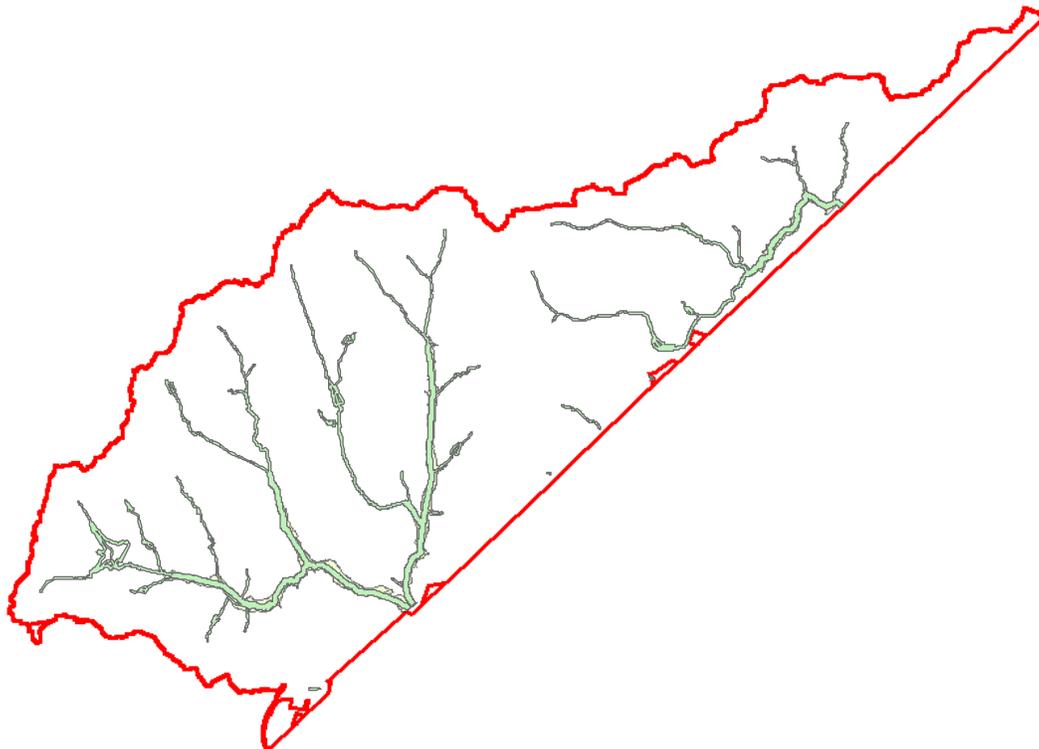
**Figure10: Approximate Extent of the Goose Creek Watershed S.W.I.M. Buffers.**

All buffers are measure horizontally on a line perpendicular to the surface water, landward from the top of the bank on each side of the stream.

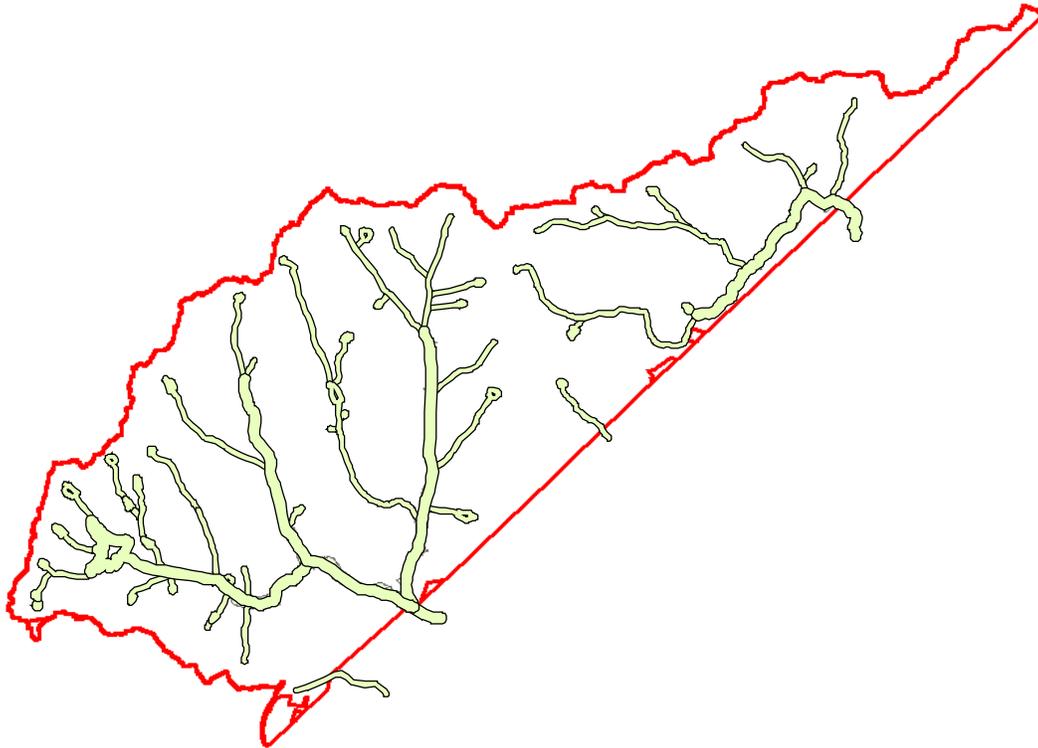
**Figure 11: Approximate Extent of the Goose Creek Watershed Post Construction Buffers.**

On June 30, 2007, Mint Hill implemented the Post Construction Ordinance that required 100-foot buffers on all dashed streams on USGS topographic maps and 200-foot buffers on all solid streams on USGS topographic maps. The Post Construction Ordinance was replaced by the Site Specific Management Plan (developed by NCDENR) for the Goose

Creek Watershed on February 1, 2009. Both ordinances apply but the more stringent requirement must be met. Properties developed from June 30, 2007 through February 1, 2009 are required to conform to the Post Construction Buffers. Figure 11 shows the approximate extent of the Goose Creek Watershed Post Construction Buffers.

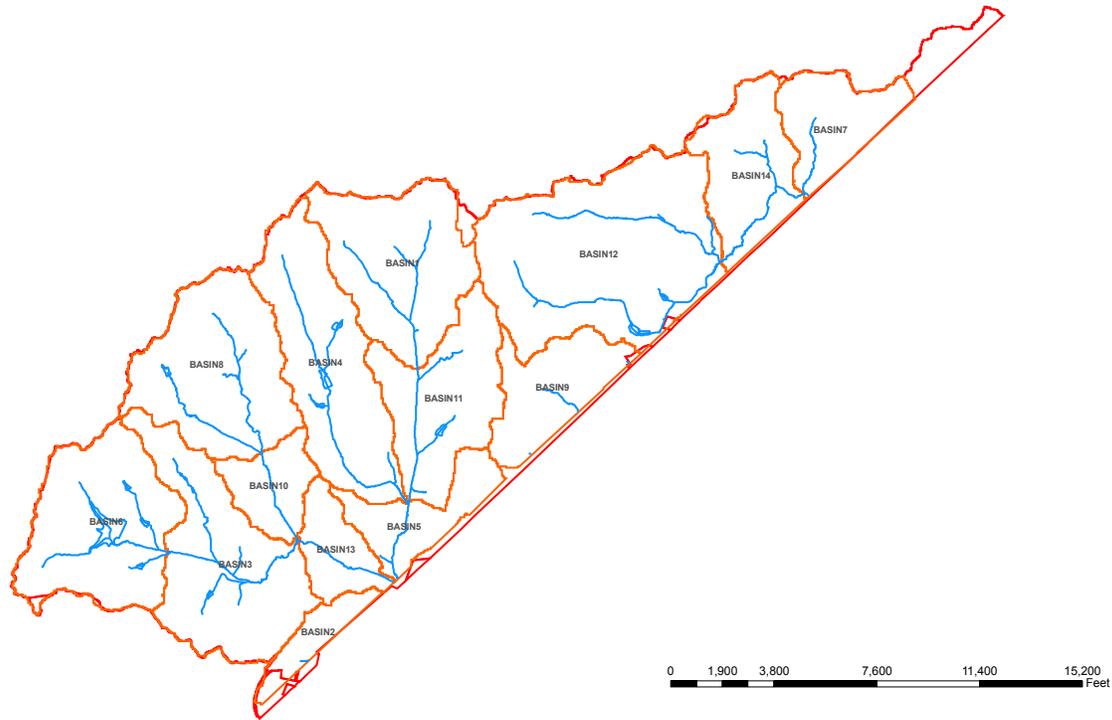
**Figure 13: Goose Creek Watershed Catchments.**

The land-use data for the Goose Creek Watershed was sub-divided into catchments using GIS software. The catchments were delineated using the Watershed Information System (WISe) with an approximate drainage area of 1 square mile per catchment. Catchments with very small drainage areas were merged into nearby catchments to reduce the number of reporting units. A total of 14 catchments were delineated for the Goose Creek Watershed. Figure 13 shows the distribution of the catchments in the Goose Creek Watershed.

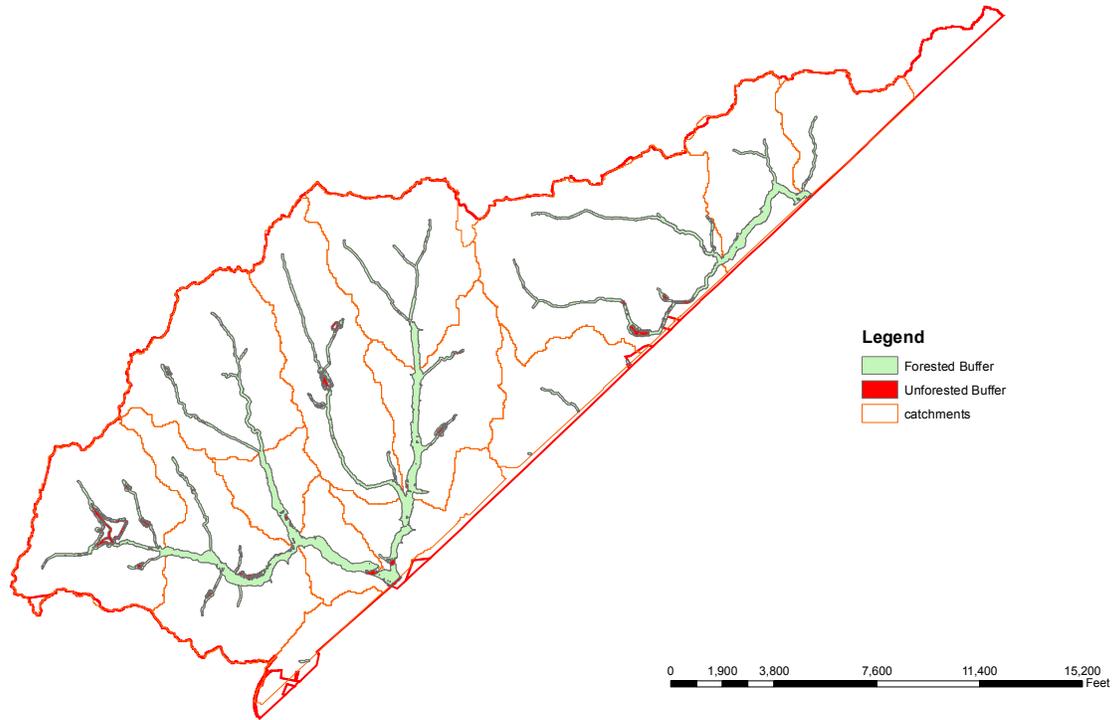
**Figure 14: Distribution of Forested and Un-forested Stream Buffers within the Goose Creek Watershed.**

The percent of impacted buffer in the Goose Creek Watershed was also characterized. The characterization was completed using tree canopy data for Mecklenburg County intersected with the FEMA floodplain delineation and the S.W.I.M. and Watershed buffer coverages. The resulting GIS dataset, which depicts the presence or absence of tree canopy within stream buffers, was intersected with the catchment coverage to determine the percent of un-forested buffer within each catchment. Figure 14 shows the distribution of forested and un-forested buffer within the Goose Creek Watershed.

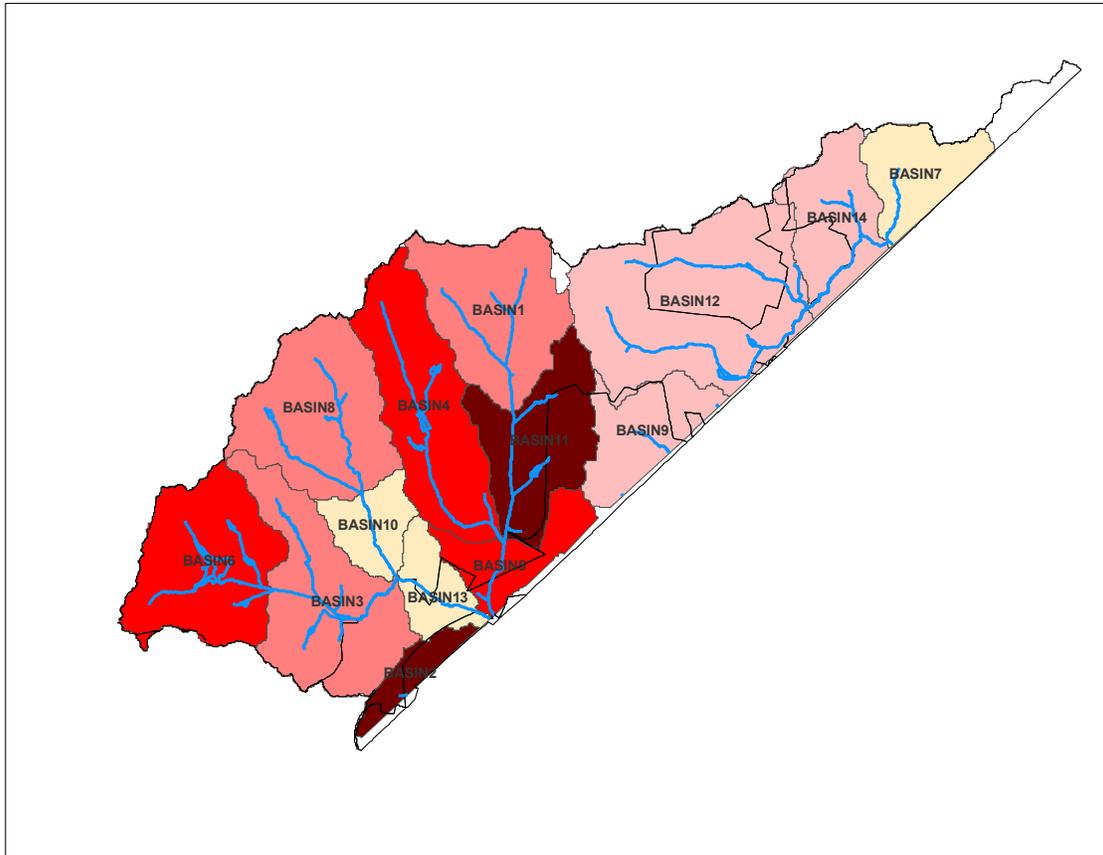
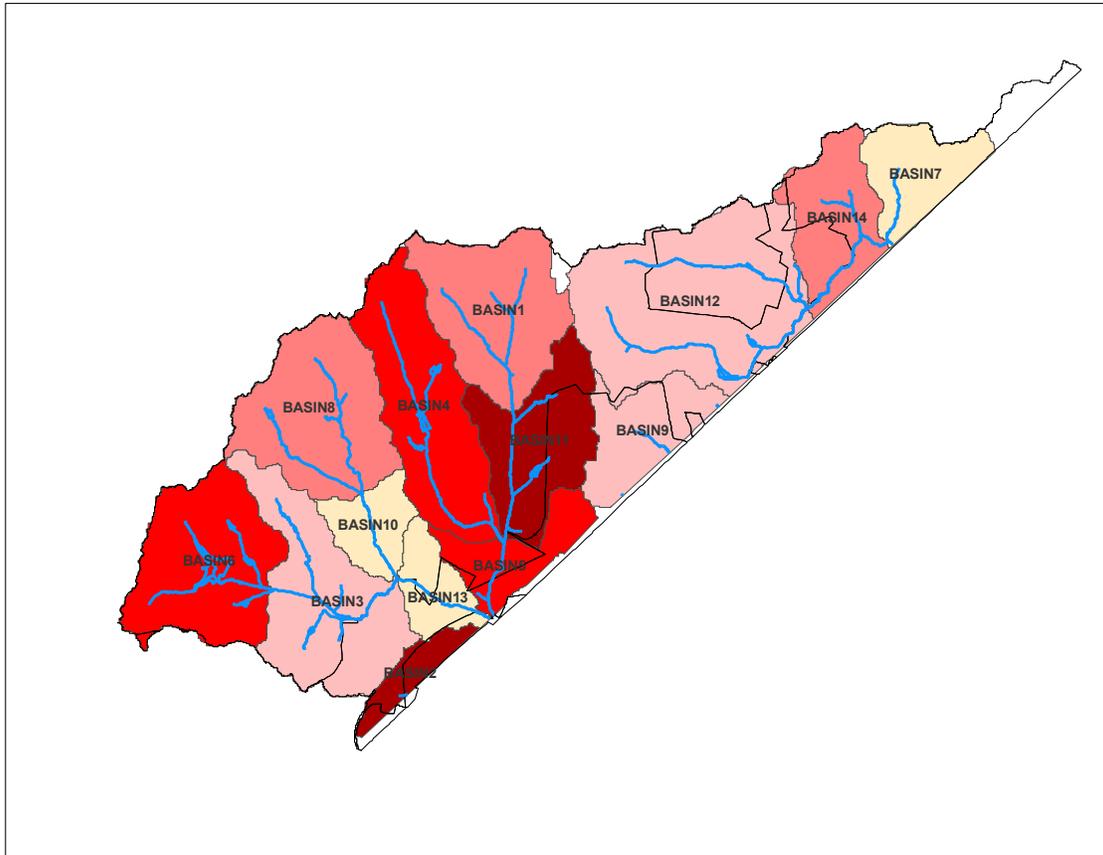
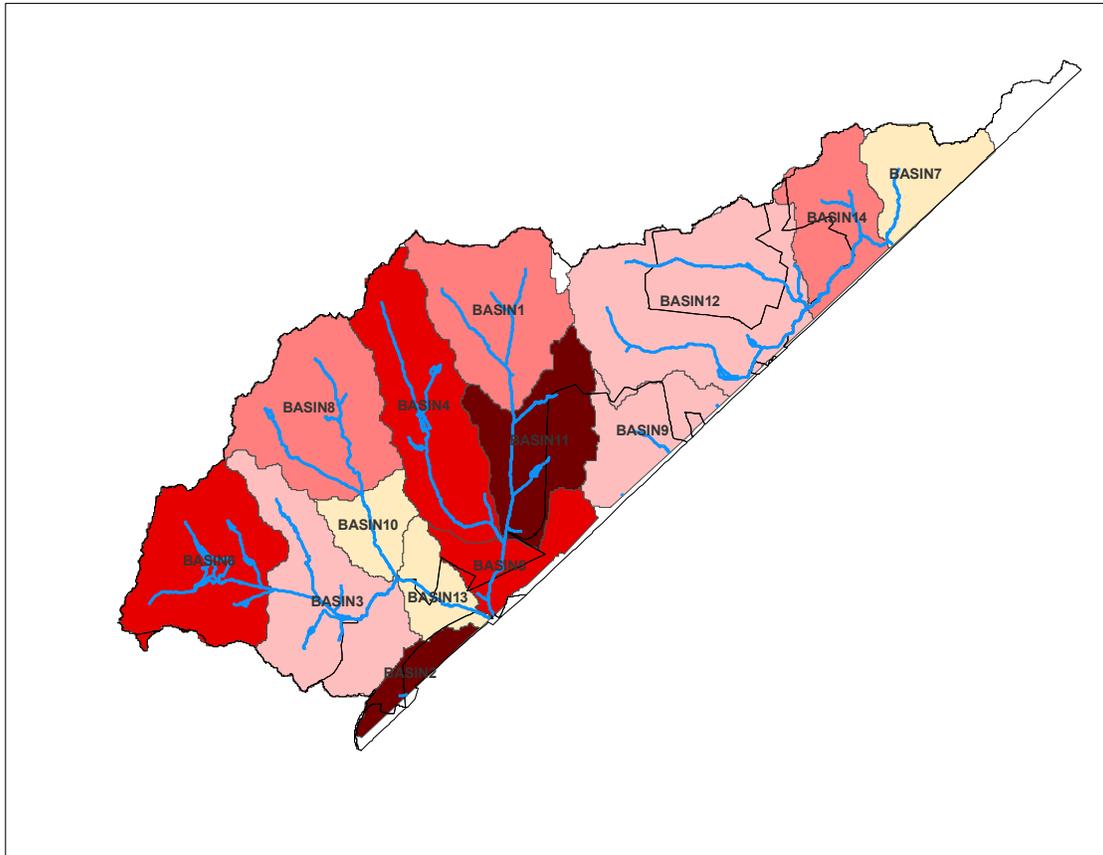
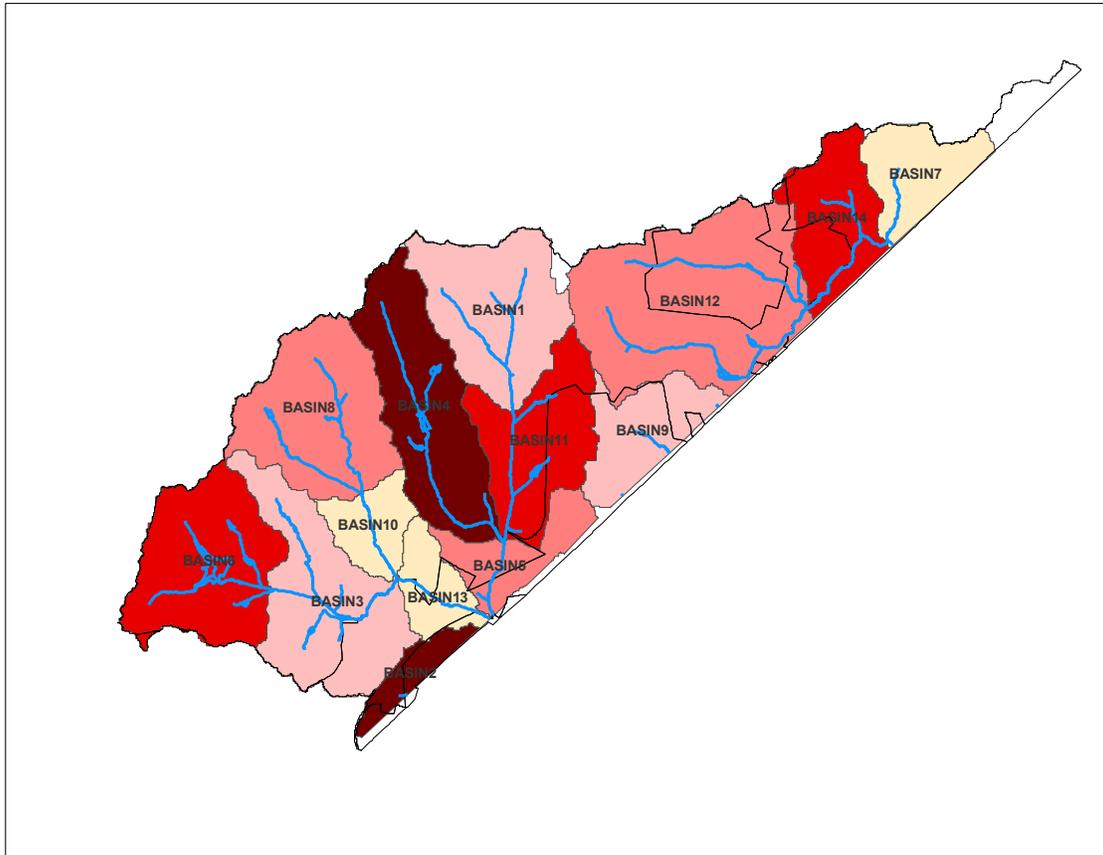
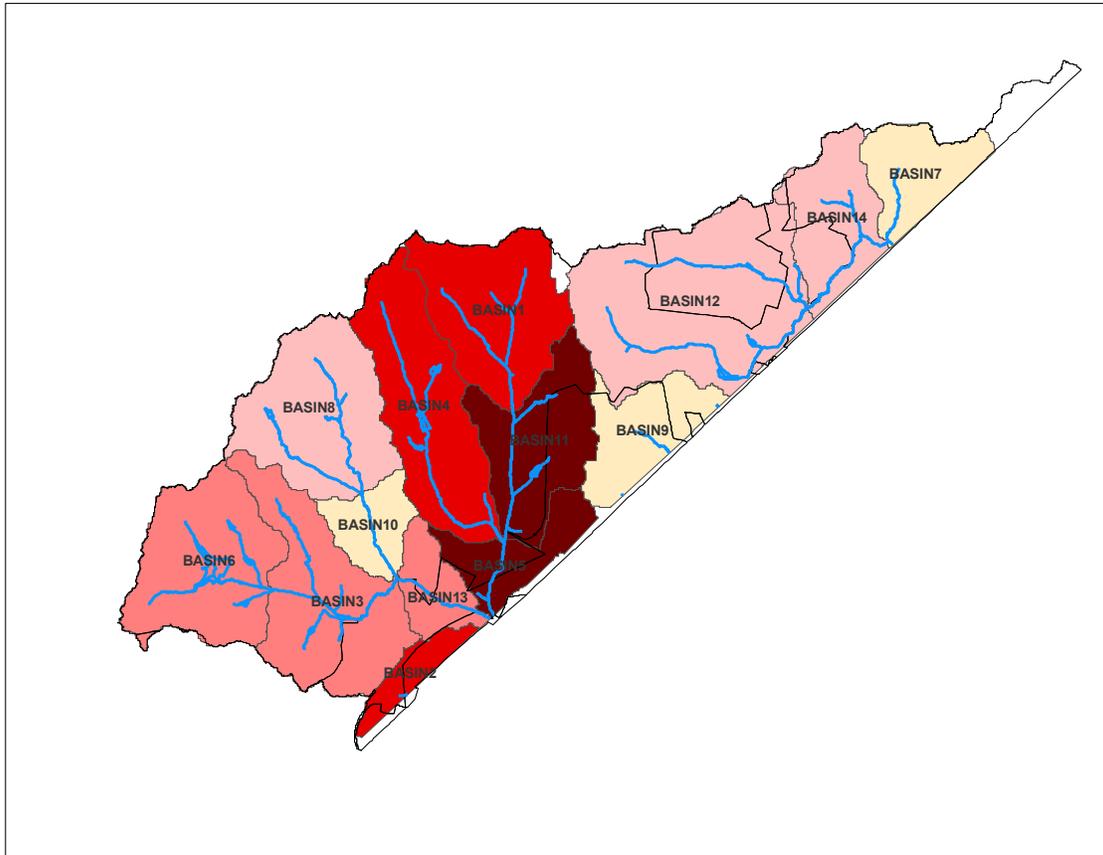
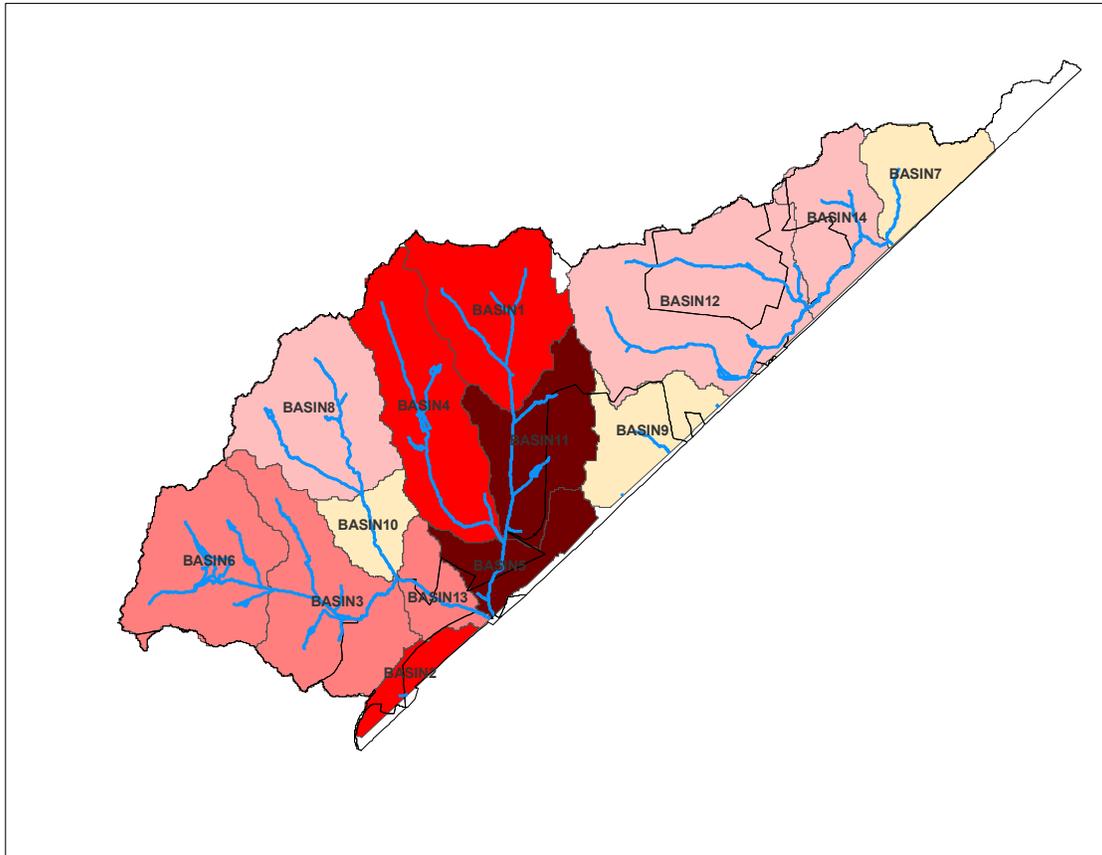
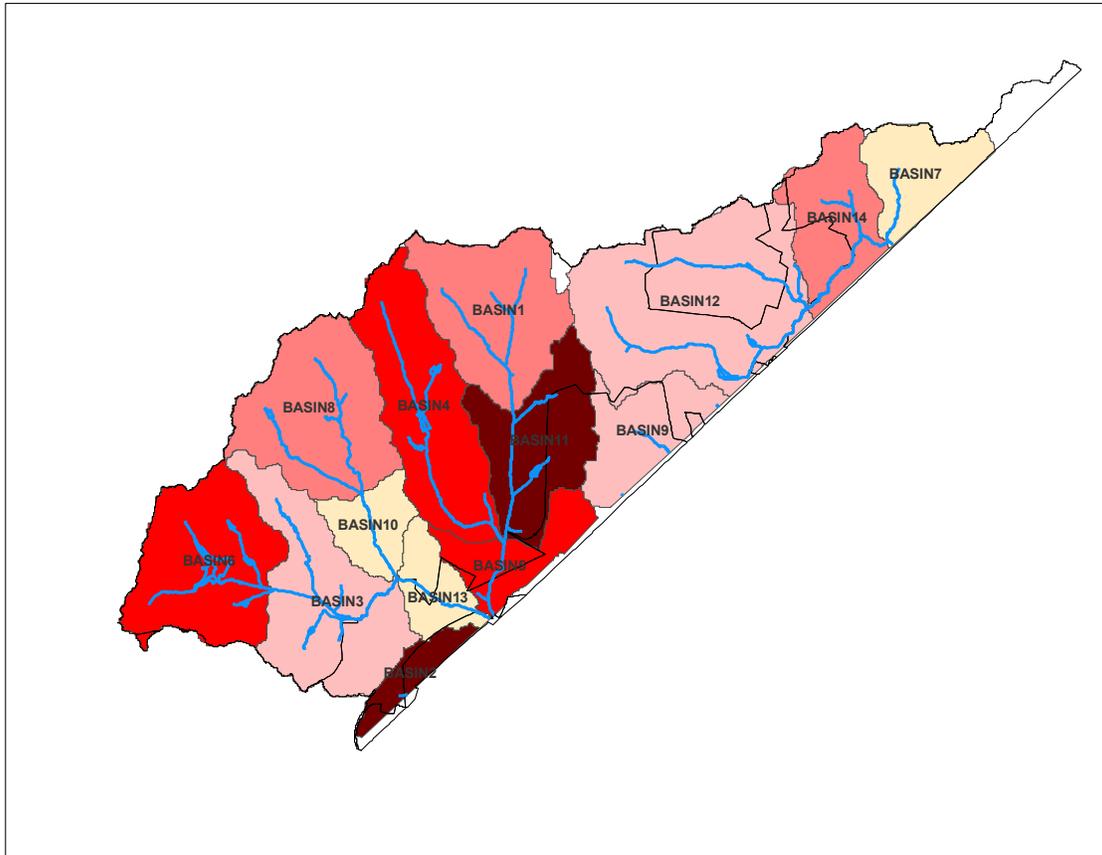
**Figure 15: Fecal Coliform Rank.**

**Figure 16: TN Ranking.**

**Figure 17: TP Ranking.**

**Figure 18: TSS Ranking.**

**Figure 19: NH4 Ranking.**

**Figure 20: Cu Ranking.**

**Figure 21: Overall Impairment (based upon upland pollutant load).**

Figures 15 – 21 present the overall ranking based upon the results of the upland characterization for Fecal Coliform, TN, TP, TSS, NH4, Cu and Overall Impairment respectively. Note that darker colors indicate increased levels of impairment.

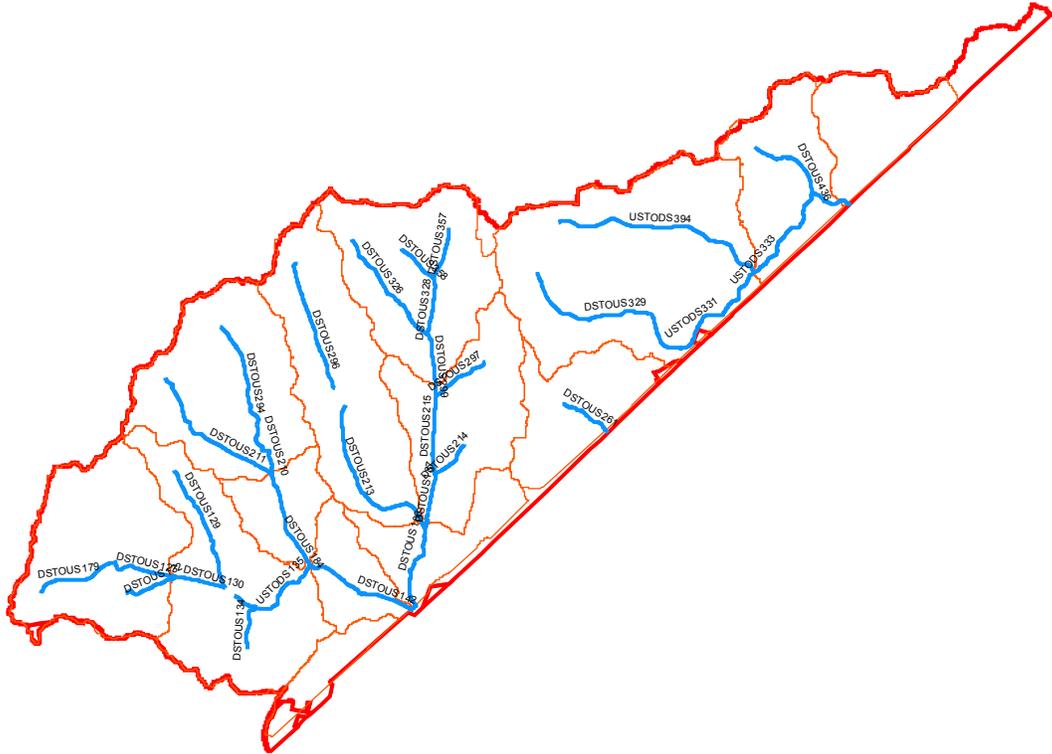
**Figure 22: Goose Creek Stream Characterization Reaches.**

MCSWS utilized base data in GIS format, including recent aerial photography, stream locations, roads and parcel boundaries. Using GIS, the Goose Creek Watershed was divided into 30 separate reaches (Figure 22). For the purposes of this study, Buck defines a reach as a discrete segment of stream that consistently exhibits a set of physical features that appear to be significantly different from its contiguous upstream and downstream segments. Twelve basins were chosen for assessment that appeared to represent a range of stream conditions and land uses found throughout the watershed. Because perennial streams were to be assessed, only streams receiving 100 acres or greater of drainage were

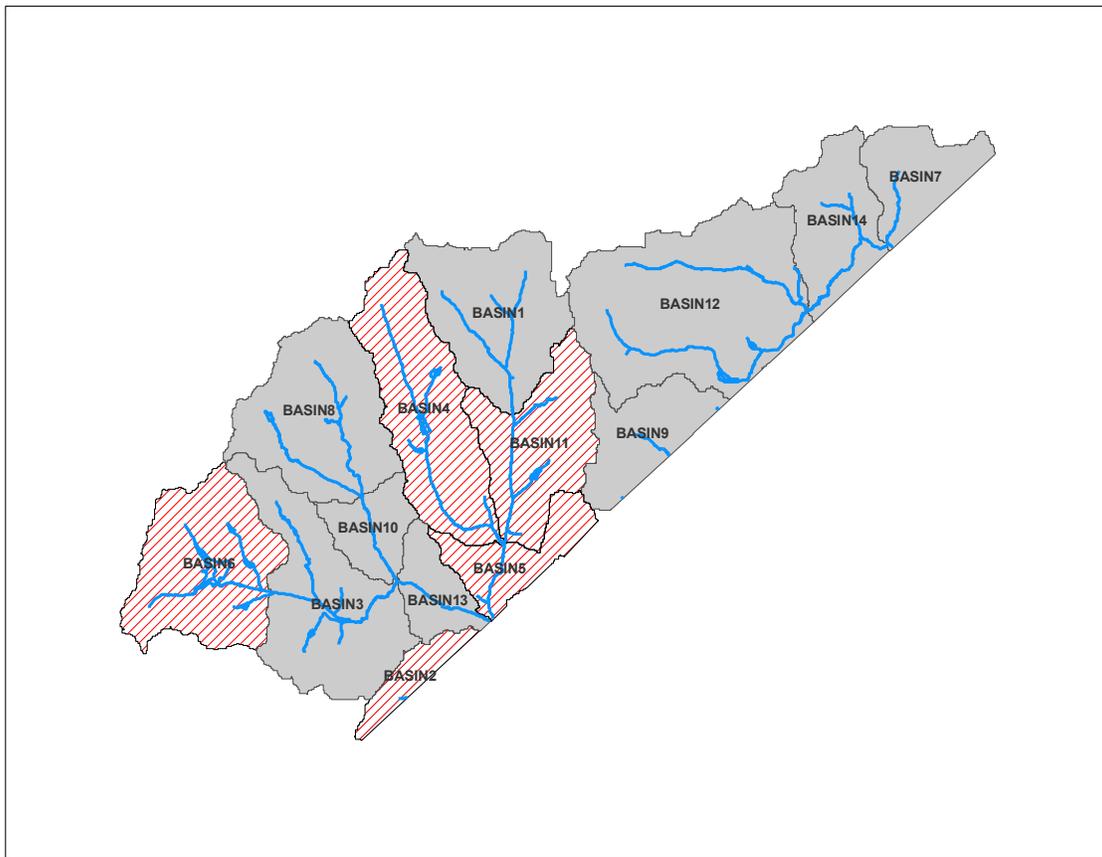
**Figure 23: Focus Basins within the Goose Creek Watershed.**

Based upon the upland pollutant load analysis, BMP retrofit efforts should be concentrated on or downstream of the most impacted basins. The 6 most impacted basins were focused upon for this plan. Figure 23 shows the extent of these focus basins within the Goose Creek Watershed. The following Section discusses each focus basin in detail.

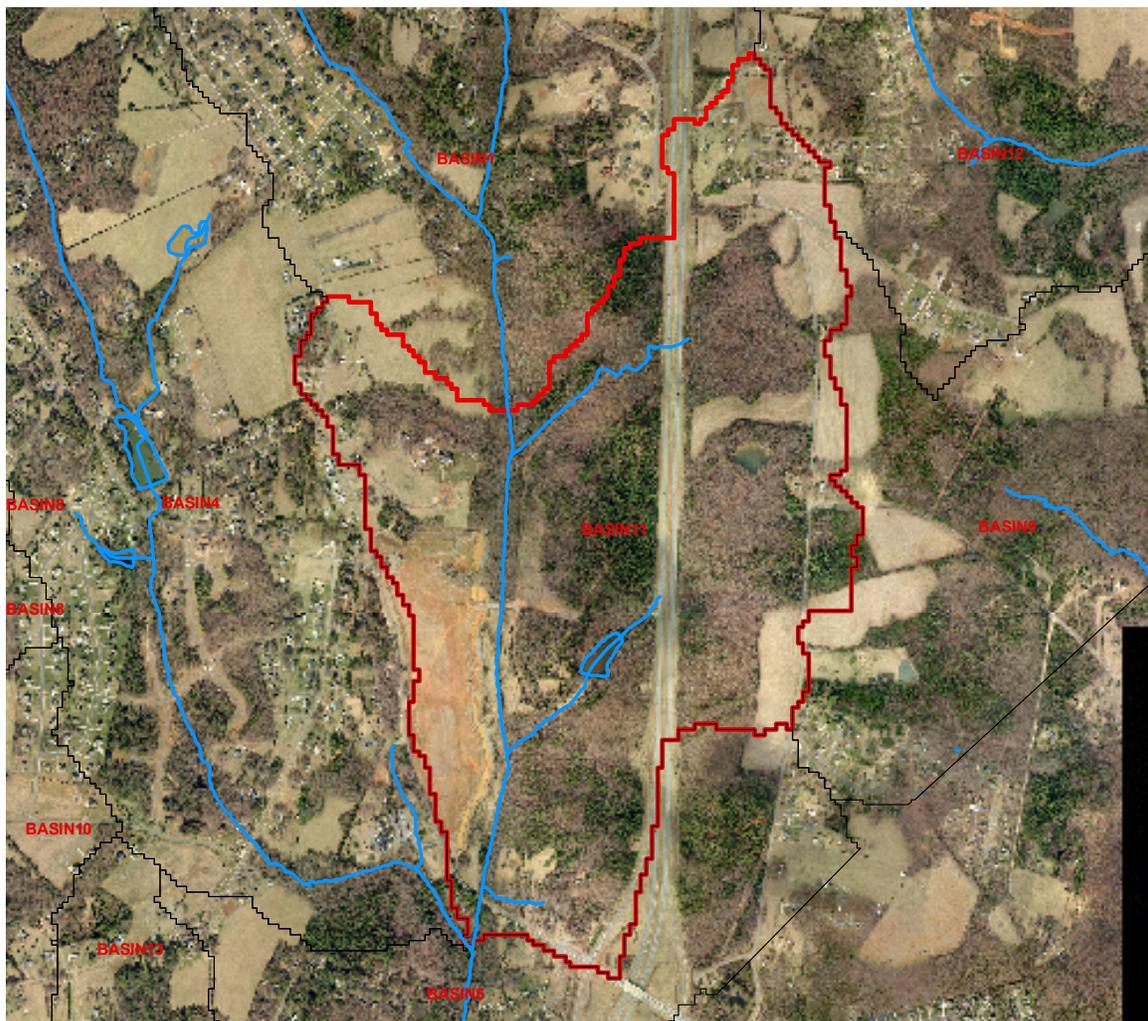
**Figure 24: Focus Basin 11**

Focus Basin 11 has the highest estimated pollutant loads in the entire Goose Creek Watershed. Figure 24 shows the extent of the Basin. The primary reason for Basin 11 receiving the highest ranking is The Bridges mall site. Although the mall has not yet been built, grading permits have been issued and land clearing begun. Moreover, this basin contains much of the I-485 Lawyers Road interchange and a significant portion of I-485 north of the interchange. A limited amount of single family residential is also present in the basin. It is very likely that after the mall is constructed storm water volume and velocity as well as pollutant runoff will increase. Currently NCDOT owns one small parcel in the northeast portion of the basin on the drainage divide. This parcel may be suitable to treat a small portion of I-485.

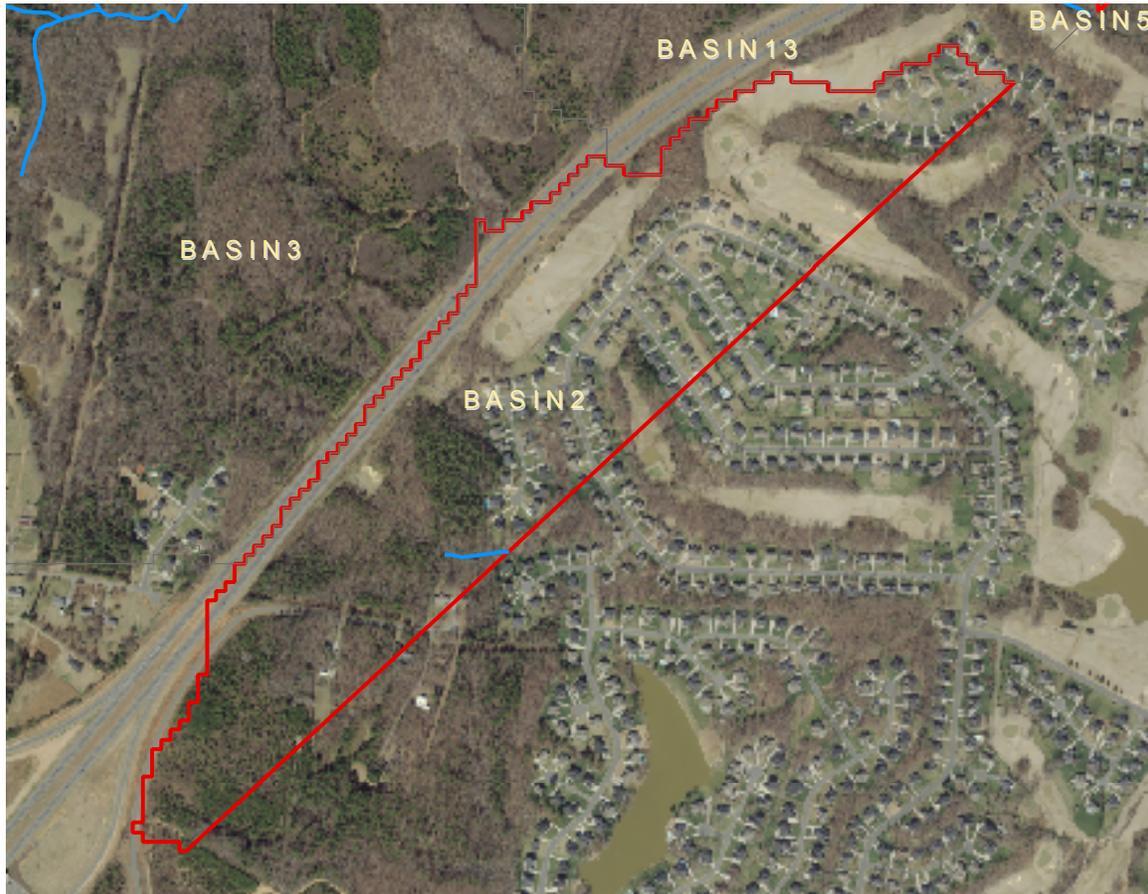
**Figure 25: Focus Basin 2**

Focus Basin 2 has the second highest estimated pollutant loads (normalized by area) in the entire Goose Creek Watershed. Figure 25 shows the extent of Focus Basin 2. The

combination of I-485 road surface, golf course and medium density residential combines to cause the high pollutant loads. There appears to be minimal opportunity for land acquisition in Focus Area 1, however NC DOT has indicated their desire to partner with MCSWS within road ROW. There is very limited retrofit opportunity within the Shannamara neighborhood.

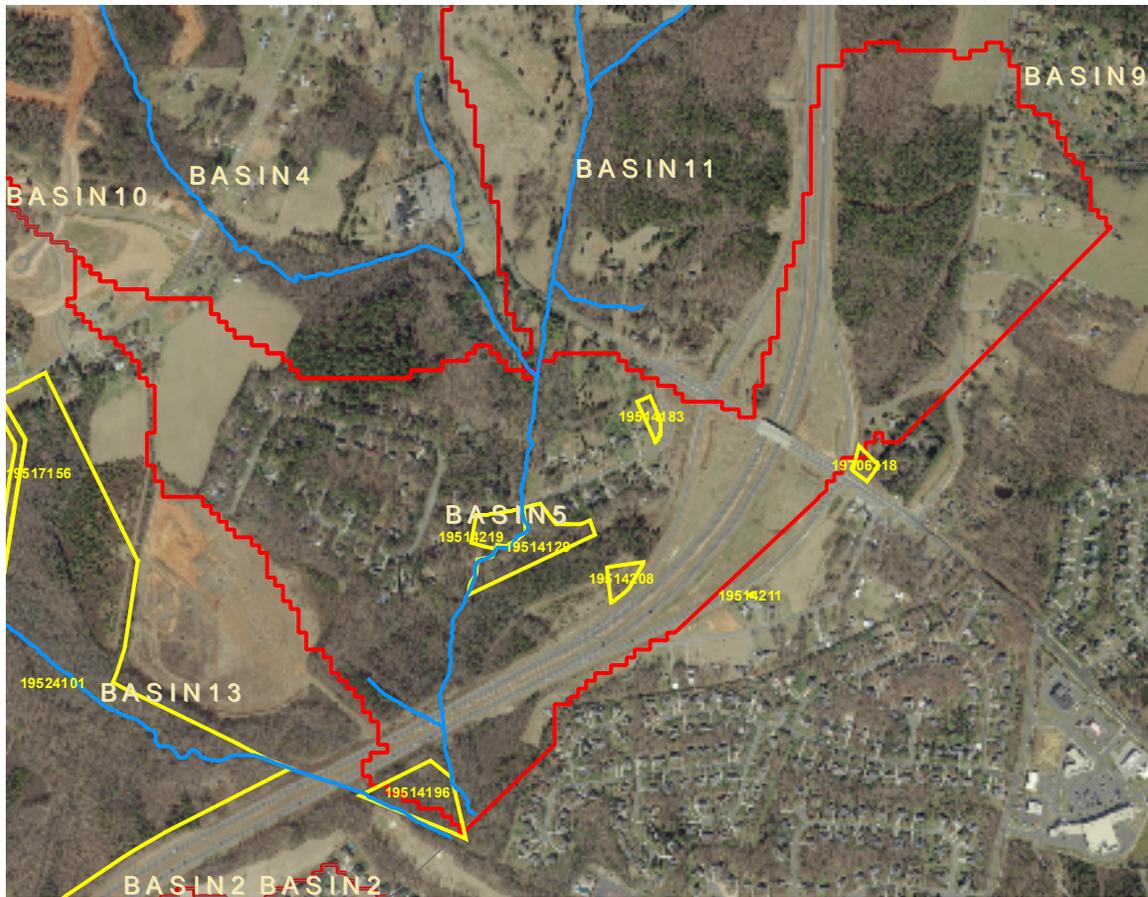
**Figure 26: Focus Basin 5 (Note: Publicly owned property shown in yellow).**

Figure 26 shows the extent of Focus Basin 5. It is comprised of I-485 with limited large lot residential. The key to this basin is capturing and treating runoff from I-485. NC DOT owns property where runoff from I-485 enters Goose Creek. During the site evaluation there appeared to be an impoundment on this property that may partially treat the runoff. Additional measures will need to be constructed to provide additional treatment to meet the goals outlined previously, particularly for NH4 and fecal coliform.

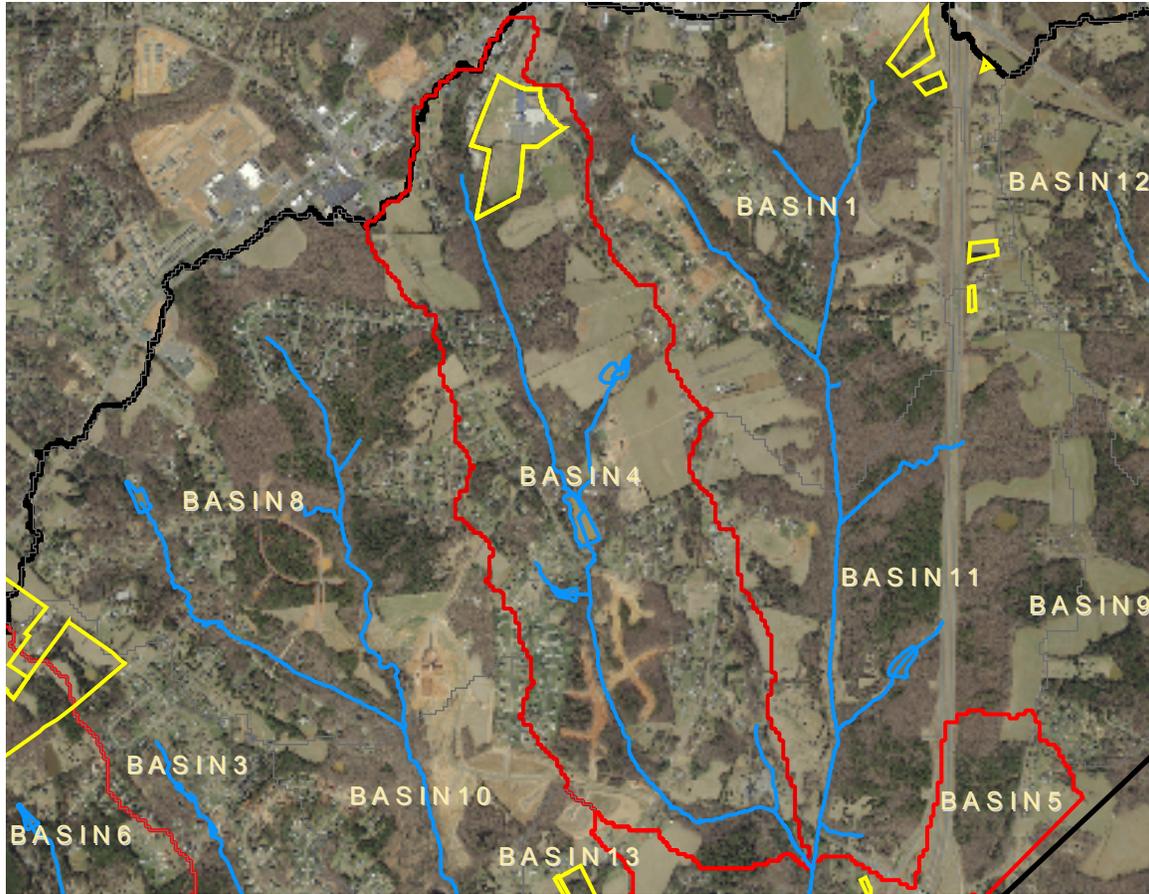
**Figure 27: Focus Basin 4.**

Figure 27 displays the extent of Focus Basin 4. It is essentially bisected by Lawyers Road from north to south. There is a substantial impoundment located in the center of the basin that could be retrofitted to provide detention and additional water quality treatment. The pond is currently poorly maintained and possibly a source of sediment. The headwaters of the basin are located at NC 51 and dominated by Queens Grant School. Bain Elementary School has an existing rain garden that treats a portion of a parking lot. Additional infiltration features should be retrofitted into the site. The basin is typified by agricultural plots with large lot residential and less medium density residential.

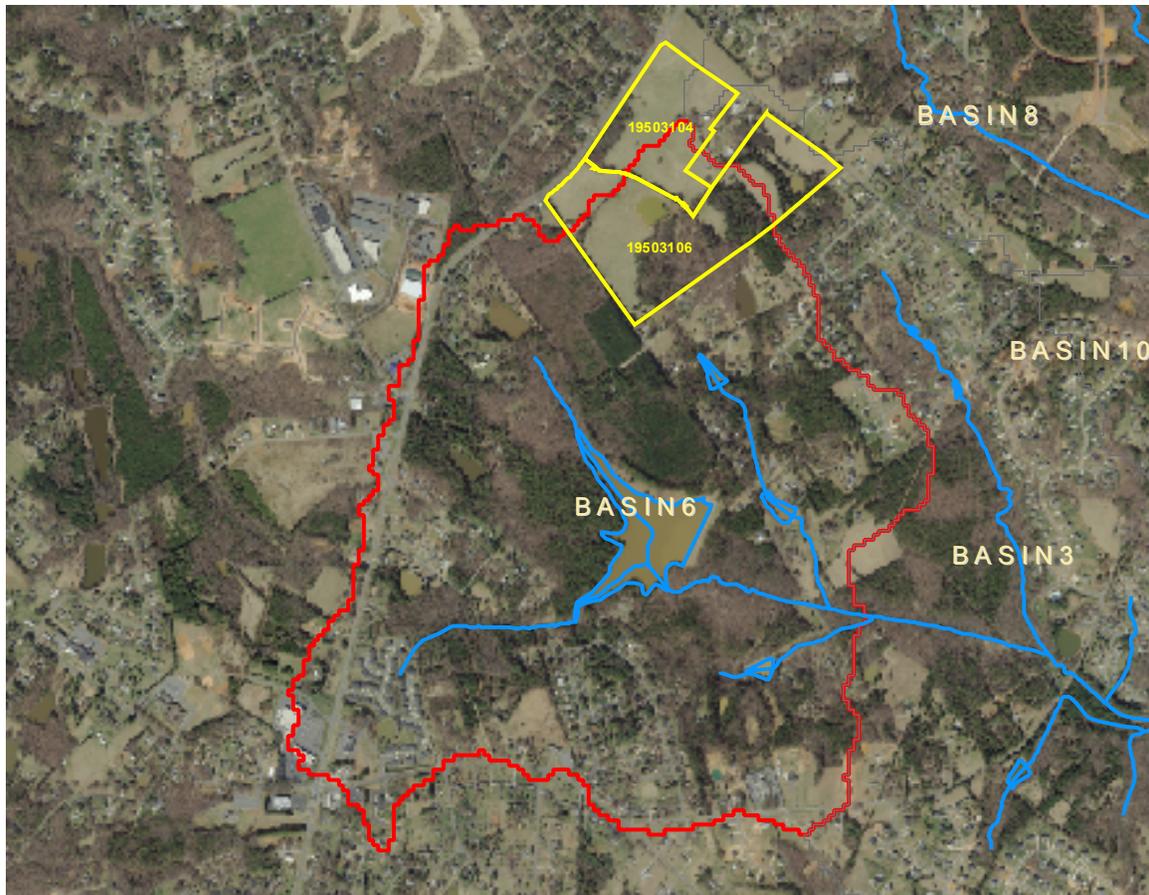
**Figure 28: Focus Basin 6 (Public Parcels in Yellow).**

Figure 28 shows the distribution of Focus Basin 6, which is dominated by McWhirter Lake. It is essential for this catchment that McWhirter Lake remain intact and enhanced if possible. It provides significant treatment for several medium density residential developments and commercial areas.
