# **Goose Creek Watershed Management Plan**

**Completed by: Charlotte-Mecklenburg Storm Water Services  
Version 1  
October 31, 2009**

**Completed by:  
Charlotte-Mecklenburg Storm Water Services  
Water Quality Program Staff**

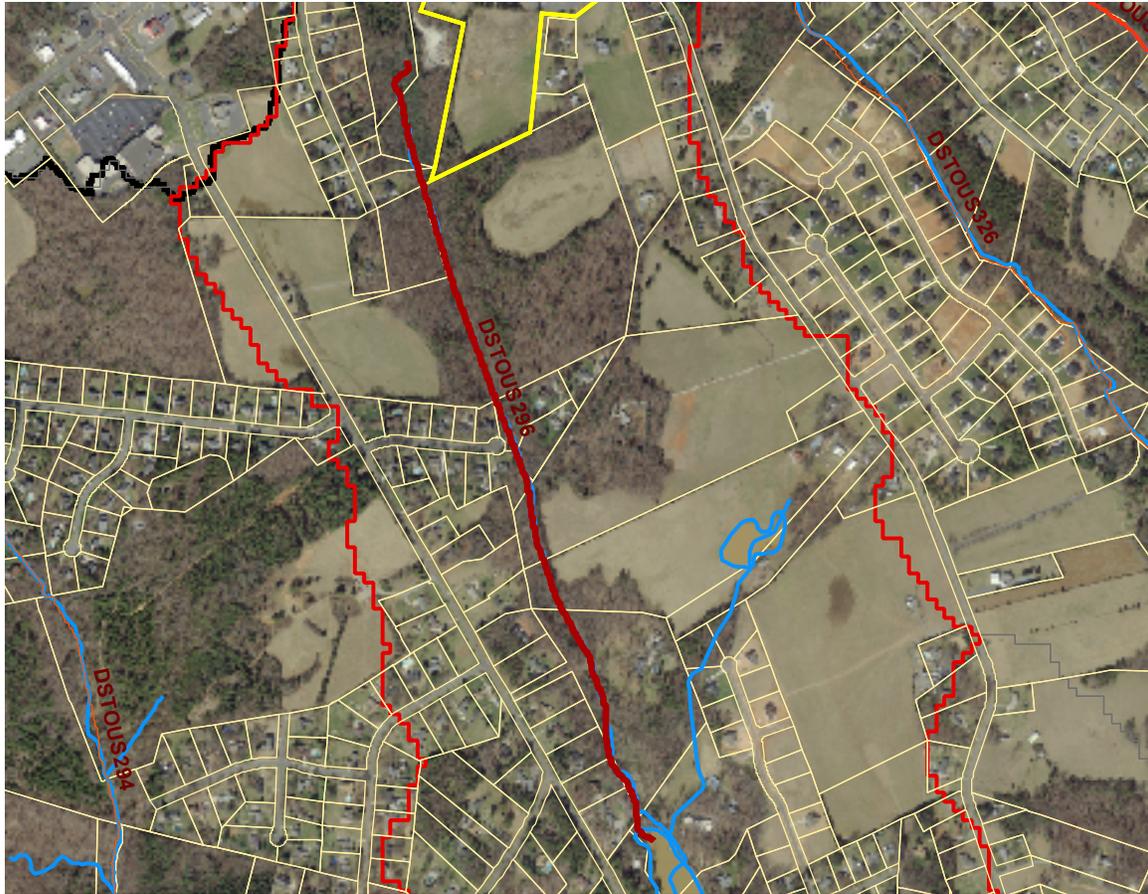
**Figure 33: Reach DSTOUS296 Area Map.**

Reach DSTOUS296 is located in Basin 14 upstream of an impoundment (see Figure 33). There is rip-rap on the upstream portion of the reach and the trees have good root depth. Gravel riffles, and a beaver dam are present. 300 ft of stream has been denuded from beaver dam breach. Woody debris and root mats form habitat. Some mid-channel bars exist. Bedrock nick-points present. Recommendation is Enhancement Level 1.

Recommendation: Enhancement Level 1  
Estimated Cost: \$844,735  
System: Minor

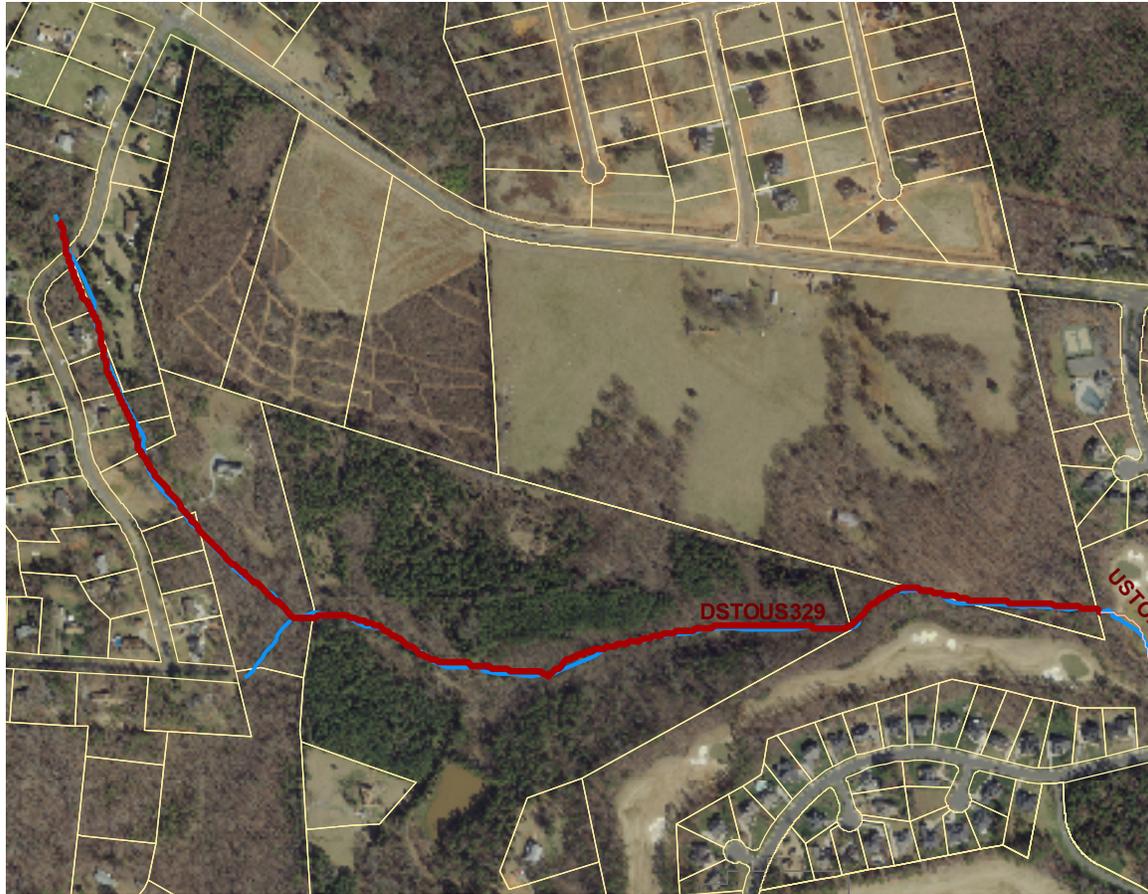
**Figure 34: Reach DSTOUS329 Area Map.**

Reach DSTOUS329 is located in Basin 12 and flows through a relatively undeveloped stream corridor (see Figure 34). There is a well-vegetated buffer, except the downstream left bank is pasture. Banks are vegetated thoroughly with shrub and trees. Bed is composed of silt and sand. Several beaver dams are present. Downstream area has extreme bank erosion from cattle.

<u>Recommendation:</u>	Enhancement Level 1
<u>Estimated Cost:</u>	\$851,879
<u>System:</u>	Minor

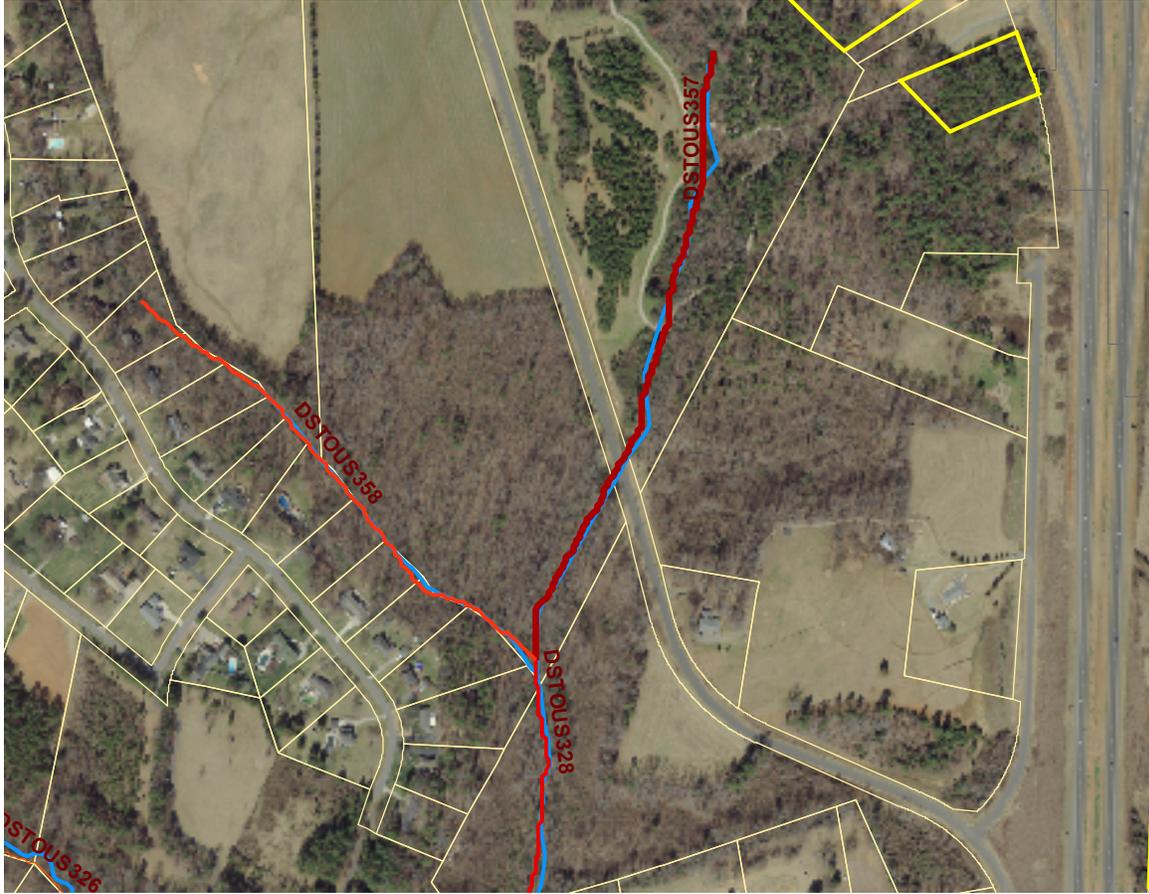
**Figure 35: Reach DSTOUS357 Area Map.**

Reach DSTOUS357 is located in Basin 1 and flows through a relatively undeveloped stream corridor (see Figure 35). A significant head-cut is present and the stream has a sandy bottom. Several bedrock nick-points were noted. Numerous deep pools below blockages have formed. Poor riffle pool sequence was noted. Numerous vegetated point bars and bank full benches present. Reach receives significant concentrated runoff from I-485.

<u>Recommendation:</u>	Restoration
<u>Estimated Cost:</u>	\$349,193
<u>System:</u>	Minor

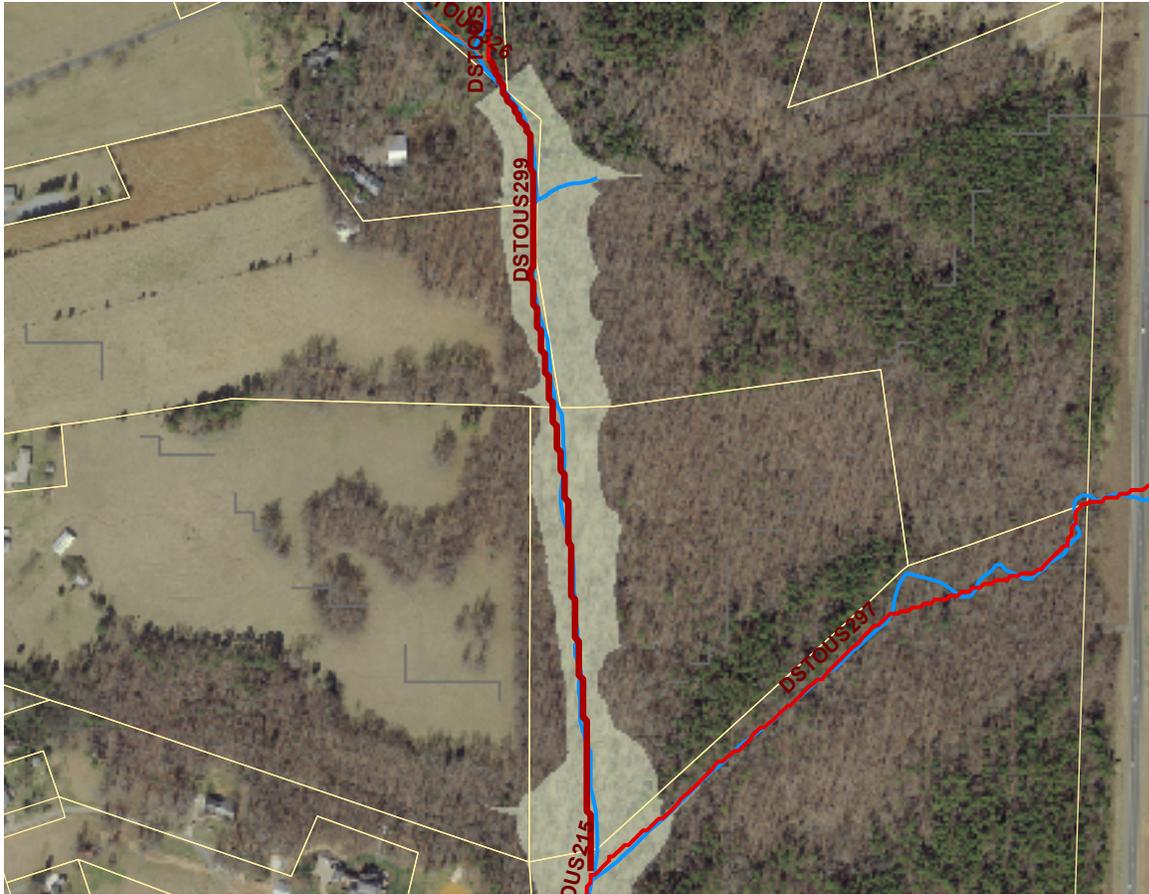
**Figure 36: Reach DSTOUS299 Area Map.**

Reach DSTOUS299 is located in Basin 1 and flows through a relatively undeveloped stream corridor downstream of DSTOUS357 (see Figure 36). It may be beneficial to combine these two projects into a single effort. Livestock have access to the stream causing significant localized erosion and cows were noted in-stream at the time of assessment. Fencing of the livestock out of the creek should be a part of any restoration or enhancement effort. Notable bedrock and cobble are present. Pools are actively filling with sand and silt. Most of the entire stream reach is severely impacted by cattle. High BEHI with low NBS was noted. Good ripple pool sequence, very long riffles with cobbles and boulders.

<u>Recommendation:</u>	Restoration
<u>Estimated Cost:</u>	\$397,271
<u>System:</u>	Major

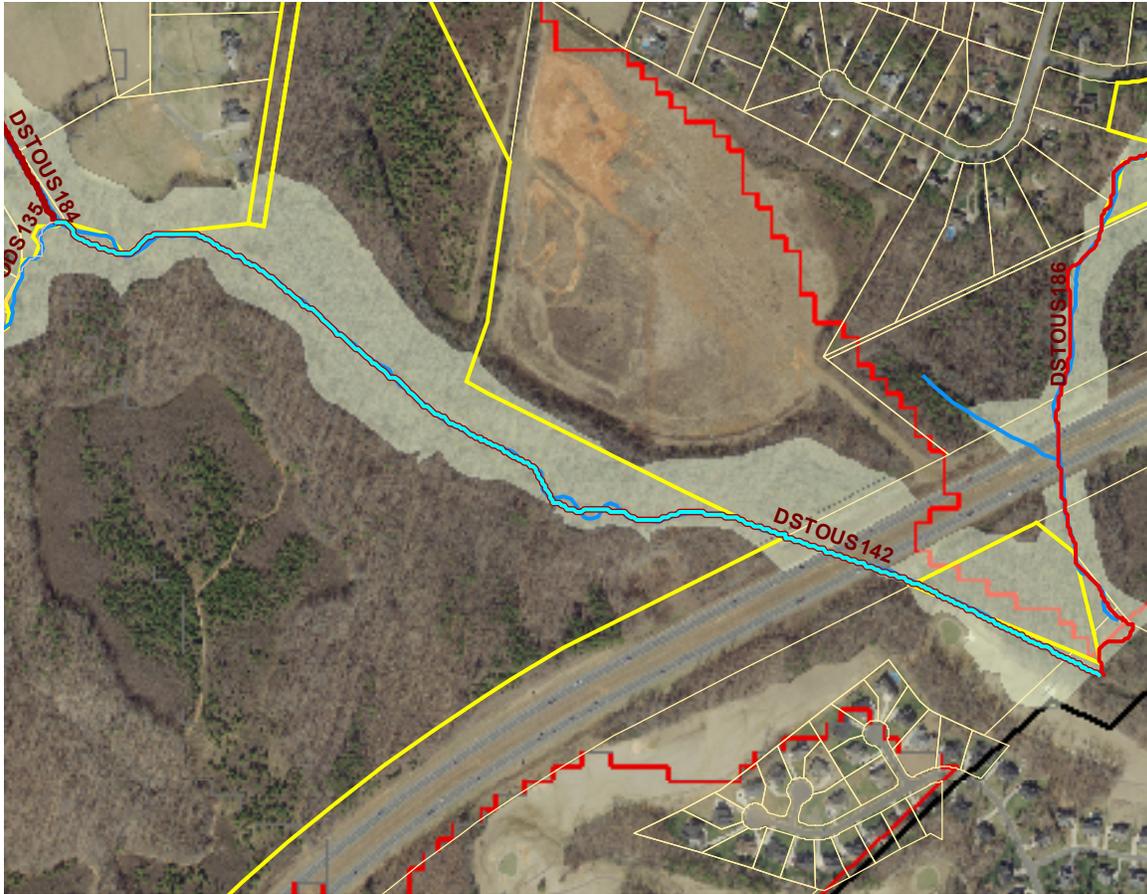
**Figure 37: Reach DSTOUS142 Area Map.**

Reach DSTOUS142 is located in Basin 13 and flows through a relatively undeveloped stream corridor that is almost entirely in public ownership (see Figure 37). Good riffle pool frequency; pools shallow; riffles embedded with coarse sand. Mid-channel bars present. Bed is fully shaded with mature vegetation. Habitat consists of large cobble and boulders. Banks are raw due to little surface coverage, good root depth from hardwoods at top of bank. Bedrock nick-points throughout the reach were noted.

<u>Recommendation:</u>	Restoration
<u>Estimated Cost:</u>	\$774,953
<u>System:</u>	Major

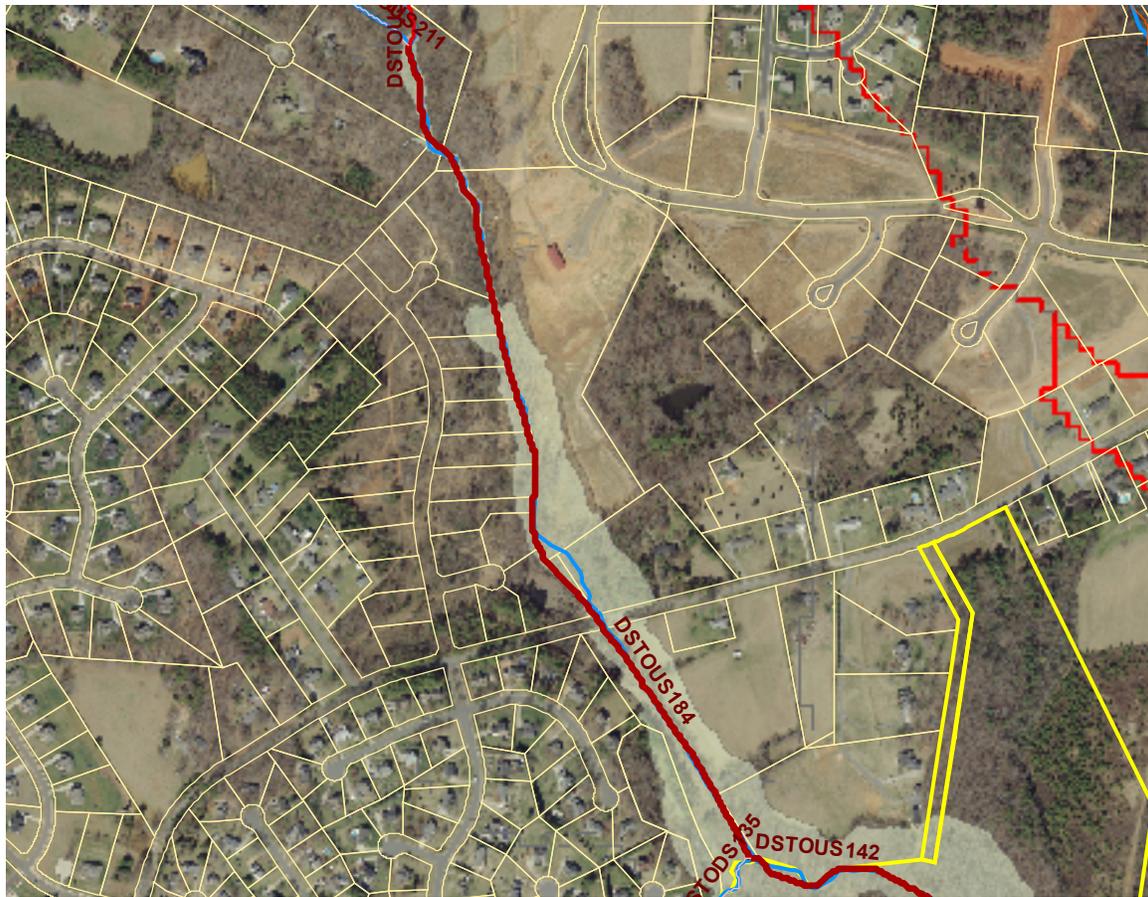
**Figure 38: Reach DSTOUS184 Area Map.**

Reach DSTOUS184 is located in Basin 10 and flows through a developed stream corridor just upstream of DSTOUS142 (see Figure 38). These 2 reaches should be combined into a single project if possible. Stream is vertically stable, and actively aggrading with coarse sediment from upstream bank erosion. Stream is over-widening. Left bank buffer protection is inadequate and a good candidate for reforestation. Gravel and small boulder riffles present with poor frequency. Good pool depth variation bed is partially shaded. Banks are partially vegetated with grass and shrubs. Deep pools are limited to meanders and are actively filling with sand. Mid-channel bars of gravel were noted. Log jams were observed within the lower portion of the bank. Good surface protection. Invasive plant species are present throughout. Several transverse bars present. Habitat consists of undercut banks and large cobble.

<u>Recommendation:</u>	Restoration
<u>Estimated Cost:</u>	\$660,333
<u>System:</u>	Major

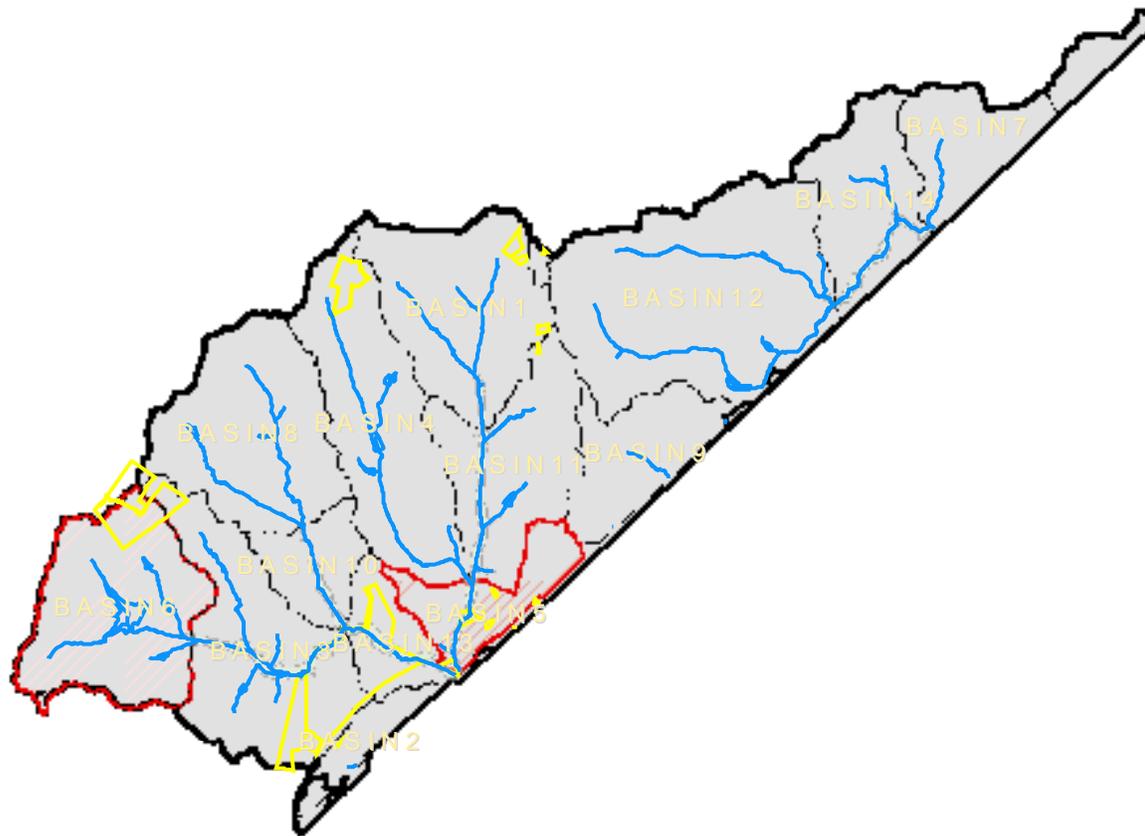
**Figure 39: Results of the Tree Canopy Analysis (priority basins are outlined in red).**

The intent of this section is to identify basins with the highest percentage of impacted (un-forested) stream buffer. Table 20 and Figure 39 present the results of the tree canopy analysis. All of the basins had more that 74% of the buffer forested which is significant. Also, the data utilized to prepare the estimates is almost 10 years old and a grant has been applied for to update the information. At this time, it is recommended that prior to the initiation of any projects the analysis be redone with the anticipated updated information.
