DRAFT
Chapter 8 –
Upper Cap Fear River Subbasin
HUC 03030004

BASINWIDE WATER RESOURCES
MANAGEMENT PLAN

CYCLE 4 –
CAPE FEAR RIVER BASIN 2026

North Carolina
 Department of Environmental Quality
 Division of Water Resources
 Basin Planning Branch

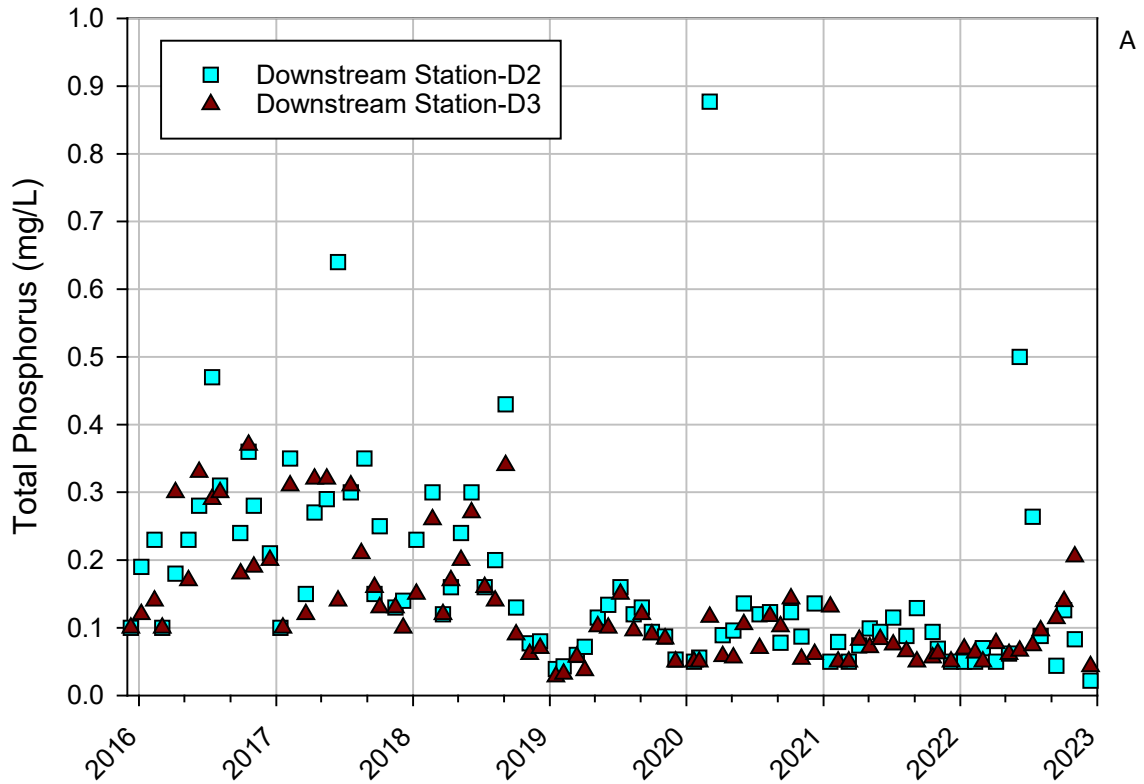
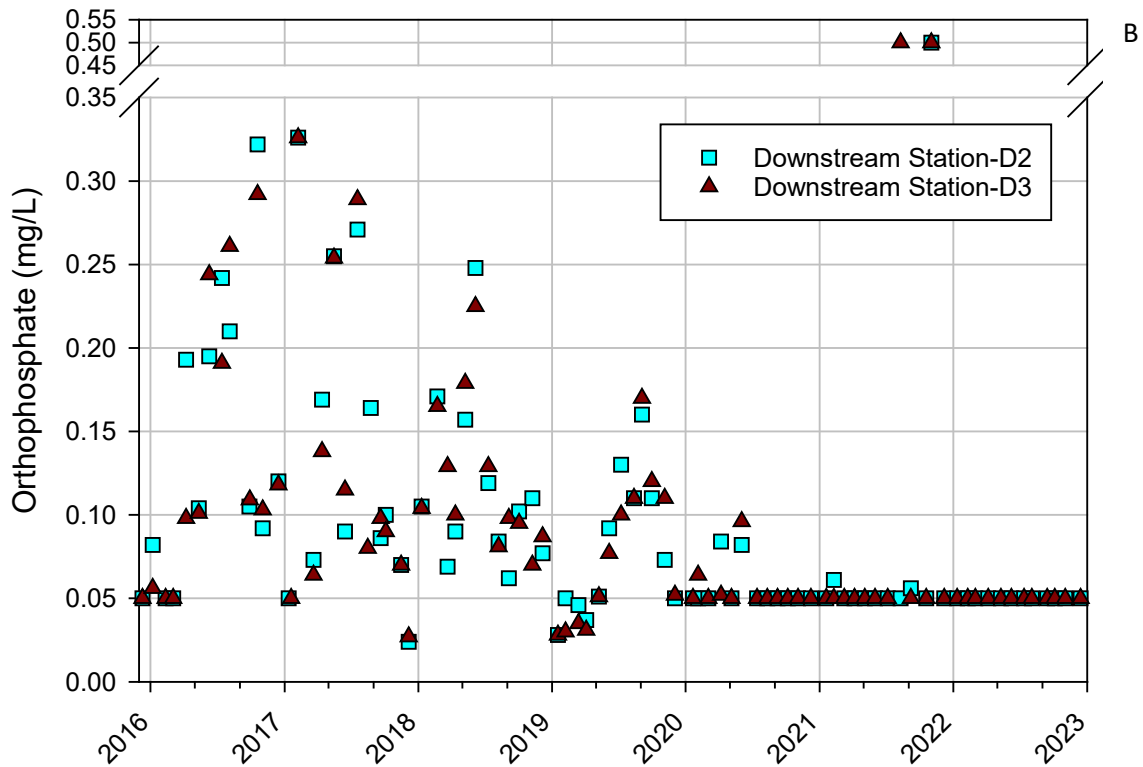
Figure 8-16: Utley Creek Instream Total Phosphorus (A) and Orthophosphate (B) Concentrations.

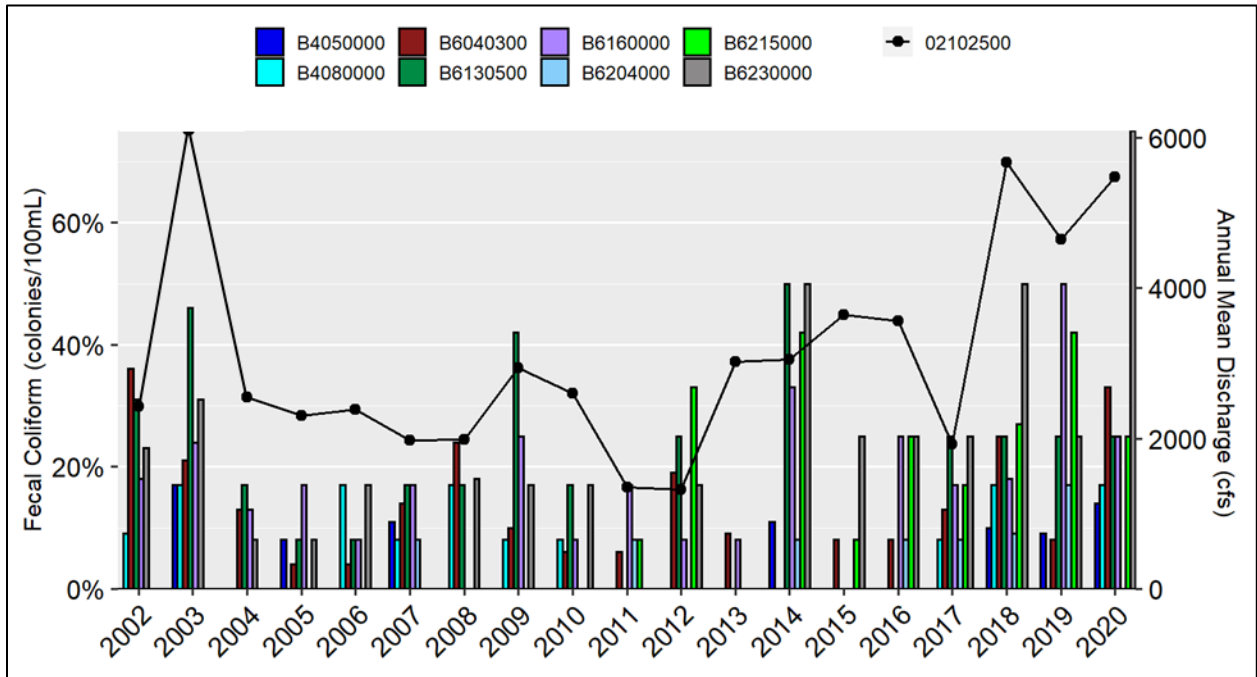
Figure 8-24: Annual Exceedance Rates for Fecal Coliform Bacteria Values in the Haw River (B4050000 and B4080000), Deep River (B6040300), Lick Creek (B6130500), Mainstem Cape Fear (B6160000 and B6215000), Buckhorn Creek (B6204000), and Avents Creek (B6230000) Based on a Water Quality Standard of 400 colonies/100 mL.
