Corpening Creek Watershed Plan

McDowell County, NC

September 2011

Prepared by Equinox Environmental Consultation & Design, Inc.
37 Haywood Street, Suite 100
Asheville, NC 28801

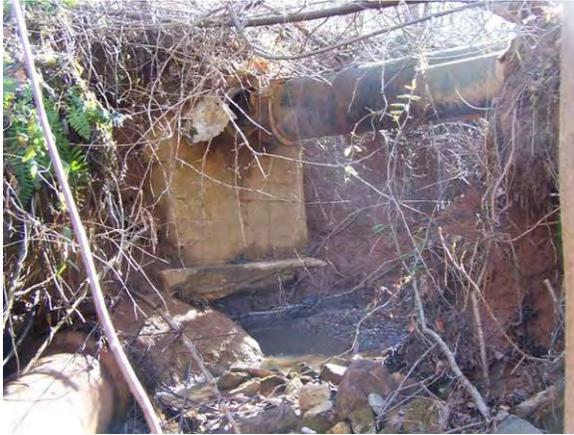
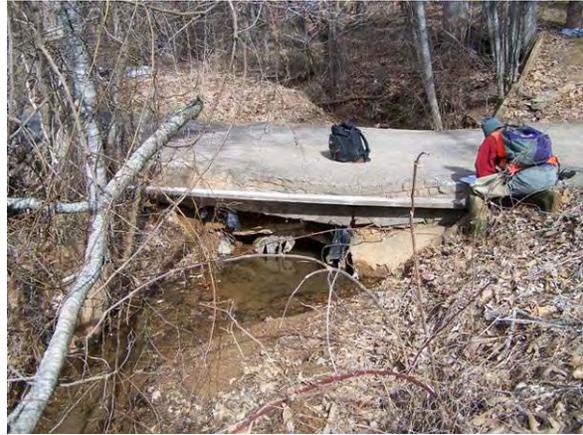
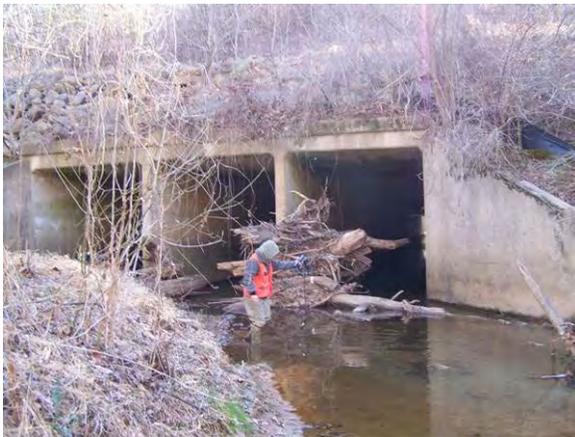
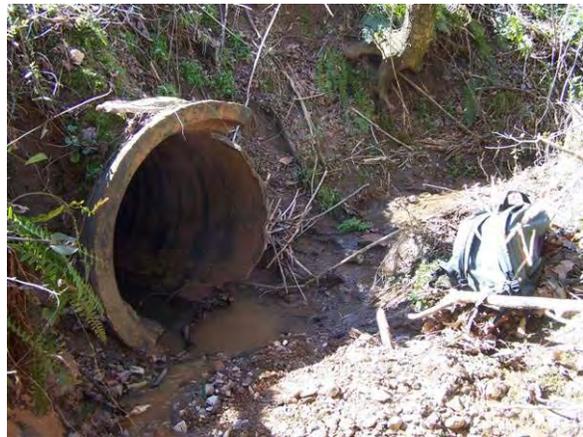
Infrastructure Damage and Risk in the Corpening Creek Stream Corridor

- Runoff during storms can wash out roadways, clog and undermine culverts, and damage bridges.
- Creekbank erosion can damage water and sewer lines that cross the stream channel.
- Streambank erosion results in the loss of property and can damage and destroy buildings.

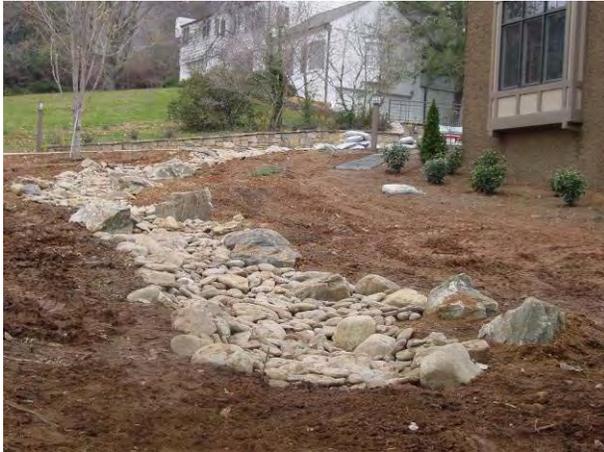
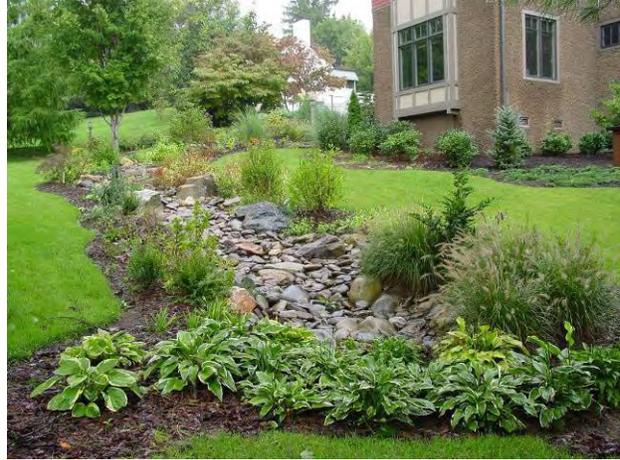
Dry Creek Beds in a Residential Setting

Dry creek beds can be an attractive landscape amenity that can serve the function of re-routing storm runoff from impervious driveways and parking lots into a yard area where infiltration can occur.

The rough edges of the stones and the interstitial spaces in between slow down runoff and allow it to be absorbed by the ground. Landscape plantings within and surrounding the dry creek bed also slow the water and promote infiltration. The stones and plants can also work together to create natural habitat for birds and small mammals.

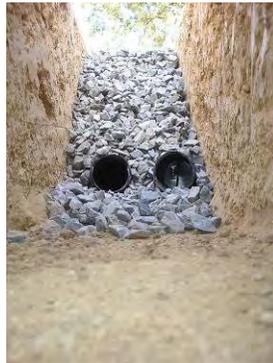
A French drain utilizes a trench, perforated pipes and gravel to capture, route and infiltrate runoff. French drains have been used in construction for centuries to solve drainage problems around foundations and to relieve water pressure from behind retaining walls. This is a relatively straightforward solution that protects structures from potential water damage and also benefits streams by allowing storm runoff to percolate into the ground rather than discharging directly to driveways, gutters, storm sewers and streams.

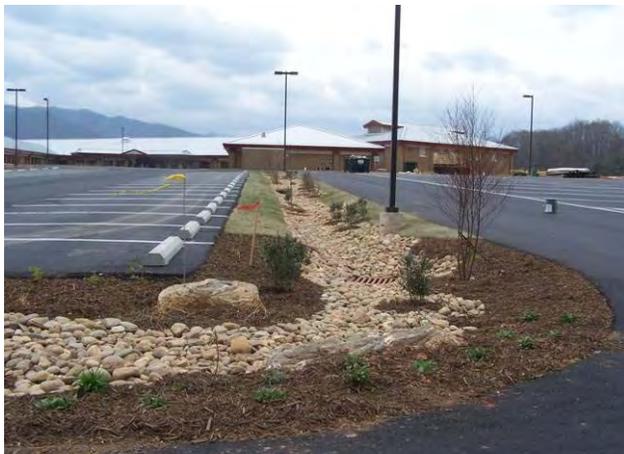
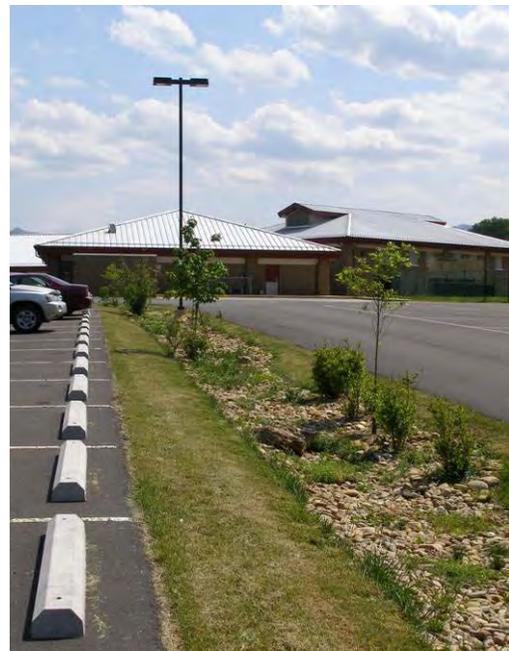
Examples of Bioretention Used in Medians at a Parking Lot

Rain gardens are also known as bioretention areas. They are shallow landscape depressions that use soils and plants to treat storm runoff, using many of the water storage and pollutant-removal mechanisms that operate in healthy forests. During storms, water temporarily ponds on the surface of a sand/soil bed, then infiltrates through the bed into an underdrain system. Bioretention areas can be designed to infiltrate water directly into native soils, if these soils are permeable. Bioretention can be used in a variety of topographic conditions, although individual retention areas are usually small and can generally treat runoff from areas of one acre or less.

The median construction cost for bioretention areas is approximately \$25,400 per impervious acre treated (CWP, 2007). BMP design will increase this cost by about 1/3. The total cost for design and construction of the bioretention area recently completed at the Eastfield Elementary School was almost \$82,000. The advantage of bioretention is that it makes a cost-effective compliment to parking lot and streetscape improvements where improved landscape aesthetics are also a goal. Rain gardens can also fit nicely in a back yard and as part of the stormwater management system of a residential development. Routine maintenance similar to landscape maintenance will be required, including replacement of top-most mulch every few years, removal of invasive exotic weeds, occasional pruning and some tilling or aeration of the soil if fine sediments accumulate on the surface.

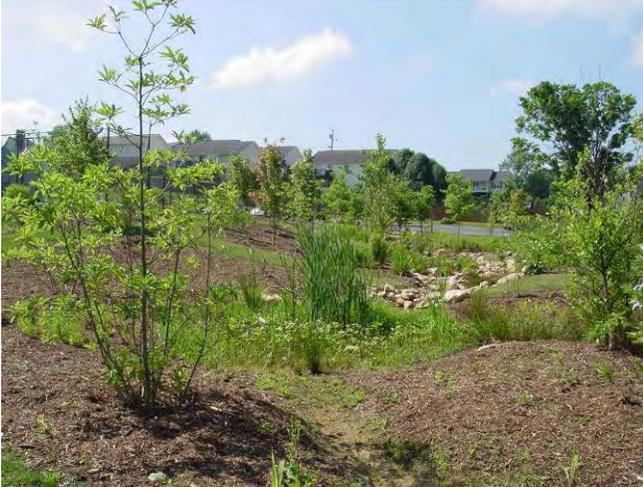
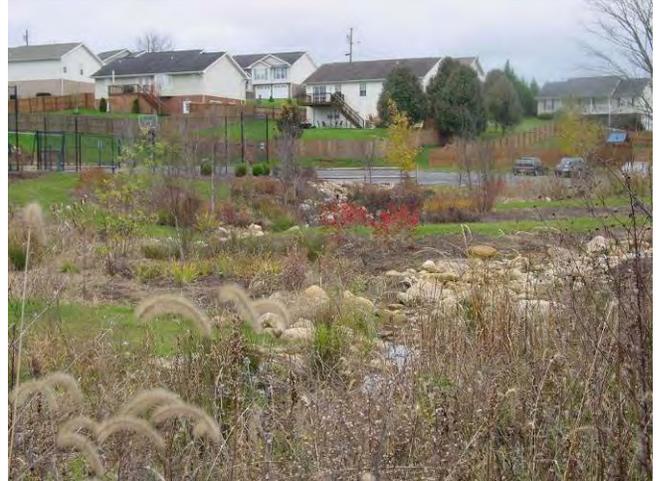
Examples of Constructed Wetlands

In contrast to rain gardens, wetlands can be used to treat runoff from a larger area. Because they are shallow, stormwater wetlands require more surface area than similar wet detention ponds.

Costs for retrofitted constructed wetlands, as reported by the Center for Watershed Protection, can be upwards of \$38,400 per impervious acre treated. BMP design will increase this by about 1/3. The estimated total cost for design and construction of the stormwater wetland at McDowell Tech is approximately \$118,000. Sediments that accumulate in the forebay need to be dug out every 5 years or when the depth of the forebay diminishes by 50%. The wetland should also be monitored for the invasion of exotic plant species and those

removed promptly when found. Other maintenance requirements include periodic inspection of the flow delivery mechanisms upstream of the wetland to ensure that stormwater is able to get to the wetland as designed. Otherwise, the wetland plant species may die. Trash and other debris removal may also be needed periodically.

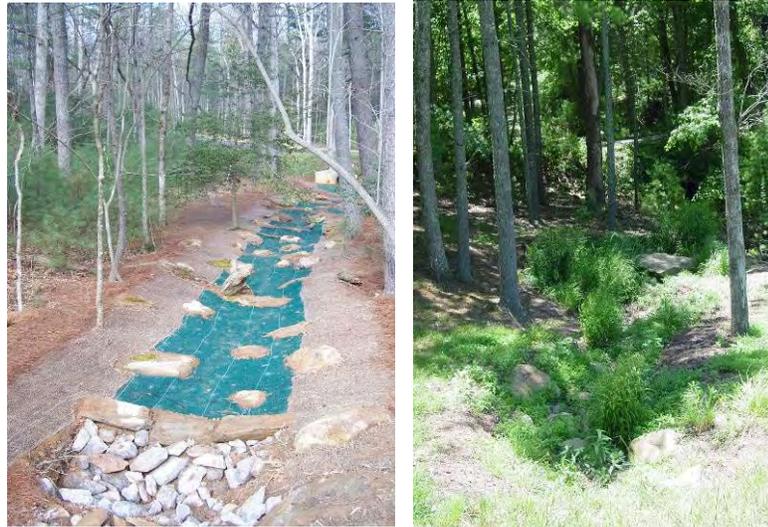
Examples of Water Quality Swales

Swales are essentially ditches, but these are ditches that do more than simply convey water from one point to another. Swales are designed to slow down water flow and allow infiltration. Swales can vary from simple grass channels to more sophisticated channels with underdrains. Swales are often utilized in conjunction with other BMPs.

Costs for grass swales in the NC Mountain region average \$1.24 per square foot (Hathaway and Hunt, 2007). Swales on steep slopes may need turf reinforcement matting or other support, which would be an additional expense (\$0.50/square foot, per (Hathaway and Hunt, 2007).

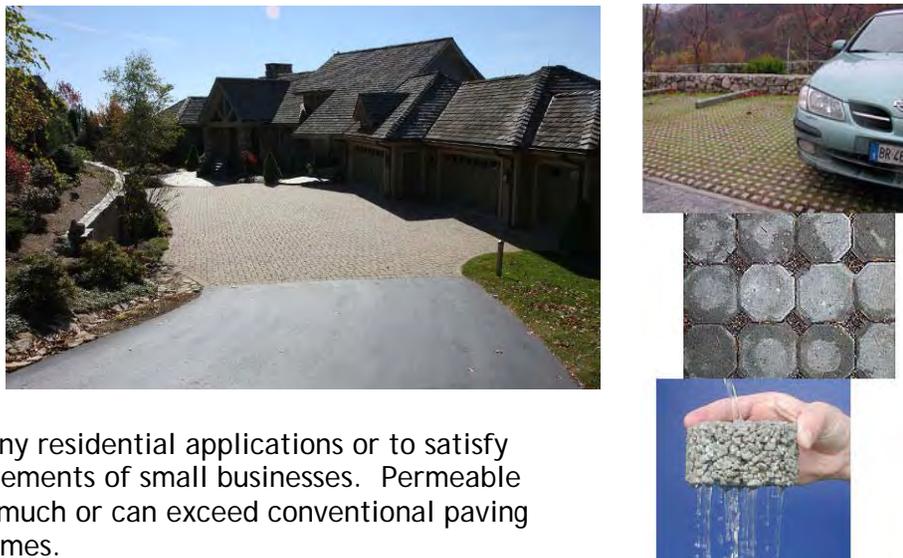
Examples of Permeable Paving

Permeable paving allows water to percolate through, rather than running off, solid surfacing materials. New engineered paving materials are designed to be porous and allow rain water to infiltrate. Conventional impervious paving materials can also be installed on gravel and sand beds rather than on concrete in a mortar bed, which also allows

for some infiltration. Weight and volume of traffic as well as slope are important considerations when deciding to use permeable paving instead of conventional impervious paving. Permeable paving is an appropriate

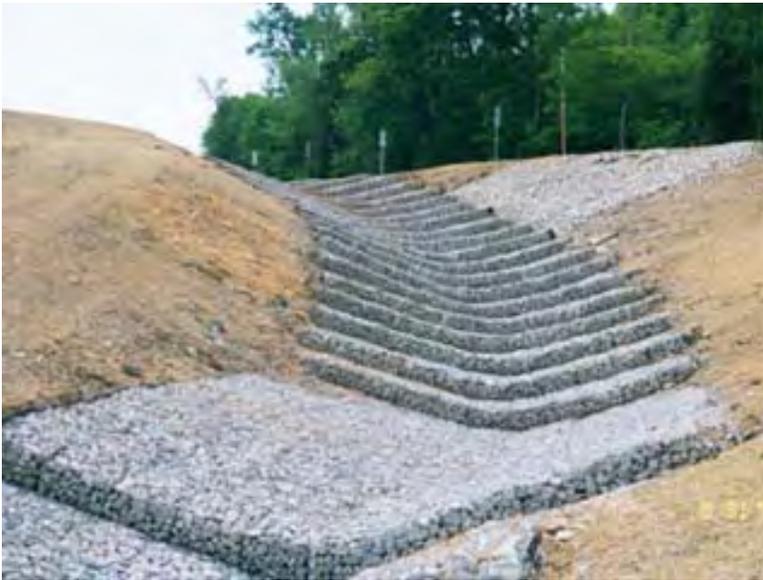
Photo of Permeable Weir

This is a type of extended detention BMP suitable for use at some sites in the Corpening Creek watershed. They consist of a check dam made of permeable materials that retain water and sediment during rainfall events. The stored water is released downstream by seeping through the porous material. These features are designed to empty completely between storm events and to remain dry until the next runoff event (dry detention). The check dams should be constructed of materials other than treated lumber to avoid toxic impacts to the aquatic community. Suitable alternatives include gabion baskets or permeable block walls. Weirs constructed of these materials should have longer life spans, require less maintenance, and be more stable than those constructed of treated lumber.

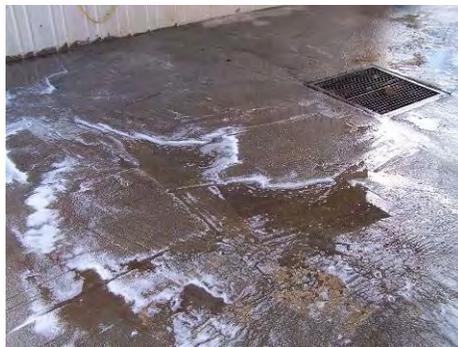
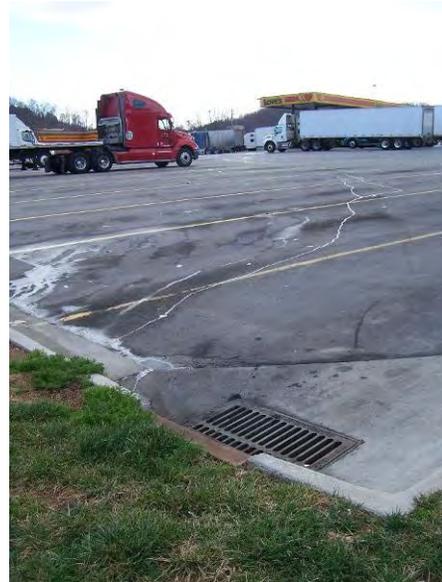
Filters provide a practical way to remove pollutants from urban runoff prior to the discharge of the runoff to the conveyance system. They are especially useful to improve water quality from highly impervious sites or pollution hotspots, though they provide only very short term storage and minimal hydrologic benefits. Filters are sometimes recommended in conjunction with other BMPs that provide hydrologic control. *Sand filters* involve filtration of runoff through a sand bed or a bed composed of organic media, which can be constructed either at ground level or underground. They are designed to treat only the first flush, which contains the most pollutants, with the remainder of larger storms bypassing the filter.

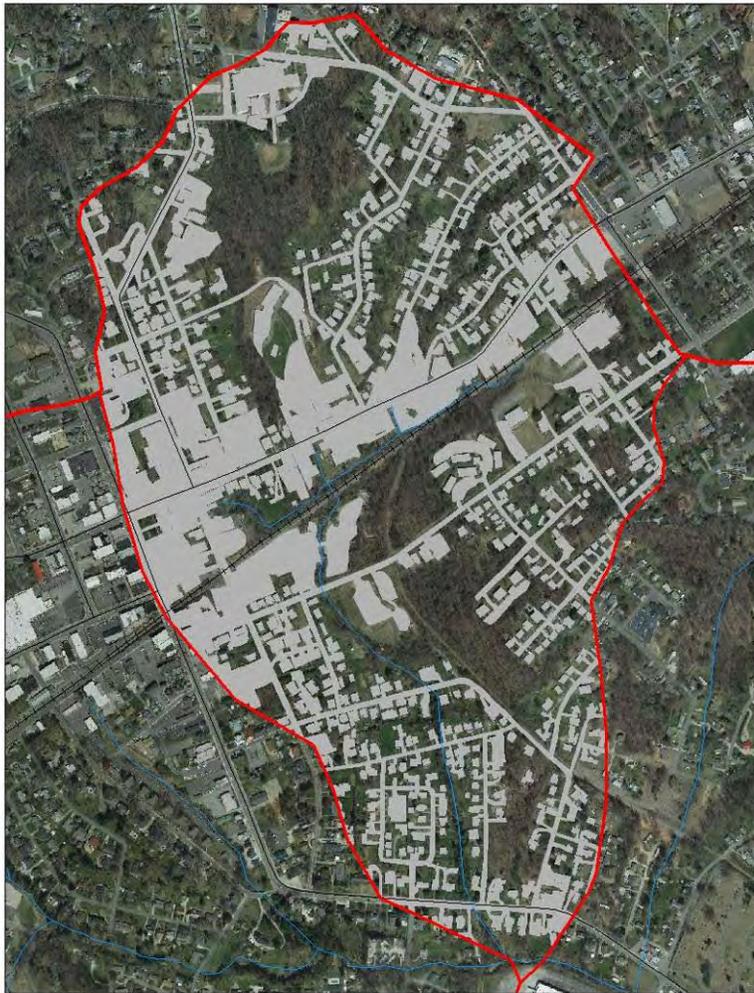
Figure 4.2 Imperviousness of example catchment in Upper Youngs Fork

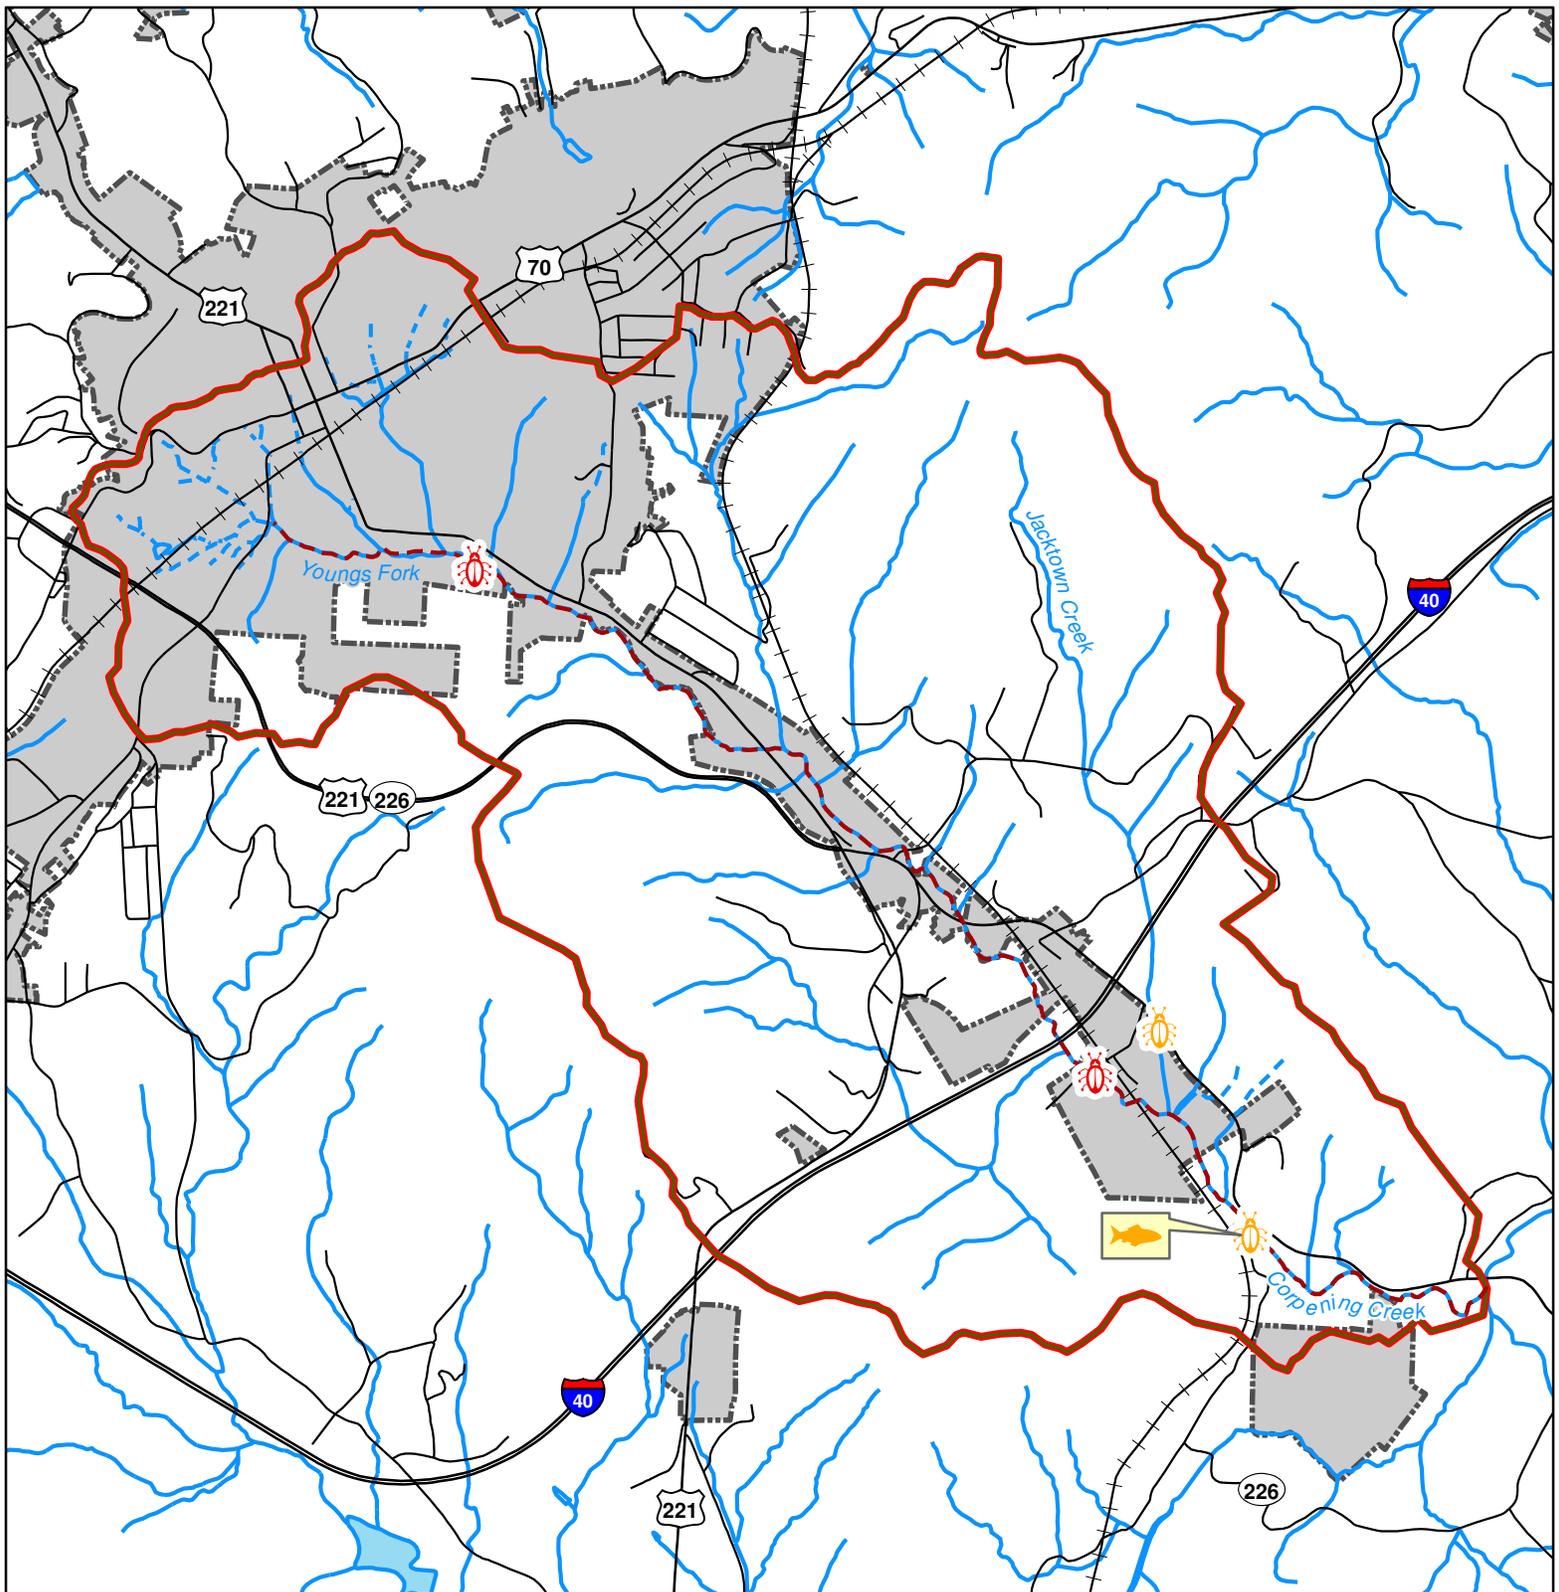
Figure A-1 NCDWQ Monitoring Sites
