# Briles Stream Restoration Monitoring Report Year 2 of 5 (2010)

Randolph County, North Carolina

Project ID No. 047

Submitted November 2010

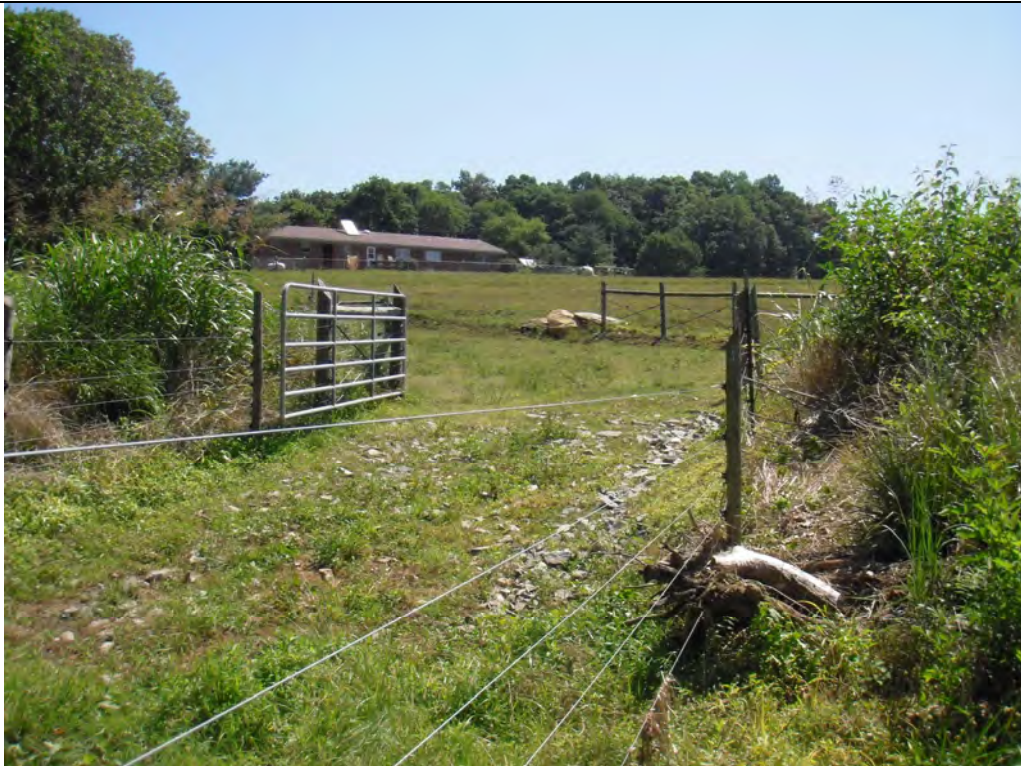
SP4: Rack line along ford crossing approximately above Design Bankfull elevation  
Taken On: 2010
