# **Clear Creek Final Monitoring Report**

## **Year 4 of 5 (2007)**

**Henderson County, North Carolina**

**USGS HUC: 06010105**  
**Project ID No. 92**

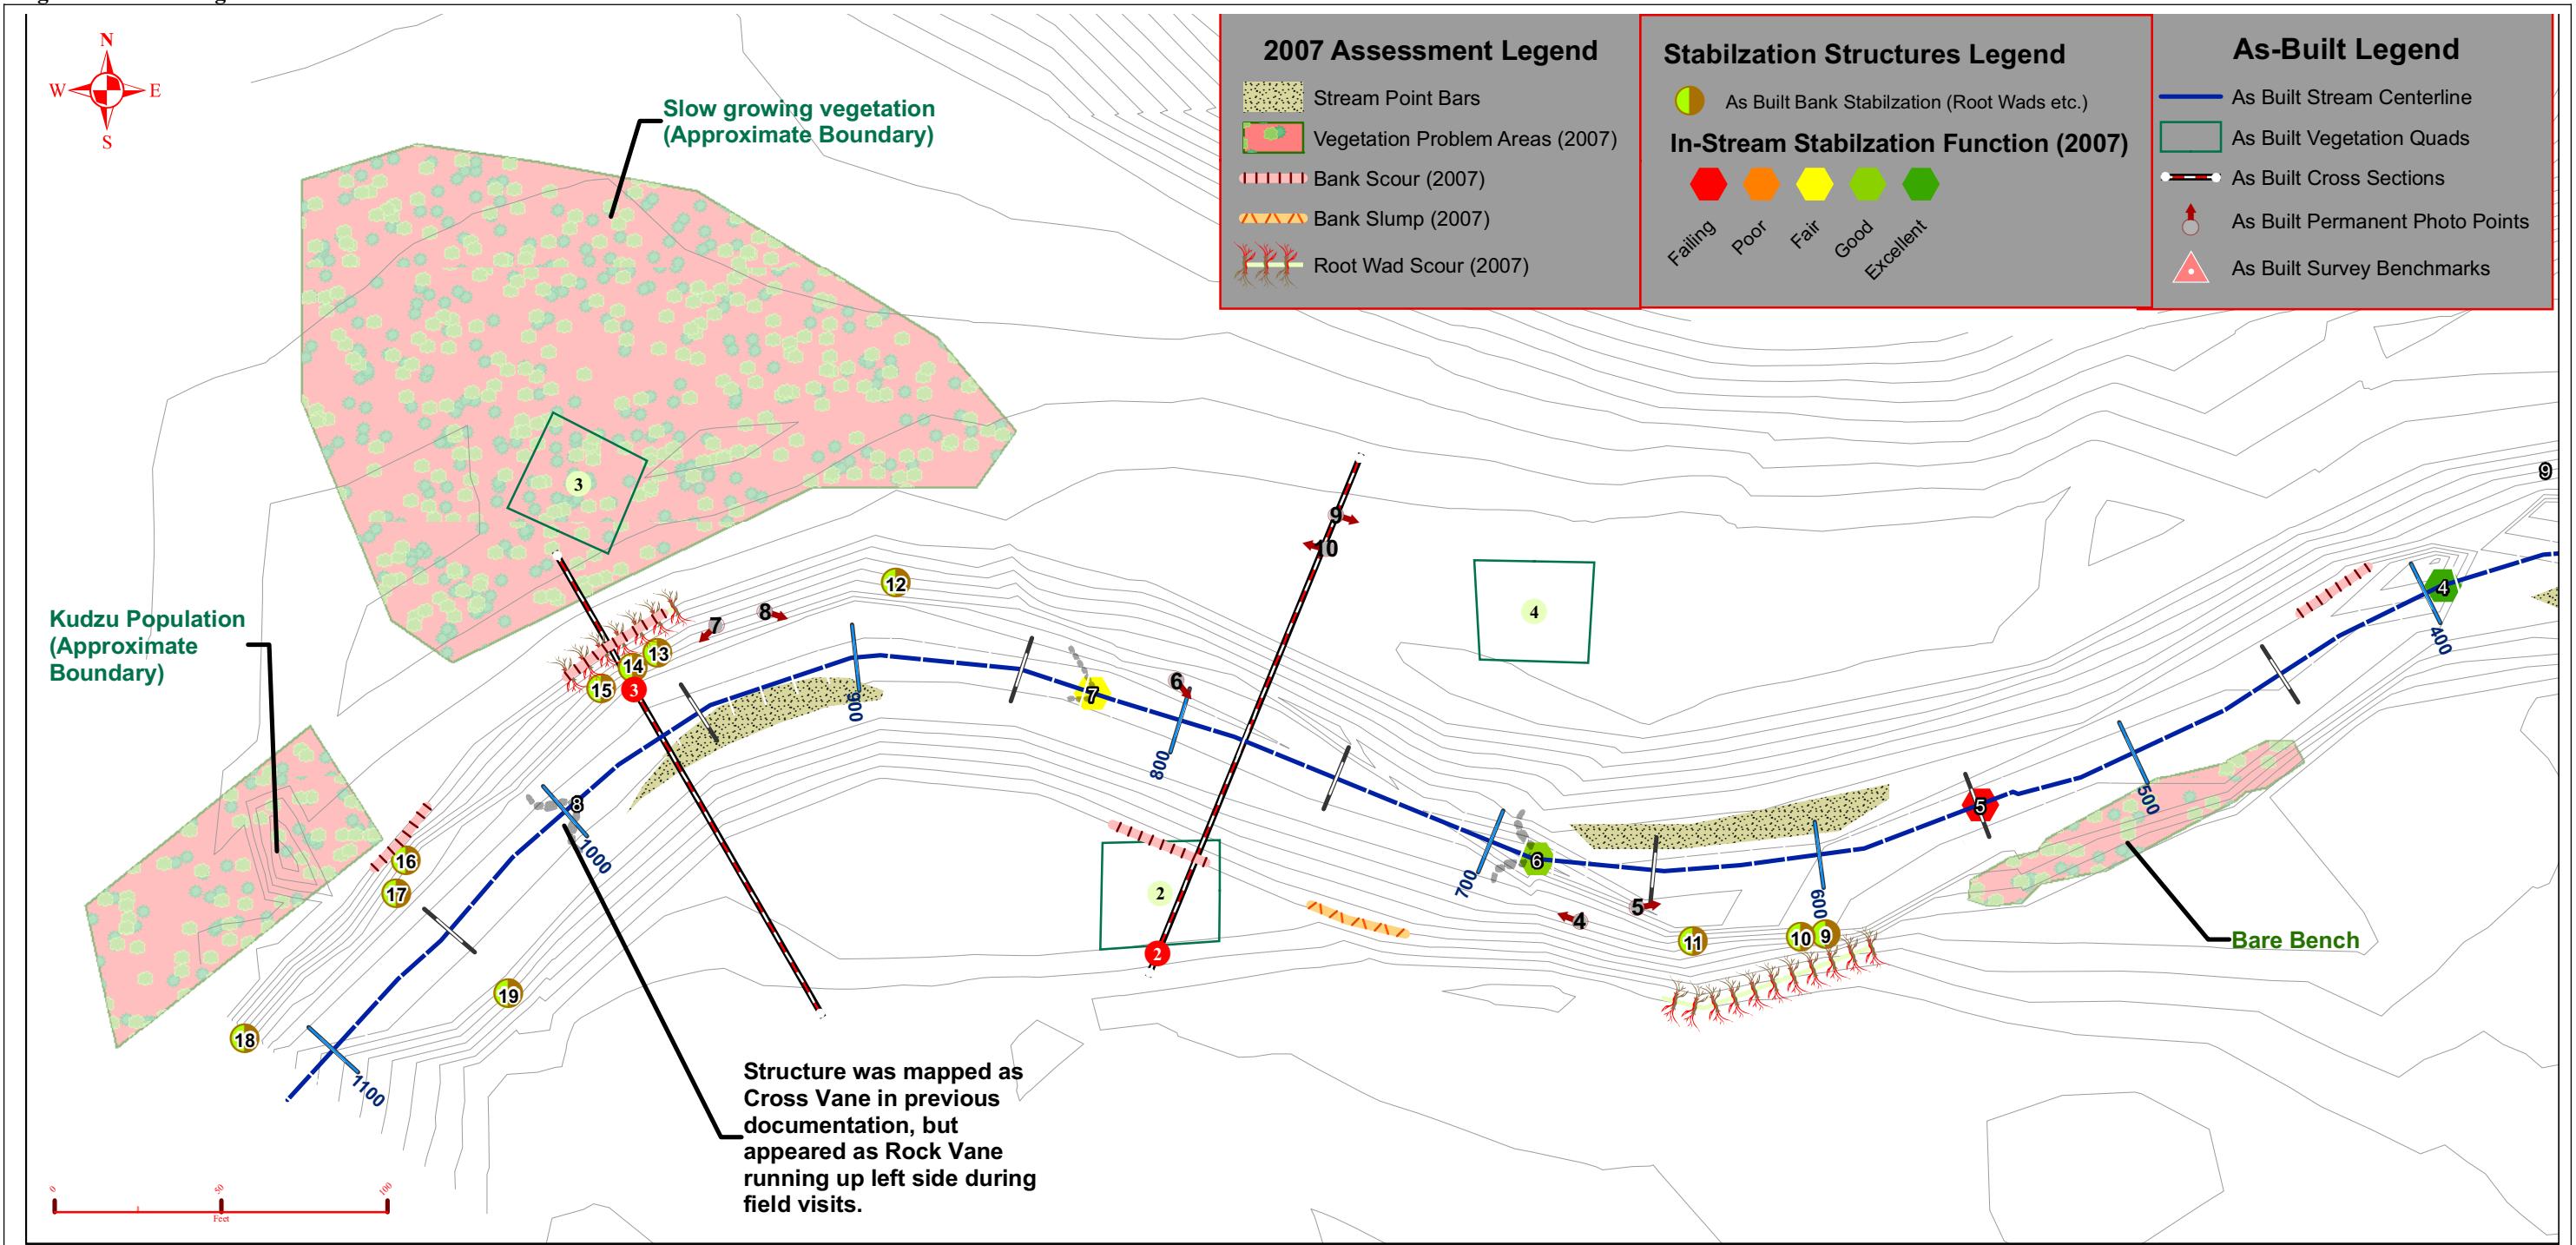
Figure 3: Monitoring Plan View Sheet 2

KHA assessed the stream channel during the spring and fall of 2007. Several isolated sections exhibited bank scour. Excessive shear stresses and possibly historic flood flows may have a role in the scour. Back eddy currents immediately below a structure may be causing bank slumping along a section of the left bank (Station 710-750). Some structures seemed to exhibit signs of stress including partial to complete structure collapse; excessive arm scour; and missing header rock. Several root wads along the middle and lower section of the reach have experienced scour behind the root balls and may be unstable. Figures 1 and 2 show the location of the stream problem areas and table B1 in appendix B summarizes the stream problem areas.
