Coddle Creek Tributary (Indian Run) Stream Restoration EEP Project # 94 DENR Contract # 5360

Annual Monitoring Report Year 4 of 5 Cabarrus County, North Carolina

Construction Completed: March 27, 2011 Data Collected: September & October 2015 Report Submission: December 2015

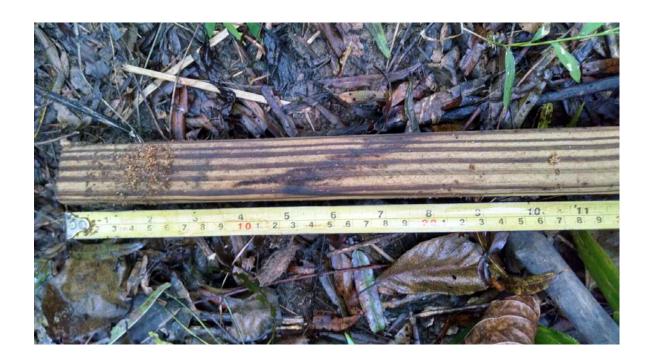
Table 12. Verification of Bankfull Events														
	Coddle Creek Tributary (Indian Run)/ 94 Segment/Reach: 2270 feet Date of Data Collection Date of Occurrence Method Photo													
5/30/2012	Between 5/11/2011 - 5/30/2012	Visual observation of wrack lines; stream gauge												
11/4/2013	Between 5/30/2012 - 11/04/2013	Visual observation of wrack lines; stream gauge	Photo in MY2 Report											
9/19/2014	Between 11/04/2013 - 9/19/2014	Visual observation of wrack lines; stream gauge reading at 35" above bankfull	Photo in MY3 Report											
9/22/2015	Between 9/19/2014 - 9/22/2015	Visual observation of wrack lines; stream gauge reading at 10.5" above bankfull	Photo below
