## FINAL MONITORING REPORT 2020 (Year 2)

#### HERON STREAM AND WETLAND MITIGATION SITE

Alamance County, North Carolina

DMS Project ID No. 100014 Full Delivery Contract No. 7192 USACE Action ID No. SAW-2017-01471 DWR No. 17-0290 RFP No. 16-006990

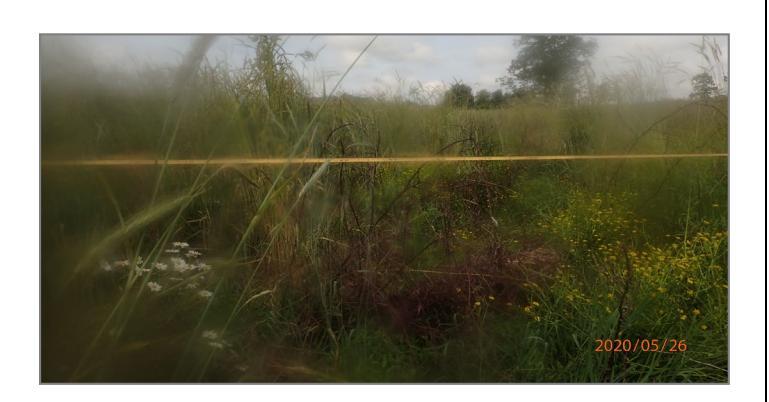
Note: Riffle degradation is natural and does not appear to pose a threat to overall stream stability. This area will be closely monitored during subsequent monitoring years.

Bankfull Elevation:	504.1
LTOB Elevation:	504.0
Bankfull Cross-Sectional Area:	6.3
Bankfull Width:	12.4
Flood Prone Area Elevation:	NA
Flood Prone Width:	NA
Max Depth at Bankfull:	0.9
Low Bank Height:	0.8
Mean Depth at Bankfull:	0.5
W / D Ratio:	NA
Entrenchment Ratio:	NA
Bank Height Ratio:	0.89

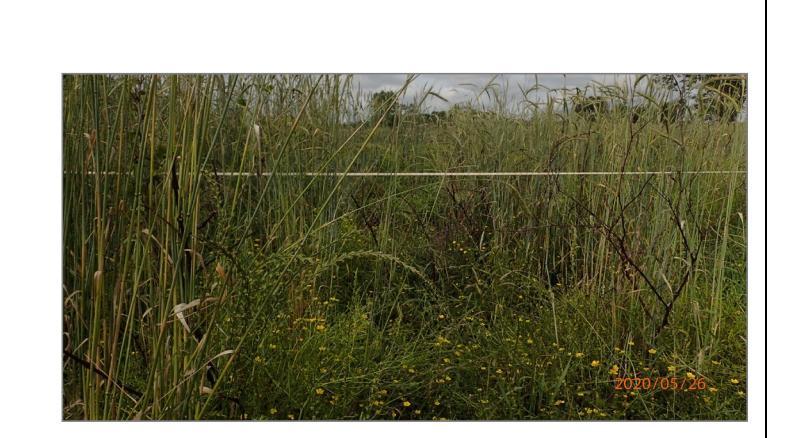
Note: Sediment deposition in pool appears natural and is not expected to lead to instability.

SUMMARY DATA	
Bankfull Elevation:	505.1
LTOB Elevation:	505.1
Bankfull Cross-Sectional Area:	3.0
Bankfull Width:	7.5
Flood Prone Area Elevation:	506.0
Flood Prone Width:	20.0
Max Depth at Bankfull:	0.9
Low Bank Height:	0.9
Mean Depth at Bankfull:	0.4
W / D Ratio:	18.8
Entrenchment Ratio:	2.7
Bank Height Ratio:	1.00

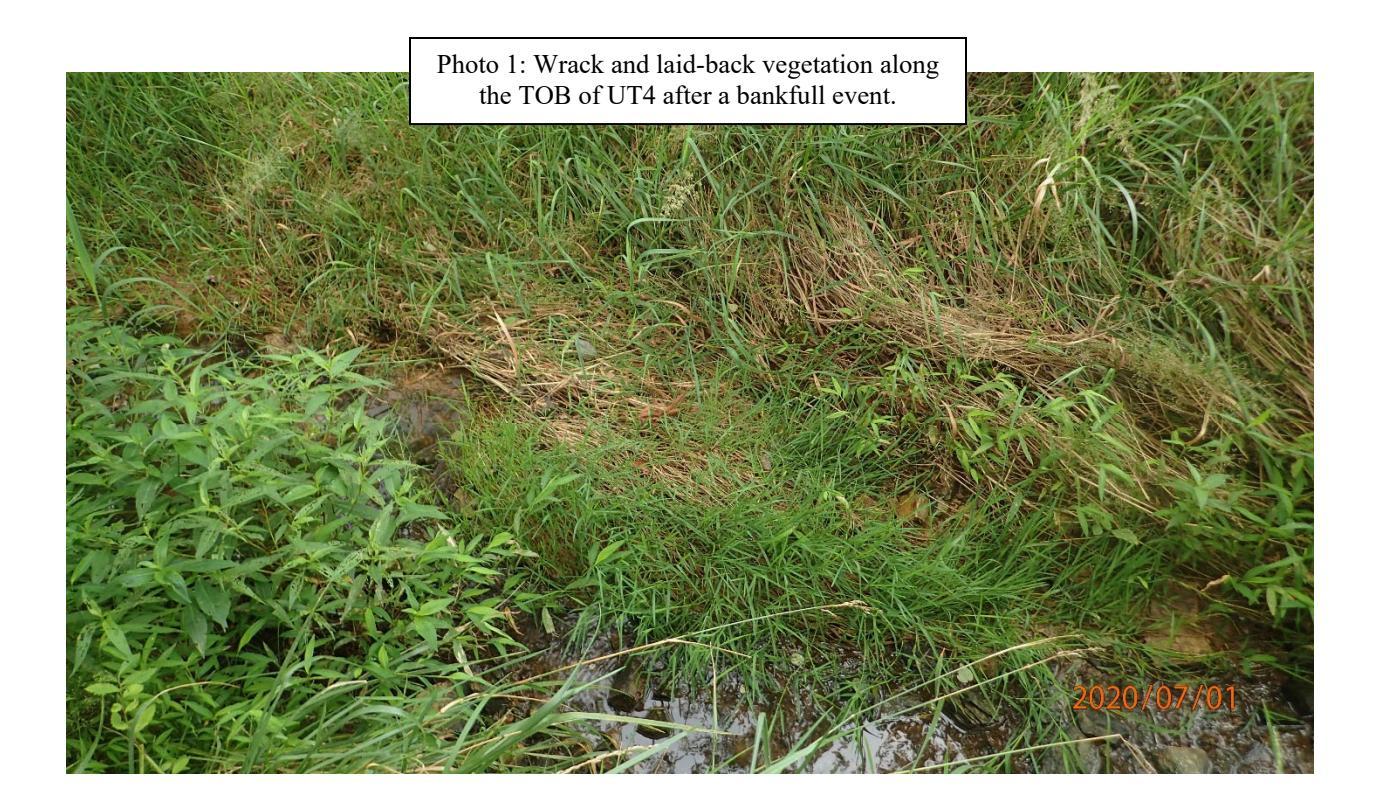
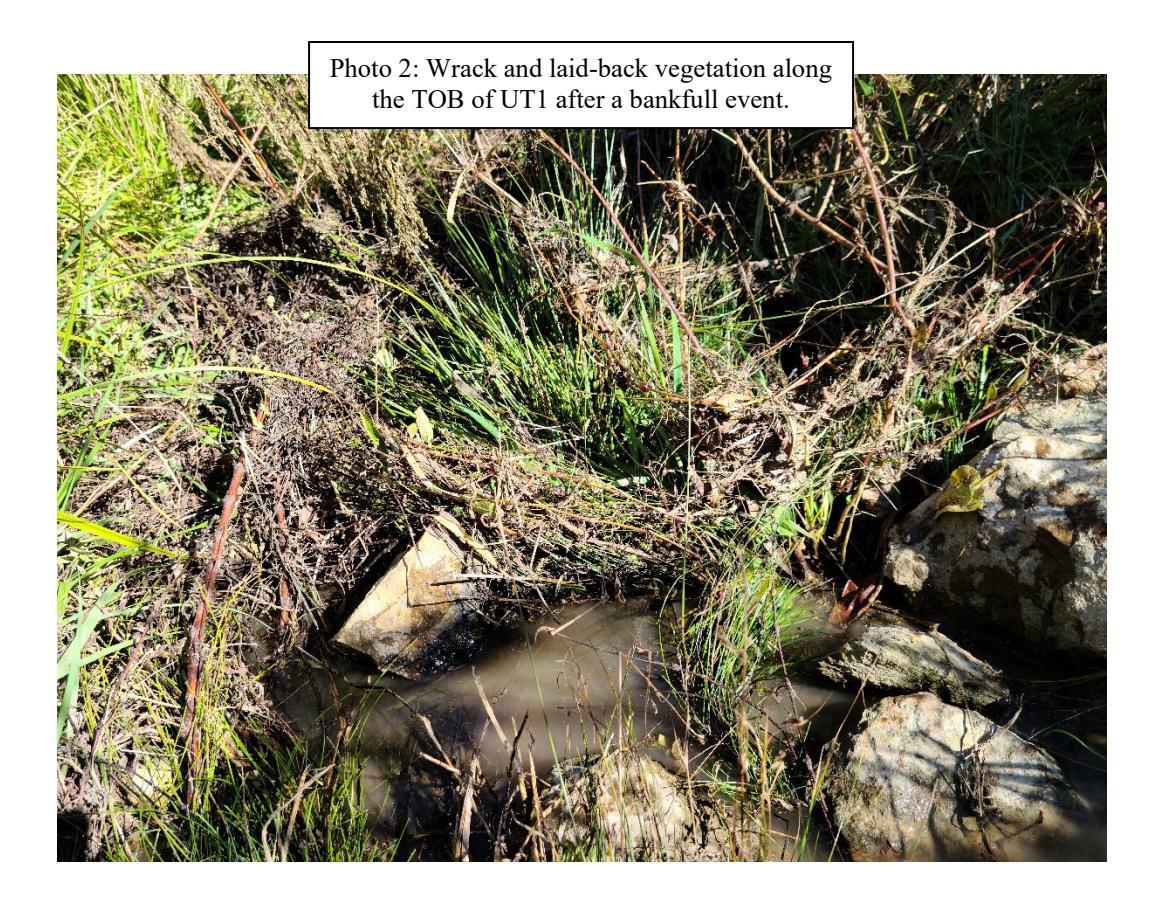
Table 16. Verification of Bankfull Events

Date of Data Collection	Date of Data CollectionDate of OccurrenceMethod		Photo (if available)
August 26, 2019	July 7, 2019	Stream gauge data indicates a bankfull event occurred after 4.06 inches of rain was documented on July 7, 2019 at an onsite rain gauge	
August 26, 2019	August 22, 2019	A bankfull event likely occurred after 7.16 inches of rain was documented between August 20-22, 2019 at an onsite rain gauge	
July 1, 2020	May 21, 2020	Wrack and laid-back vegetation were observed on the TOB of UT4 after 3.03 inches of rain was documented between May 19 and 21, 2020 at an onsite rain gauge.	1
November 16, 2020	November 12, 2020	Wrack and laid-back vegetation were observed on the TOB of UT1 after 3.13 inches of rain was documented between November 11 and 12, 2020 at an onsite rain gauge.	2
