Modlin Property Wetland Mitigation Site Martin County, NC

2007 Annual Monitoring Report Year 1, Baseline

NCEEP Project Number D050241

Date: December, 2007

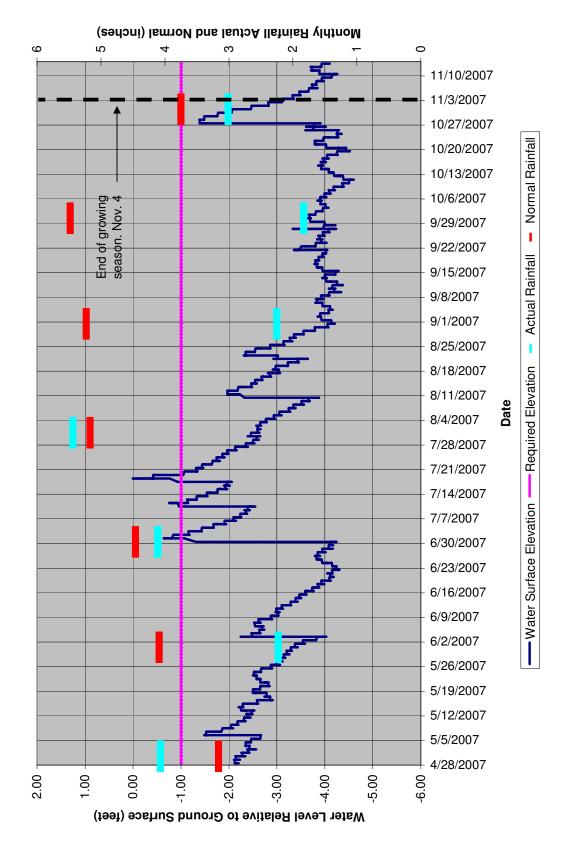
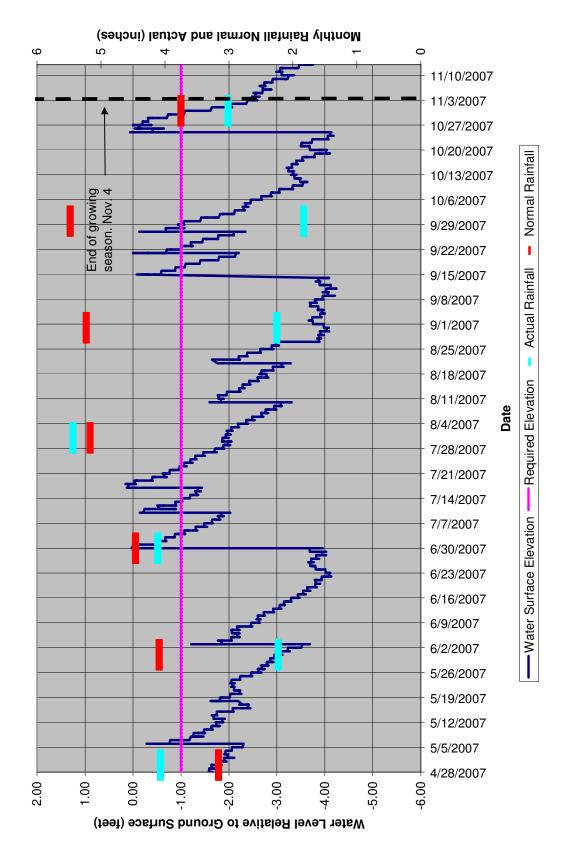
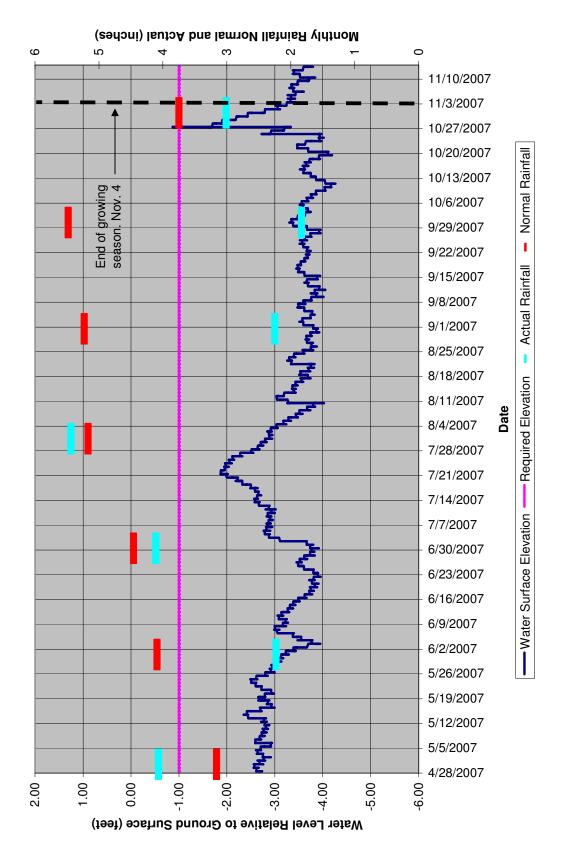
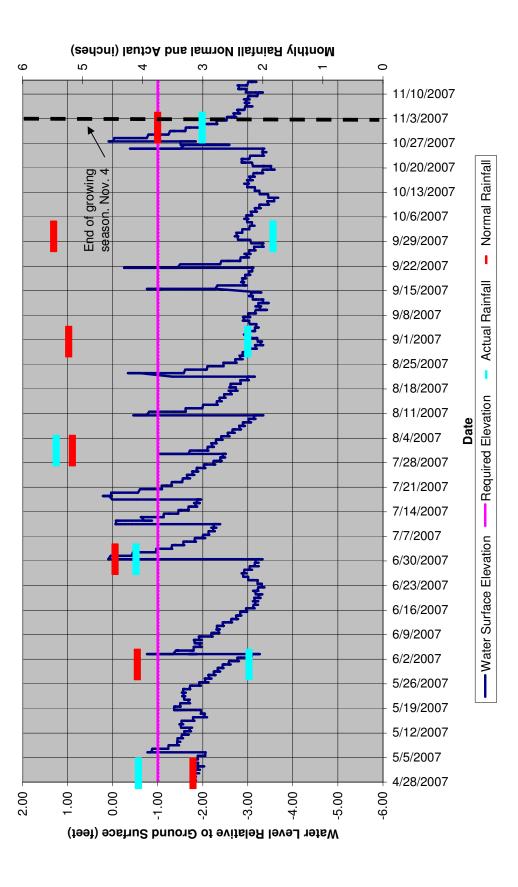
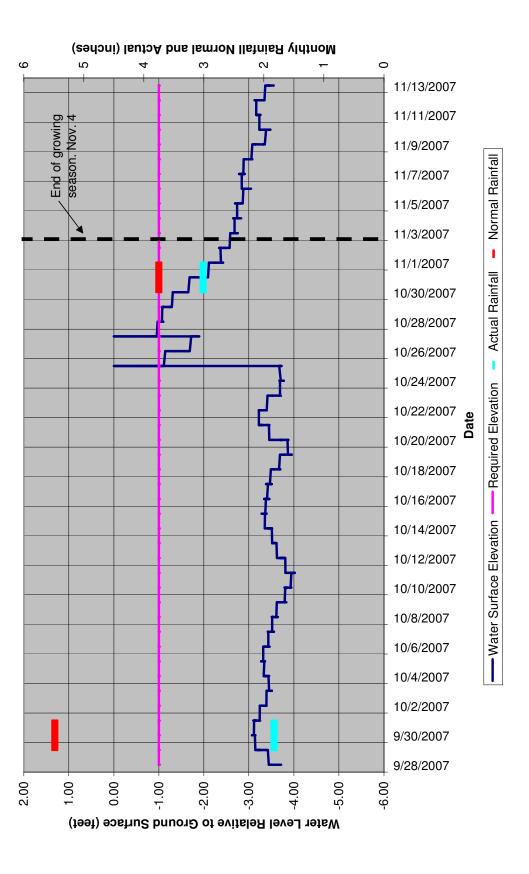
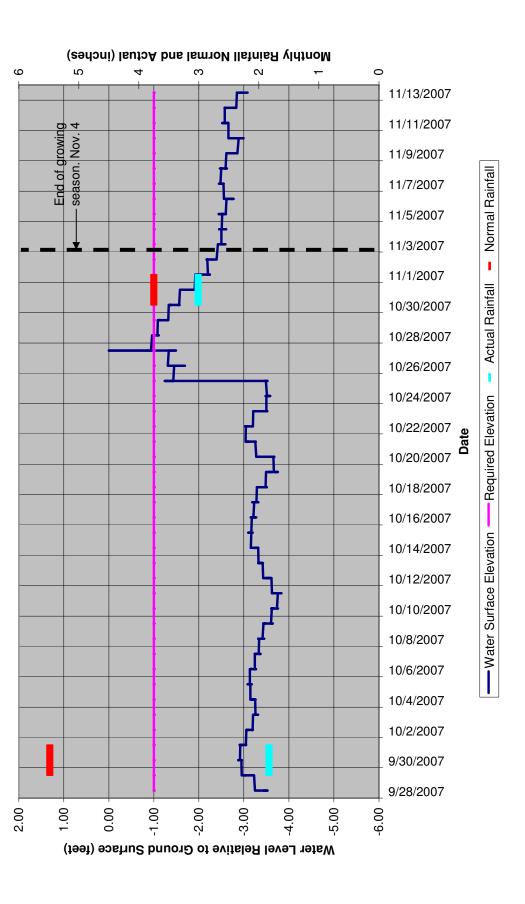
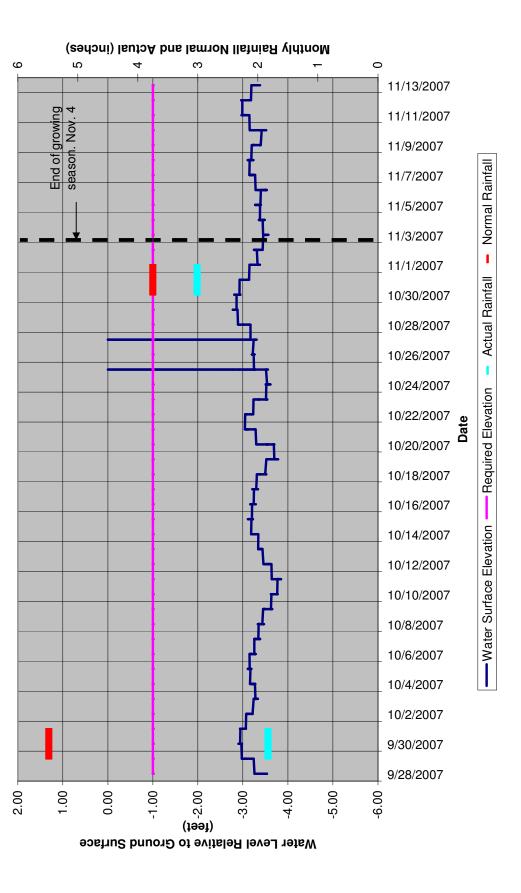
The wetland problem areas coincide with the vegetation problem areas. The lower areas of the emergent zone were able to retain water for longer periods, but the upper reaches of the flood plain were not. The hydrographs in Appendix C show the how the soil moisture levels responded to the sporadic rainfall. Although they reached the necessary level on numerous occasions, the soil saturation levels were not sustained for 21 consecutive days at any of the 7 well locations during the growing season.

Table C-1. Hydrologic Monitoring Results					
Well	# days within 12" (% of growing season)	# days within 12" (during growing season)	Hydrologic Success			
1	2%	6	No			
2	13%	32	No			
3	1%	1	No			
4	9%	22	No			
5	N/A	N/A	N/A			
6	N/A	N/A	N/A			
7	N/A	N/A	Reference Well
