FINAL-MY3 Monitoring Report

Seniard Creek Mitigation Site

Henderson County French Broad River Basin Cataloging Unit # 06010105

NCDMS Project No. 100017 NCDMS Contract No. 7189 DMS RFP No. 16-006991

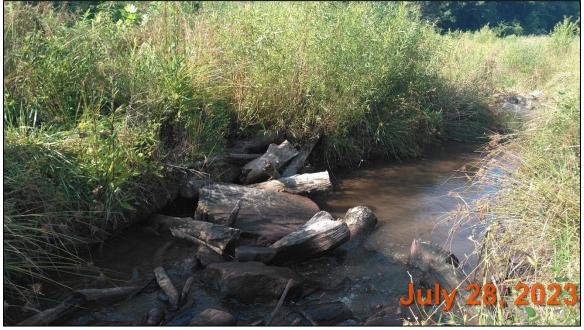
The two areas along Lee and Sitton Creek identified in MY1 as problem areas, Lee Branch at Station 300+25, and Sitton Creek at Station 211+25, have remained stable through MY3. Lee branch experienced a pulse of sediment related to a heavy storm event during MY1. The area had stabilized and revegetated by MY2. Lee Branch had undergone some bank building over the MY3 season indicating additional sediment inputs from upstream. The heavy riparian vegetation along this reach has trapped most of this deposition and Lee continues to maintain bed and bank. The area of bank scour and slump noted at Sitton Creek Station 211+25 during MY1 has completely revegetated following the installation of live stakes in MY2. No further erosion has taken place in this area following the addition and growth of live stakes (See problem area photographs, Appendix A). No additional areas of concern were identified in MY3.

MY3 (2023) Sitton Creek Station 211+25 facing downstream.

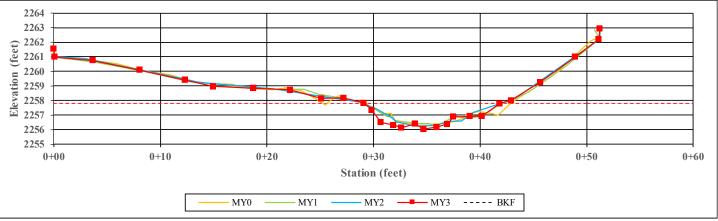
Project Name: SeniardXS Number:1Station: 100+32

CHANNEL DIMENSIONS SUMMARY	MY0	MY1	MY2	MY3	MY4	MY5	MY6	MY7
Bankful Width (ft)	14.2	12.9	12.9	12.8	-	-	-	-
Floodprone Width (ft)	50.0	50.0	50.0	50.0	-	-	-	-
Bankfull Mean Depth (ft)	1.0	1.1	1.1	1.1	-	-	-	-
Bankfull Max Depth (ft)	1.5	1.8	1.8	1.8	-	-	-	-
Bankfull Cross-Sectional Area (ft²)	14.6	14.6	14.6	14.6	-	-	-	-
Width/Depth Ratio	13.8	11.5	11.3	11.1	-	-	-	-
Entrenchment Ratio	3.5	3.9	3.9	3.9	-	-	-	-
Bank Height Ratio	1.0	0.9	0.9	1.1	-	-	-	-

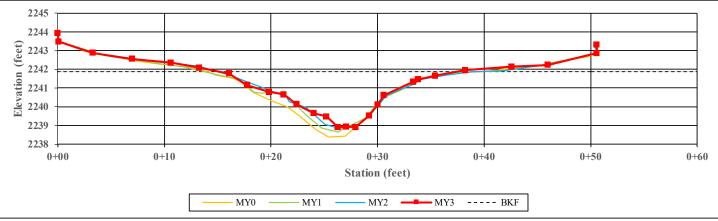
Project Name: Seniard XS Number: 2 Station: 107+60

CHANNEL DIMENSIONS SUMMARY	MY0	MY1	MY2	MY3	MY4	MY5	MY6	MY7
Bankful Width (ft)	17.0	17.0	15.8	15.6	ı	ı	ı	ı
Floodprone Width (ft)	50.0	50.0	50.0	50.0	-	-	-	-
Bankfull Mean Depth (ft)	1.6	1.6	1.7	1.8	-	-	-	-
Bankfull Max Depth (ft)	3.1	3.1	3.0	3.0	-	-	-	-
Bankfull Cross-Sectional Area (ft²)	27.6	27.6	27.6	27.6	-	-	-	-
Width/Depth Ratio	10.5	10.5	9.0	8.8	-	-	-	-
Entrenchment Ratio	2.9	2.9	3.2	3.2	-	-	-	-
Bank Height Ratio	1.0	0.9	0.9	0.9	-	-	-	-
