PROJECT NARRATIVE

**EXISTING GROIN REHABILITATION
FEASIBILITY STUDY**

CAPE HATTERAS, NORTH CAROLINA

5 JULY 2006

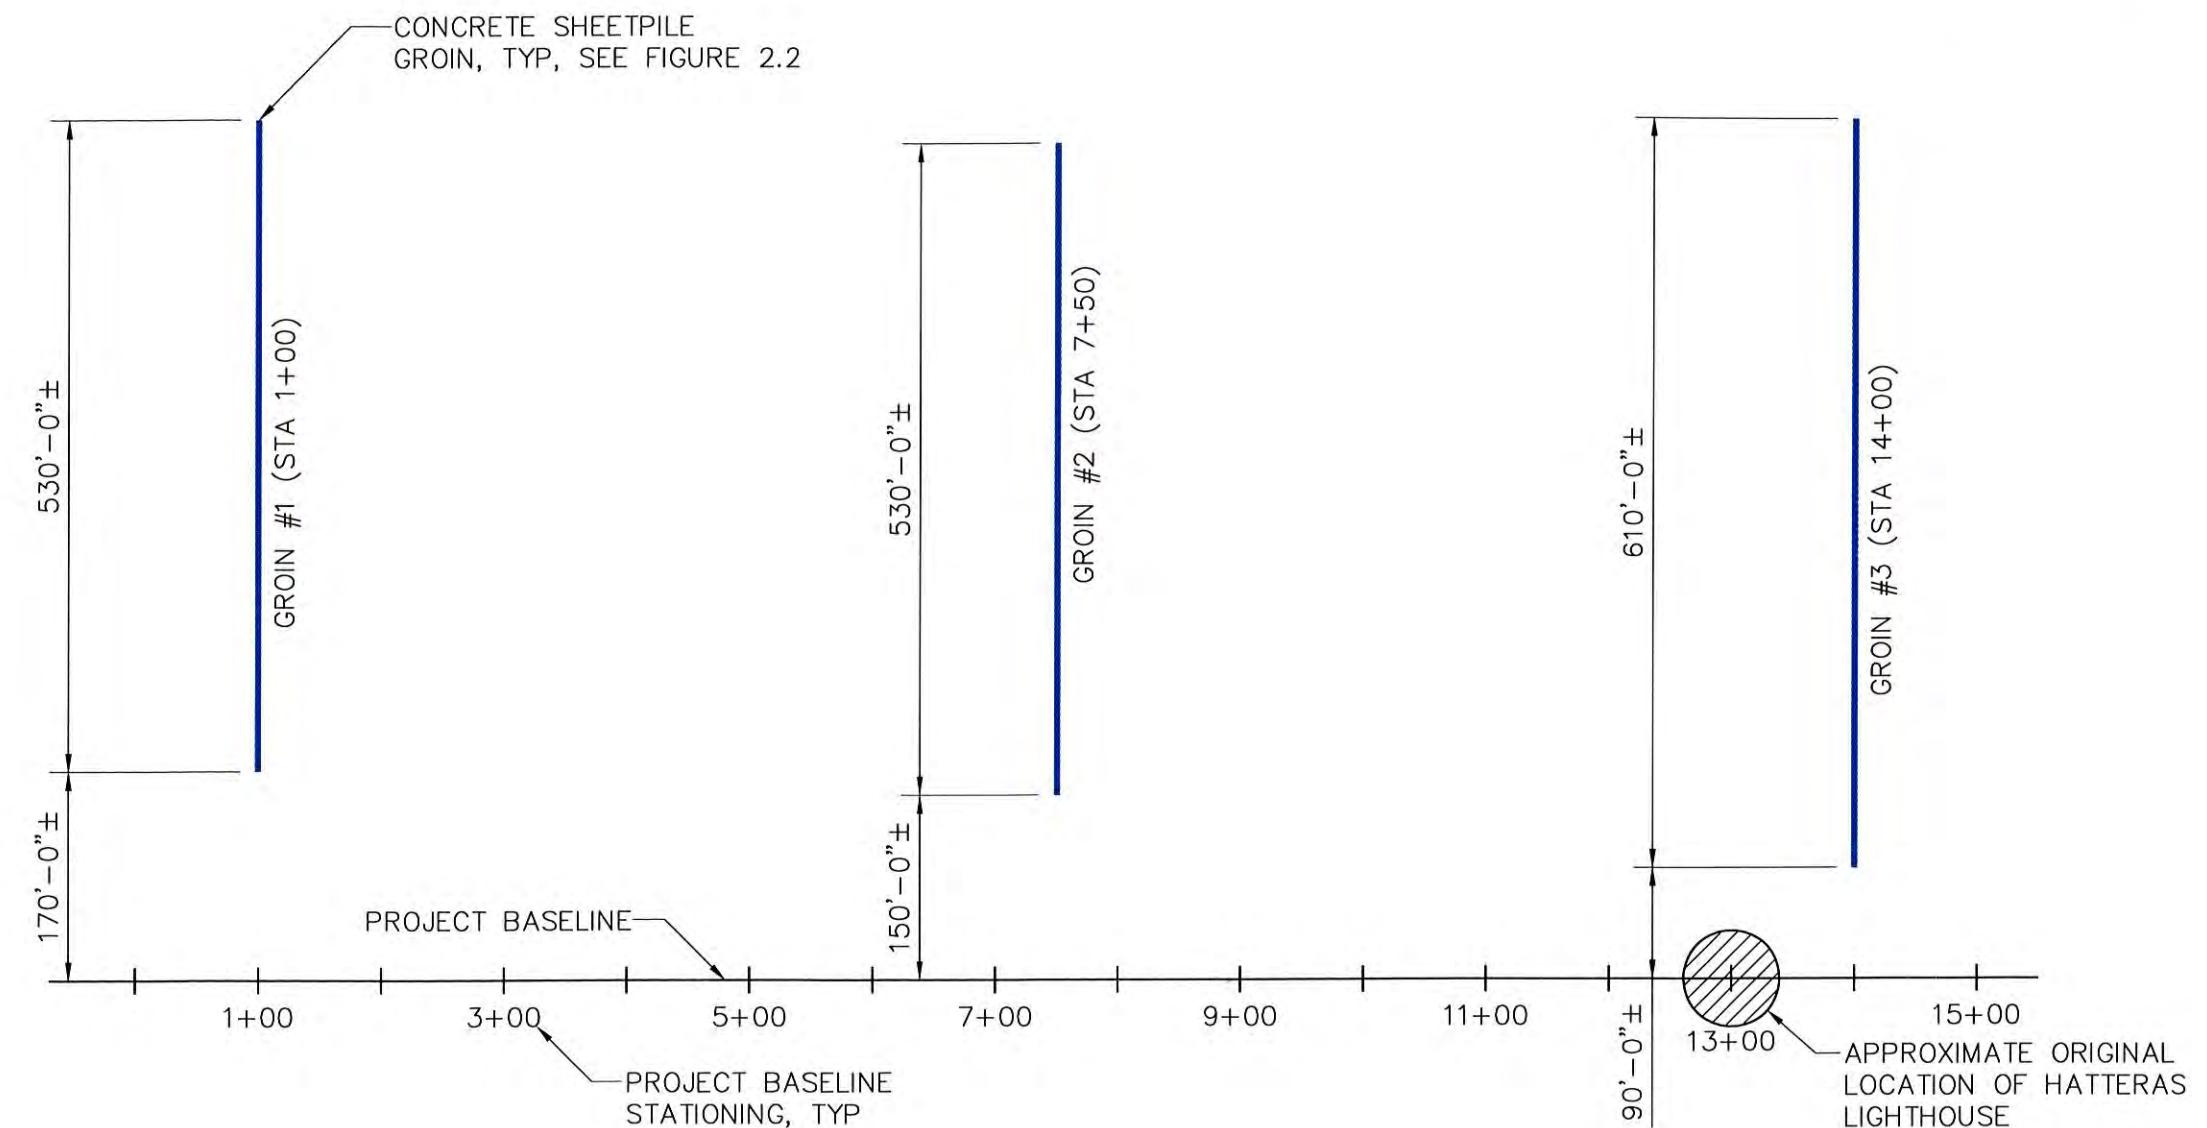
FIGURE 2.1

The main reason for constructing the three original groins was to stop or slow down beach erosion near the original location of the Cape Hatteras Lighthouse. The 1969 construction of the three precast concrete sheet pile groins are shown in plan on Figure 2.1 in Appendix A. Figure 2.2 shows the original conceptual construction details. Groin 1, the northern most groin, was approximately 530 feet long. Groin 2, the middle groin, was also approximately 530 feet long. Groin 3, the southern most groin, was

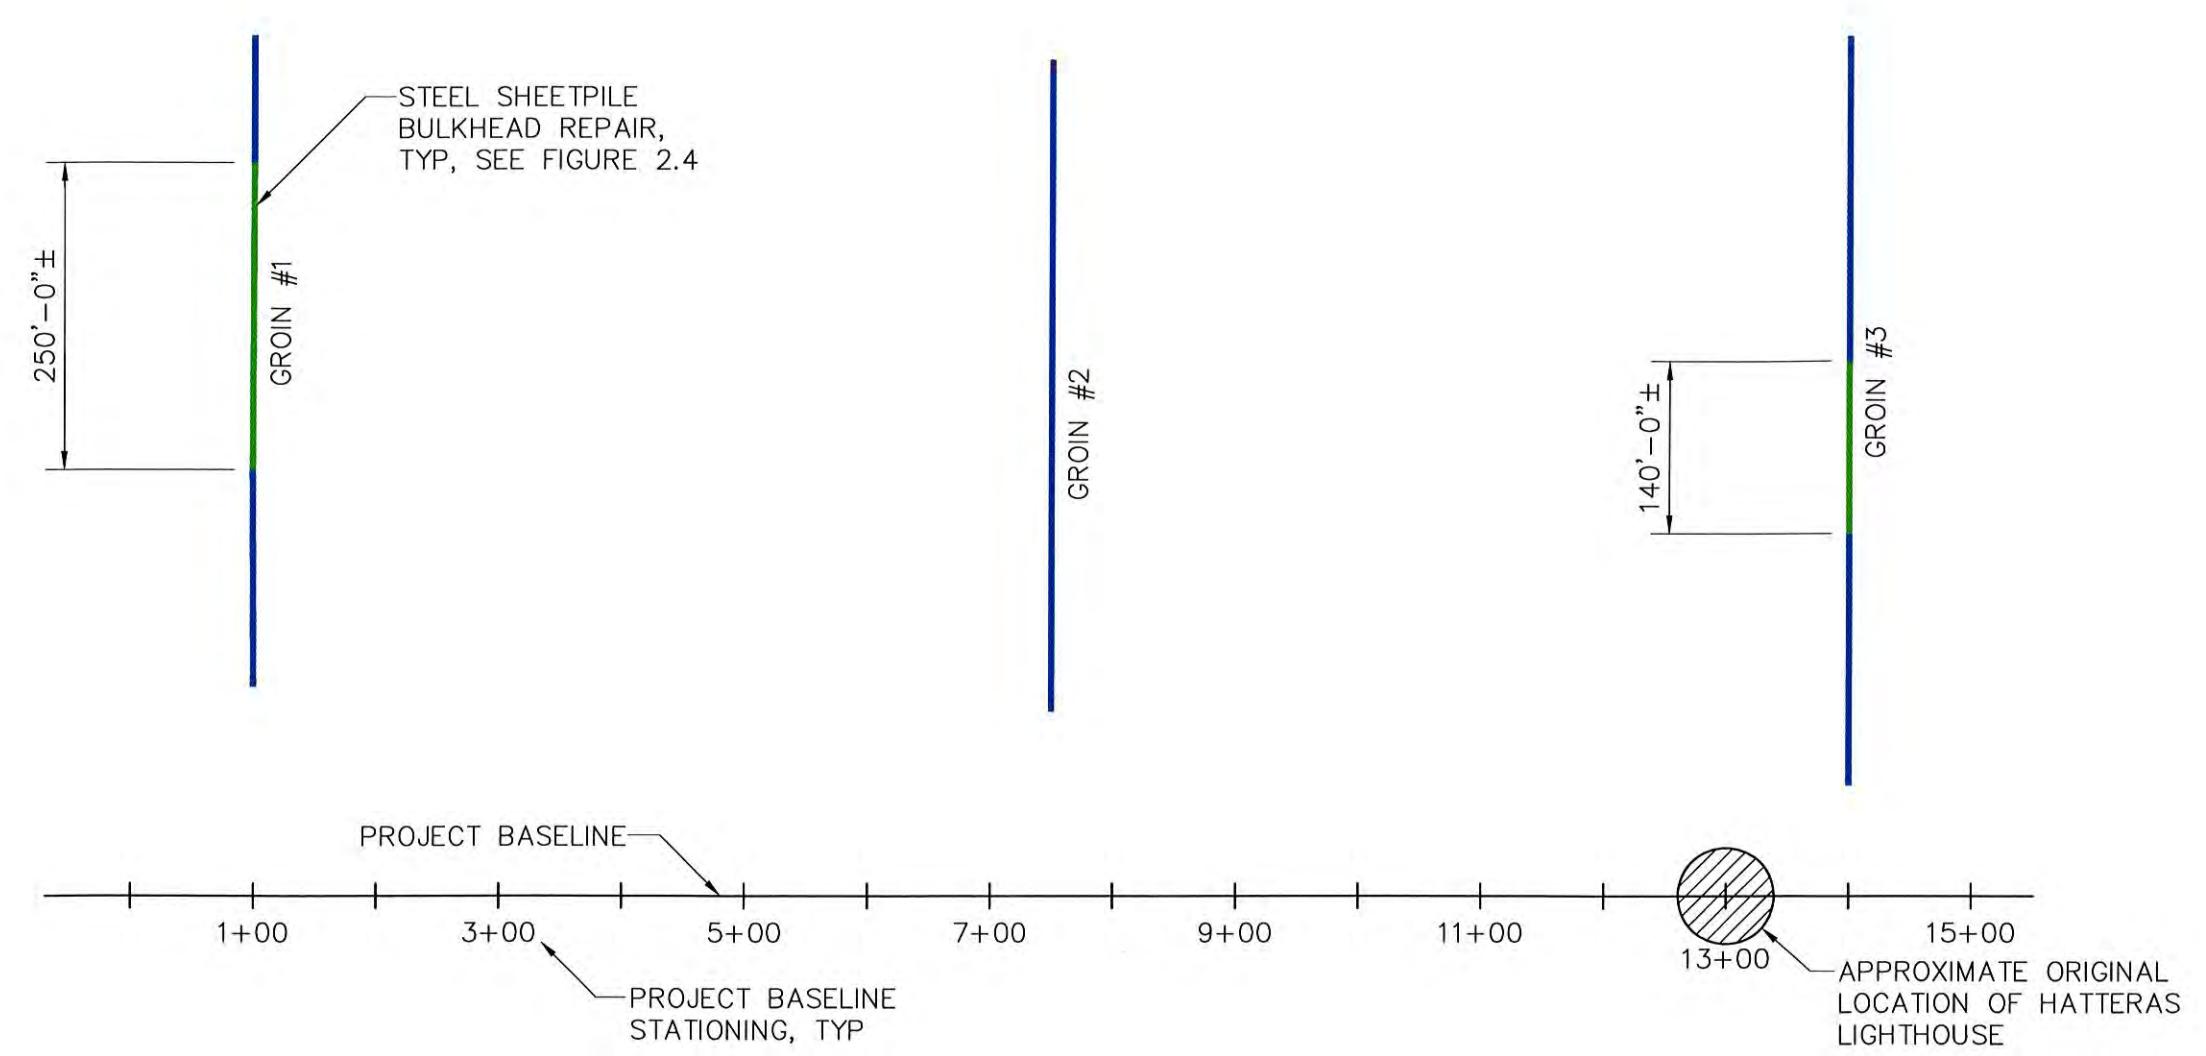
FIGURE 2.3

In 1975, steel sheet piles were installed, which appeared to be a PZ-27 size based on the field dimensions that were taken during this inspection. At Groin 1, steel sheet piles replaced approximately 250 feet of the original concrete sheet piles. At Groin 3, steel sheet piles replaced approximately 140 feet of the original concrete sheet piles. No repairs were performed on Groin 2 at this time. Figures 2.3 and 2.4 in Appendix A show conceptually the construction that was performed in 1975.

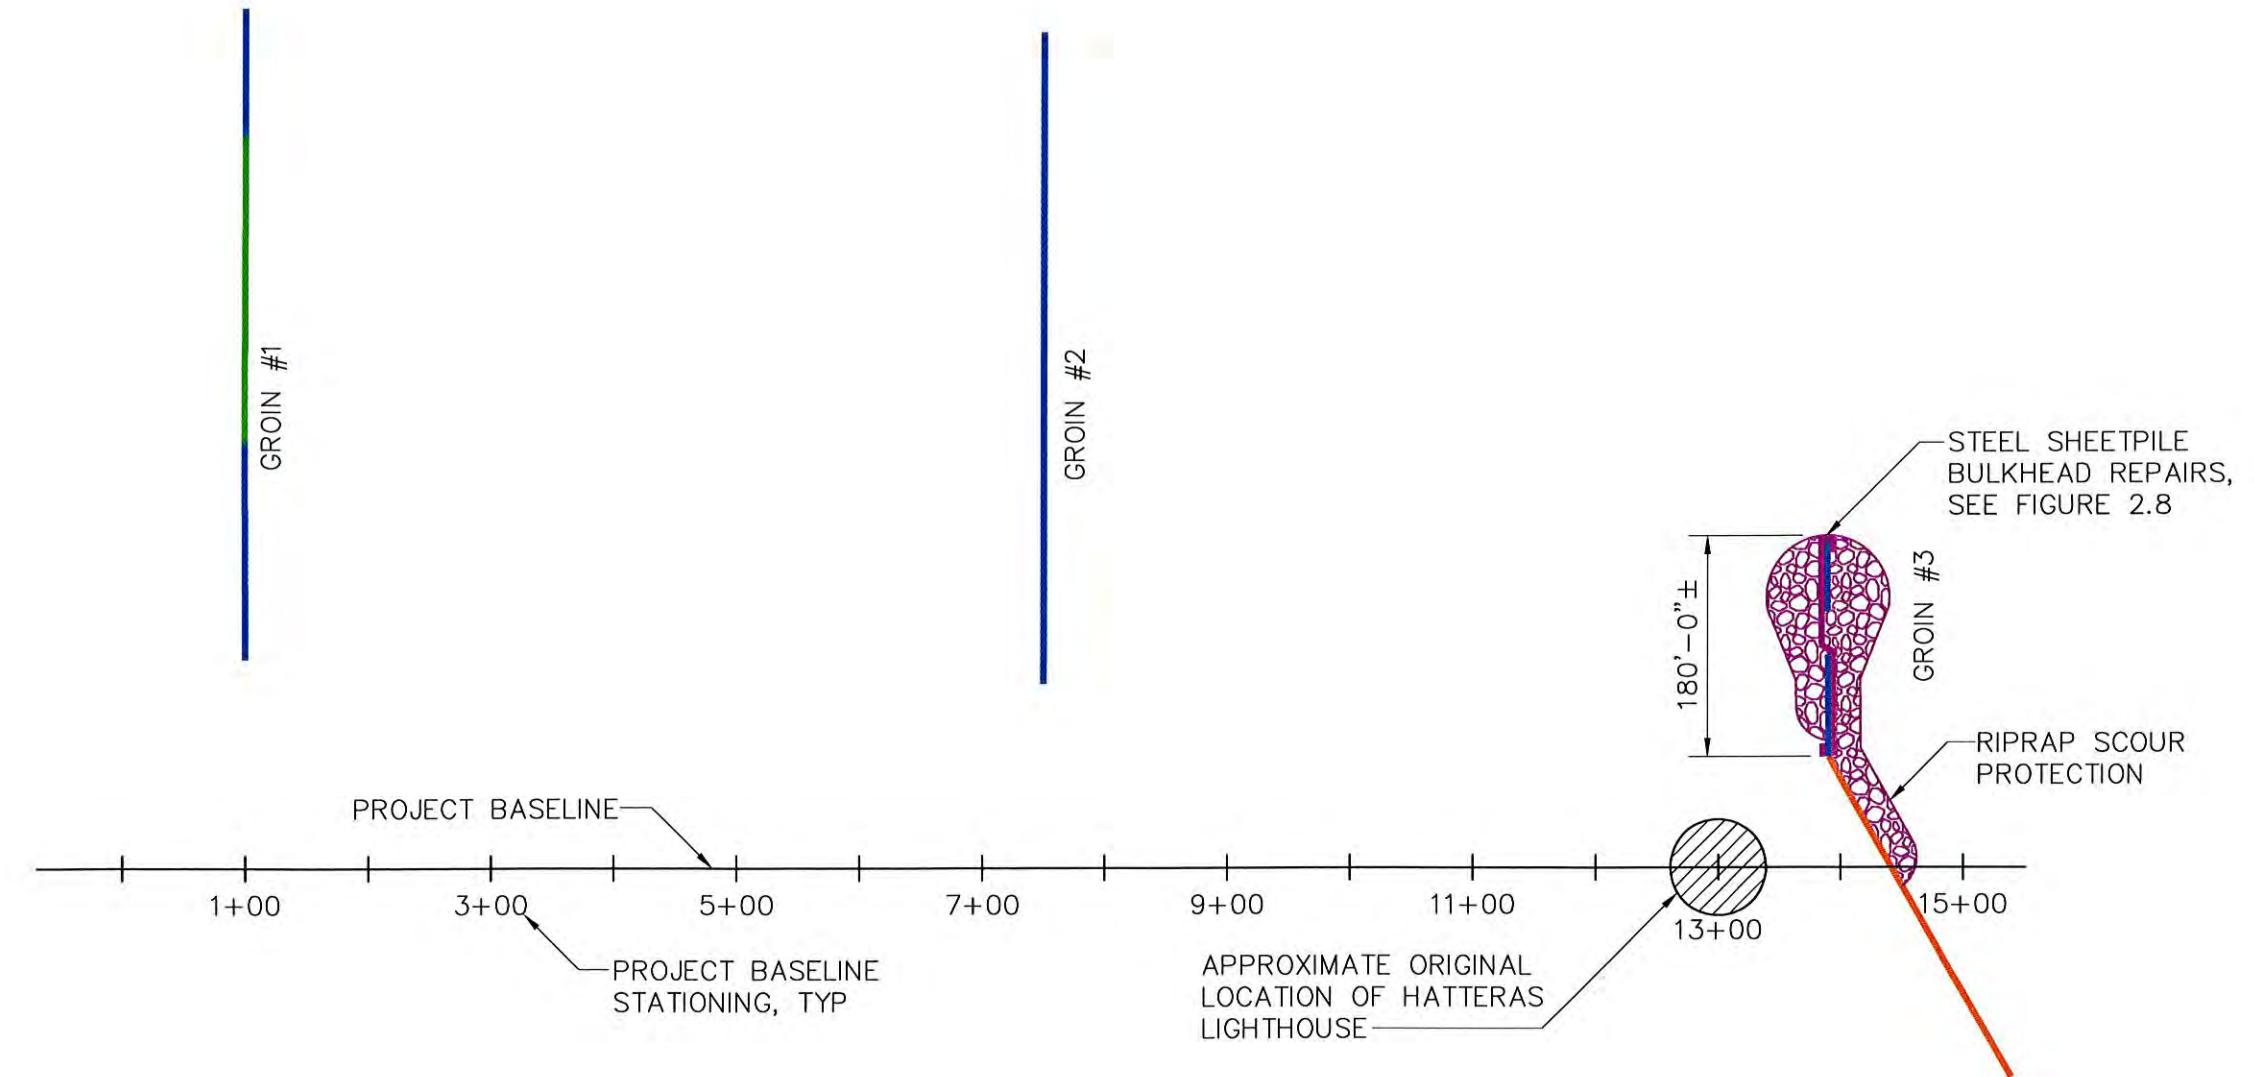
FIGURE 2.7

The most recent repairs made to the structure (in 1994) consisted of new sheet piles driven adjacent to the original sheet piles, and additional scour protection at the base of the structure. According to engineered drawings (Attachment 3 Figure 2.7), ~180 ft of sheet piles were installed. By 1999, much of the scour protection was buried along with the sandbags as shown in Figure C.

In 1994, additional improvements were made at Groin 3. Approximately 180 feet of PZ-40 steel sheet piles were installed near the landside end. Additionally, drawings and records indicate some scour protection was installed at Groin 3 in 1984 and 1994. Figures 2.7 and 2.8 in Appendix A show conceptually the construction that was performed for these improvements. There appeared to be sacrificial anodes installed toward the top of each sheet.
