Middle Fork New River Restoration Prioritization Plan

Watauga County, North Carolina

August 31, 2018

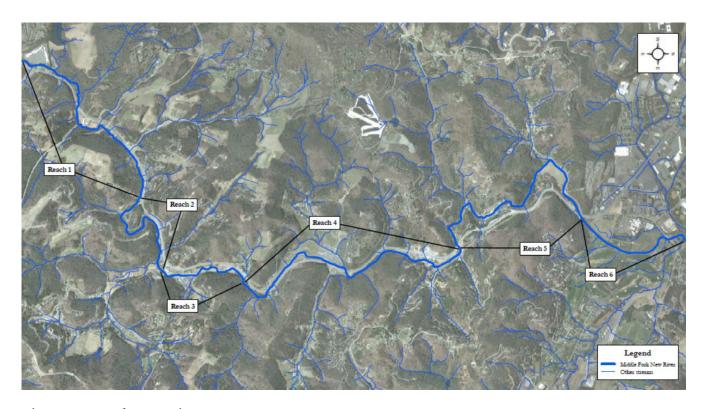
Figure 1. Reach Overview

The project begins at the greenway parking area near the Tanger Outlets and ends at the confluence of the Middle Fork and the East Fork of the South Fork New River. Total river length within this project is 7.46 miles. The six planning reaches delineated in the "Middle Fork Greenway Master Plan" have generally been adopted as the stream reaches for the Middle Fork New River Restoration Prioritization Plan. Precise reach boundaries have been adjusted based on property ownership, stream conditions, and potential restoration approaches. These reaches are listed below, and shown in Figure 1 and on Sheets 1 through 7.

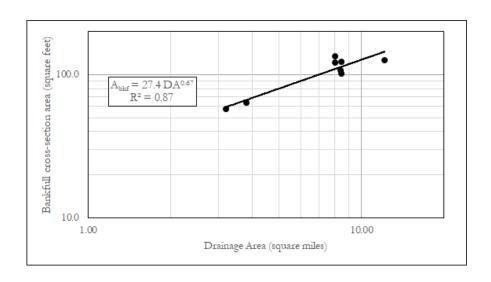
Figure 2. Bankfull riffle cross-section area related to drainage area.

The measured bankfull riffle cross-sectional areas range from 56.1 to 133.8 square feet (Table 4 and Appendix A), with the relationship between cross-sectional area (A_{bkf}) and drainage area (DA) shown in Figure 2. Similarly, the bankfull channel riffle widths (W_{bkf}) and mean depths (d_{bkf}) related to drainage area are shown in Figures 3 and 4.

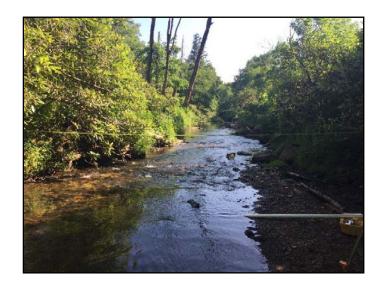
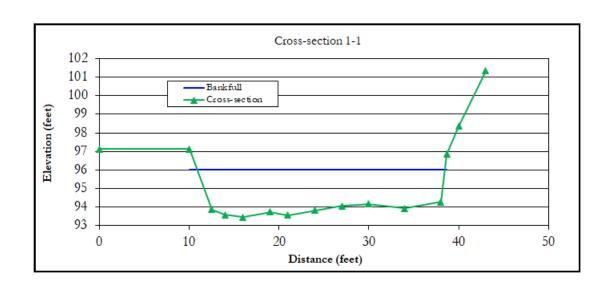
Drainage area: 3.19 square miles **Median particle size:** gravel

Stream classification: C4

1-1
Area (square feet) =	57.6
Width (feet) =	27.6
Mean depth =	2.1
Max depth =	2.6
Width/depth ratio =	13.3
Entrenchment ratio =	3.3

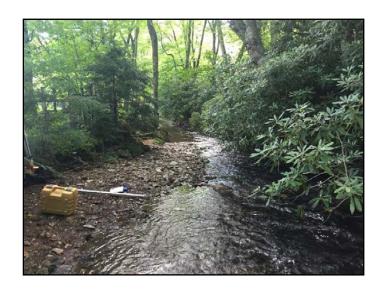
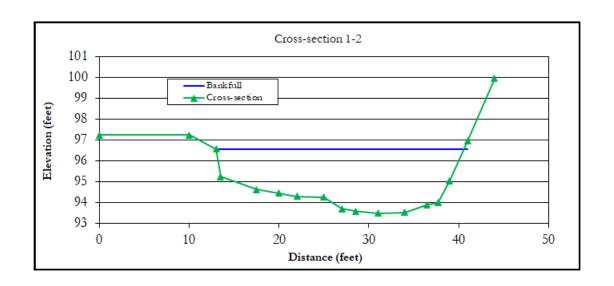
Cross-section 1-2 Middle Fork New River

Drainage area: 3.80 square miles Median particle size: cobble Stream classification: E3

1-2
Area (square feet) =	63.4
Width (feet) =	27.6
Mean depth =	2.3
Max depth =	3.1
Width/depth ratio =	12.0
Entrenchment ratio =	3.4

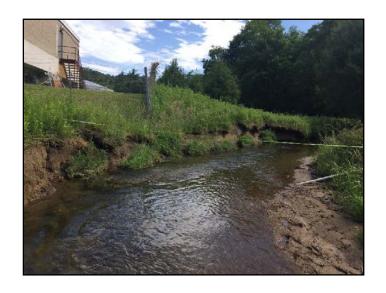
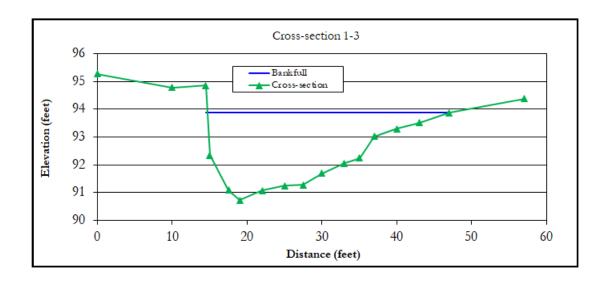
Cross-section 1-3 Middle Fork New River

Drainage area: 3.86 square miles **Median particle size:** gravel

1-3
Area (square feet) =	56.1
Width (feet) =	32.3
Mean depth =	1.7
Max depth =	3.2

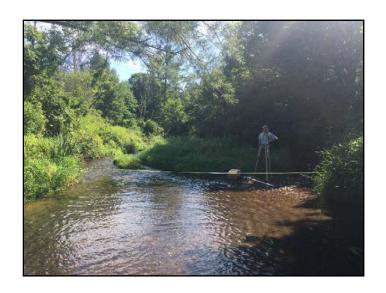
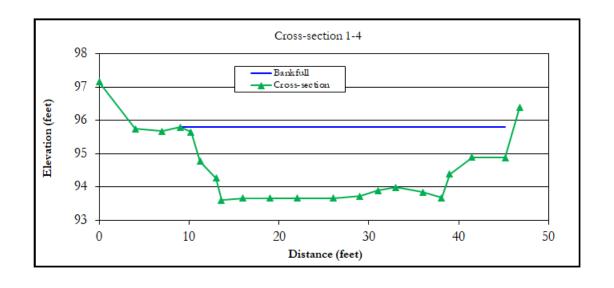
Cross-section 1-4 Middle Fork New River

Drainage area: 4.04 square miles Median particle size: gravel Stream classification: C4

1-4
Area (square feet) =	62.6
Width (feet) =	37.2
Mean depth =	1.7
Max depth =	2.2
Width/depth ratio =	22.1
Entrenchment ratio =	3.0

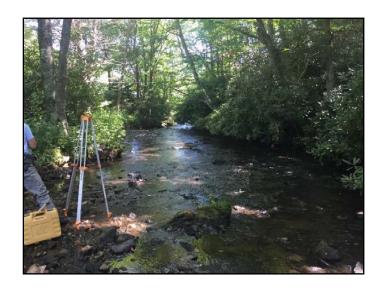
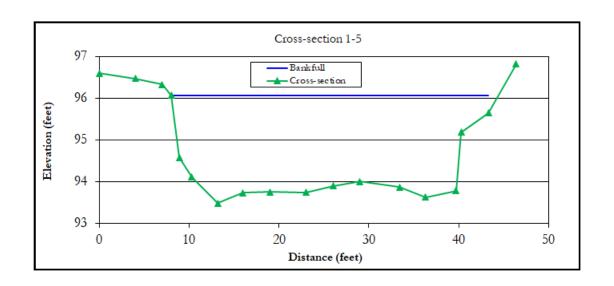
Cross-section 1-5 Middle Fork New River

Drainage area: 4.07 square miles Median particle size: gravel Stream classification: B4c

1-5
Area (square feet) =	73.3
Width (feet) =	36.4
Mean depth =	2.0
Max depth =	2.6
Width/depth ratio =	18.1
Entrenchment ratio =	2.0

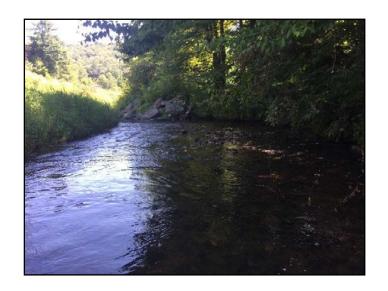
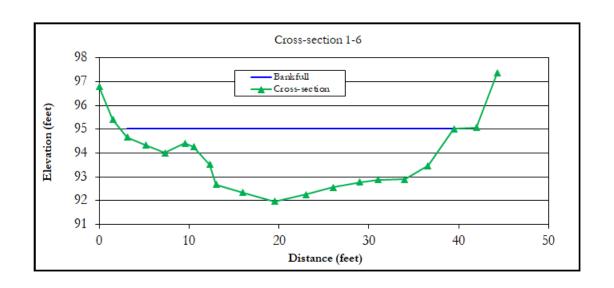
Cross-section 1-6 Middle Fork New River

Drainage area: 4.89 square miles **Median particle size:** gravel

Stream classification: C4

1-6
Area (square feet) =	69.1
Width (feet) =	37.2
Mean depth =	1.9
Max depth =	3.0
Width/depth ratio =	20.0
Entrenchment ratio =	2.4

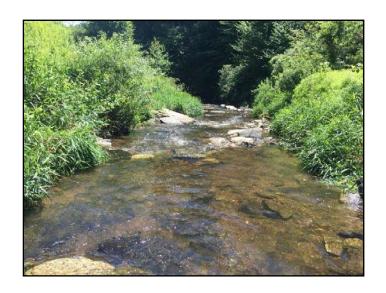
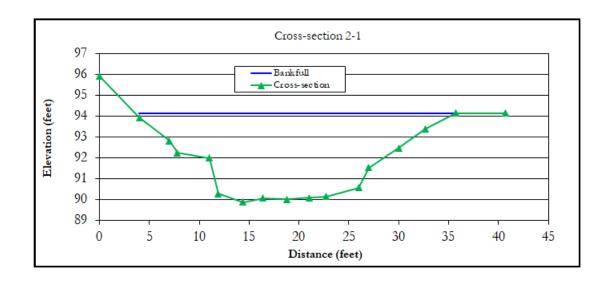
Cross-section 2-1 Middle Fork New River

Drainage area: 5.56 square miles Median particle size: cobble Stream classification: C3

2-1
Area (square feet) =	83.7
Width (feet) =	32.1
Mean depth =	2.6
Max depth =	4.3
Width/depth ratio =	12.3
Entrenchment ratio =	2.2

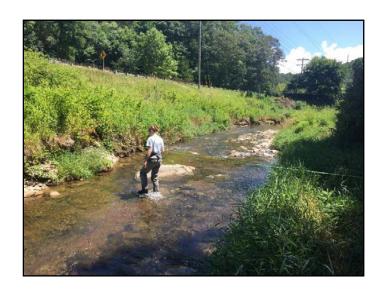
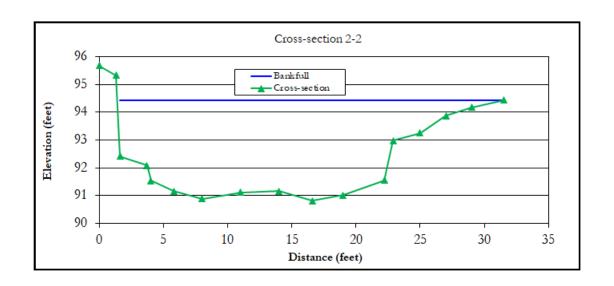
Cross-section 2-2 Middle Fork New River

Drainage area: 5.57 square miles Median particle size: cobble Stream classification: C3

2-2
Area (square feet) =	73.7
Width (feet) =	30.1
Mean depth =	2.4
Max depth =	3.6
Width/depth ratio =	12.3
Entrenchment ratio =	2.5

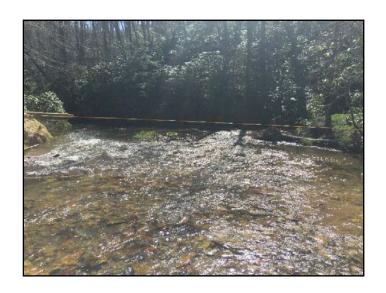
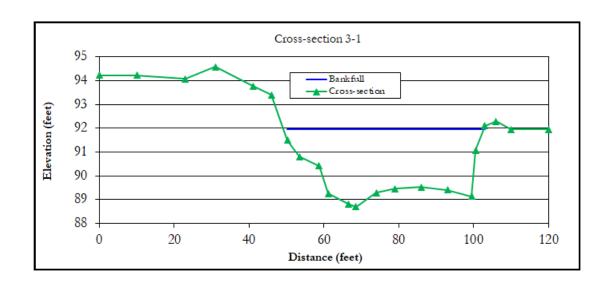
Cross-section 3-1 Middle Fork New River

Drainage area: 8.01 square miles Median particle size: gravel Stream classification: C4

3-1
Area (square feet) =	120.9
Width (feet) =	53.4
Mean depth =	2.3
Max depth =	3.3
Width/depth ratio =	23.5
Entrenchment ratio =	2.9

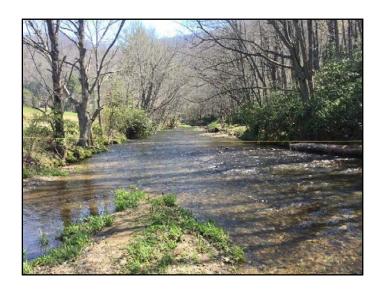
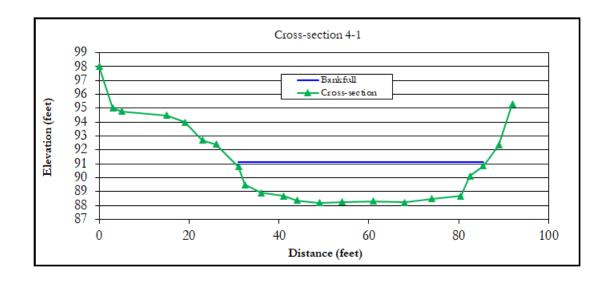
Cross-section 4-1 Middle Fork New River

Drainage area: 8.01 square miles Median particle size: gravel Stream classification: B4c

4-1
Area (square feet) =	133.8
Width (feet) =	56.0
Mean depth =	2.4
Max depth =	2.9
Width/depth ratio =	23.5
Entrenchment ratio =	1.3

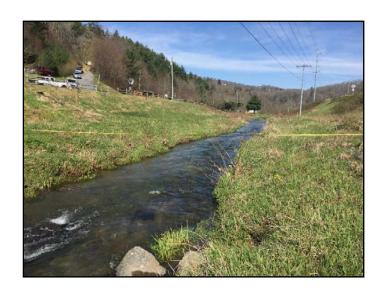
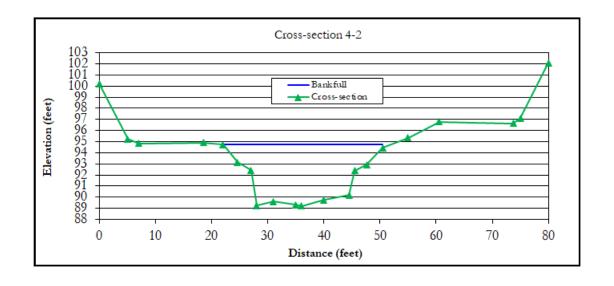
Cross-section 4-2 Middle Fork New River

Drainage area: 8.40 square miles Median particle size: cobble Stream classification: E3

4-2
Area (square feet) =	106.8
Width (feet) =	29.9
Mean depth =	3.6
Max depth =	5.5
Width/depth ratio =	8.4
Entrenchment ratio =	2.6

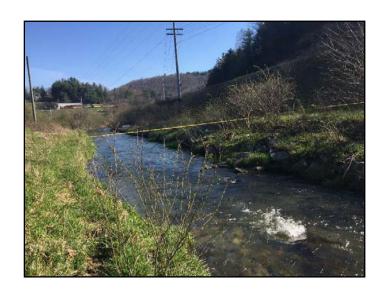
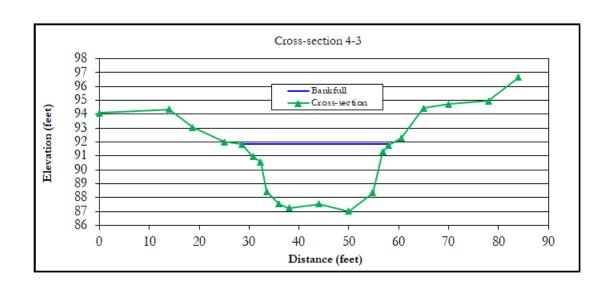
Cross-section 4-3 Middle Fork New River

Drainage area: 8.47 square miles Median particle size: cobble Stream classification: E3

4-3
Area (square feet) =	102.4
Width (feet) =	29.8
Mean depth =	3.4
Max depth =	4.8
Width/depth ratio =	8.6
Entrenchment ratio =	4.5

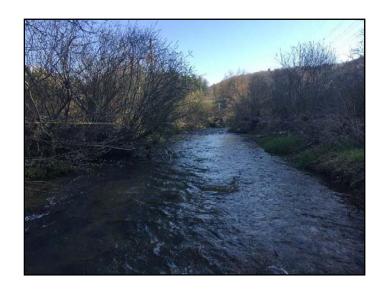
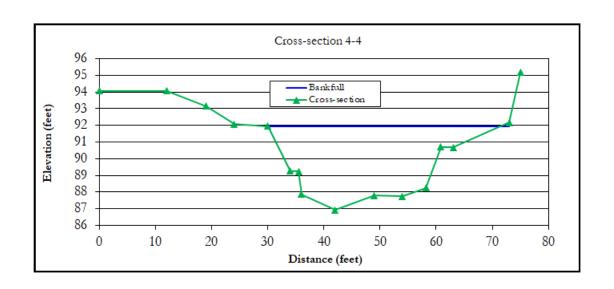
Cross-section 4-4 Middle Fork New River

Drainage area: 8.47 square miles Median particle size: cobble Stream classification: C3

4-4
Area (square feet) =	123.2
Width (feet) =	41.6
Mean depth =	3.0
Max depth =	5.0
Width/depth ratio =	14.0
Entrenchment ratio =	3.1

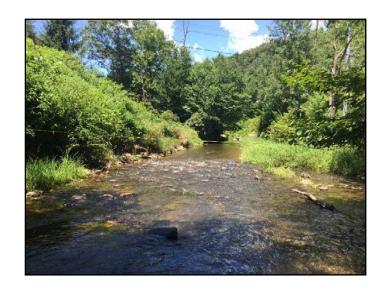
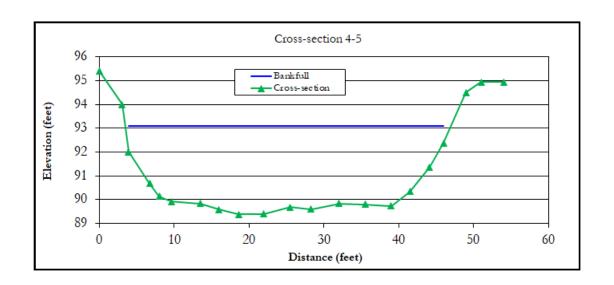
Cross-section 4-5 Middle Fork New River

Drainage area: 10.20 square miles

Median particle size: cobble Stream classification: C3

4-5
Area (square feet) =	130.5
Width (feet) =	42.6
Mean depth =	3.1
Max depth =	3.7
Width/depth ratio =	13.9
Entrenchment ratio =	2.6

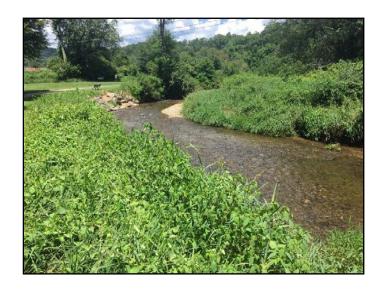
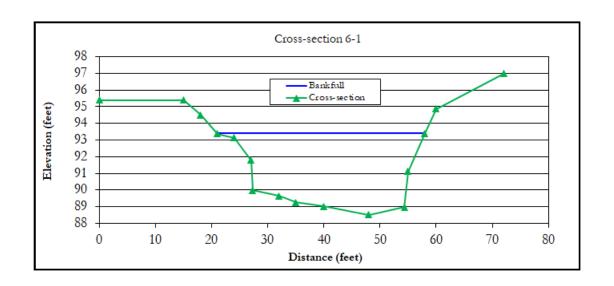
Cross-section 6-1 Middle Fork New River

Drainage area: 12.20 square miles

Median particle size: gravel Stream classification: E4

6-1
Area (square feet) =	126.1
Width (feet) =	37.1
Mean depth =	3.4
Max depth =	4.9
Width/depth ratio =	10.9
Entrenchment ratio =	4.6
