**YEAR 1 (2015) MONITORING REPORT**  
**ABBEY LAMM**  
**STREAM AND WETLAND MITIGATION SITE**  
**ALAMANCE COUNTY, NORTH CAROLINA**  
**FULL DELIVERY CONTRACT NO. 5790**

**CAPE FEAR RIVER BASIN**  
**CATALOGING UNIT 03030002**

**Data Collection – March-October 2015**

**November 2015**

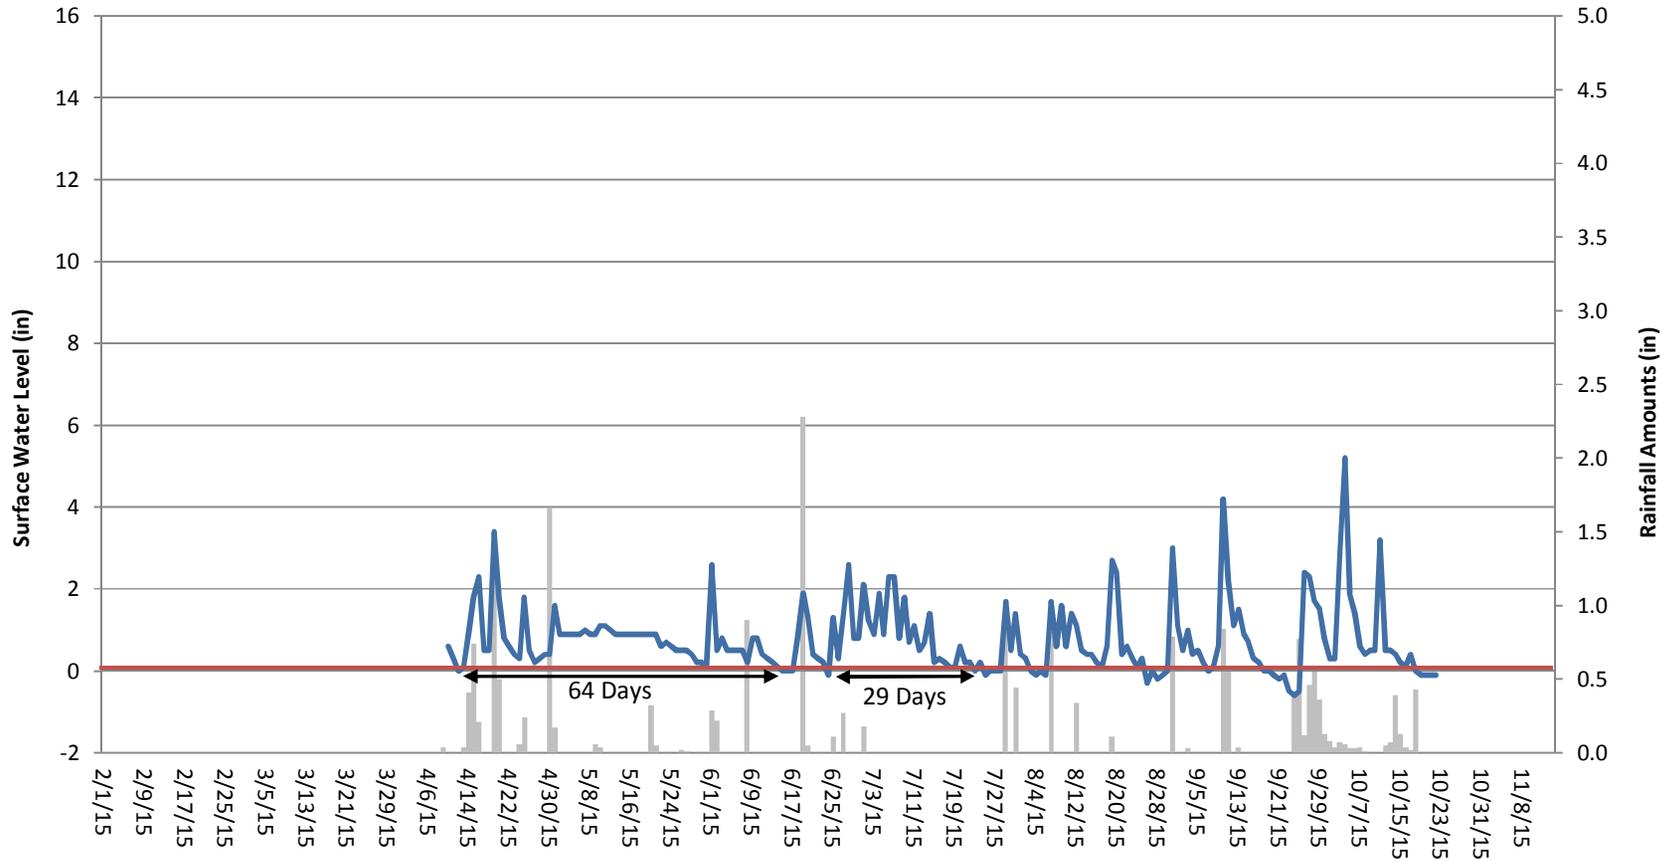
### Lamm Surface Gauge UT-1 Upstream Year 1 (2015 Data)

<b>UT1 Channel Evidence</b>	<b>Year 1 (2015)</b>
Max consecutive days channel flow	
Presence of litter and debris (wracking)	Yes
Leaf litter disturbed or washed away	Yes
Matted, bent, or absence of vegetation (herbaceous or otherwise)	Yes
Sediment deposition and/or scour indicating sediment transport	Yes
Water staining due to continual presence of water	Yes
Formation of channel bed and banks	Yes
Sediment sorting within the primary path of flow	Yes
Sediment shelving or a natural line impressed on the banks	Yes
Change in plant community (absence or destruction of terrestrial vegetation and/or transition to species adapted for flow or inundation for a long duration, including hydrophytes)	Yes
Development of channel pattern (meander bends and/or channel braiding) at natural topographic breaks, woody debris piles, or plant root systems	Yes
Exposure of woody plant roots within the primary path of flow	No
Other:

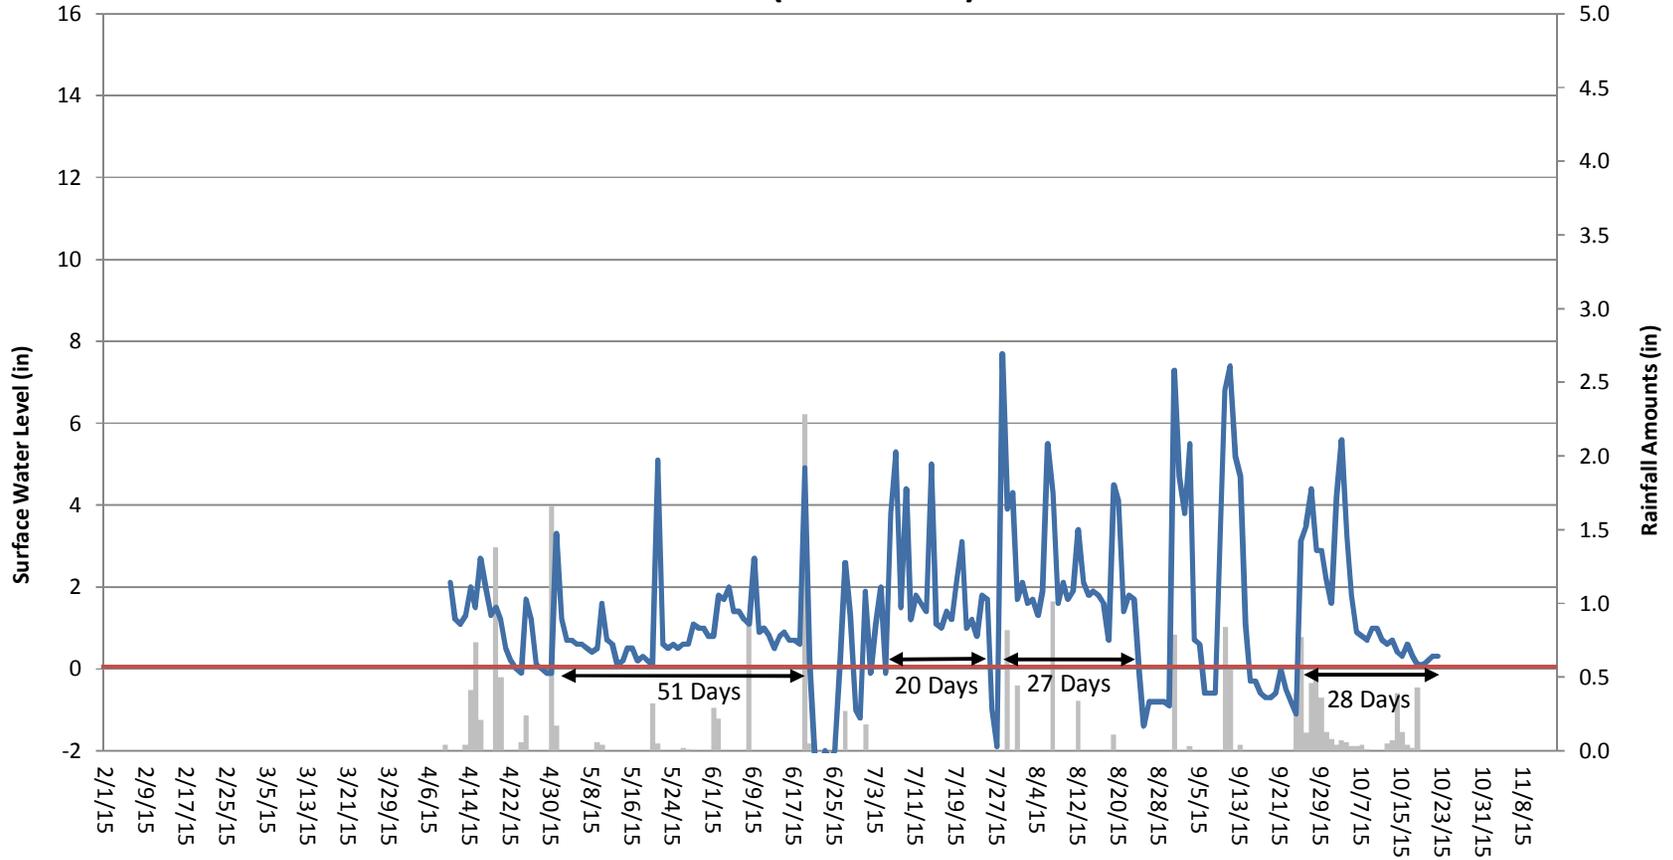
# Lamm Surface Gauge UT-3 Upstream Year 1 (2015 Data)

<b>UT3 Channel Evidence</b>	<b>Year 1 (2015)</b>
Max consecutive days channel flow	
Presence of litter and debris (wracking)	Yes
Leaf litter disturbed or washed away	Yes
Matted, bent, or absence of vegetation (herbaceous or otherwise)	Yes
Sediment deposition and/or scour indicating sediment transport	Yes
Water staining due to continual presence of water	Yes
Formation of channel bed and banks	Yes
Sediment sorting within the primary path of flow	Yes
Sediment shelving or a natural line impressed on the banks	Yes
Change in plant community (absence or destruction of terrestrial vegetation and/or transition to species adapted for flow or inundation for a long duration, including hydrophytes)	Yes
Development of channel pattern (meander bends and/or channel braiding) at natural topographic breaks, woody debris piles, or plant root systems	Yes
Exposure of woody plant roots within the primary path of flow	No
Other:

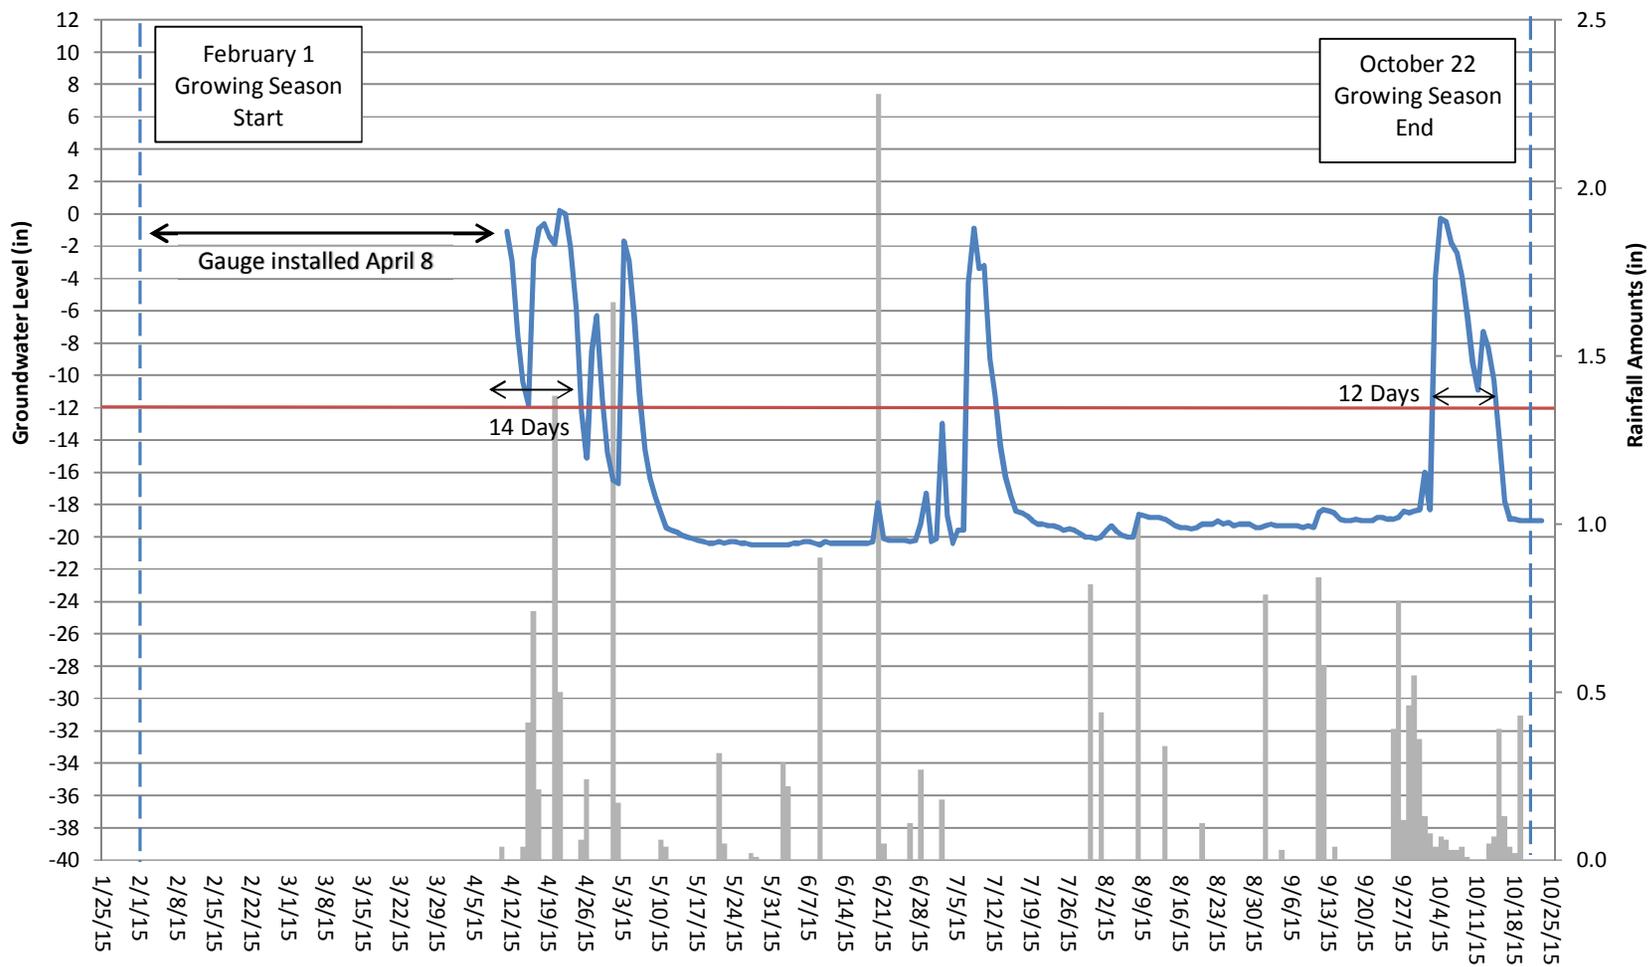
# Lamm Groundwater Gauge 3 Year 1 (2015 Data)

Gauge	Success Criteria Achieved/Max Consecutive Days During Growing Season (Percentage)						
	Year 1 (2015) February 1 Growing Season Start	Year 2 (2016)	Year 3 (2017)	Year 4 (2018)	Year 5 (2019)	Year 6 (2020)	Year 7 (2021)
1	No*/10 days (3.8 percent)						
2	Yes/35 days (13.3 percent)						
3	No*/14 days (5.3 percent)						
4	No*/14 days (5.3 percent)						
5	Yes/32 days (12.1 percent)						
6	No*/9 days (3.4 percent)
