FINAL
YEAR 1 (2014) ANNUAL MONITORING REPORT
BEAR CREEK (PHILLIPS SITE) RESTORATION PROJECT

Chatham County, North Carolina
EEP Project No. 26 (Contract No. 5715)
DWR Project No. 0713-94
SCO No. 09-07726-01A

Data Collection – May-October 2014

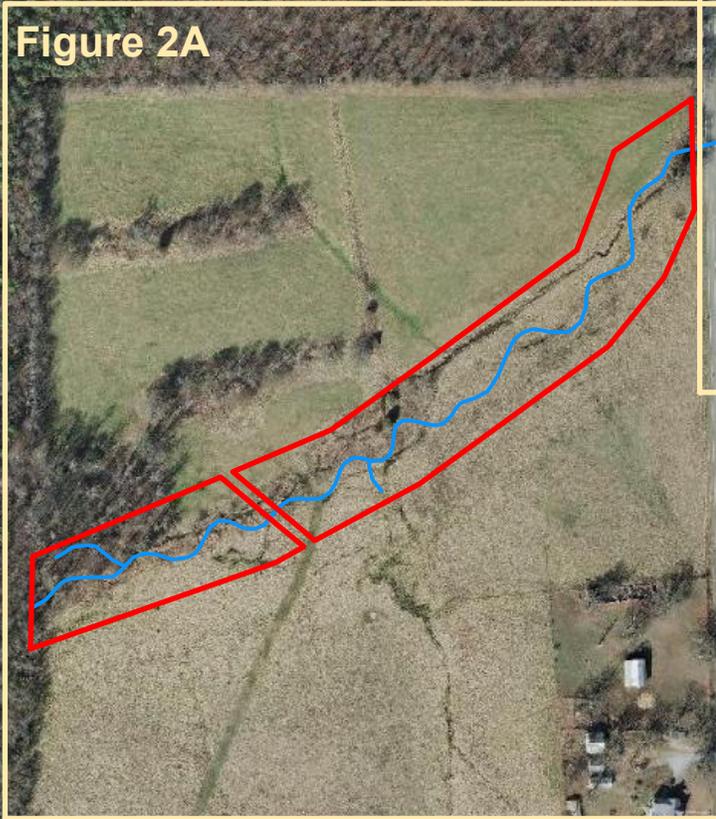
Figure 2A

During monitoring year 1 (2014), two stream areas of concern were observed. An outer bend on the Unnamed Tributary to Bear Creek has been severely scoured (Area of Concern #1). The bank appears unstable and is void of all vegetation. One additional area of concern is the upstream culverted crossing on Bear Creek (Area of Concern #2). Rain events since construction have caused a significant amount of debris to block the culverts. Efforts to remove debris manually have been unsuccessful. During storm events the stream is bypassing the culvert and scouring the crossing. These areas of concern are depicted on Figures 2A-2B in Appendix B.

monitored include species composition and species density. Visual observations of the percent cover of shrub and herbaceous species will also be documented by photograph. Vegetation plot information can be found in Appendix C. MY1 (2014) stem count measurements indicate an average of 314 planted stems per acre (excluding livestakes) across the Site, which is slightly below success criteria for monitoring year 1 (2014). Additionally, six of the twelve vegetation monitoring plots met success criteria. The lack of vegetation survival can be attributed to poor soils in the graded floodplain throughout the site. Also, just after construction was complete, several large rain events caused flooding that scoured the floodplain, leaving it bare. Vegetation is slowly establishing, but there are still many bare areas. These scoured areas have been depicted on Figures 2A-2B in Appendix B.
