**FINAL**  
**YEAR 4 (2017) ANNUAL MONITORING REPORT**  
**BEAR CREEK (PHILLIPS SITE) RESTORATION PROJECT**

Chatham County, North Carolina  
DMS Project No. 26 (Contract No. 5715)  
DWR Project No. 0713-94  
SCO No. 09-07726-01A

**Data Collection – January-August 2017**

RE: Bear Creek (Phillips) Monitoring (DMS Project # 26, Contract #5715)  
Final MY4 (2017) Annual Monitoring Report

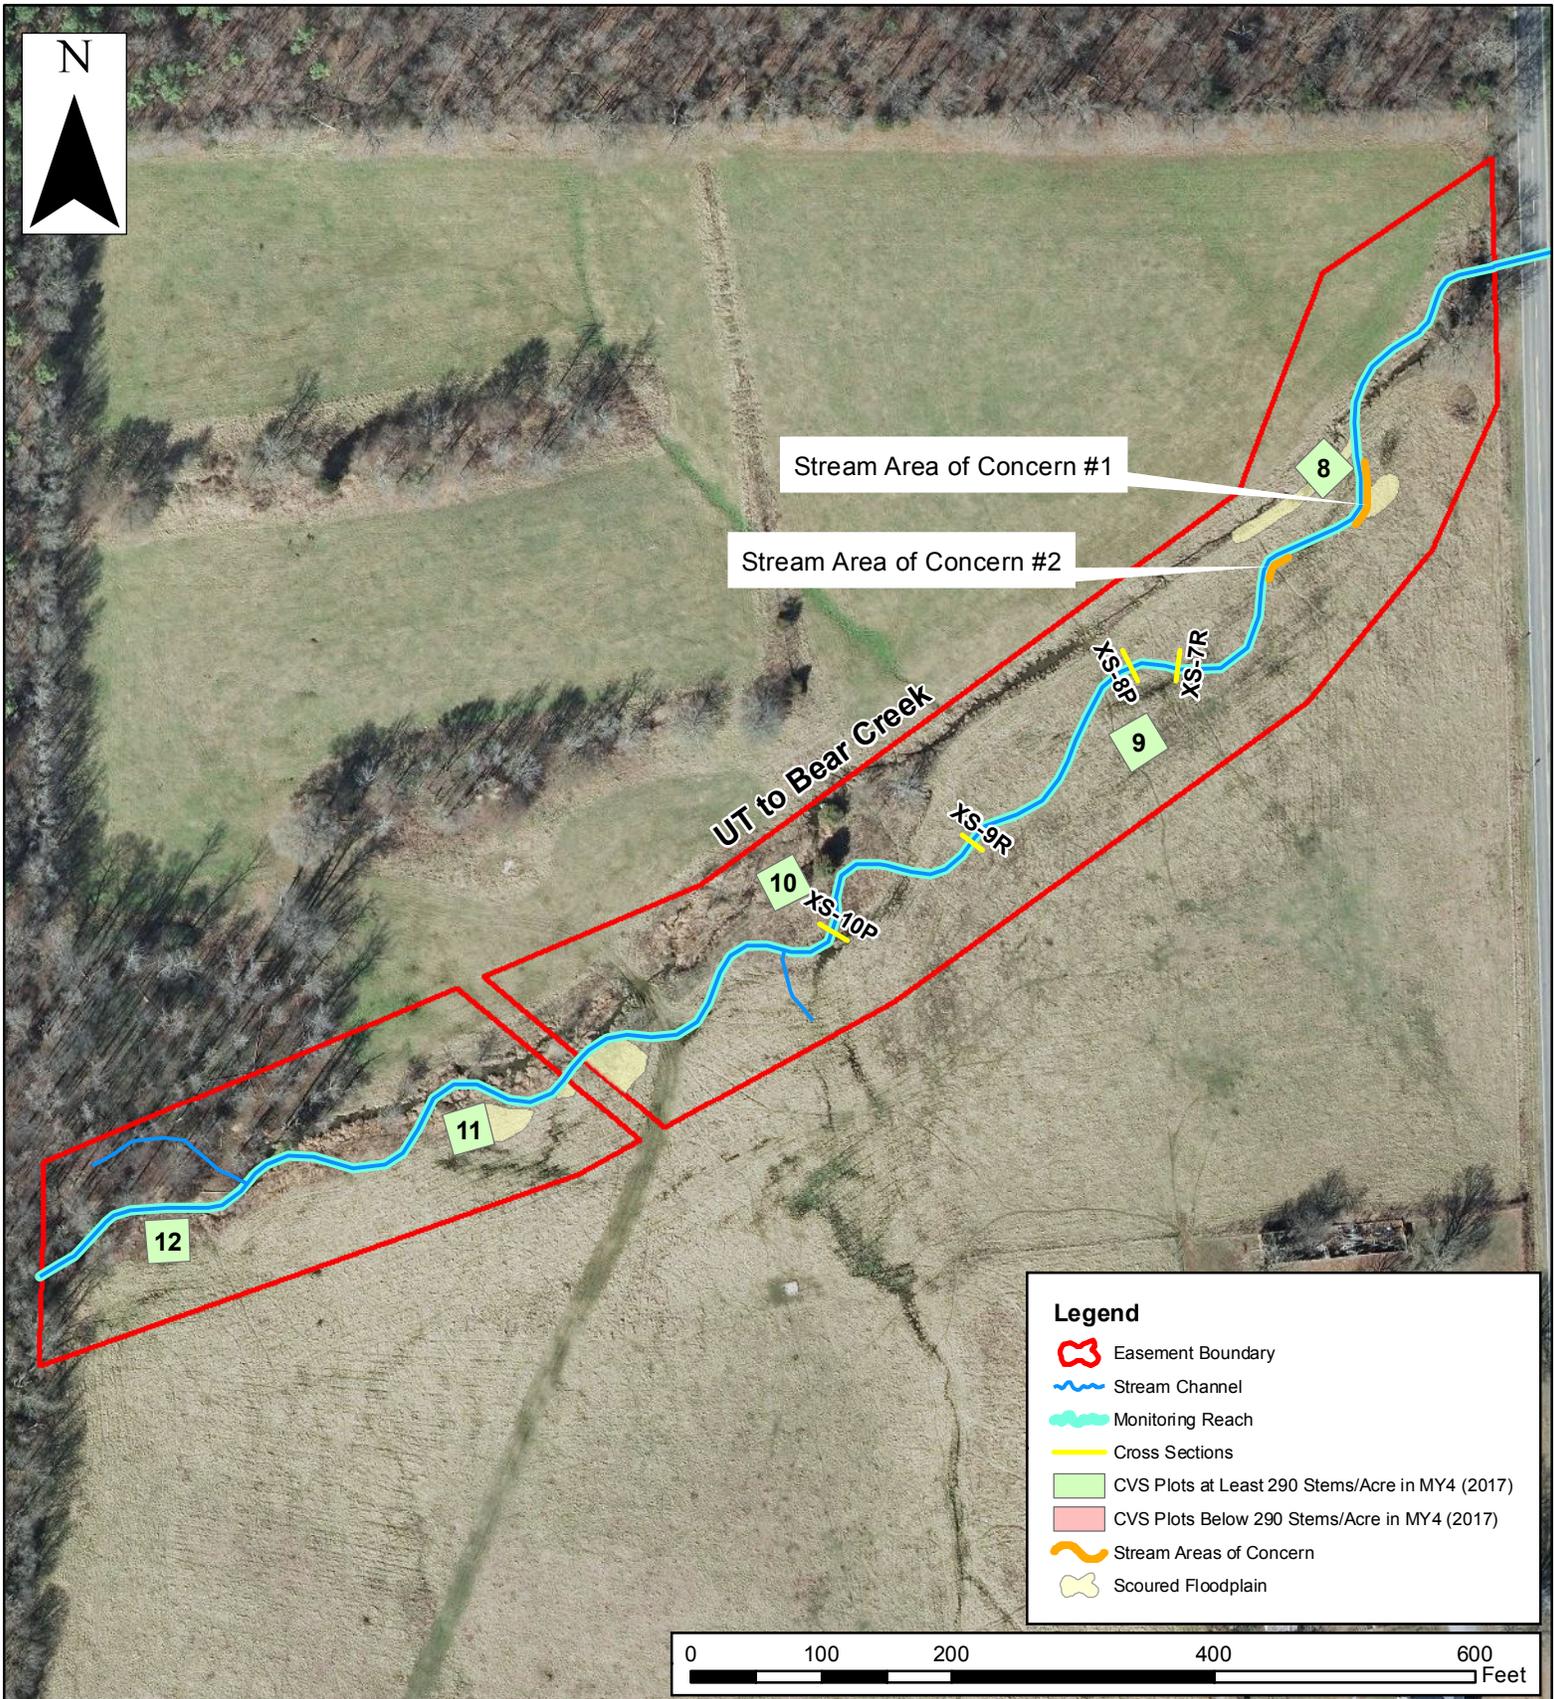
2

Two stream areas of concern were observed during monitoring year 4 (2017). Area of Concern #1 was observed during the previous three monitoring years, and it remains concerning during monitoring year 4 (2017). The right bank of the Unnamed Tributary to Bear Creek has failed causing the water to leave the stream channel and scour a new, smaller channel during heavy flow events. The bank and new channel appear unstable and are void of vegetation. Area of Concern #2 consists of bank scour in the inner bend of a pool caused by instream vegetation that has changed the flow path causing it to undercut the stream bank. These areas of concern are depicted on Figure 2A in Appendix B and will be closely monitored throughout the remainder of the monitoring period.

Shortly after construction was complete, several large rain events caused flooding that scoured the floodplain, leaving it bare. Vegetation has established throughout much of the floodplain, but there are still some bare areas. These scoured areas have been depicted on Figures 2A-2B in Appendix B.

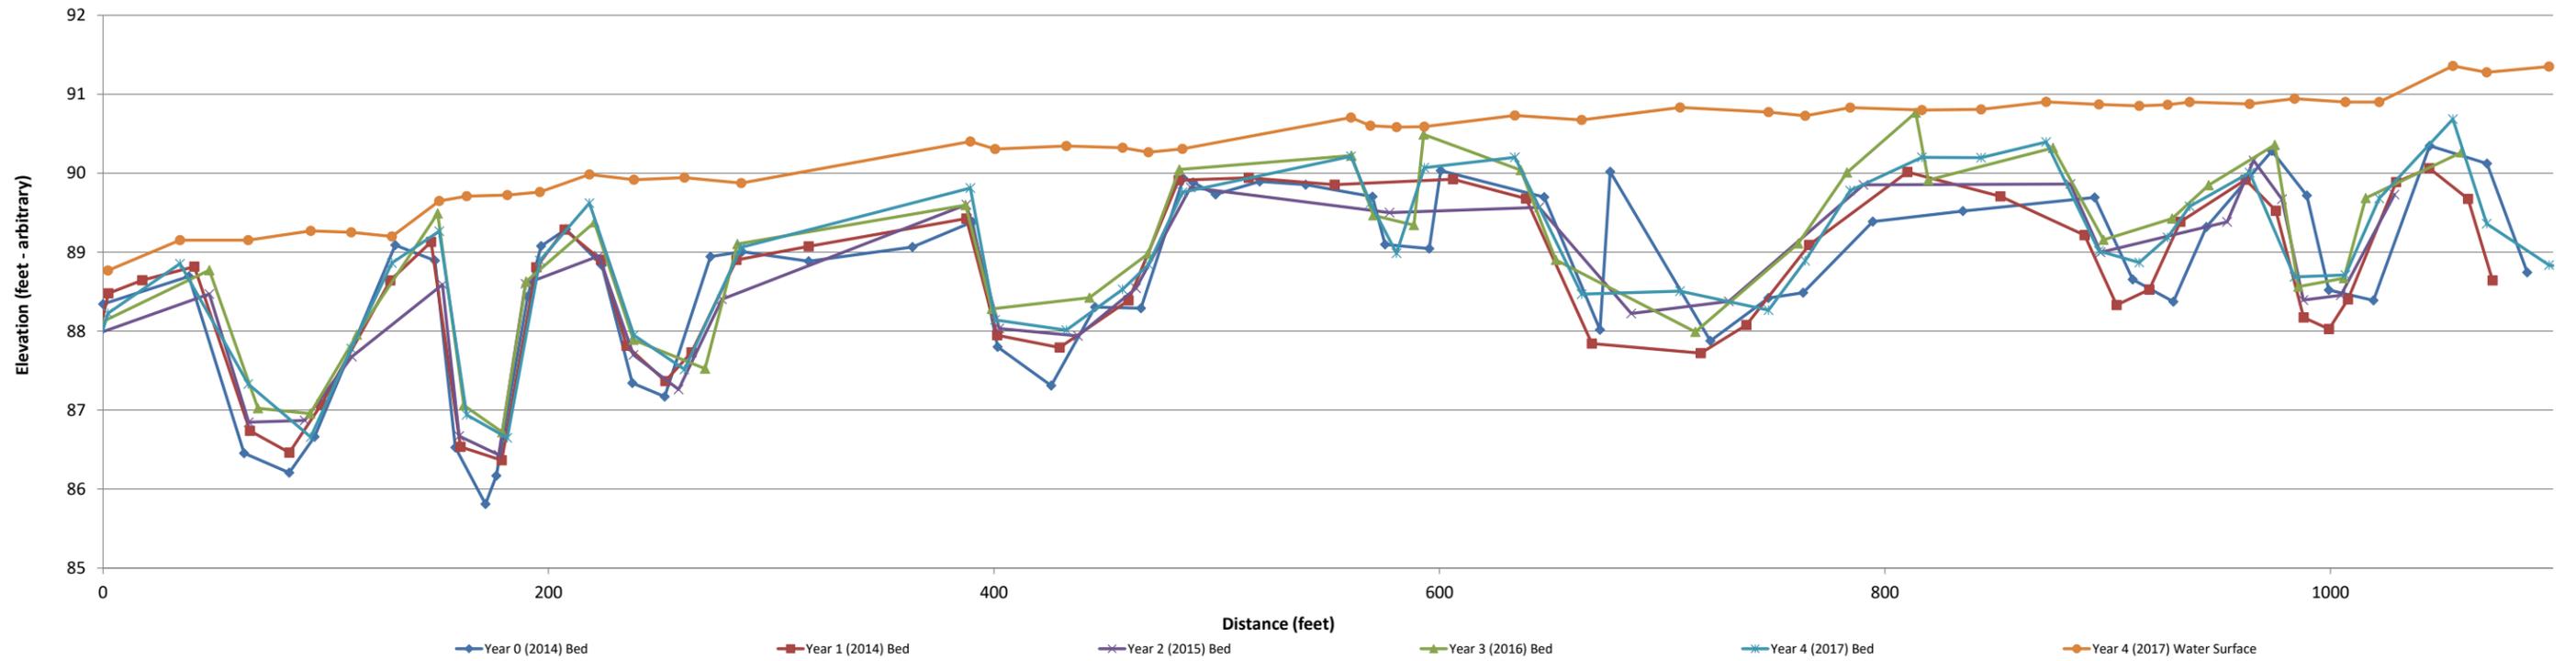
Bear Creek Year 3 (2016) Profile - Reach 2 (Downstream), Station 00+00 to 10+00

<b>Avg. Water Surface Slope</b>	2014	2014	2015	2016	2017
	0.0019	0.0020	0.0017	0.0023	0.0022
<b>Riffle Length</b>	45	60	52	44	39
<b>Avg. Riffle Slope</b>	0.0052	0.0048	0.0043	0.0058	0.0057
<b>Pool Length</b>	33	32	33	35	39
<b>Pool to Pool Spacing</b>	107	122	123	107	110

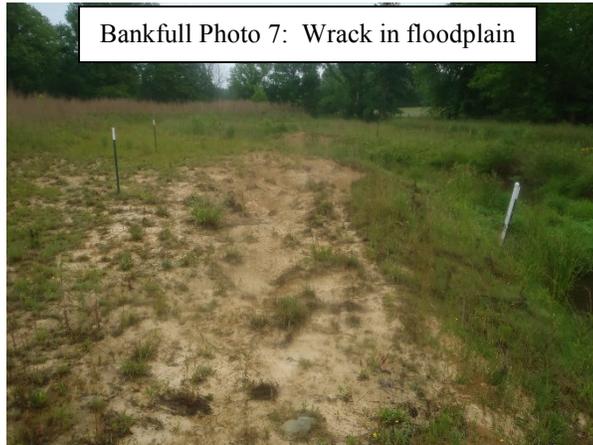
Bankfull Photo 7: Wrack in floodplain
