**Bold Run
Stream/Buffer Restoration
Monitoring Report
EEP Project # 439
Monitoring Year - 01**

January 2008

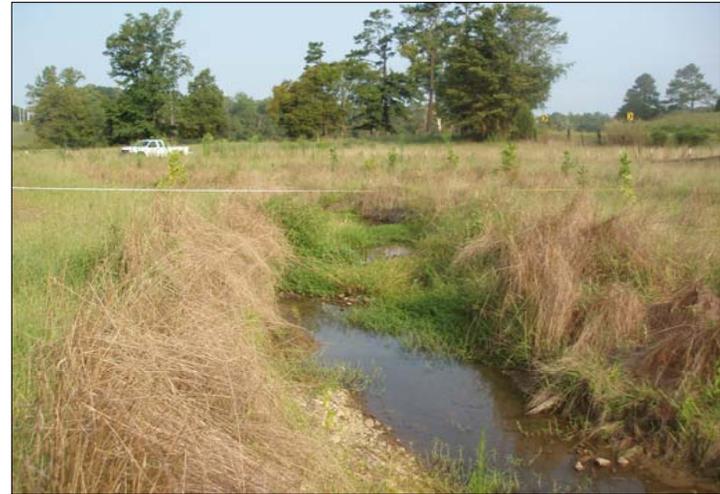
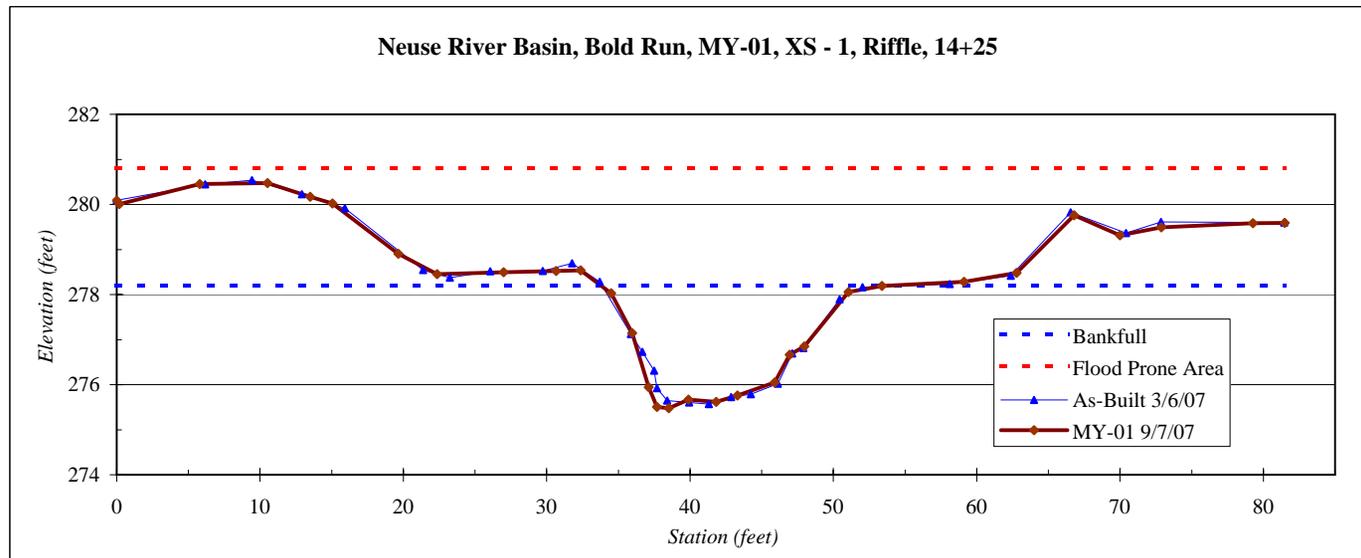
River Basin:	Neuse
Watershed:	Bold Run, MY-01
XS ID	XS - 1, Riffle, 14+25
Drainage Area (sq mi):	1.6
Date:	9/7/2007
Field Crew:	B. Roberts, J. Costante

SUMMARY DATA	
Bankfull Elevation:	278.2
Bankfull Cross-Sectional Area:	30.6
Bankfull Width:	20.1
Flood Prone Area Elevation:	280.8
Flood Prone Width:	>80
Max Depth at Bankfull:	2.7
Mean Depth at Bankfull:	1.5
W / D Ratio:	13.2
Entrenchment Ratio:	>4.0
Bank Height Ratio:	1.0

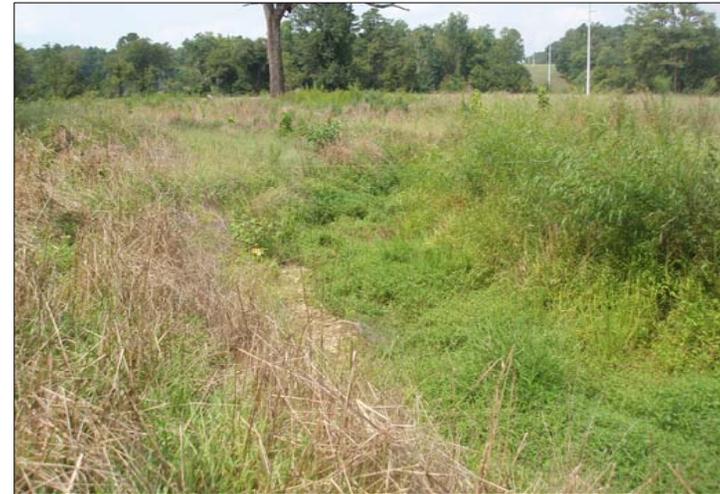
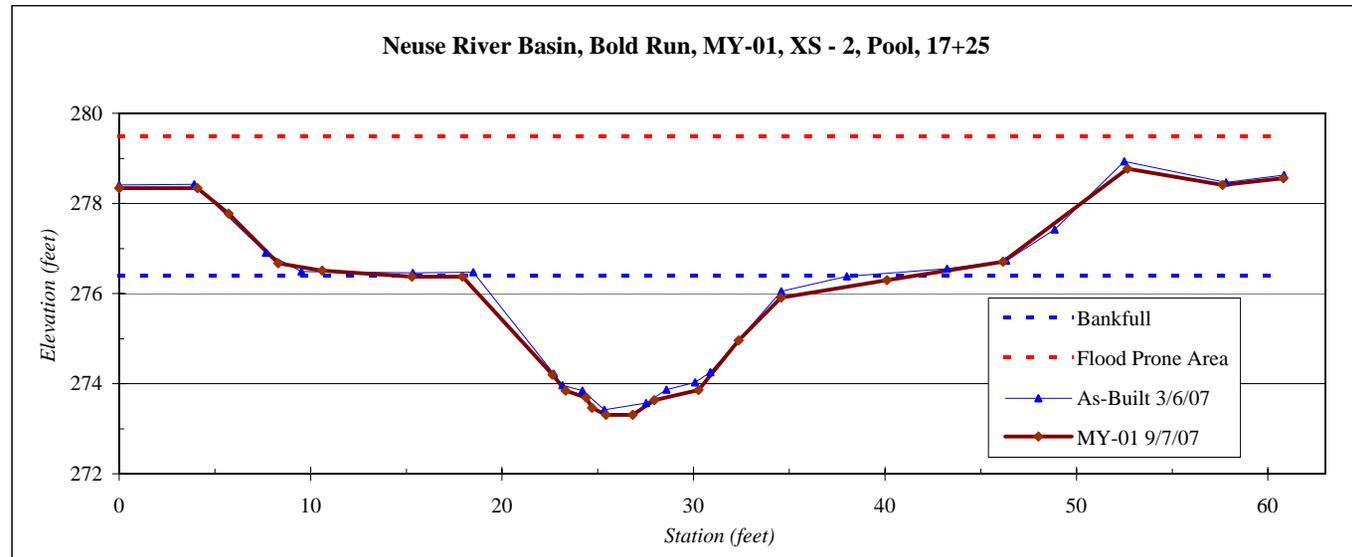
River Basin:	Neuse
Watershed:	Bold Run, MY-01
XS ID	XS - 2, Pool, 17+25
Drainage Area (sq mi):	1.6
Date:	9/7/2007
Field Crew:	B. Roberts, J. Costante

SUMMARY DATA	
Bankfull Elevation:	276.4
Bankfull Cross-Sectional Area:	29.3
Bankfull Width:	19.0
Flood Prone Area Elevation:	279.5
Flood Prone Width:	>65
Max Depth at Bankfull:	3.1
Mean Depth at Bankfull:	1.5
W / D Ratio:	12.3
Entrenchment Ratio:	>3.4
Bank Height Ratio:	0.9
