BROCK STREAM ENHANCEMENT

FINAL AS-BUILT & BASELINE MONITORING REPORT

Jones County, North Carolina SCO Project Number 050650601-A EEP Project Number 92333

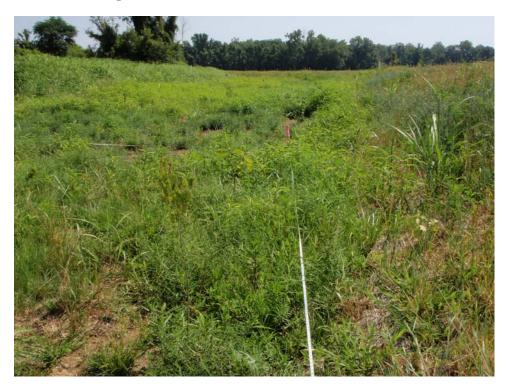
Photo C1 – (Photo Station 2) Veg Plot 1 looking downstream (7/2/2009 Year 0)

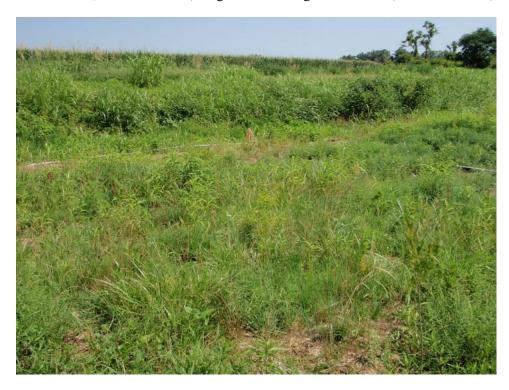
Photo C2 – (Photo Station 3) Veg Plot 1 looking north across floodplain (7/2/2009 Year 0)

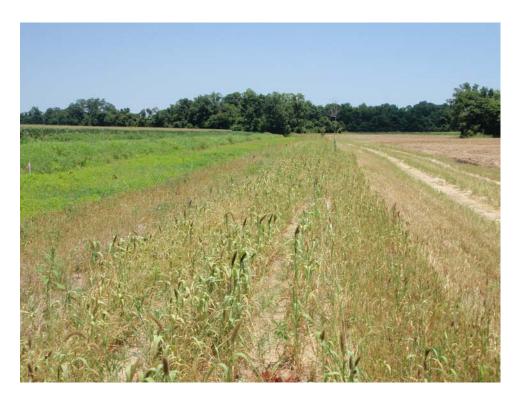
Photo C4 - (Photo Station 5) Veg Plot 2 looking downstream (crest gauge in far left of photo) (7/2/2009 Year 0)

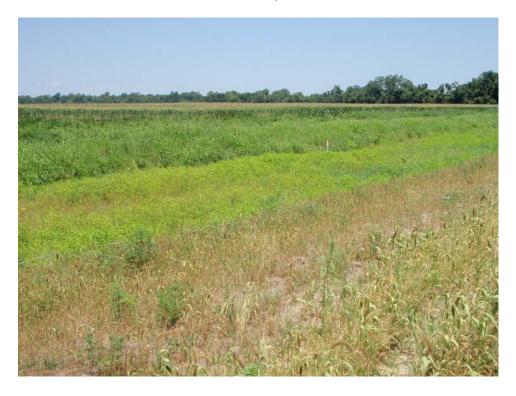
Photo C5 – (**Photo Station 6**) Veg Plot 2 looking northwest across floodplain (crest gauge in right portion of photo) (7/2/2009 Year 0)

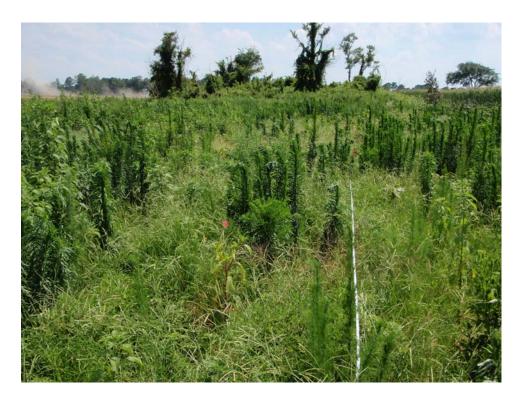
Photo C6 – (Photo Station 8) Veg Plot 3 looking upstream (toward cemetery) (7/2/2009 Year 0)

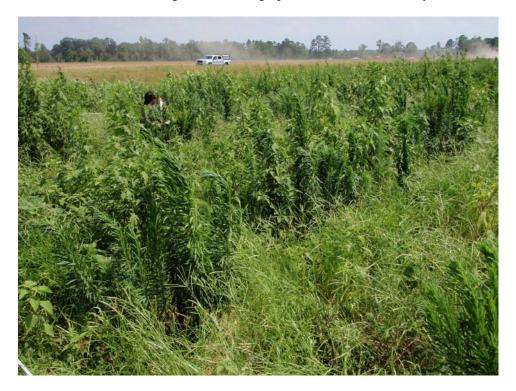
$\textbf{Photo C7} - (\textbf{Photo Station 9}) \ \text{Veg Plot 3 looking southeast across floodplain } (7/2/2009 \ \text{Year 0})$

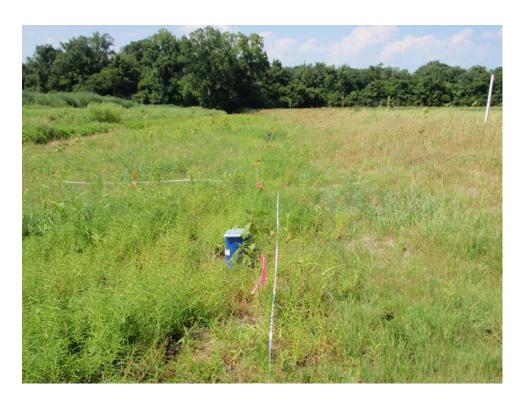
Photo C8 – (Photo Station 11) Veg Plot 4 looking downstream (7/2/2009 Year 0)

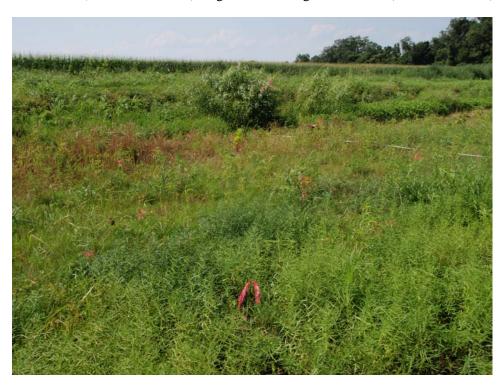
$\textbf{Photo C9} - (\textbf{Photo Station 12}) \ \text{Veg Plot 4 looking north across floodplain } (7/2/2009 \ \text{Year 0})$

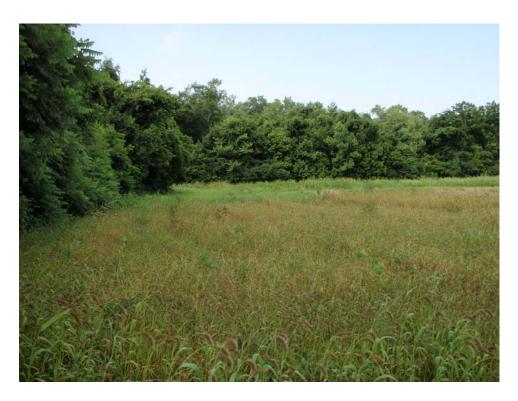
Photo C10 – (**Photo Station 14**) Upland Buffer planting zone looking toward Big Chinquapin Branch from lower end of stream enhancement reach (7/2/2009 Year 0)

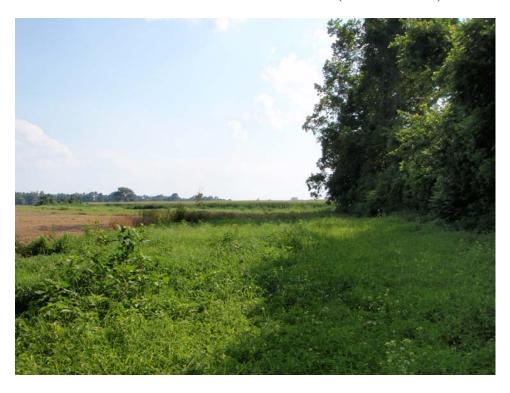
Photo C11 – (**Photo Station 15**) Upland buffer planting zone along UT near Big Chinquapin Branch, looking southwest (7/2/2009 Year 0)

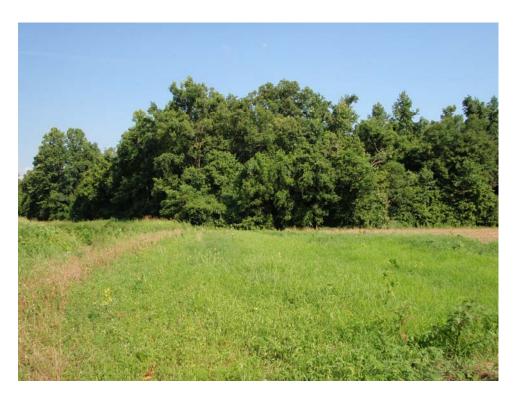
$\textbf{Photo C12} - \textbf{(Photo Station 16)} \ Upland \ Buffer \ planting \ zone \ along \ Big \ Chinquapin \ Branch, \ looking \ southeast \ (7/2/2009 \ Year \ 0)$
