# Brown Creek Tributaries Restoration Project Final Year 5 Monitoring Report

Anson County, North Carolina

DMS Project ID No. 95351, DEQ Contract No. 004641

Report Prepared and Submitted by Michael Baker Engineering, Inc.

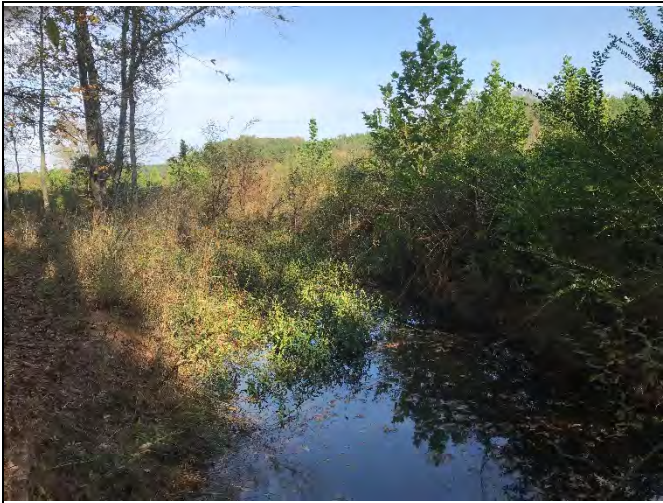
PP-1: HC Reach 1, view downstream at Station 10+00

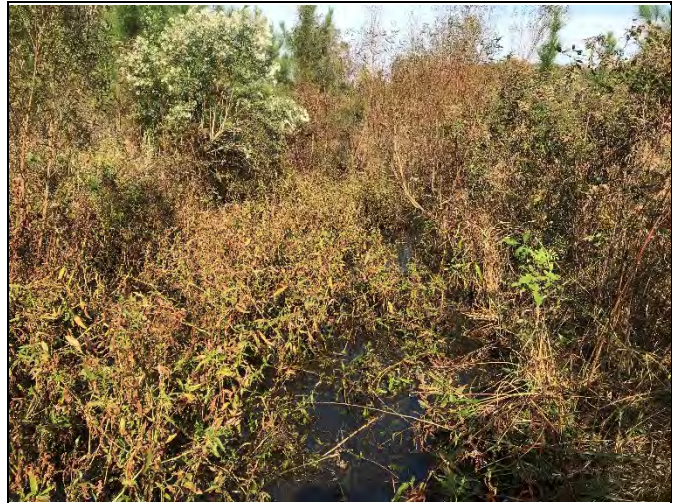
PP-2: HC Reach 1, view downstream at Station 11+80

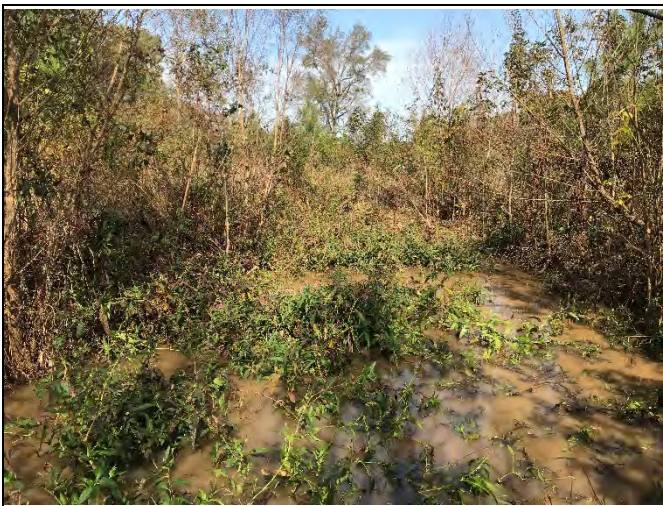
PP-3: HC Reach 1, view downstream at Station 14+50

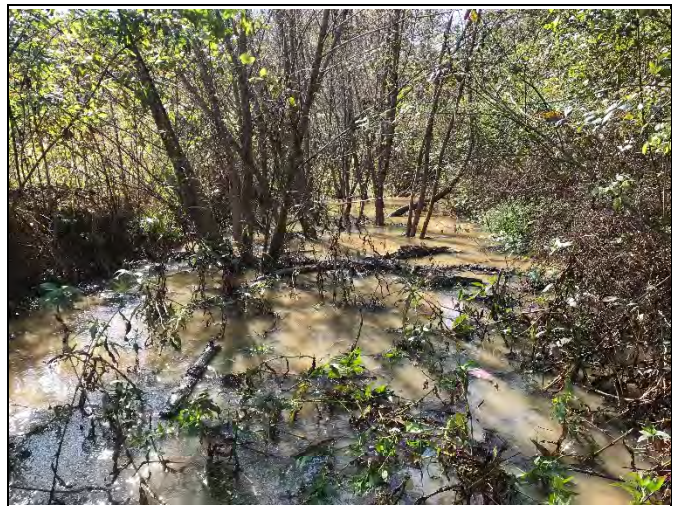
PP-4: HC Reach 1, view upstream at Station 17+50

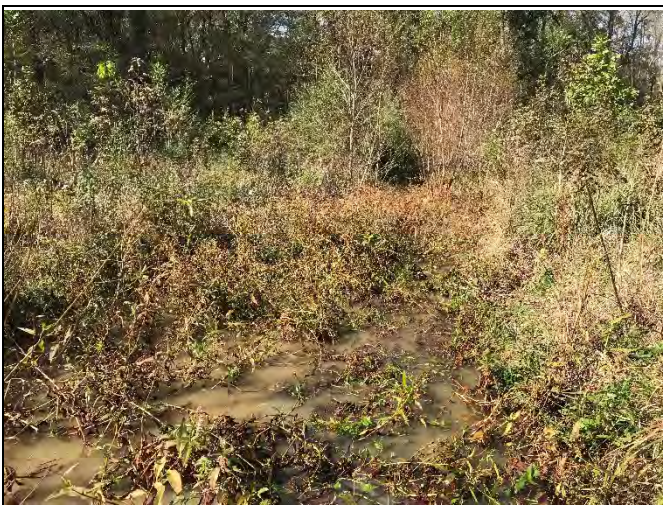
PP-5: HC Reach 1, view downstream at Station 18+00

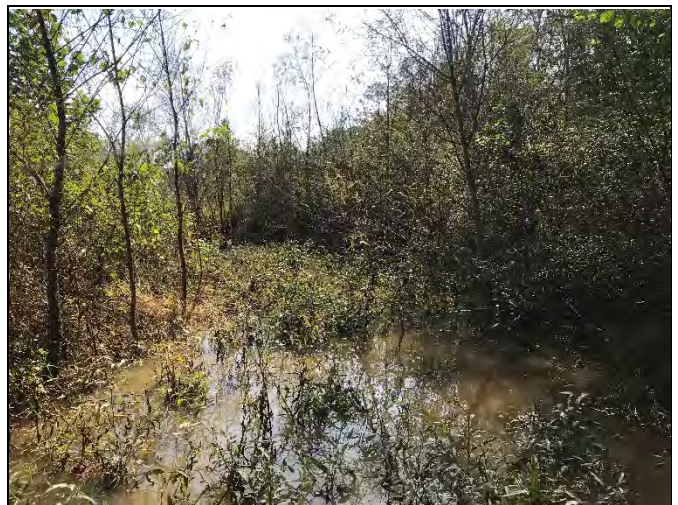
PP-6: HC Reach 1, view upstream at Station 19+50

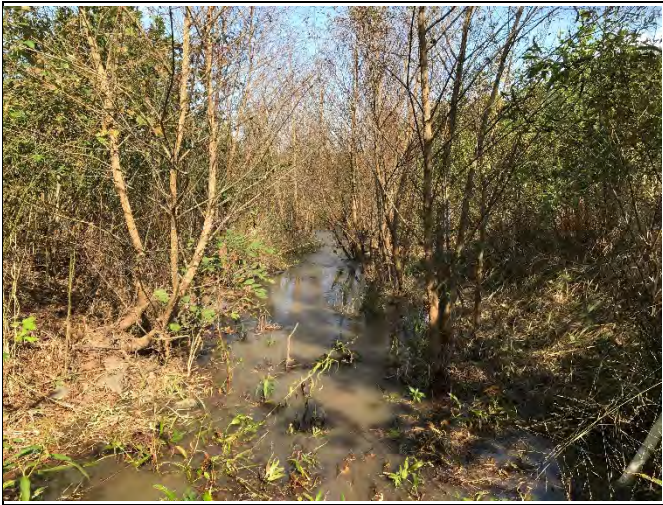
PP-7: HC Reach 1, view downstream at Station 19+75

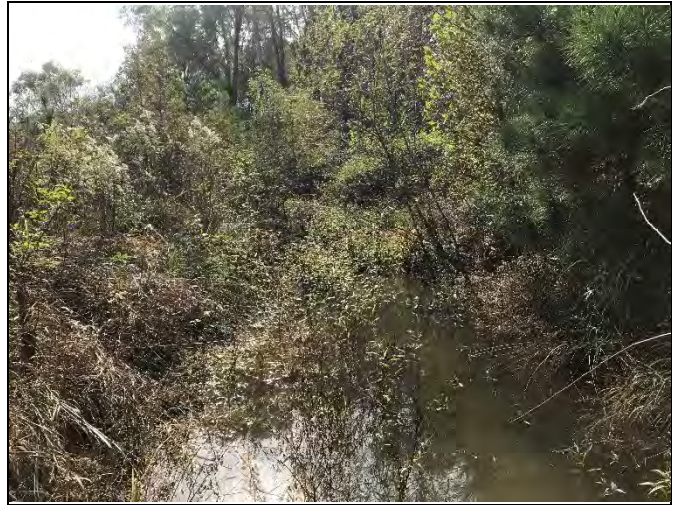
PP-8: HC Reach 1, view upstream at Station 22+40

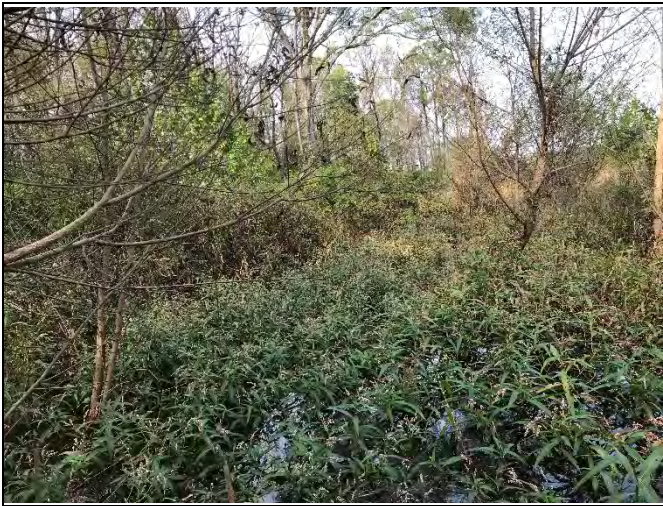
PP-9: HC Reach 1, view downstream at Station 24+00

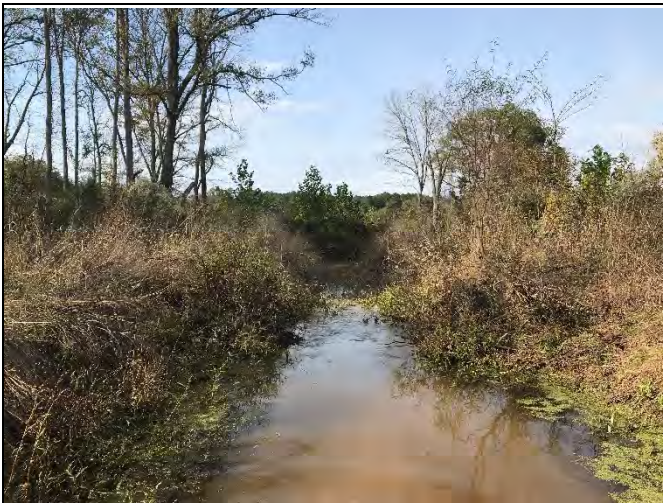
PP-11: HC Reach 1, view downstream at Station 29+30

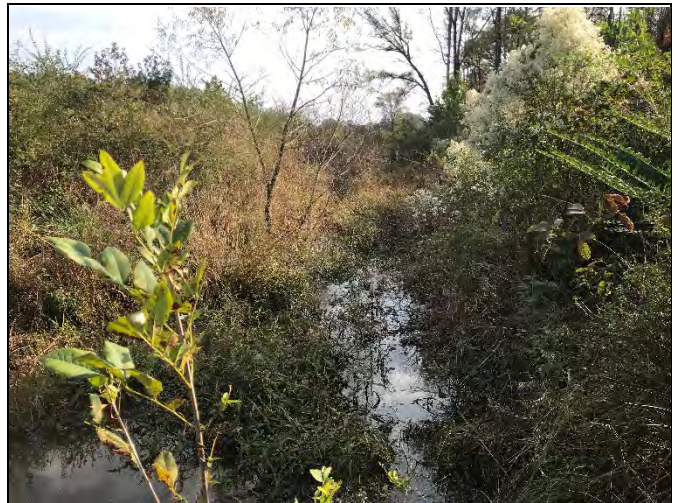
PP-12: HC Reach 2, view upstream at Station 31+40

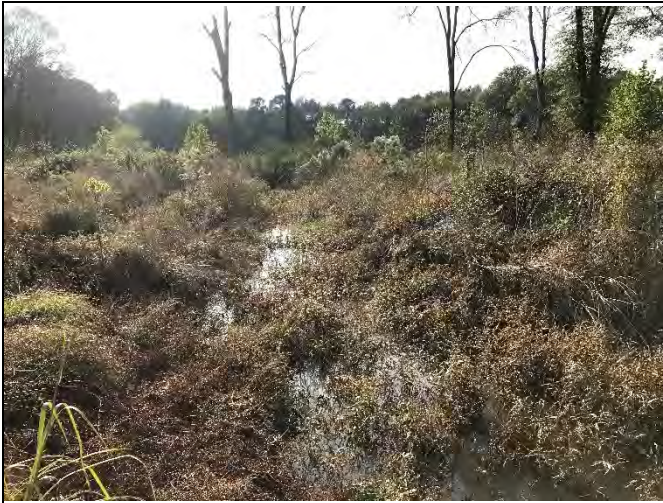
PP-13: HC Reach 2, view upstream at Station 32+75

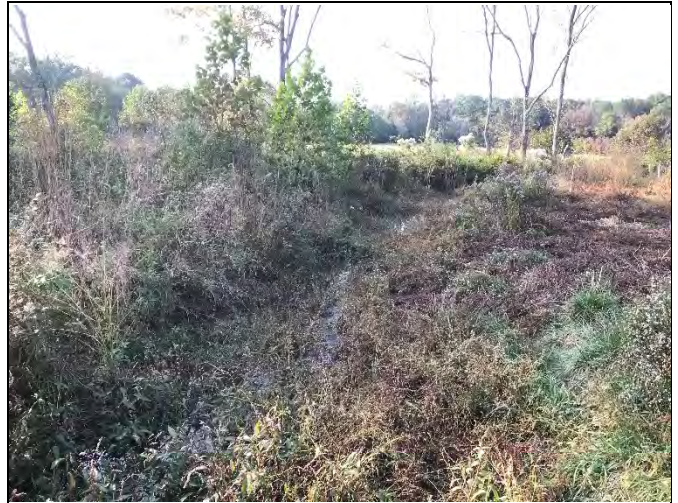
PP-14: HC Reach 2, view downstream at Station 33+00

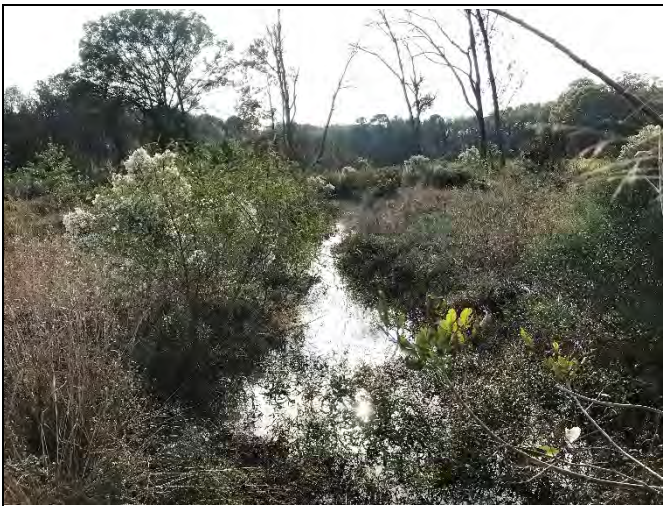
PP-15: HC Reach 2, view upstream at Station 35+70

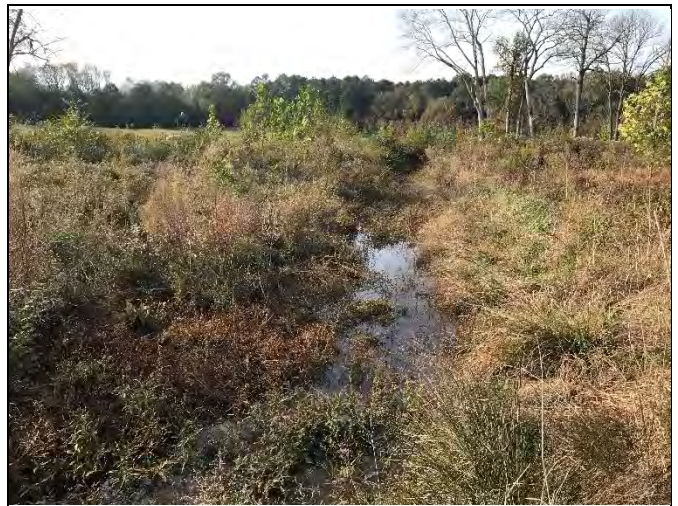
PP-16: HC Reach 2, view downstream at Station 36+00

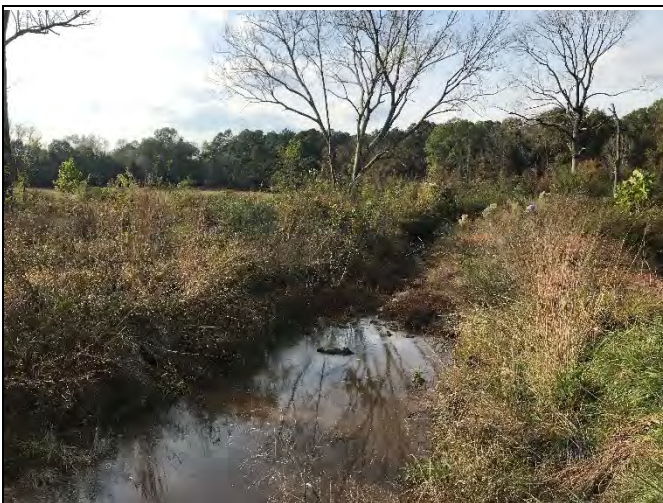
PP-17: HC Reach 2, view downstream at Station 39+10

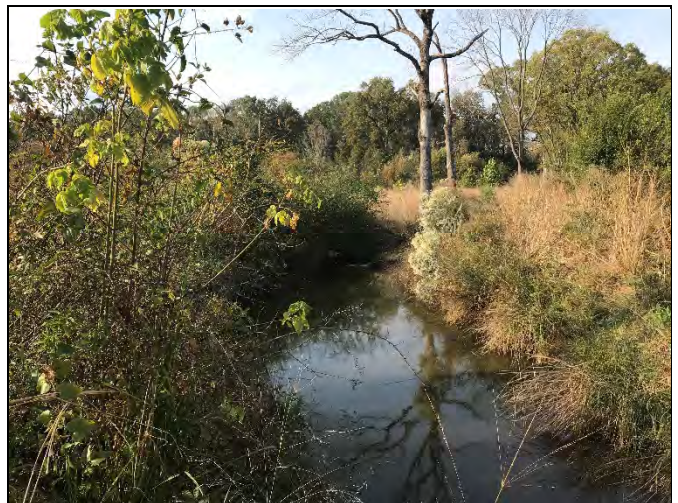
PP-18: HC Reach 2, view downstream at Station 40+75

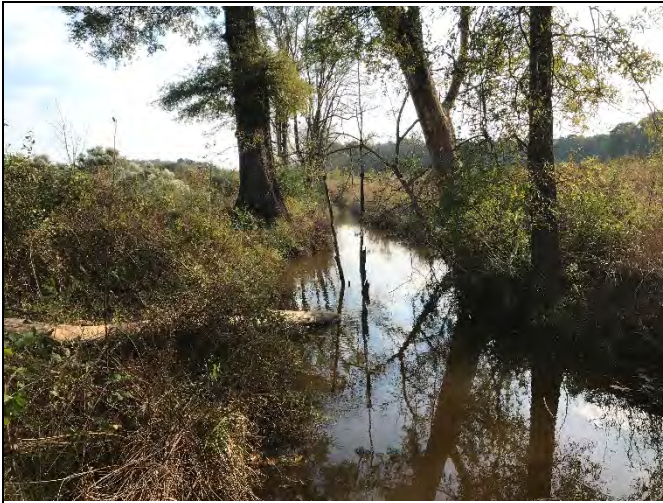
PP-19: HC Reach 2, view upstream at Station 43+75

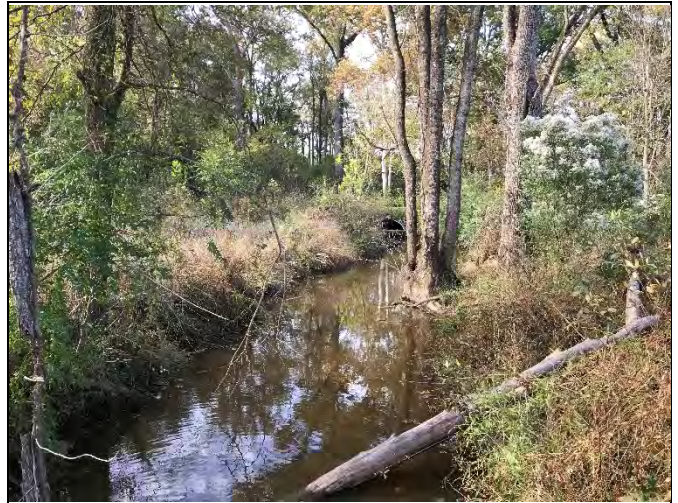
PP-20: HC Reach 2, view downstream at Station 44+25

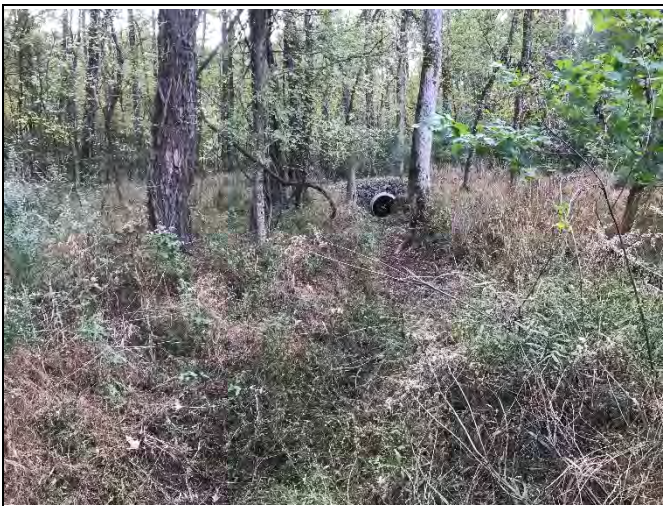
PP-21: HC Reach 3, view upstream at Station 11+40

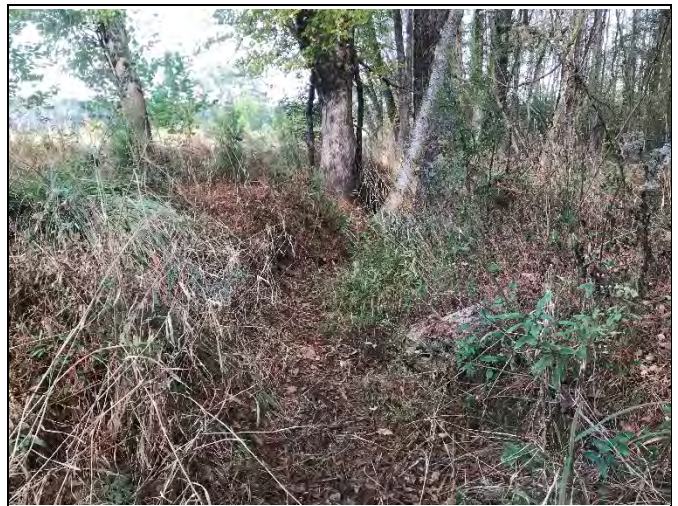
PP-22: HC Reach 3, view downstream at Station 14+00

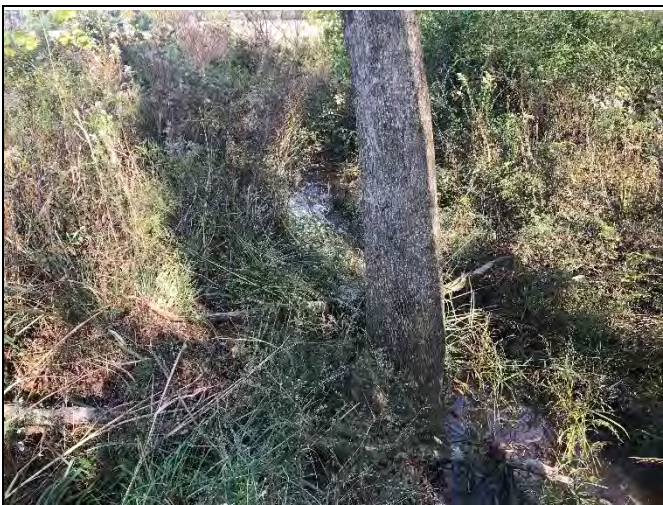
PP-23: HC Reach 3, view downstream at Station 15+50

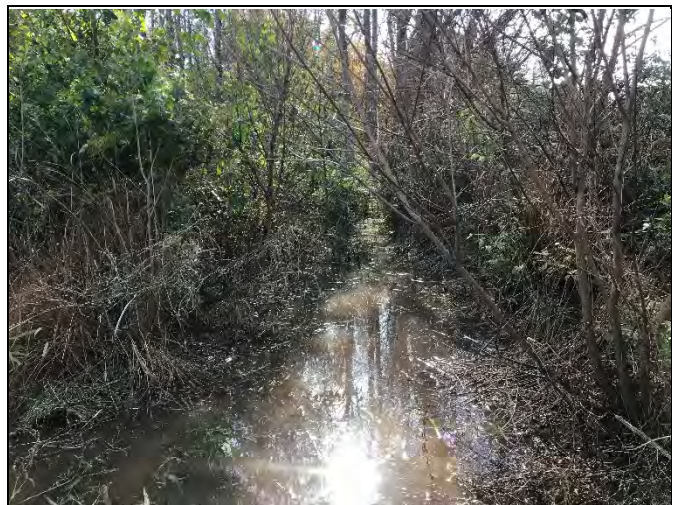
PP-24: HC Reach 3, view upstream at Station 15+90

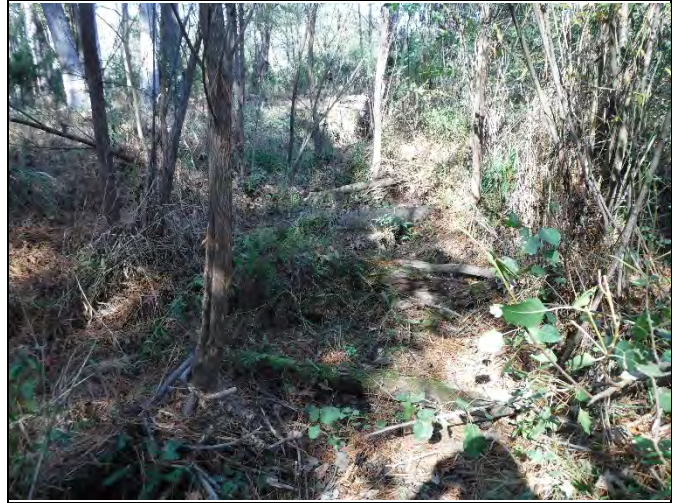
PP-2: Reach UT4-R4a – View downstream, Station 12+40

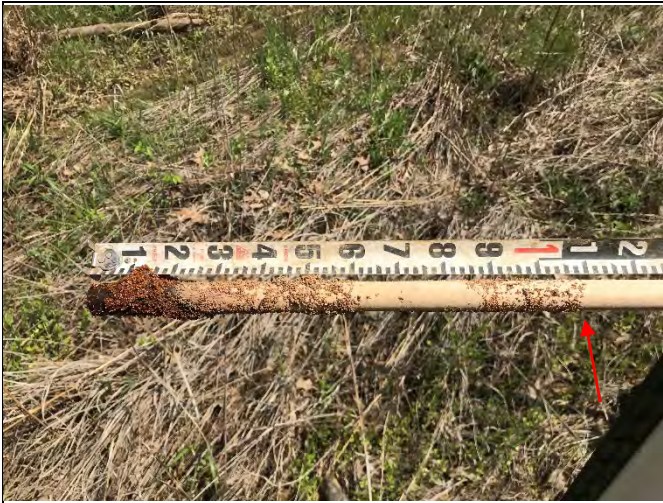
Crest Gauge Reach UT4-R2: Overbank event of 1.09'  
(photo from 4/11/19)

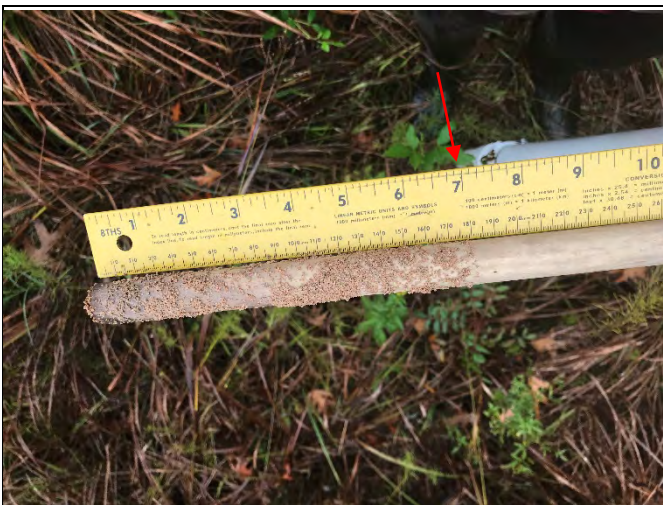
Crest Gauge Reach UT4-R2: Overbank event of 0.58'  
(photo from 10/16/19)

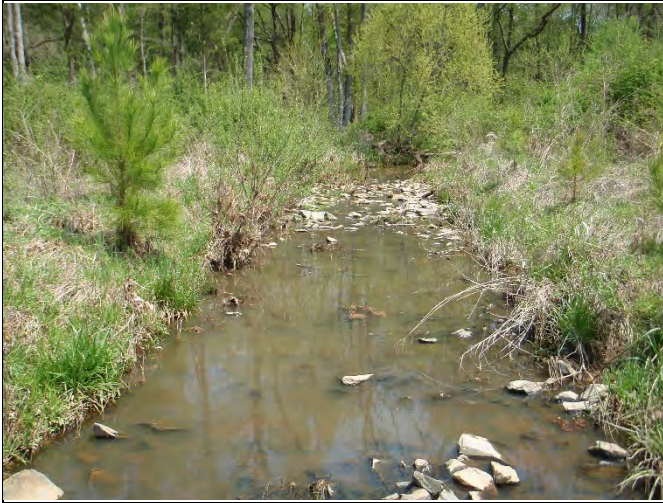
Photo showing flow on middle Reach UT4-R2  
(photo from 4/11/19)

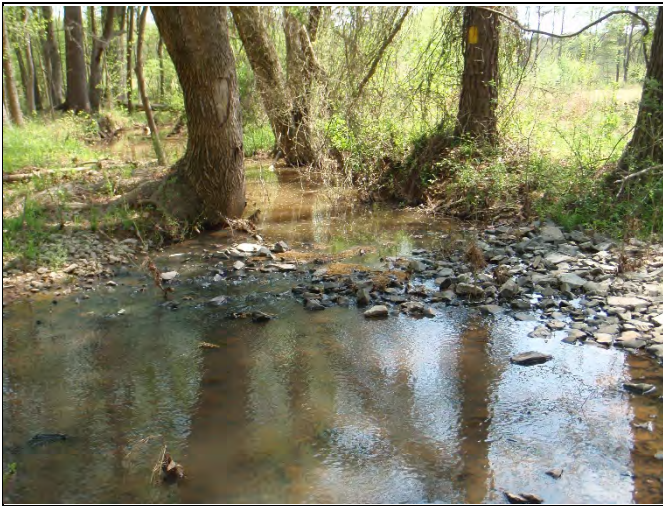
Photo showing flow at crossing on upper Reach  
UT4-R2 (photo from 4/11/19)

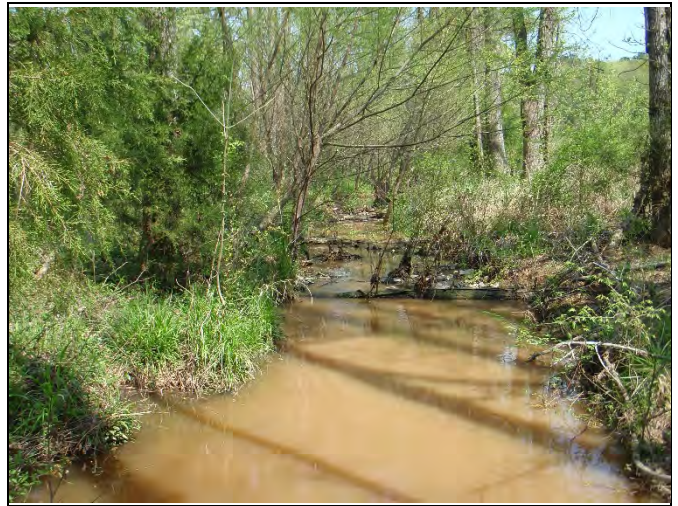
Photo showing flow on middle Reach UT4-R1B  
(photo from 4/11/19)
