# Brown Creek Tributaries Restoration Project Final Year 6 Monitoring Report

Anson County, North Carolina

DMS Project ID No. 95351

Monitoring Year: 6 of 7

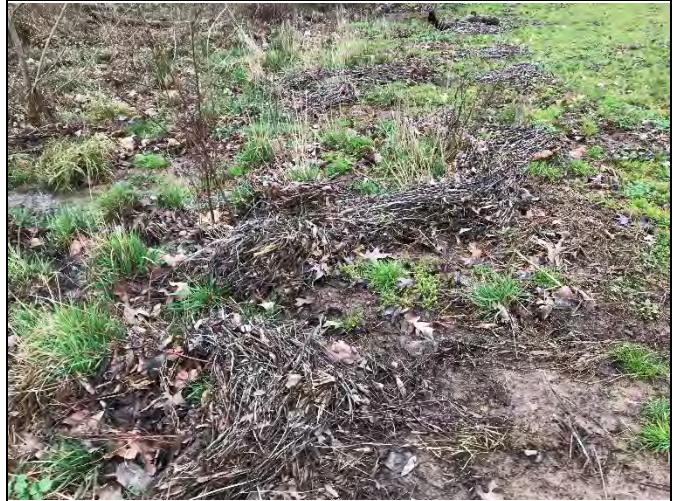
Reach UT4-R2: Evidence of overbank event  
(photo from 2/27/20)

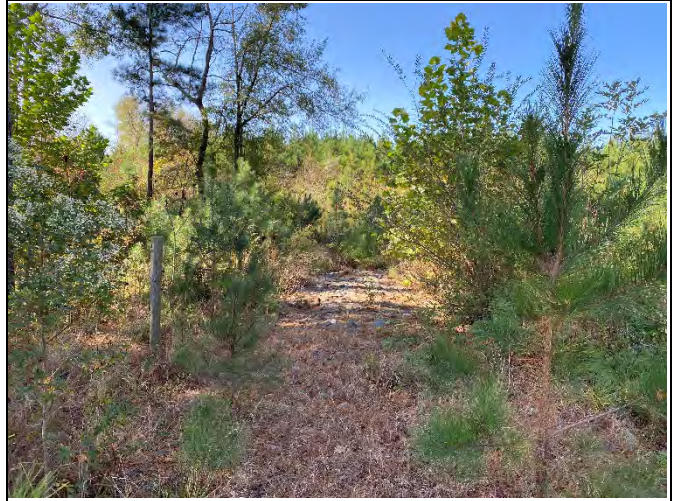
Rock ford crossing on lower UT4-R4 (crossing not used and is overgrown)

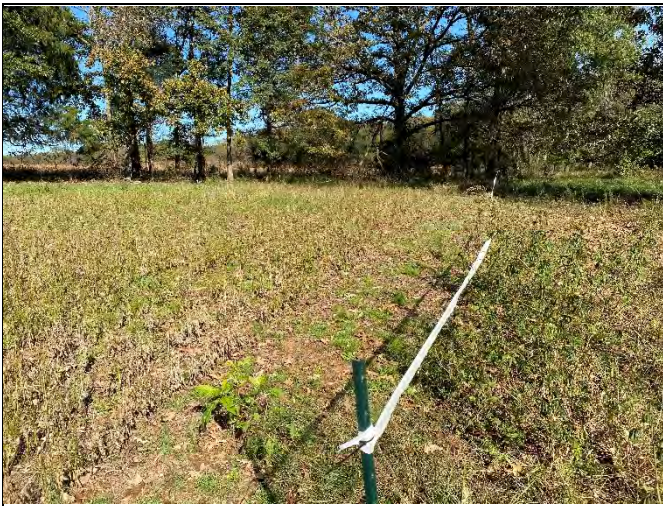
Previous easement boundary encroachment on UT4-R1b was marked and is no longer planted.

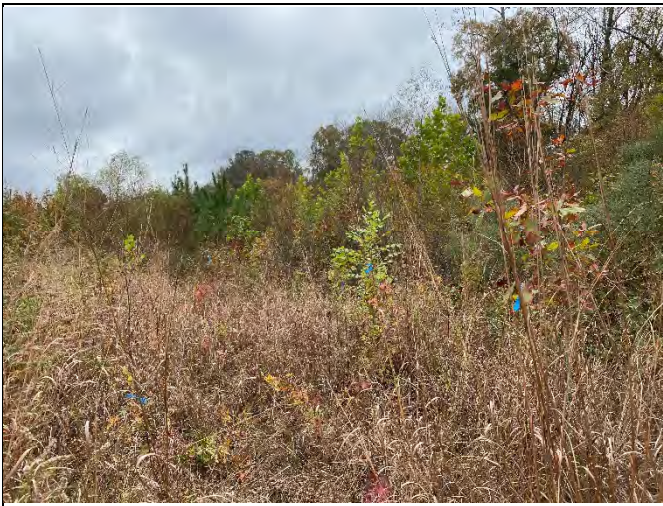
Previously identified area of short stem / low vigor trees on upper HC-R1 is still relatively short but is clearly improving (tall grass hides many stems)
