**MONITORING YEAR 0
ANNUAL REPORT
FINAL**

BUG HEADWATERS MITIGATION SITE

Wilkes County, NC
Yadkin River Basin
HUC 03040101

DMS Project No. 100084
NCDEQ Contract No. 7617
DMS RFP No. 16-007406
USACE Action ID No. 2018-01788
DWR Project No. 2018-1273
Data Collection Dates: April 2021

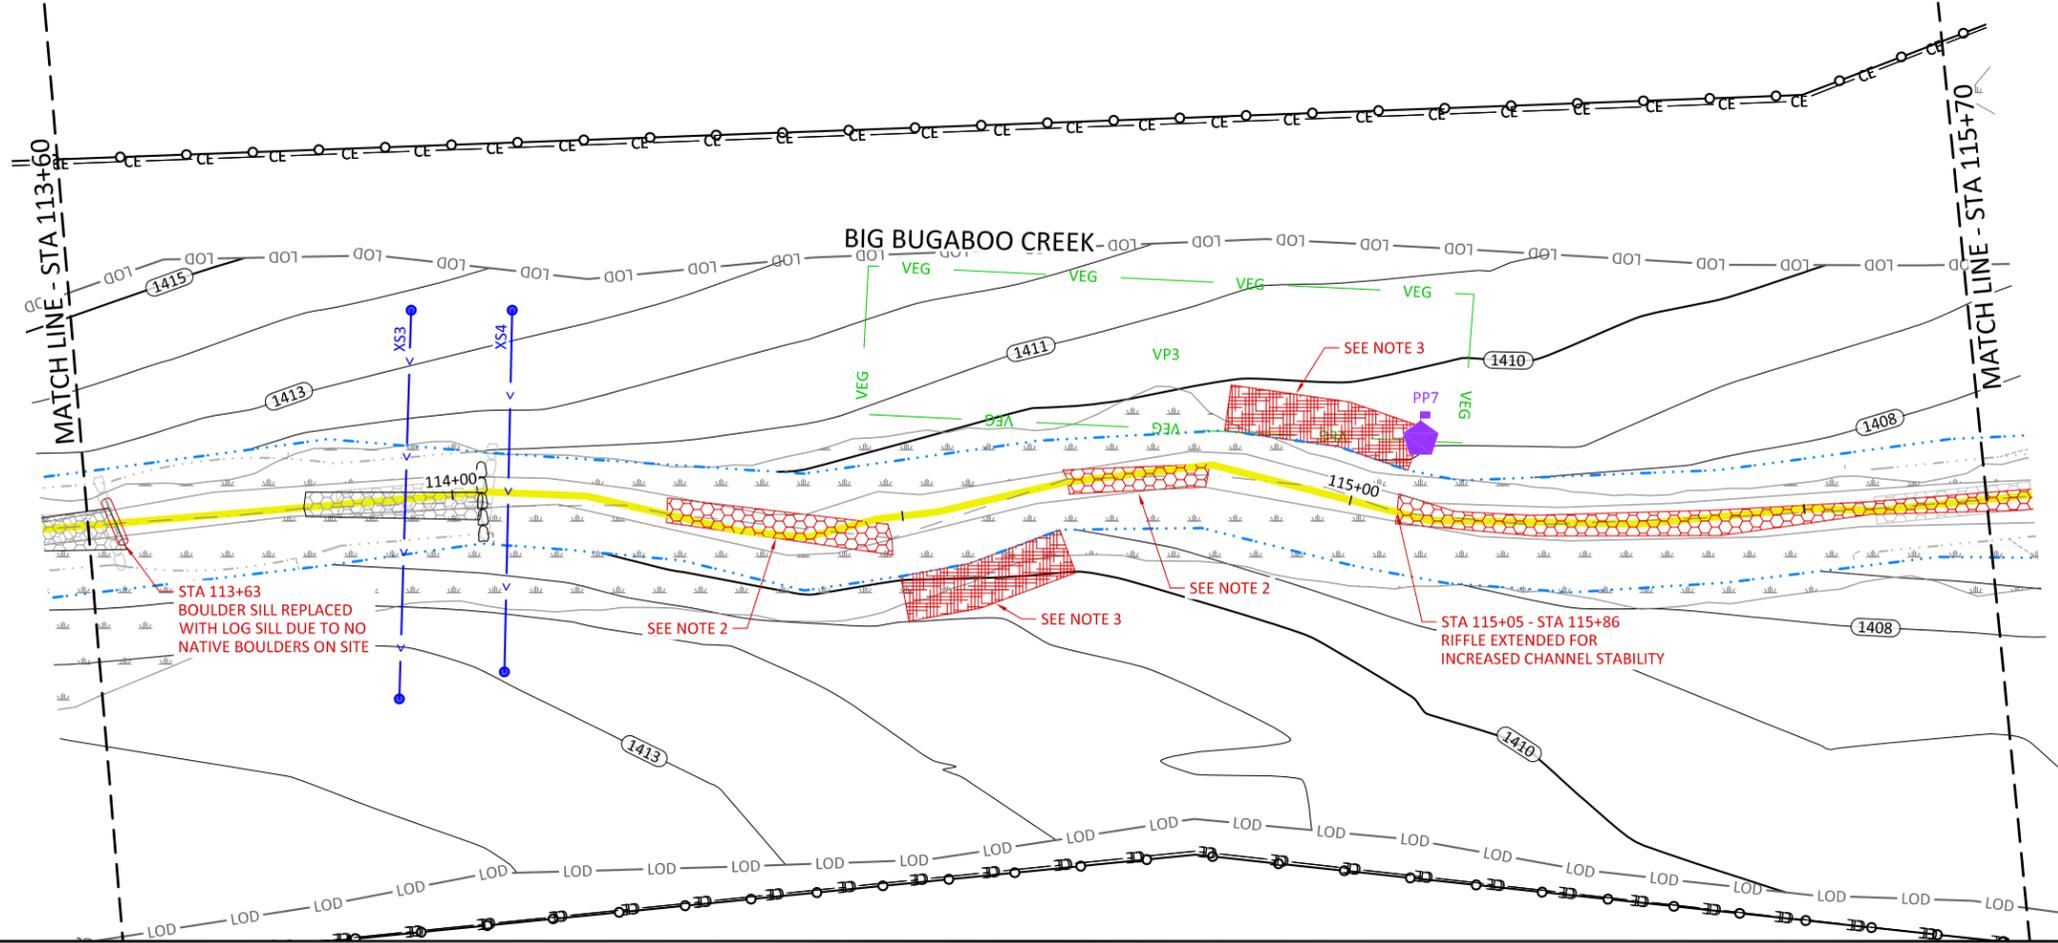
- NOTES:**
1. DEVIATIONS FROM THE DESIGN WILL BE SHOWN IN RED.
 2. STA 114+24 - STA 114+49 & STA 114+68 - STA 114+84 RIFFLE ADDED FOR INCREASED CHANNEL STABILITY
 3. STA 114+49 - STA 114+66 & STA 114+85 - STA 115+05 BRUSH TOE ADDED FOR INCREASED CHANNEL STABILITY

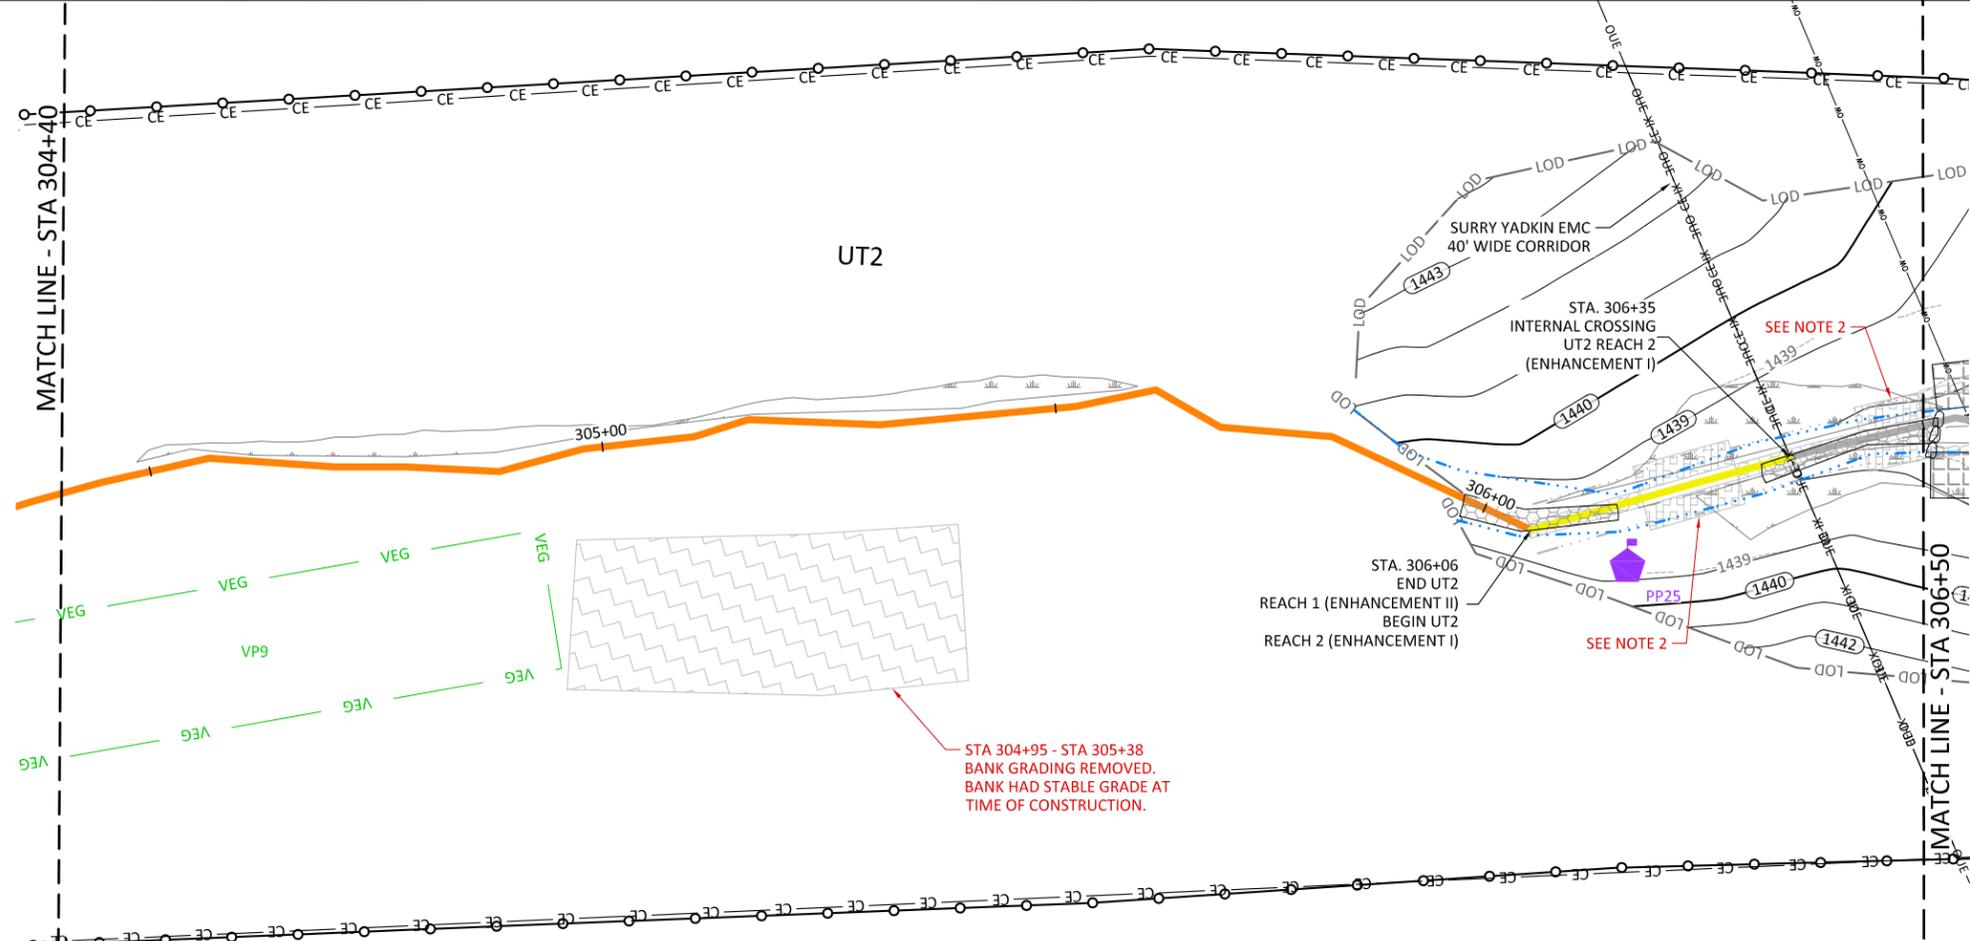
1.25
Sheet

- NOTES:
1. DEVIATIONS FROM THE DESIGN WILL BE SHOWN IN RED.
 2. STA 306+18 - STA 306+29 & STA 306+43 - STA 306+50 NO SUITABLE SOD ON SITE. BANKS QUICKLY STABILIZED WITH SEEDING VEGETATION AND SOD MATS NOT NEEDED FOR STABILITY.

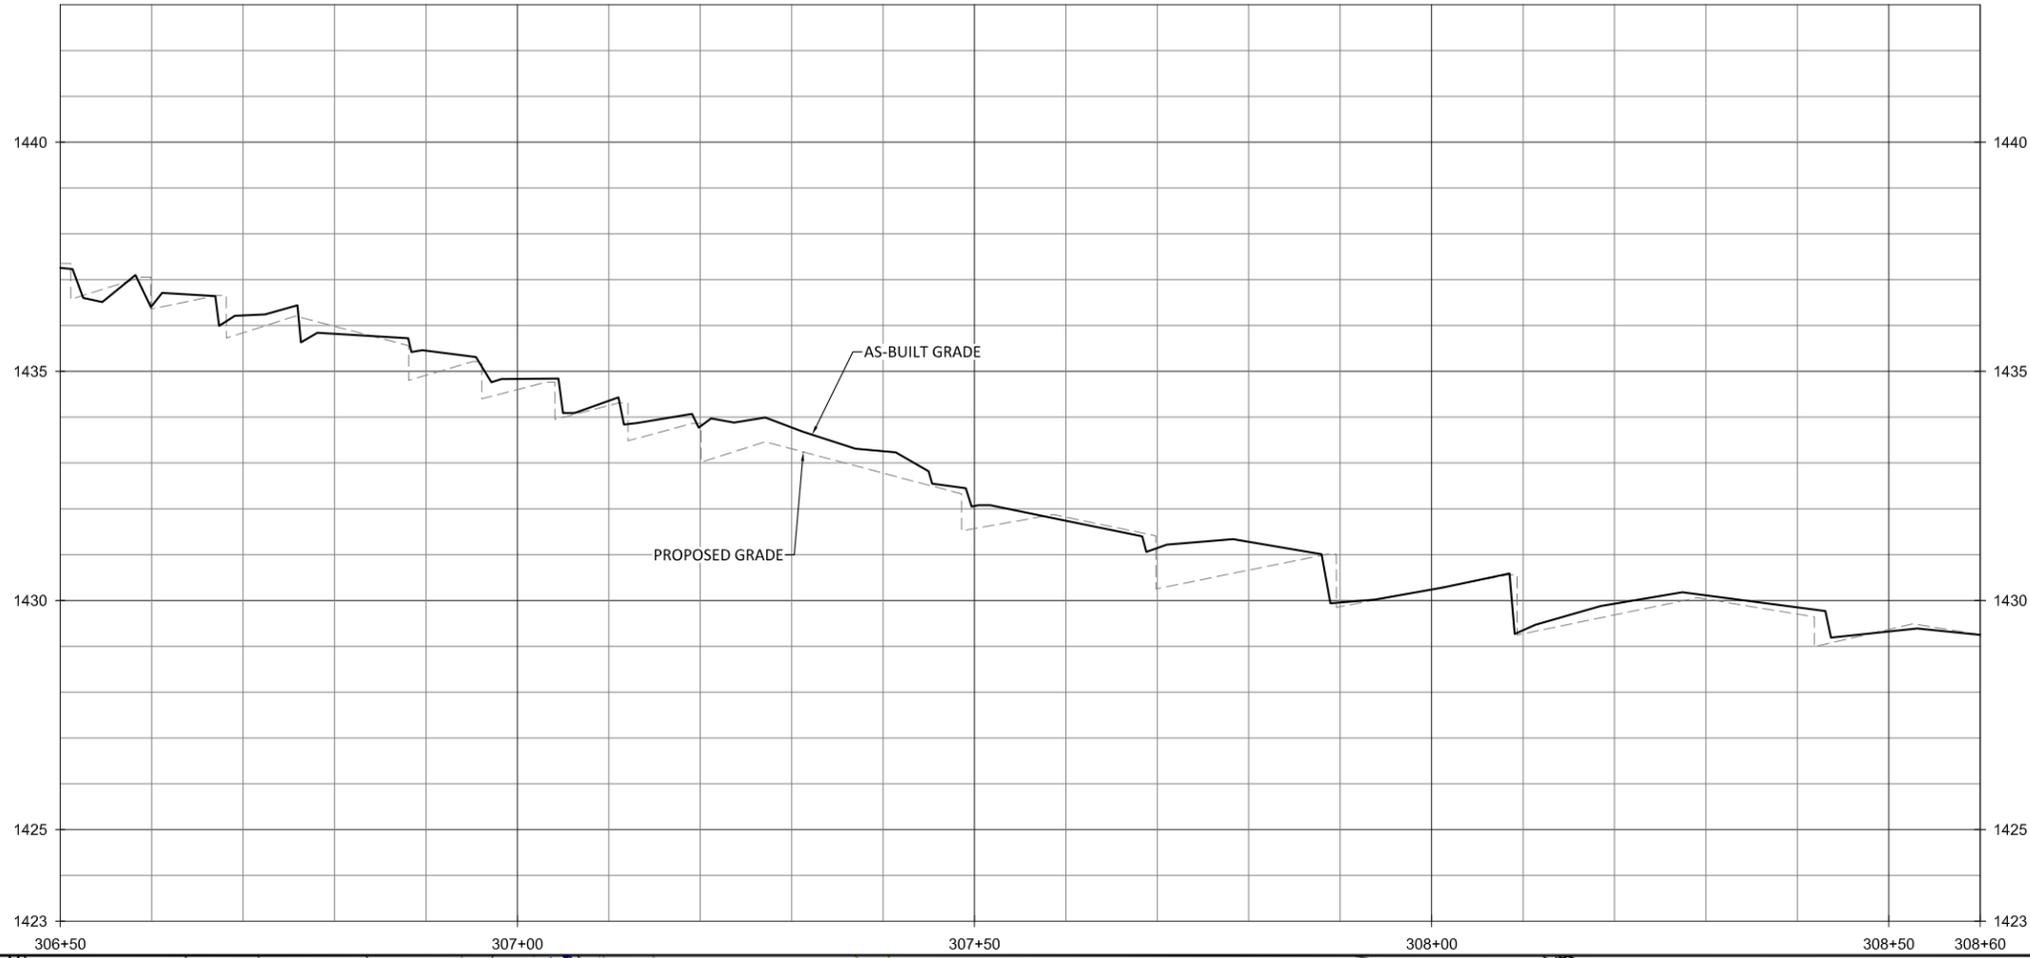
1.26

- NOTES:
1. DEVIATIONS FROM THE DESIGN WILL BE SHOWN IN RED.
 2. AS-BUILT INFORMATION FOR UT2A IS ADDRESSED ON SHEETS 1.34 THROUGH 1.36.
 3. STA 306+60 - STA 306+68, STA 306+68 - STA 306+76, STA 307+49 - STA 307+59 & STA 308+42 - STA 308+53 NO SUITABLE SOD ON SITE. BANKS QUICKLY STABILIZED WITH SEEDING VEGETATION AND SOD MATS NOT NEEDED FOR STABILITY.

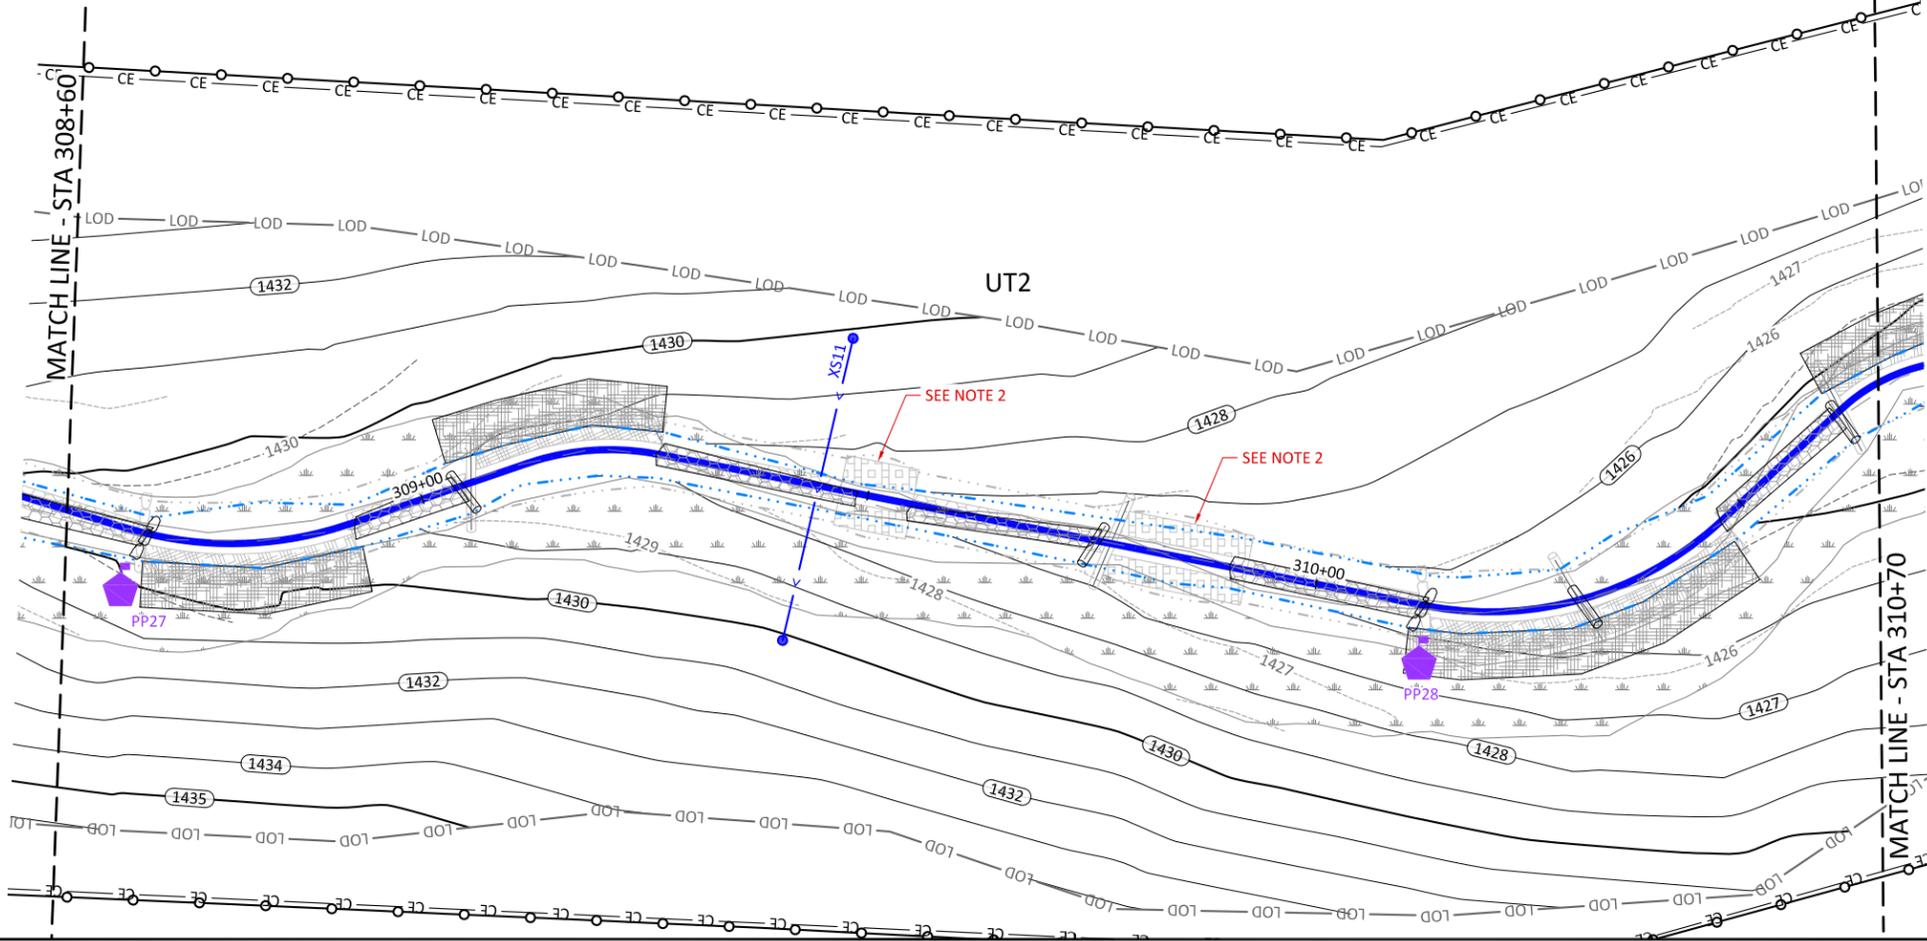
1.27

- NOTES:
1. DEVIATIONS FROM THE DESIGN WILL BE SHOWN IN RED.
 2. STA 309+47 - STA 309+55 & STA 309+77 - STA 309+92
NO SUITABLE SOD ON SITE. BANKS QUICKLY STABILIZED WITH SEEDED VEGETATION AND SOD MATS NOT NEEDED FOR STABILITY.

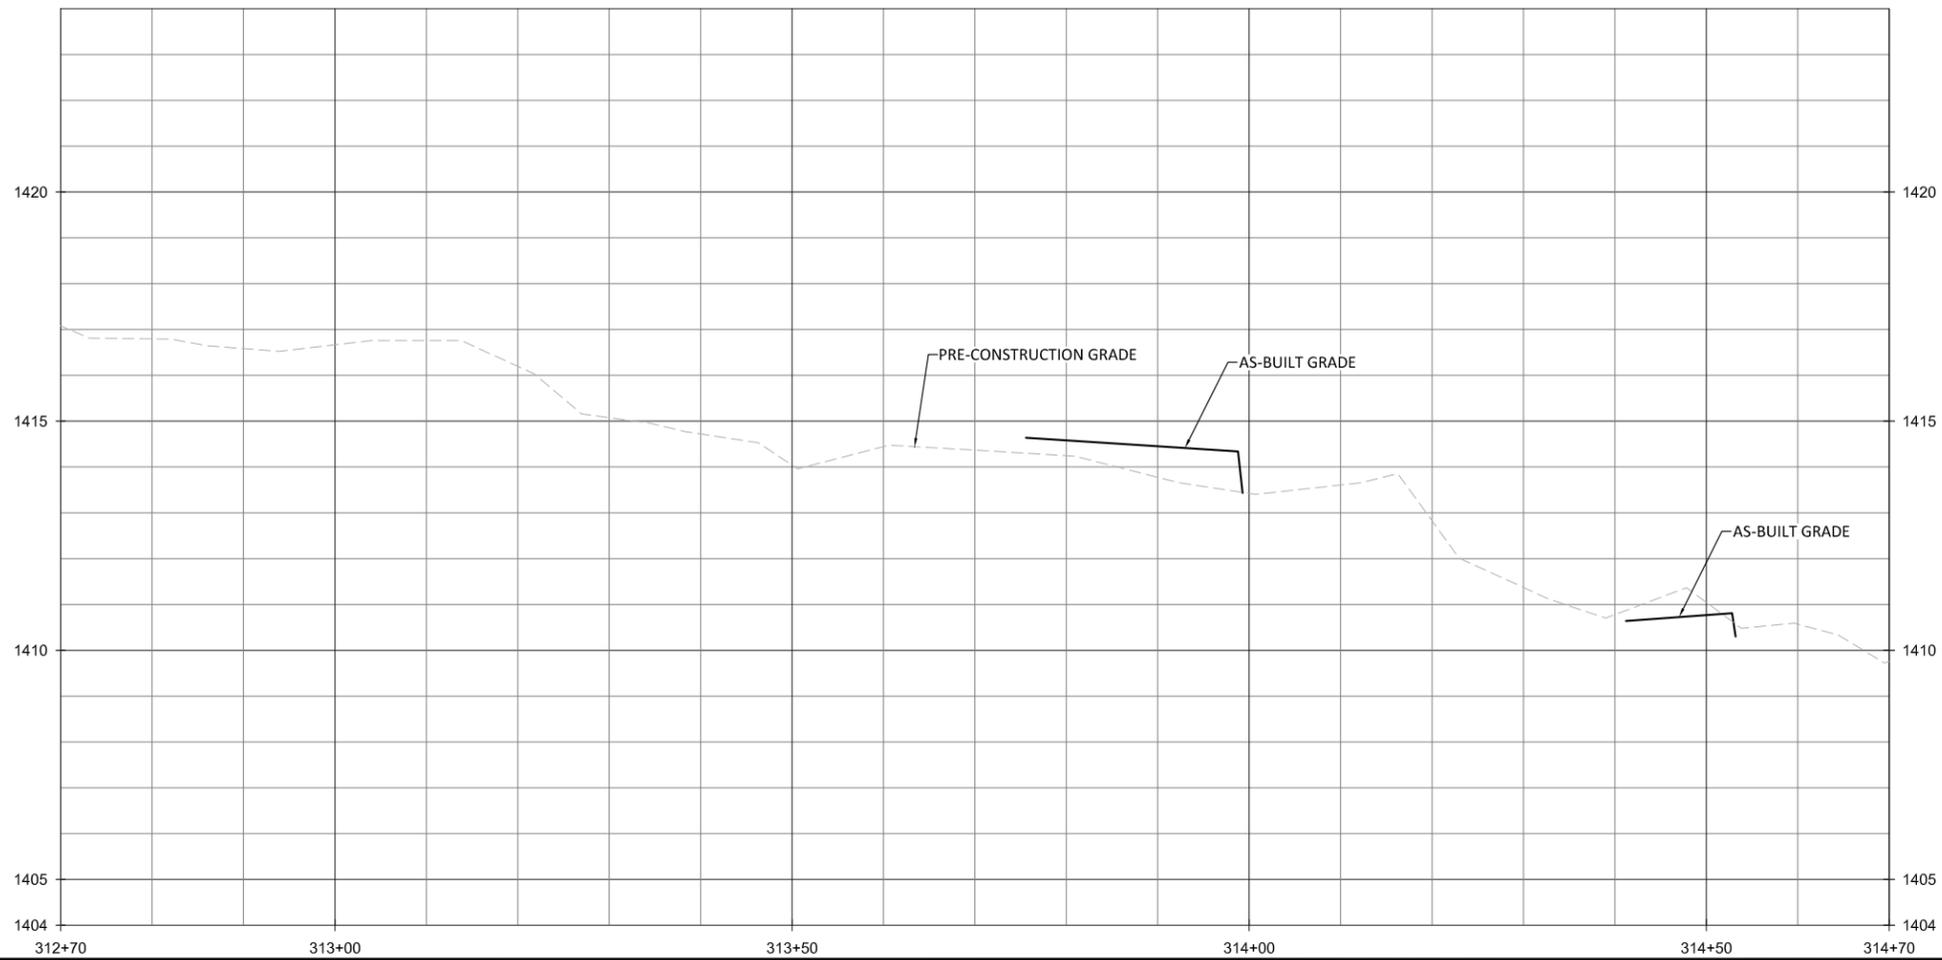
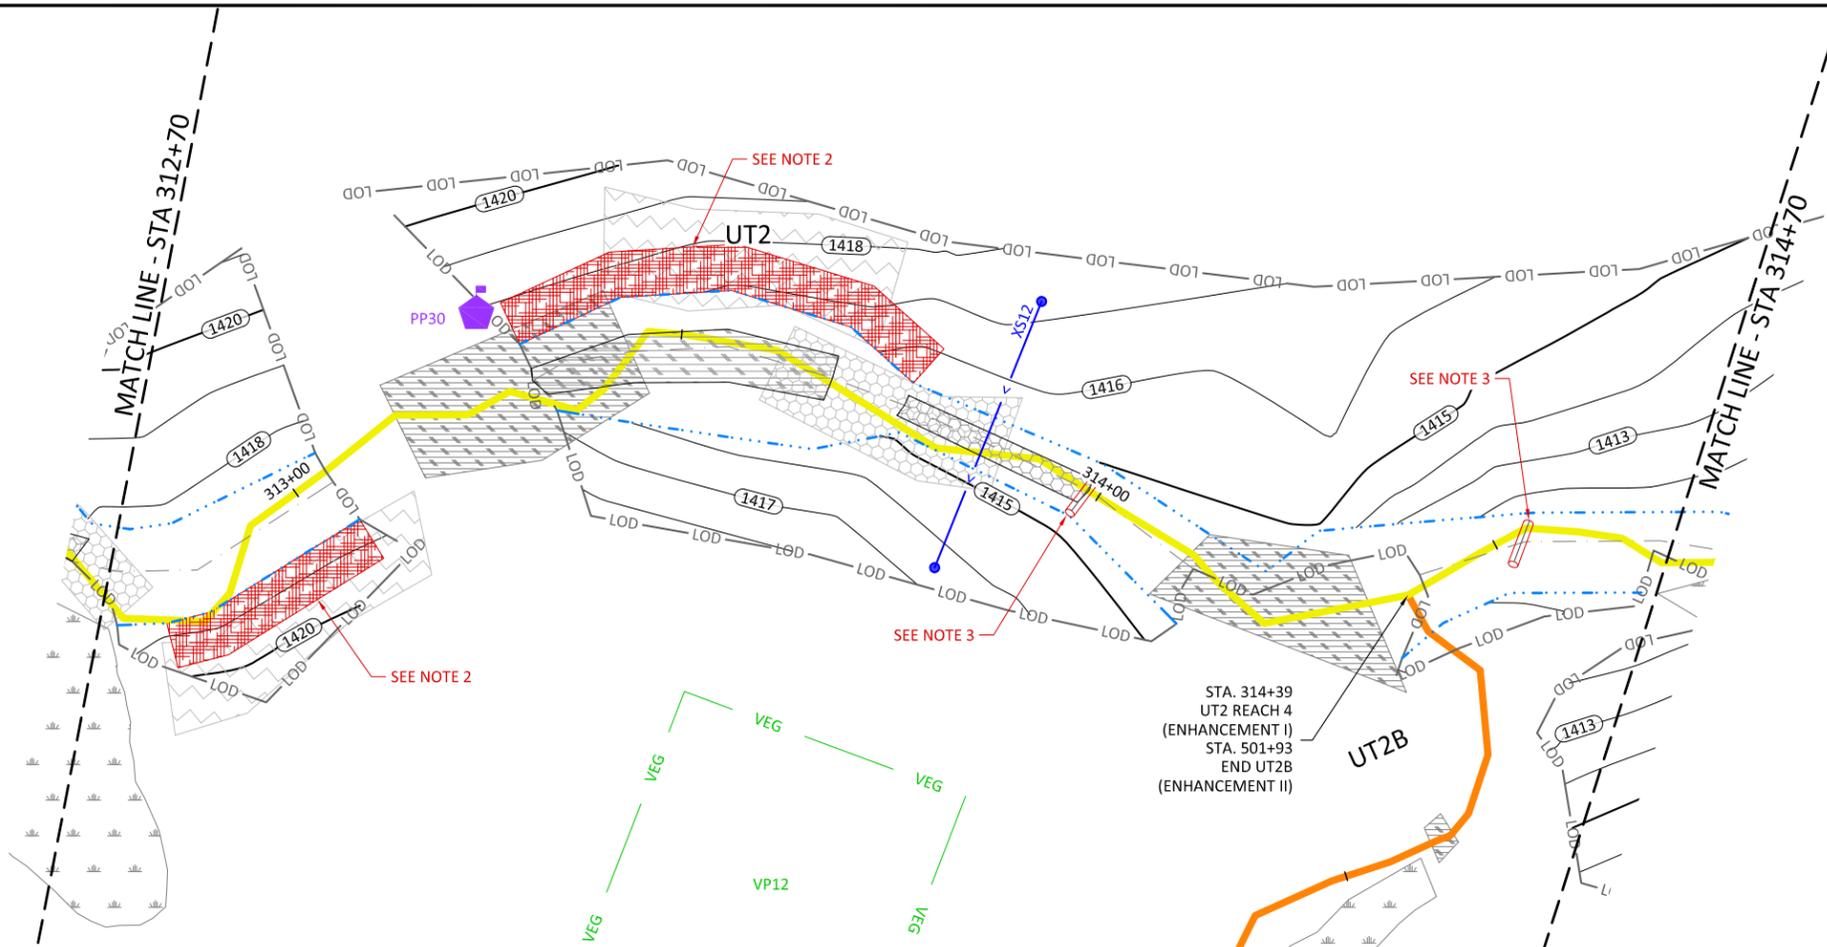
1.28

- NOTES:
1. DEVIATIONS FROM THE DESIGN WILL BE SHOWN IN RED.
 2. STA 312+78 - STA 313+04 & STA 313+29 - STA 313+75 BRUSH TOE ADDED TO STABILIZE STREAMBANK.
 3. STA 313+99 & STA 314+54 LOG SILL ADDED FOR ADDITIONAL GRADE STABILITY.

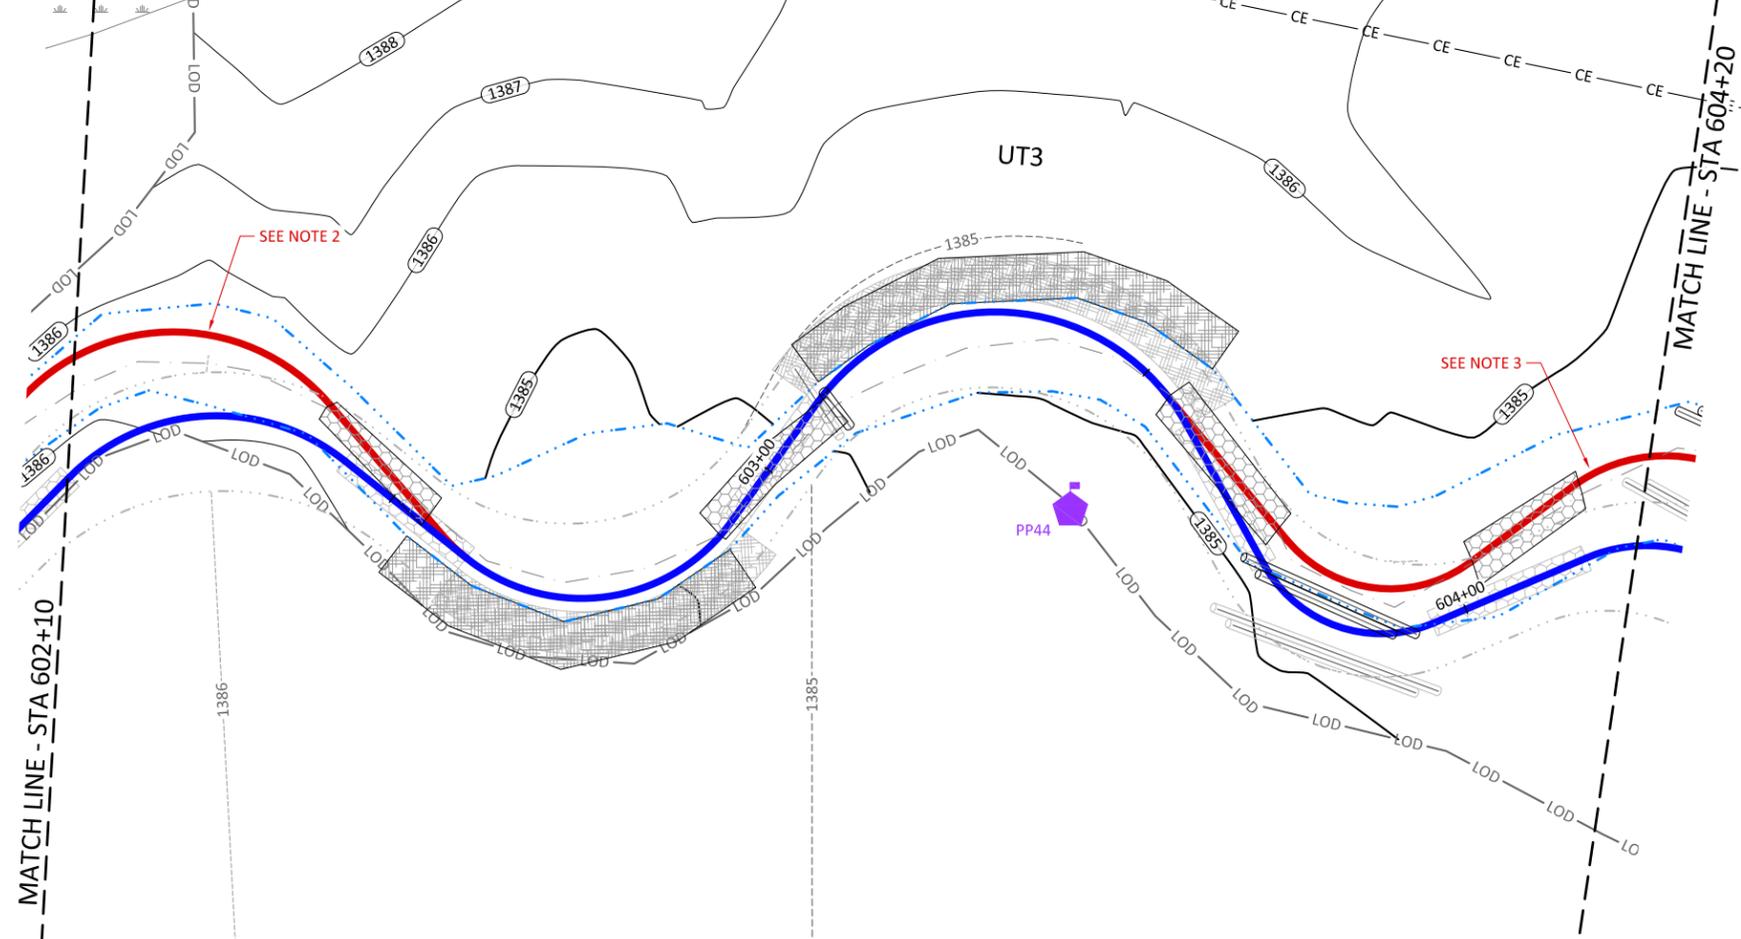
- NOTES:**
1. DEVIATIONS FROM THE DESIGN WILL BE SHOWN IN RED.
 2. STA 600+34 - STA 602+60
231 LINEAR FEET OF STREAM WAS REALIGNED FOR BETTER CONSTRUCTABILITY THROUGH POND AREA.
 3. STA 603+56 - STA 606+69
313 LINEAR FEET OF STREAM WAS REALIGNED FOR BETTER CONSTRUCTABILITY THROUGH POND AREA.

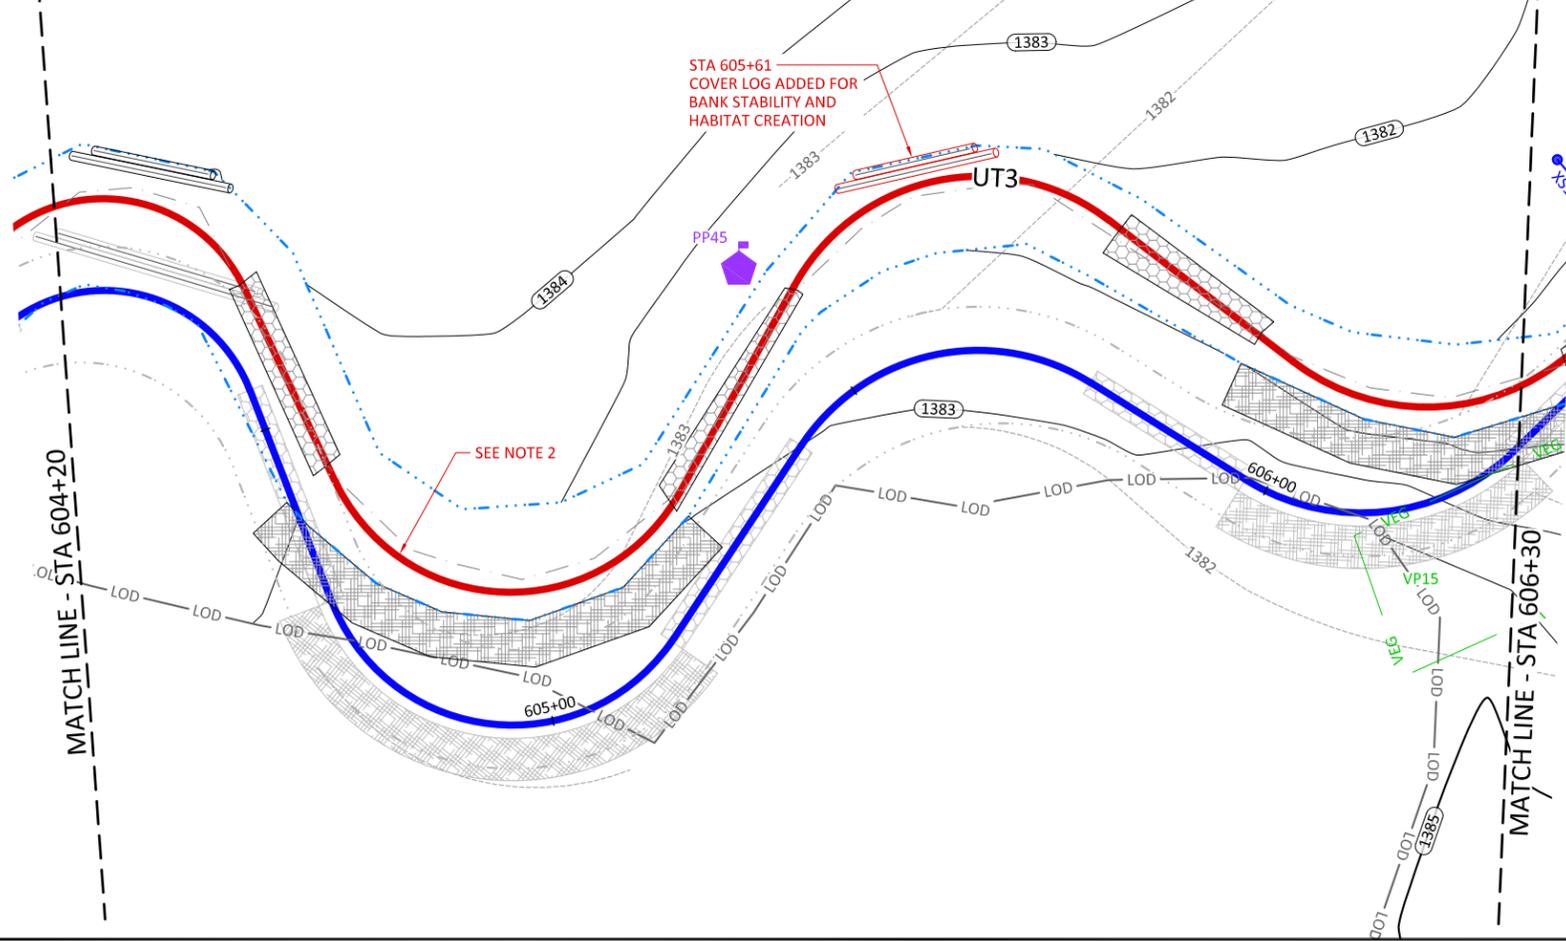
1.39

- NOTES:
1. DEVIATIONS FROM THE DESIGN WILL BE SHOWN IN RED.
 2. STA 603+56 - STA 606+69
313 LINEAR FEET OF STREAM WAS REALIGNED FOR BETTER CONSTRUCTABILITY THROUGH POND AREA.

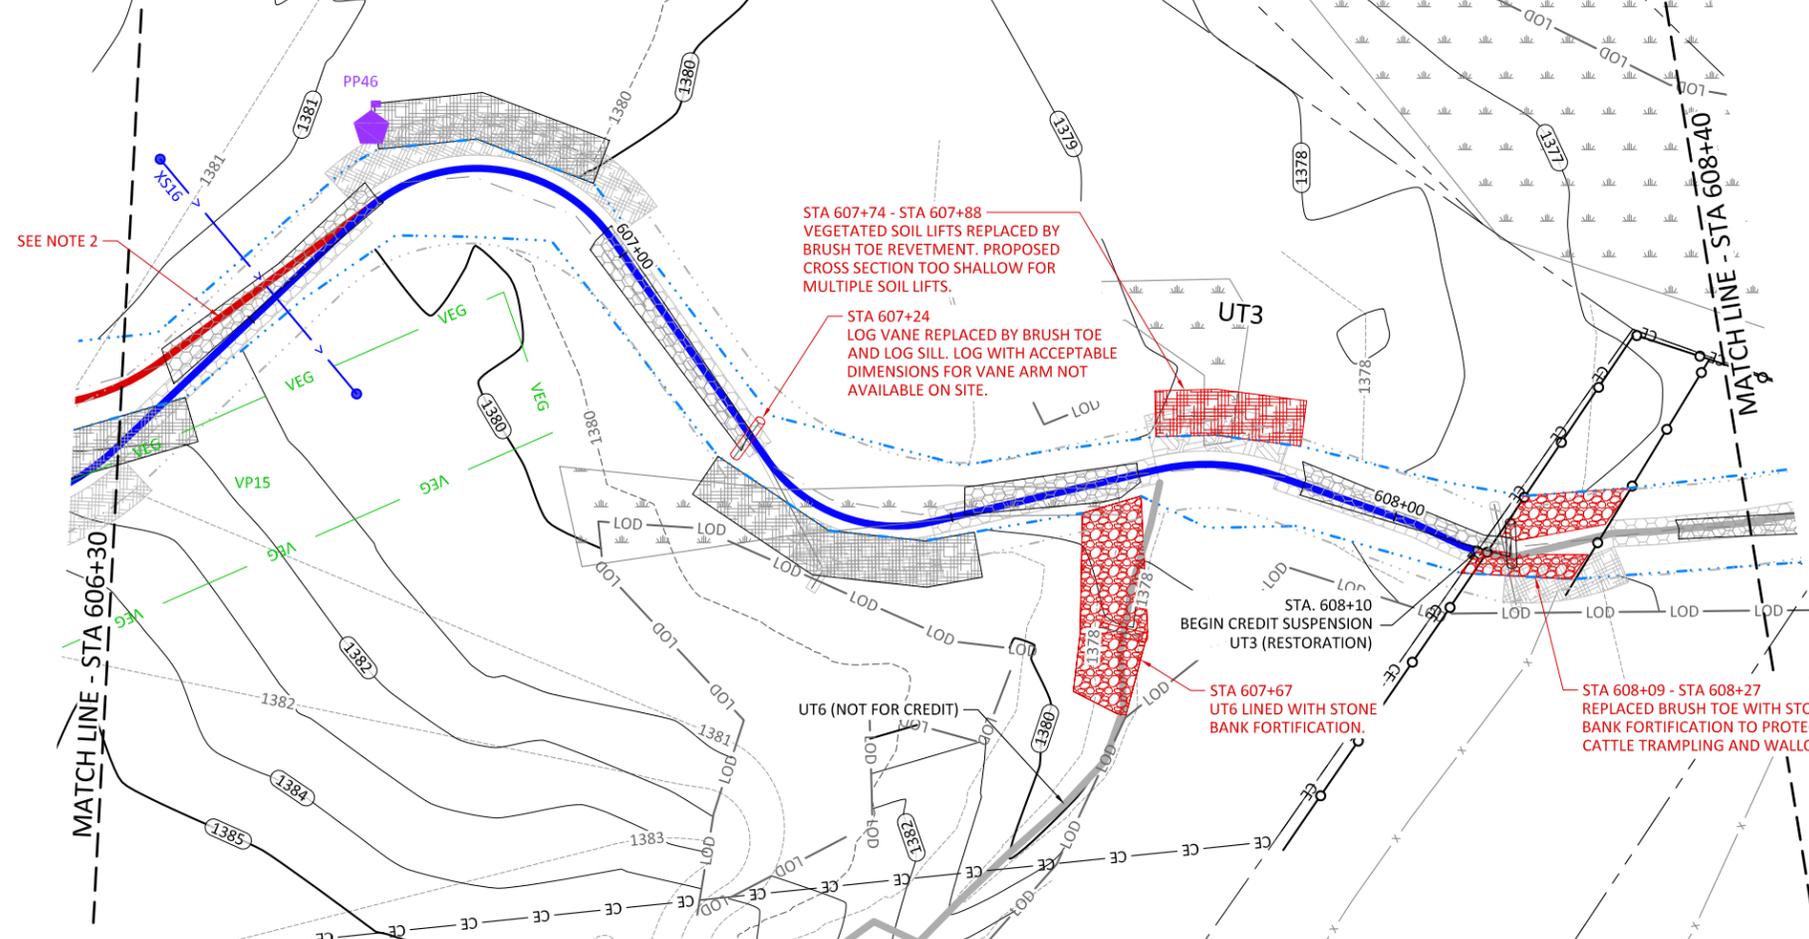
1.40
Sheet

- NOTES:
1. DEVIATIONS FROM THE DESIGN WILL BE SHOWN IN RED.
 2. STA 603+56 - STA 606+69
313 LINEAR FEET OF STREAM WAS REALIGNED FOR BETTER CONSTRUCTABILITY THROUGH POND AREA.

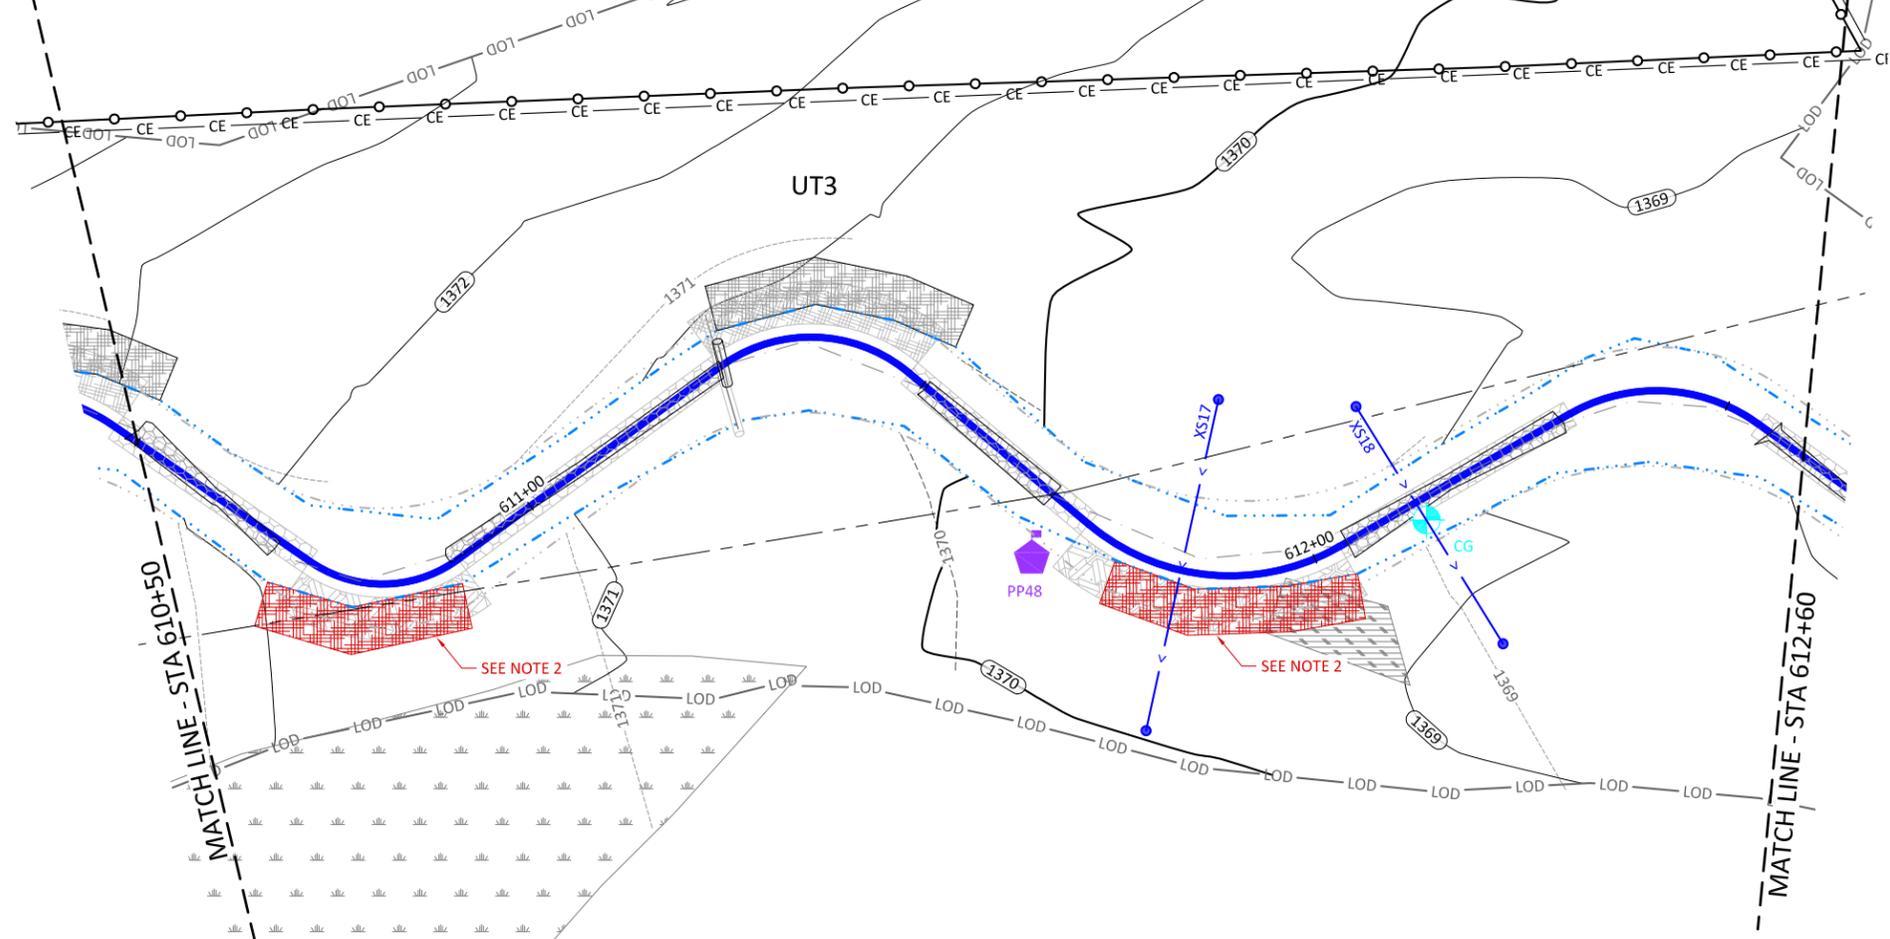
1.42

- NOTES:
1. DEVIATIONS FROM THE DESIGN WILL BE SHOWN IN RED.
 2. STA 610+71 - STA 610+89 & STA 611+78 - STA 612+03 BRUSH TOE WAS USED INSTEAD OF SOIL LIFTS DUE TO CHANNEL DIMENSIONS NOT DEEP ENOUGH FOR MULTIPLE SOIL LIFTS.

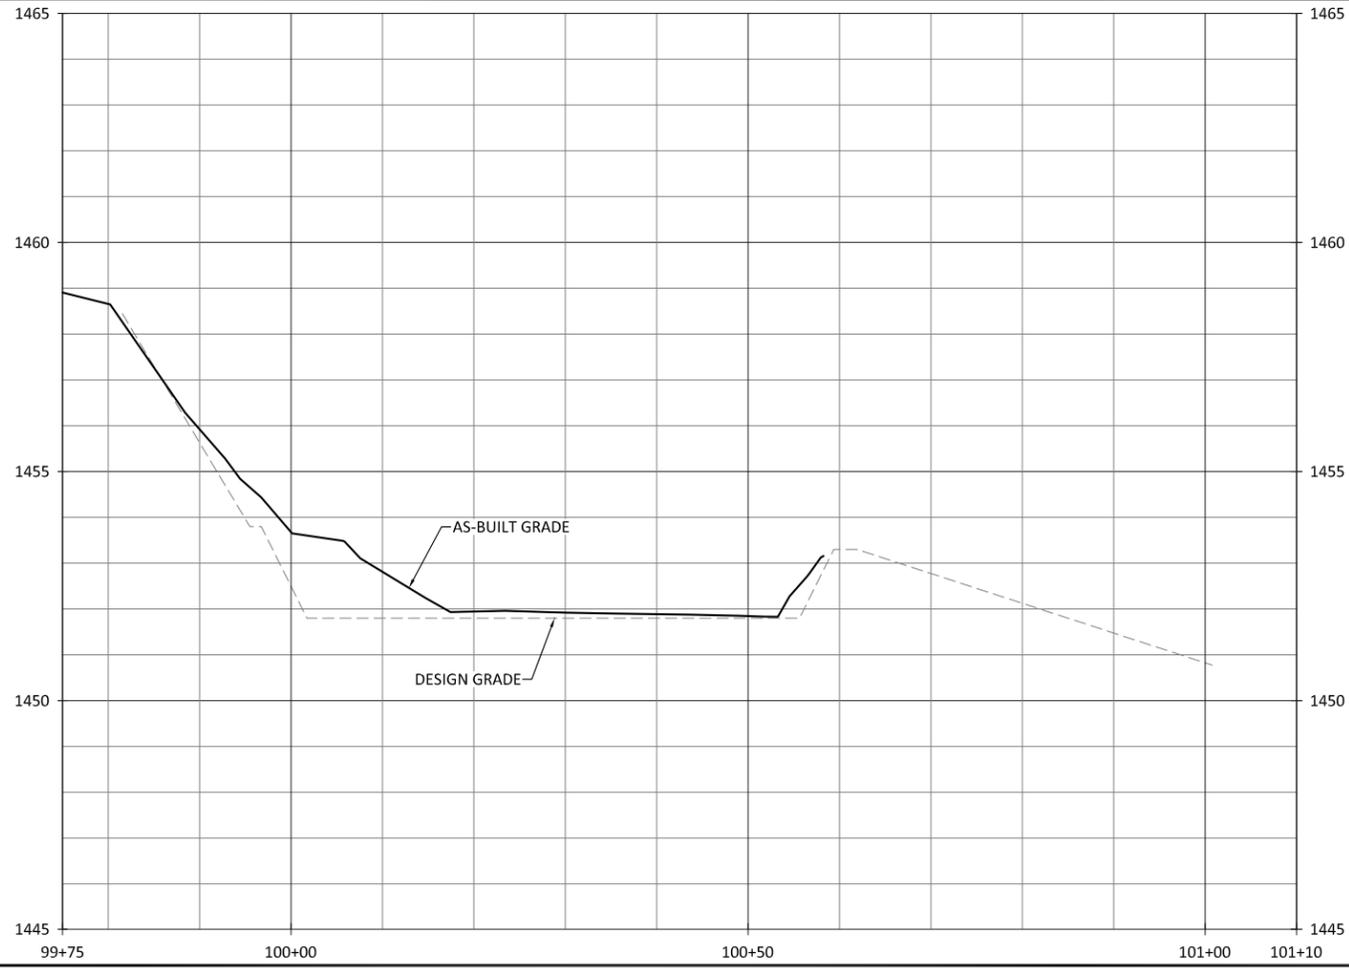
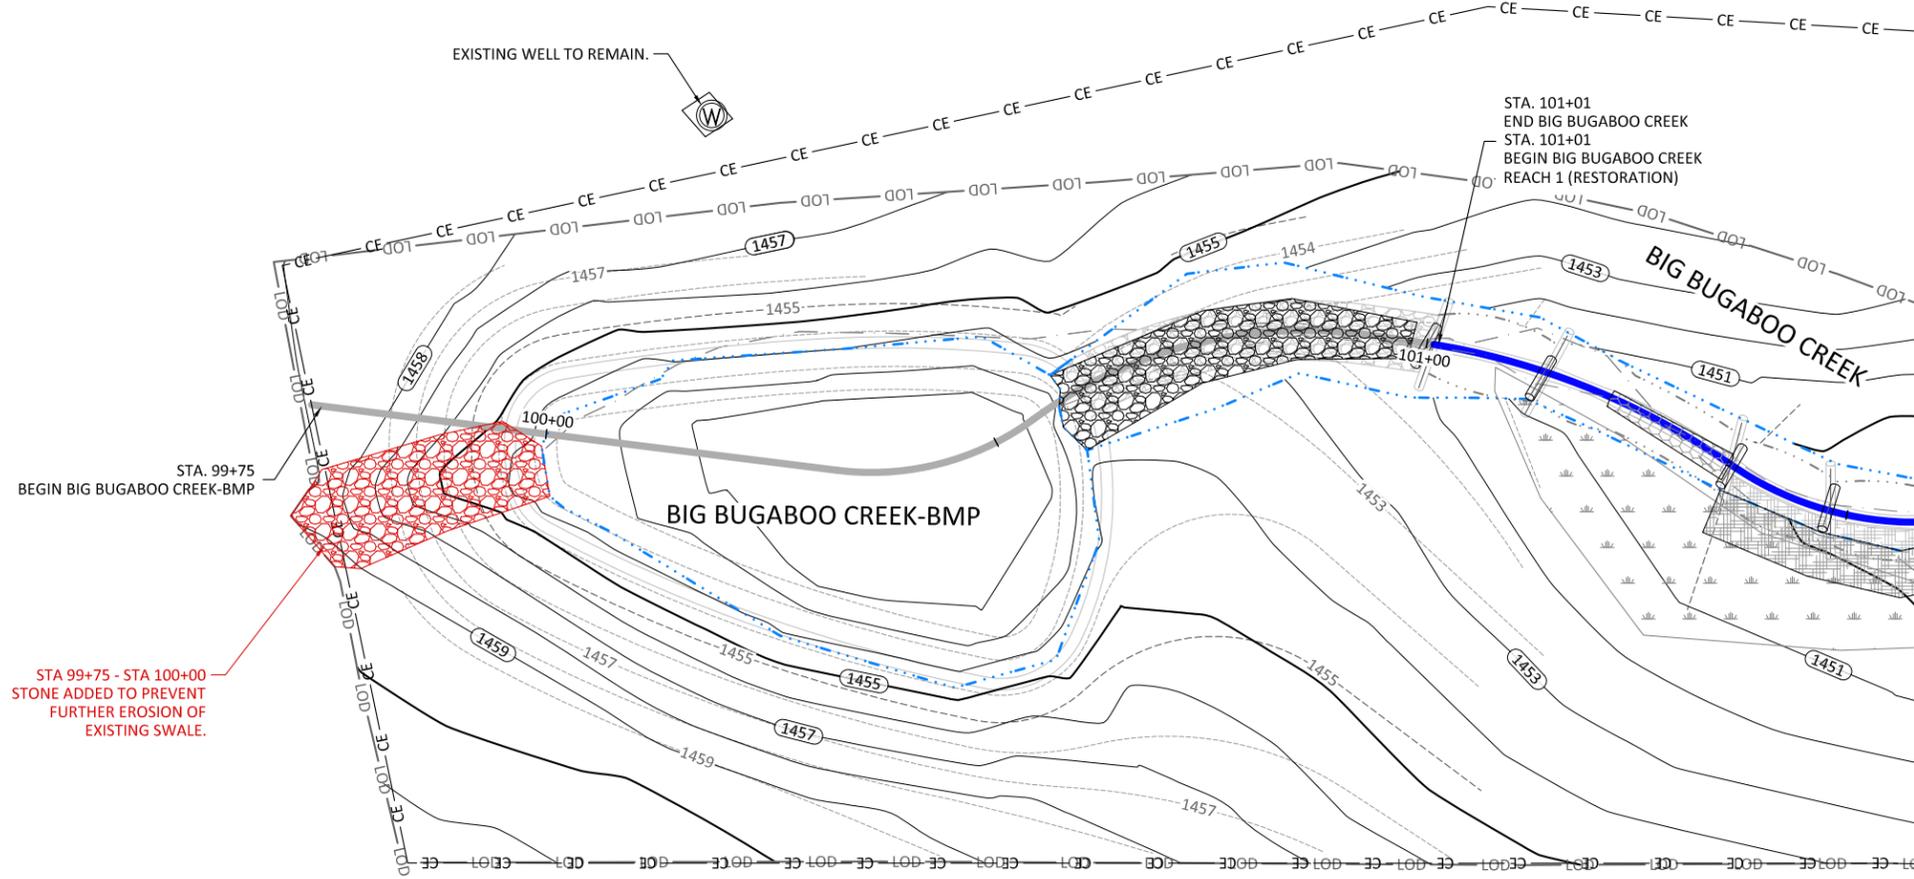
2.00

STA 99+75 - STA 100+00
STONE ADDED TO PREVENT
FURTHER EROSION OF
EXISTING SWALE.
