**CEDAR CREEK STREAM AND WETLAND RESTORATION
PROJECT
MONITORING REPORT
MONITORING YEAR 2**

SAMPSON COUNTY, NORTH CAROLINA
CONTRACT No. 005011 - PROJECT No. 95718

January 2017

**Cedar Creek
Sampson County, North Carolina
DMS Project ID 95718**

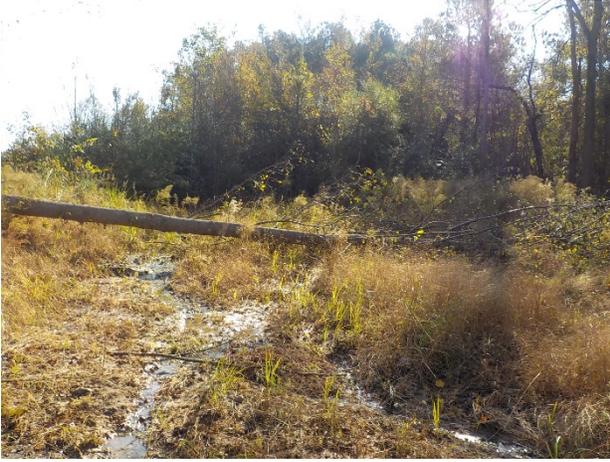
SPA1- Debris Jam/Fallen Tree- UT2 @ Sta. 0+50 to 1+00

Table 7. Stream Problem Areas			
Cedar Creek Stream and Wetland Restoration Project - Project # 95718			
Feature Issue	Station # / Range	Suspected Cause; Repair	Photo Number
Debris Jam/Fallen Tree	UT2 @ 0+50 to 1+00	Fallen tree is blocking flow within the stream channel and causing piping and overland flow; removal of tree is recommended.	SPA1
Log Ramp Structure	UT2 @ 9+28	Log ramp structure is dislodged and is unfunctional. Structure repair is recommended.	SPA2
Bank Erosion	UT1 @ 27+50 to 28+75	Localized bank erosion on left and right banks. Recommended minimal earthwork, re-matting and livestaking.	SPA3

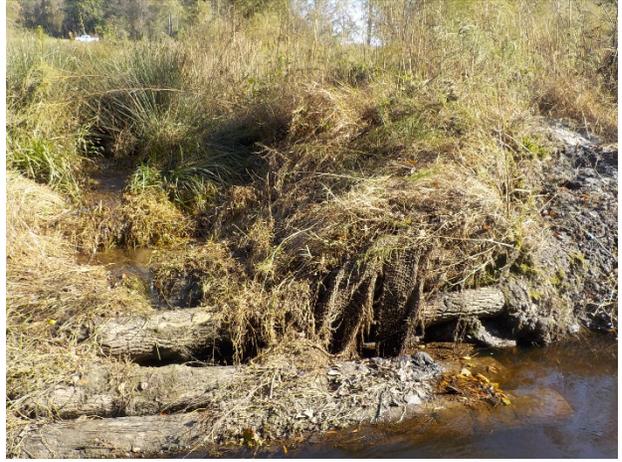
SPA2-Unfunctional Log Ramp Structure - UT2 @ Sta. 9+28

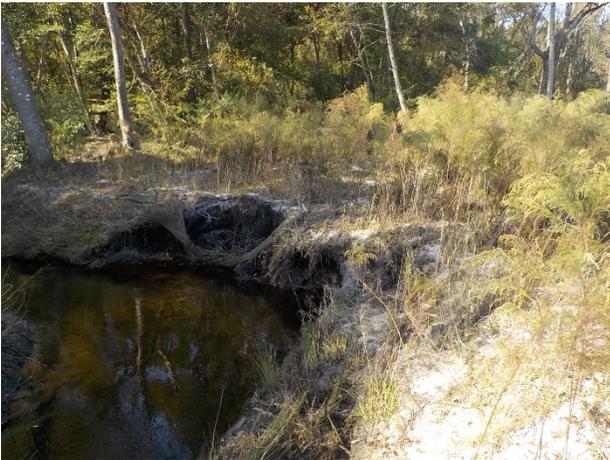
One stream problem was identified during the Year 1 monitoring period and was mapped on the Current Conditions Plan View (CCPV), specifically Figure 3b. The problem was noted on the right bank of Reach UT1, just before the confluence with Reach UT2 (Sta 25+50). The problem area consisted of a tree that had fallen into the channel, associated bank erosion, and scouring with the disturbed root system. This problem area was monitored throughout MY2 and did not worsen or need any remediation. Following Hurricane Matthew, several areas with fallen trees similar to the problem area documented in MY1 report are present along UT-1. These areas will be monitored; however, they are not documented on the stream problem areas table or CCPV for MY2. During MY2 activities, three stream problem areas were documented. Stream Problem Area 1 (SPA1) consists of a debris jam associated from a fallen tree at the upstream portion (Sta. 0+50 – 1+00) of UT-2. The fallen tree has diverted stream flow out of the stream channel and across the floodplain on the right stream bank. Minor bank erosion has resulted in this area. Removal of the fallen tree is recommended along with any additional debris within the stream channel to allow natural channel flow pattern. Stream Problem Area 2 (SPA2) is located at the downstream end (Sta. 9+28) of UT-2. SPA2 is a log ramp structure that has become dislodged and non-functional. The footer logs are no longer tied into the banks resulting in piping around and under the log structure. Repair or replacing this log structure is recommended. The last stream problem area (SPA3) is localized erosion along UT-1. Bank erosion on both left and right stream banks was documented from station 27+50 to 28+75. Most areas are minor; however, a few consists of bank failures. These areas are primarily a result of severe flooding and high flow events resulting from Hurricane Matthew. Remediation is recommended on these areas of localized erosion. Most areas can be matted and live staked to remedy the problem. The more extensive bank failures will need the banks sloped back and matting and live stakes installed.

SPA3- Bank Erosion on left and right banks- UT1 @ Sta. 27+50 to 28+75

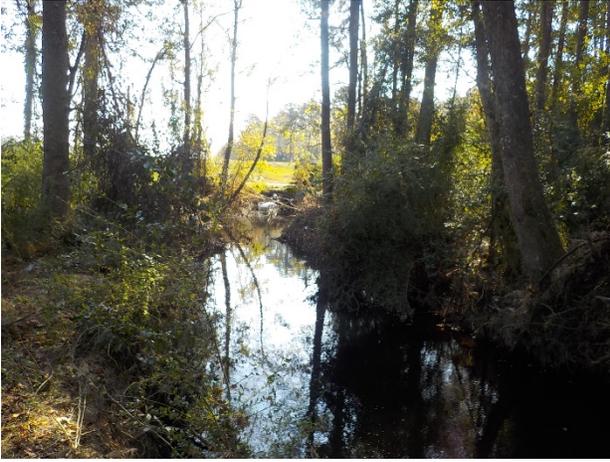
Two vegetation problem areas were identified during the Year 2 monitoring period. These vegetation problem areas are mapped on the Current Conditions Plan View (CCPV) as part of the annual monitoring report. The first vegetation problem area (VPA1) consists of invasive species Chinese

Privet (*Ligustrum sinense*) located at the upstream portion of UT-1. This problem area is approximately 0.60 acres; however, invasive control treatment (cutting and spraying) is recommended before it grows larger and spreads throughout the easement. The other vegetation problem (VPA2) is a small bare area (0.05 ac.) along UT-2 above the stream crossing (Sta. 4+00). This area lacks herbaceous cover. Reseeding and mulching is recommended in this area.

VPA1- Invasive Species (Chinese Privet) - UT1 @
Sta. 1+50 to 3+75

Table 8. Vegetation Problem Areas			
Cedar Creek Stream and Wetland Restoration Project - Project # 95718			
Feature Category	Station Numbers	Suspected Cause; Repair	Photo Number
VPA1	UT1 @ 1+50 to 3+75	Invasives: Chinese Privet common along left and right stream banks. Recommend treatment.	VPA1
VPA2	UT2 @ 4+00 to 4+66	Bare Area: Sparse vegetation and ground cover. Recommend reseeding and mulching.	VPA2

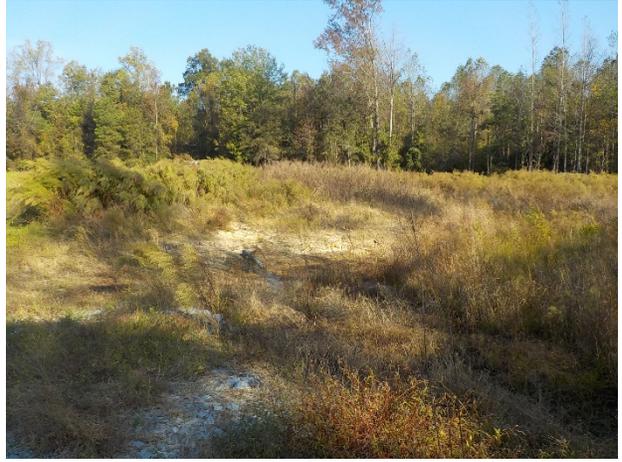
VPA2- Sparse Vegetation - UT2 @ Sta 4+00 to
4+66
