CLEGHORN CREEK STREAM RESTORATION PROJECT
ANNUAL MONITORING REPORT FOR 2010 (YEAR 5)
Project Number: D-04010

CLEGHORN CREEK YEAR 5 MONITORING PLANS RUTHERFORDTON, RUTHERFORD COUNTY, NC

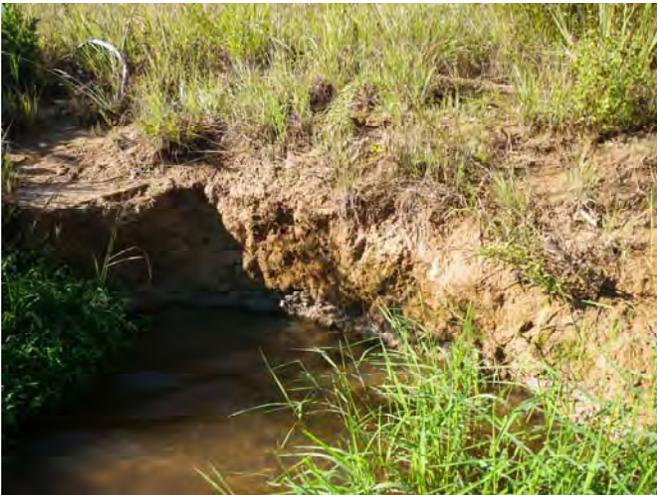
Approximately 15-feet of scour along right bank at Sta. 121+50.

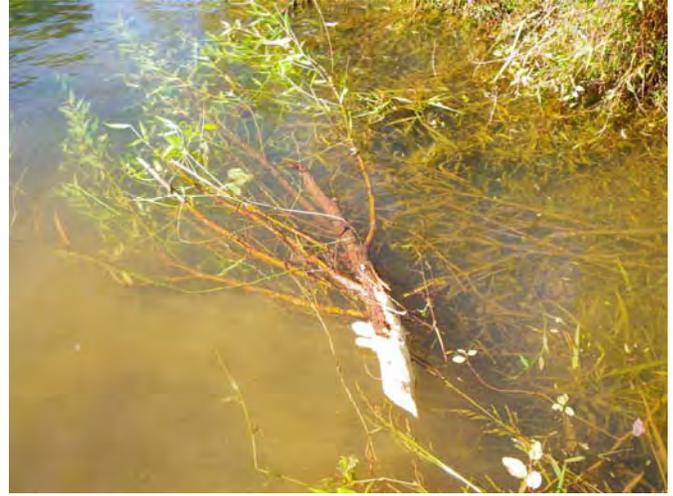
Loss of vegetation to beaver impacts has been minimized by periodic site visits to assess the area for beaver activity. Beavers will likely continue to be present at the site, particularly in light of the proximity of the site to the confluence of Cleghorn Creek with the Broad River.
