# **MONITORING YEAR 5 ANNUAL REPORT FINAL**

## **DEVIL'S RACETRACK MITIGATION SITE**

Johnston County, NC

NCDEQ Contract 003989

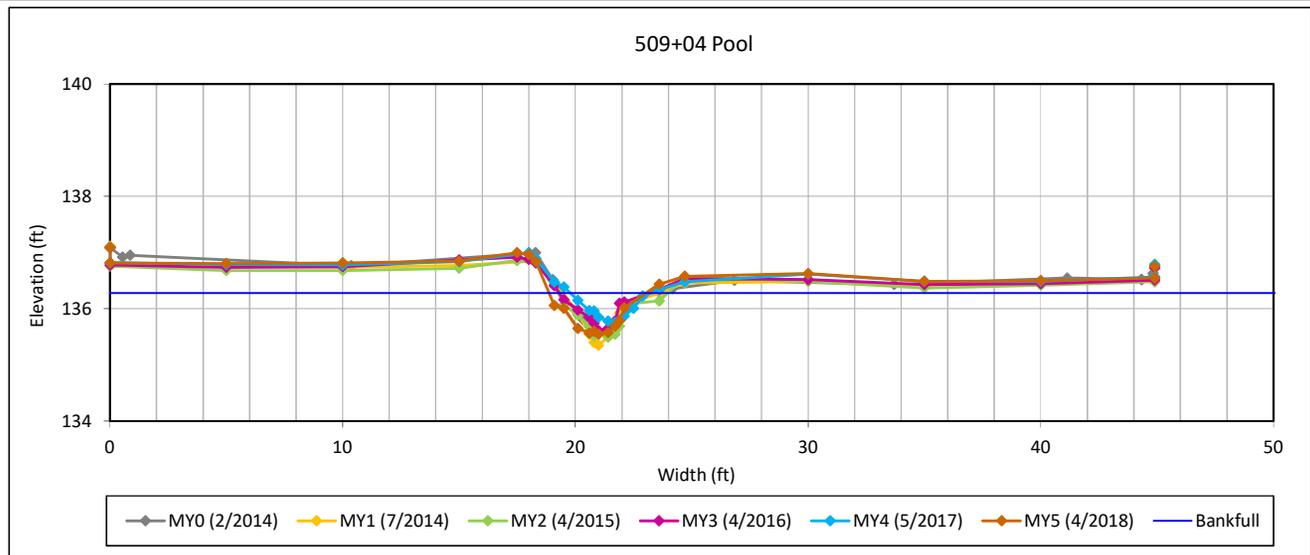
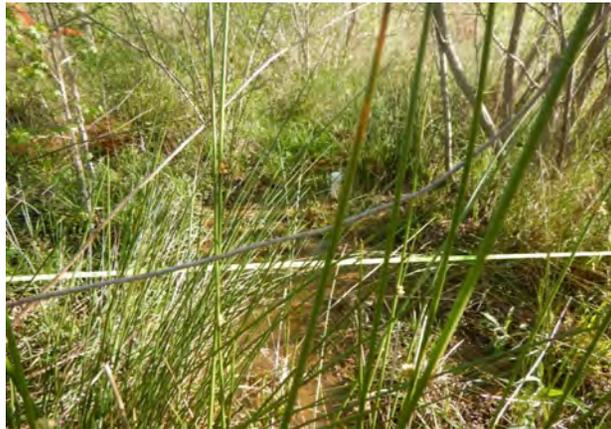
#### Cross Section 22-Southwest Branch

1.8	x-section area (ft.sq.)
4.2	width (ft)
0.4	mean depth (ft)
0.7	max depth (ft)
4.6	wetted parimeter (ft)
0.4	hyd radi (ft)
9.6	width-depth ratio

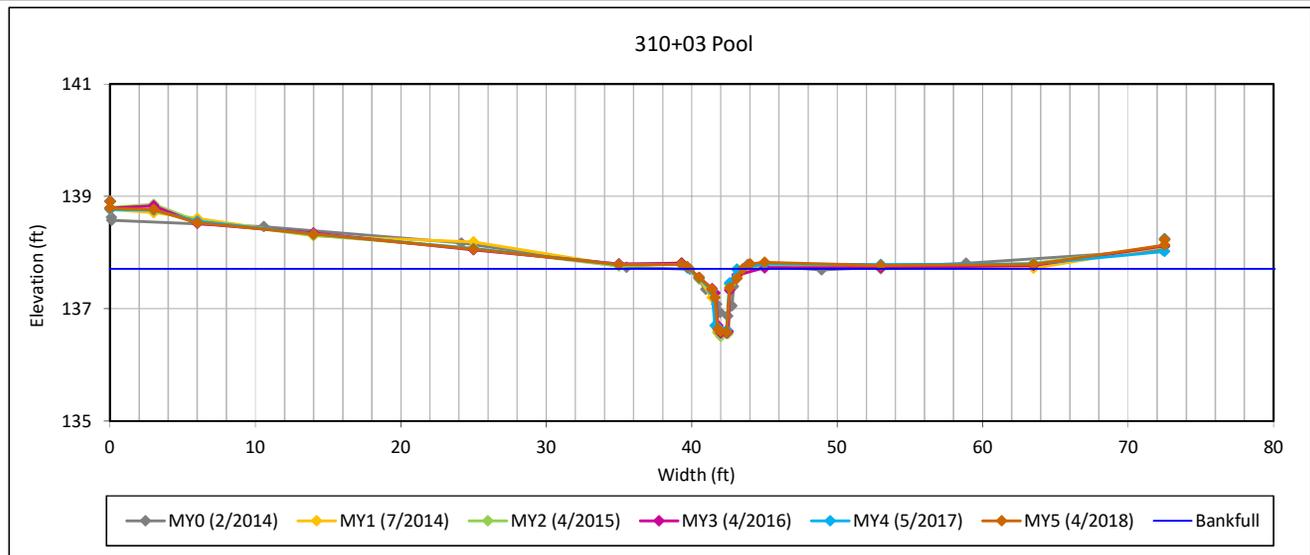
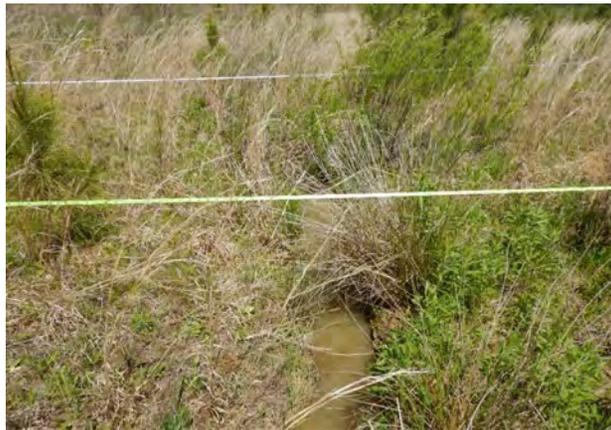
#### Cross Section 28-Southeast Branch

1.5	x-section area (ft.sq.)
3.6	width (ft)
0.4	mean depth (ft)
1.1	max depth (ft)
4.8	wetted parimeter (ft)
0.3	hyd radi (ft)
8.8	width-depth ratio

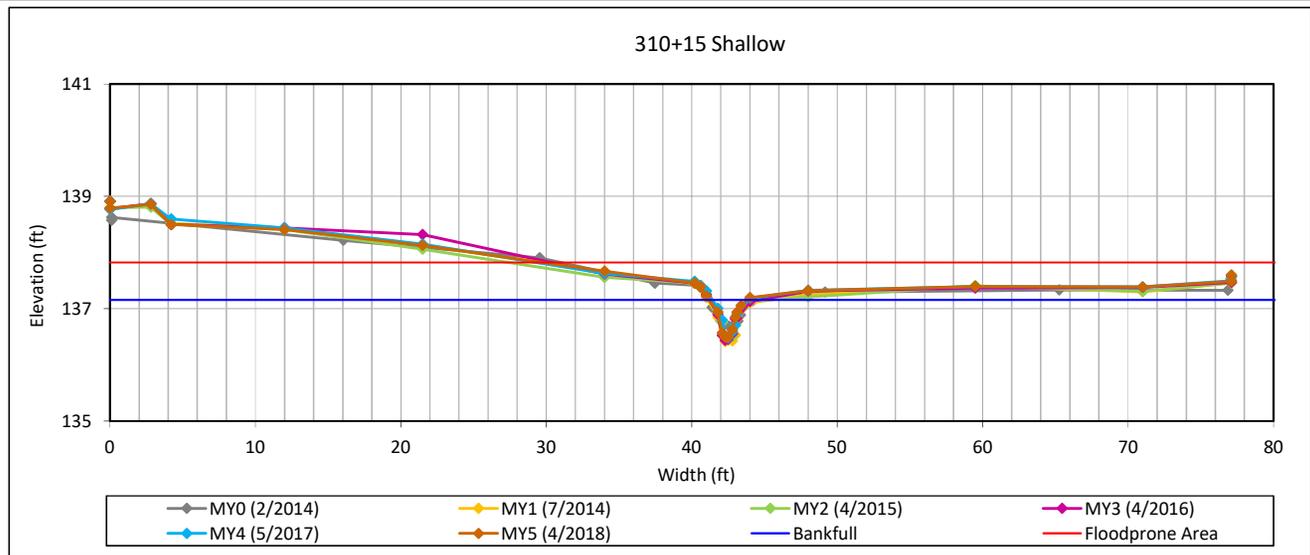
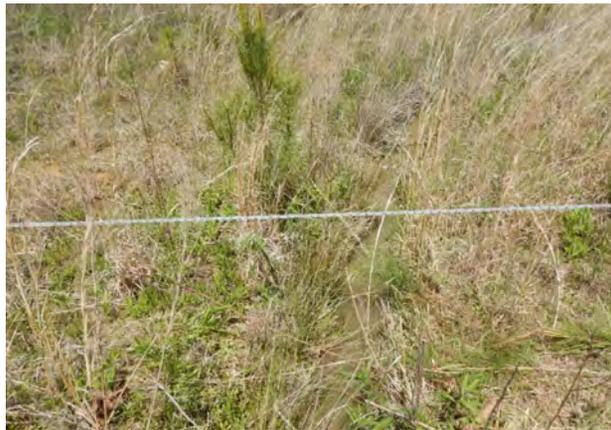
#### Cross Section 29-Southeast Branch

0.8	x-section area (ft.sq.)
2.6	width (ft)
0.3	mean depth (ft)
0.7	max depth (ft)
3.0	wetted perimeter (ft)
0.3	hyd radi (ft)
8.6	width-depth ratio
30.0	W flood prone area (ft)
11.5	entrenchment ratio
1.1	low bank height ratio

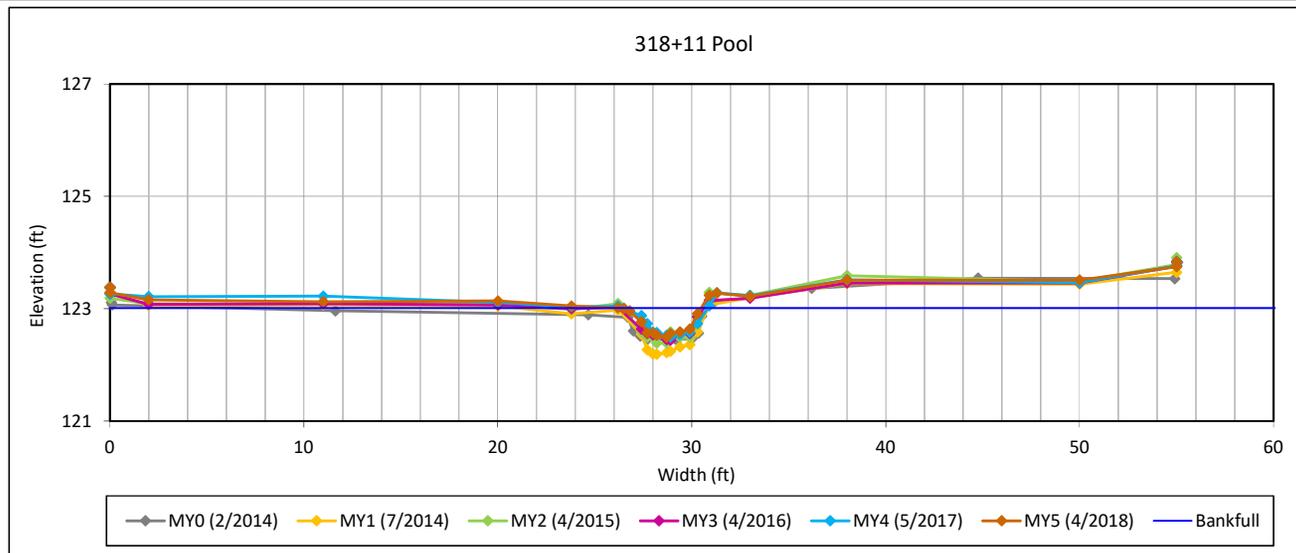
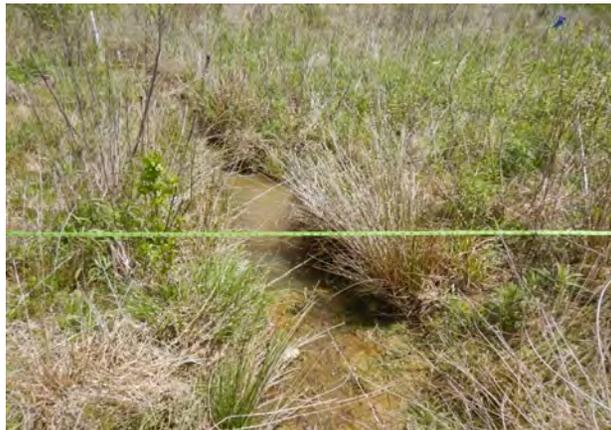
#### Cross Section 30-Southeast Branch

1.3	x-section area (ft.sq.)
4.1	width (ft)
0.3	mean depth (ft)
0.5	max depth (ft)
4.3	wetted parimeter (ft)
0.3	hyd radi (ft)
12.9	width-depth ratio

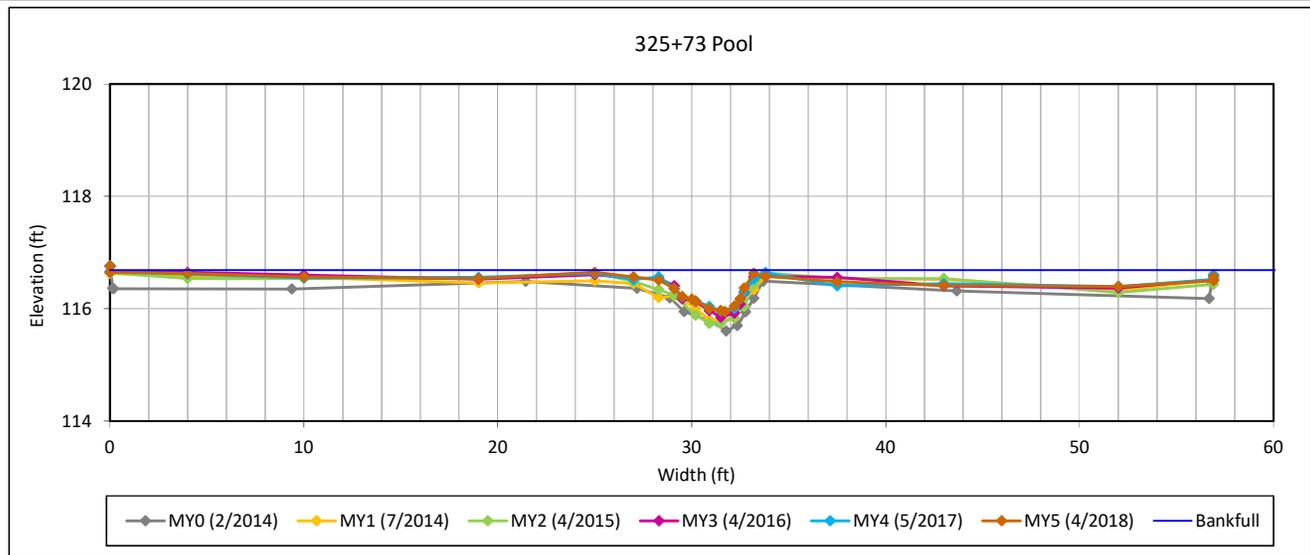
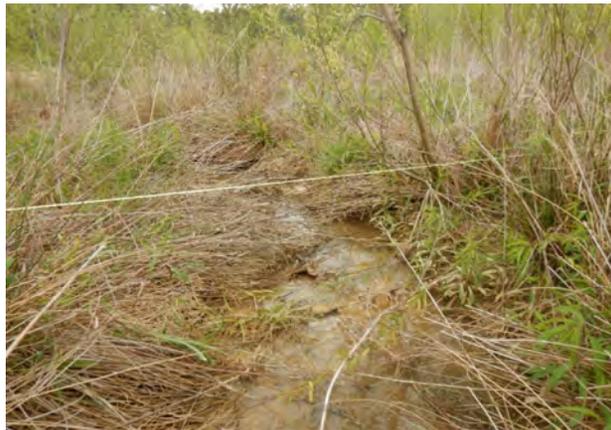
#### Cross Section 33-Southeast Branch

2.4	x-section area (ft.sq.)
4.9	width (ft)
0.5	mean depth (ft)
0.7	max depth (ft)
5.1	wetted parimeter (ft)
0.5	hyd radi (ft)
10.0	width-depth ratio
