Monitoring Report
FINAL VERSION
Horne Creek Tributaries Mitigation Project
Monitoring Year 2
Calendar Year of Data Collection: 2021

NCDEQ DMS Project Identification # 100026
NCDEQ DMS Contract # 7181
Yadkin River Basin (Cataloging Unit 03040101)
USACE Action ID Number: SAW-2017-01510
NCDEQ DWR Project # 2017-1156
Surry County, NC
Contracted Under RFP # 16-006993
Data Collection Period: October 2021
Submission Date: December 2021

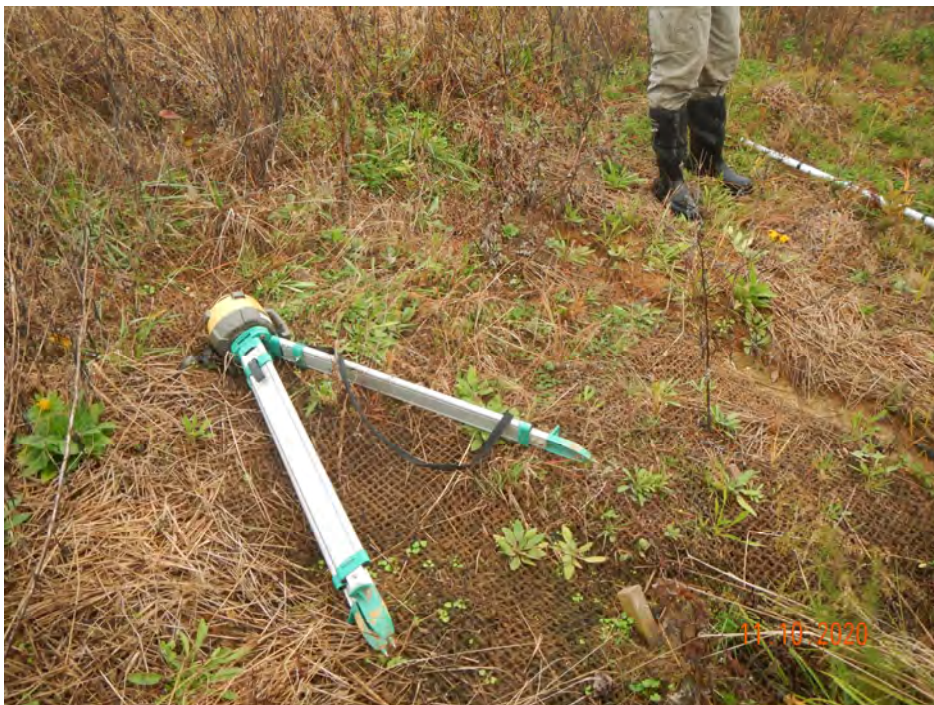
SPA1, R1 Right Floodplain, Minor Slumping (MY-02)

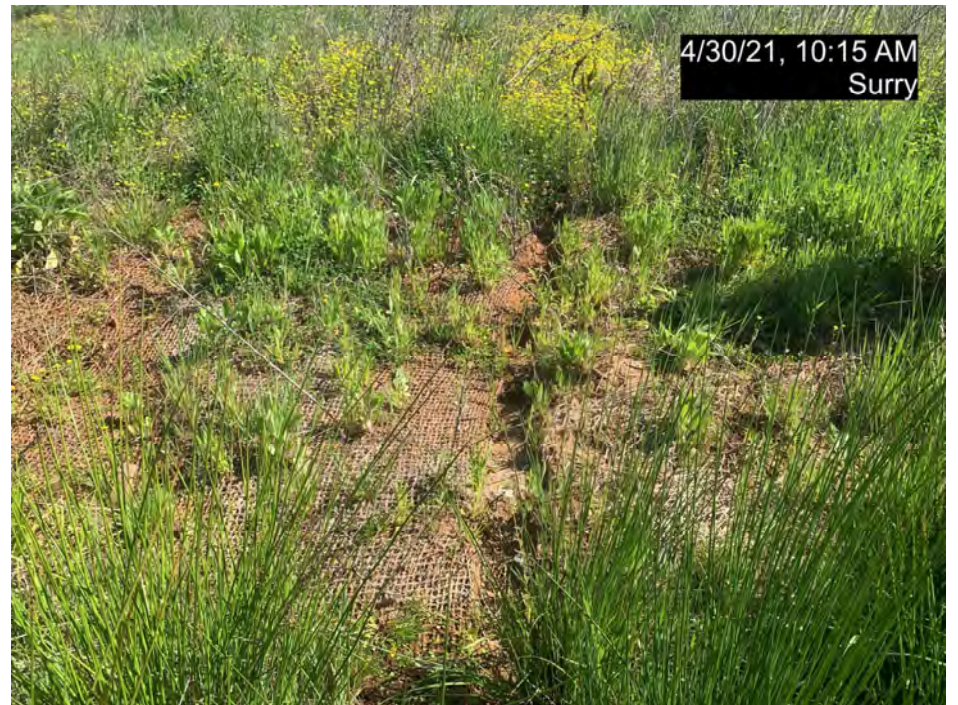
SPA2, R1 Left Floodplain, Minor Erosion (MY-01)

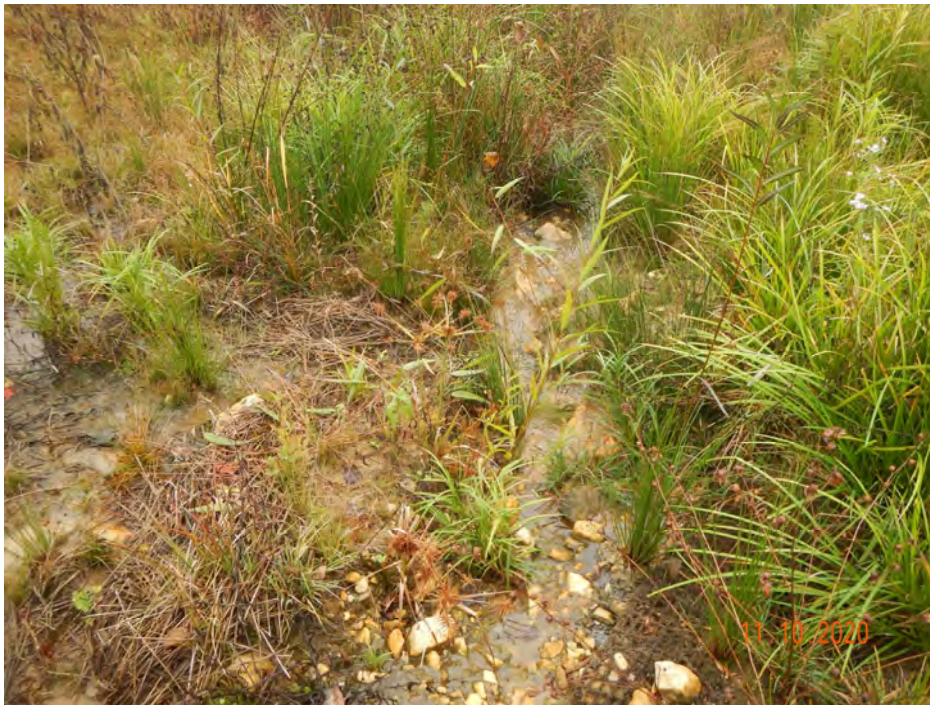
SPA2, R1 Left Floodplain, Minor Erosion (MY-02)

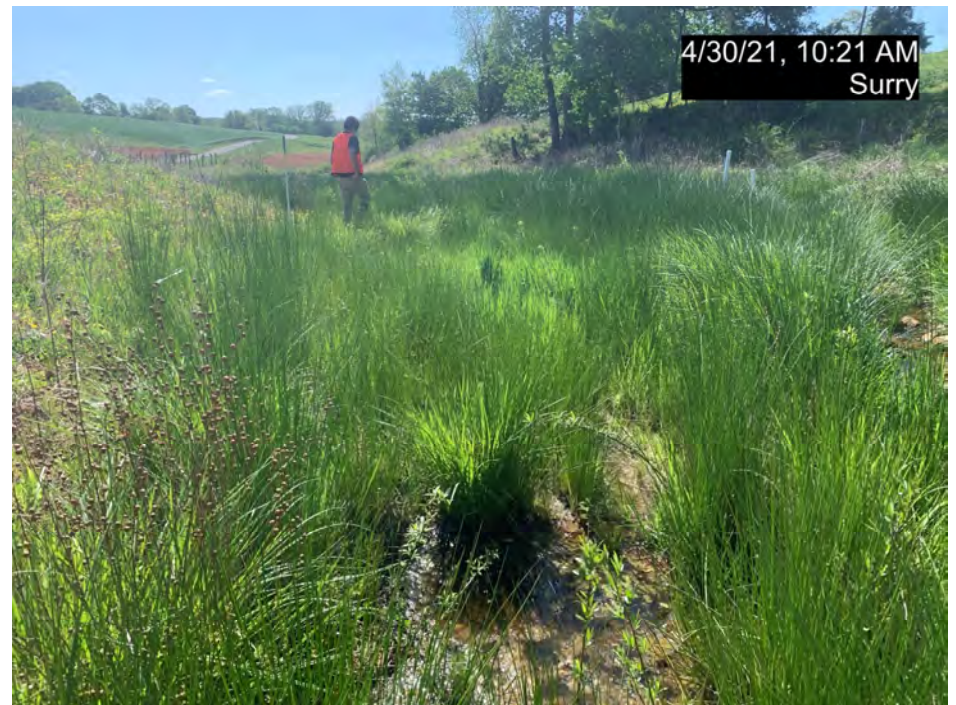
SPA3, R1 Left Floodplain, Minor Erosion (MY-01)

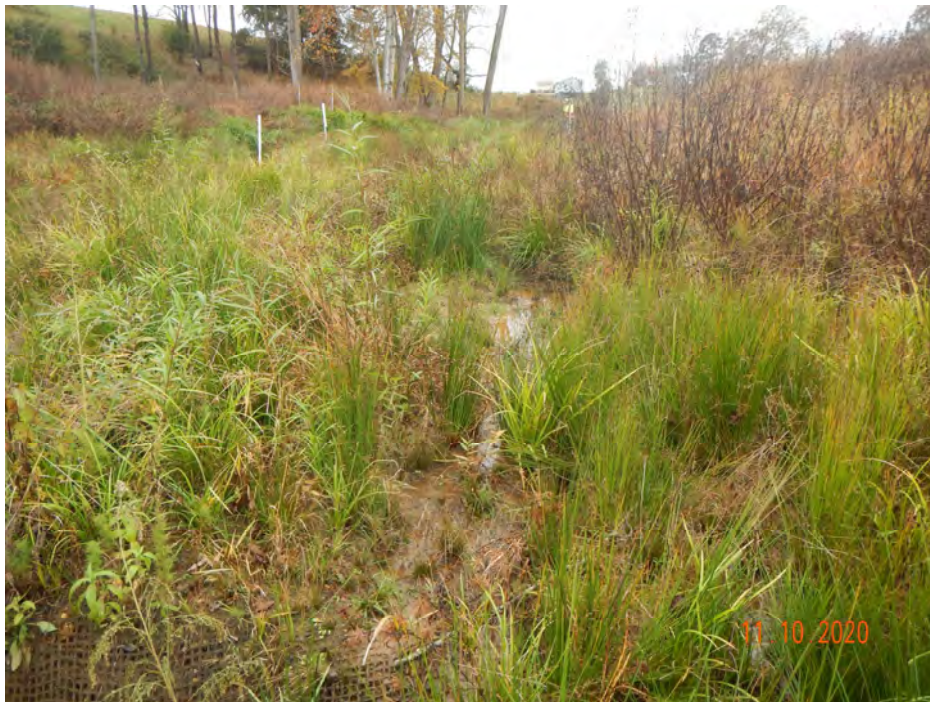
SPA3, R1 Left Floodplain, Minor Erosion (MY-02)

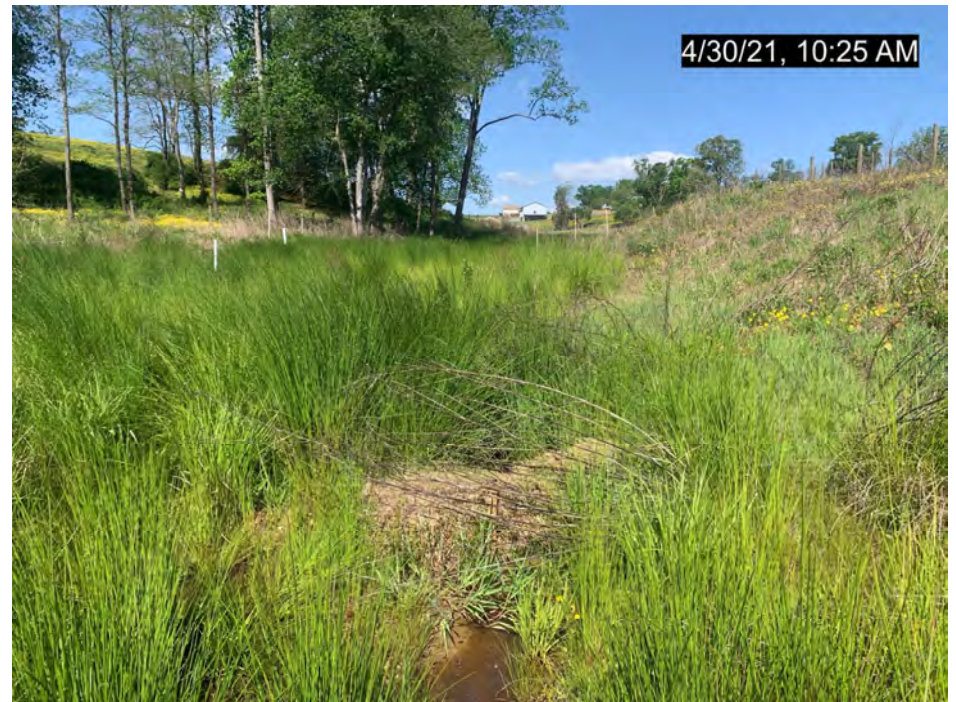
SPA3, R1 Left Floodplain, Minor Erosion (MY-01)

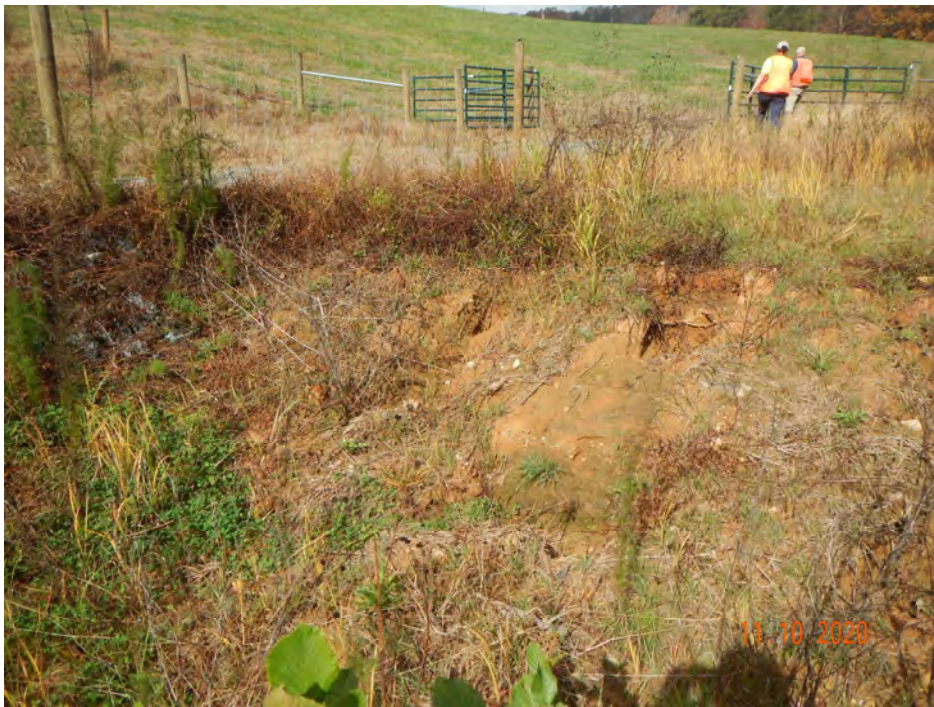
SPA3, R1 Left Floodplain, Minor Erosion (MY-02)

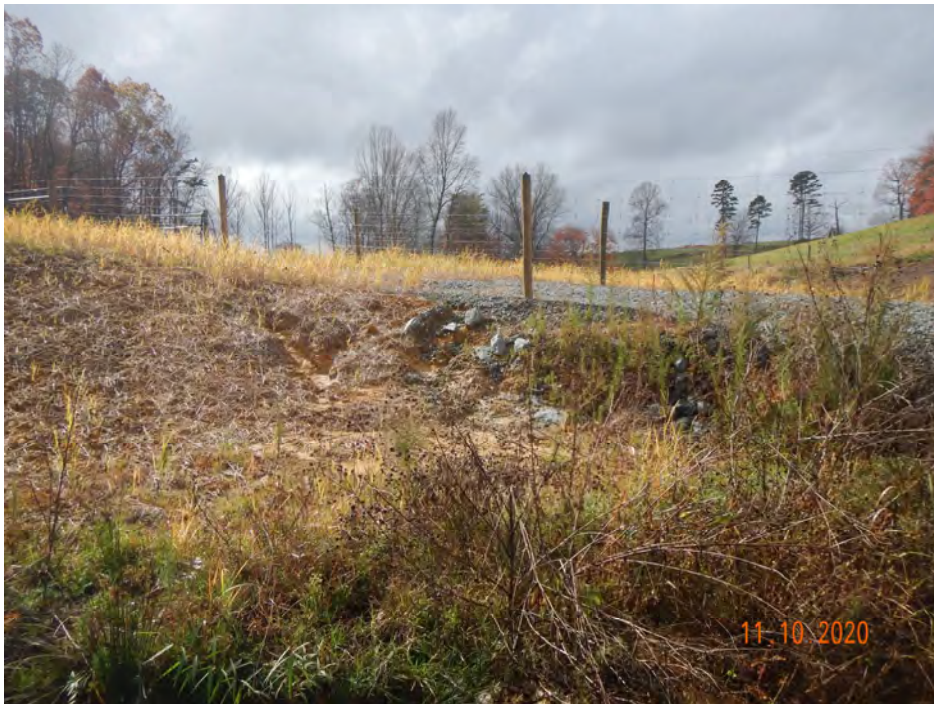
- **SPA4-** On R2, minor erosion was observed on both the right and left bank side slopes at approximate station 15+75, above the culvert crossing.
 - **MY2 Action:** Planted livestakes to stabilize soils in February 2021. Vegetation cover is improving in these areas and WLS will continue to monitor them closely in MY3.

SPA4, R2 Left Floodplain, Minor Erosion (MY-02)

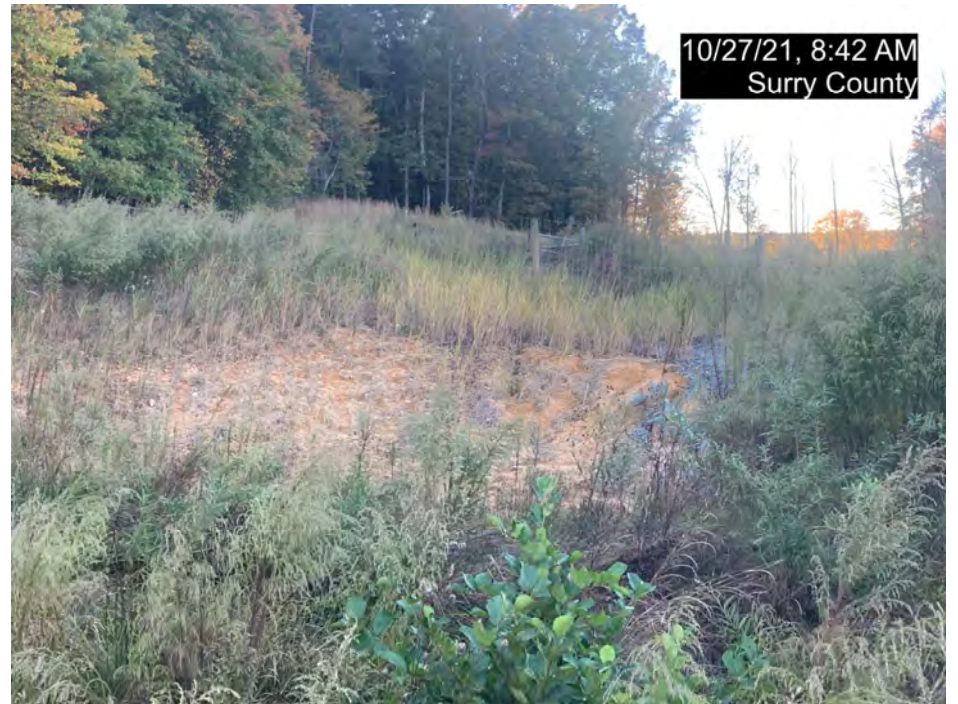
SPA4, R2 Right Floodplain, Minor Erosion (MY-01)

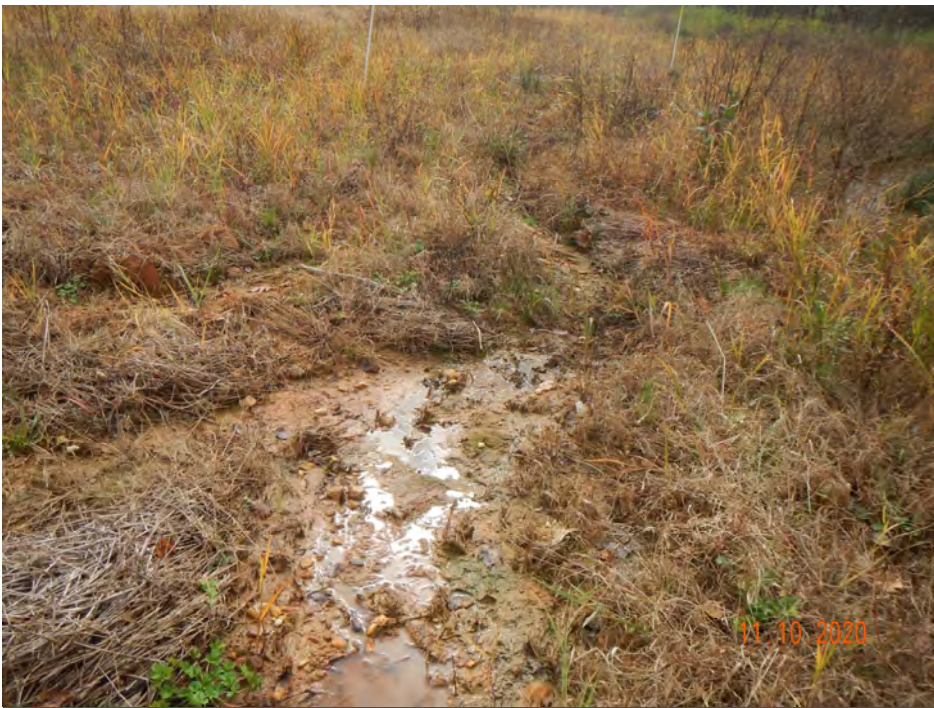
SPA4, R2 Right Floodplain, Minor Erosion (MY-02)

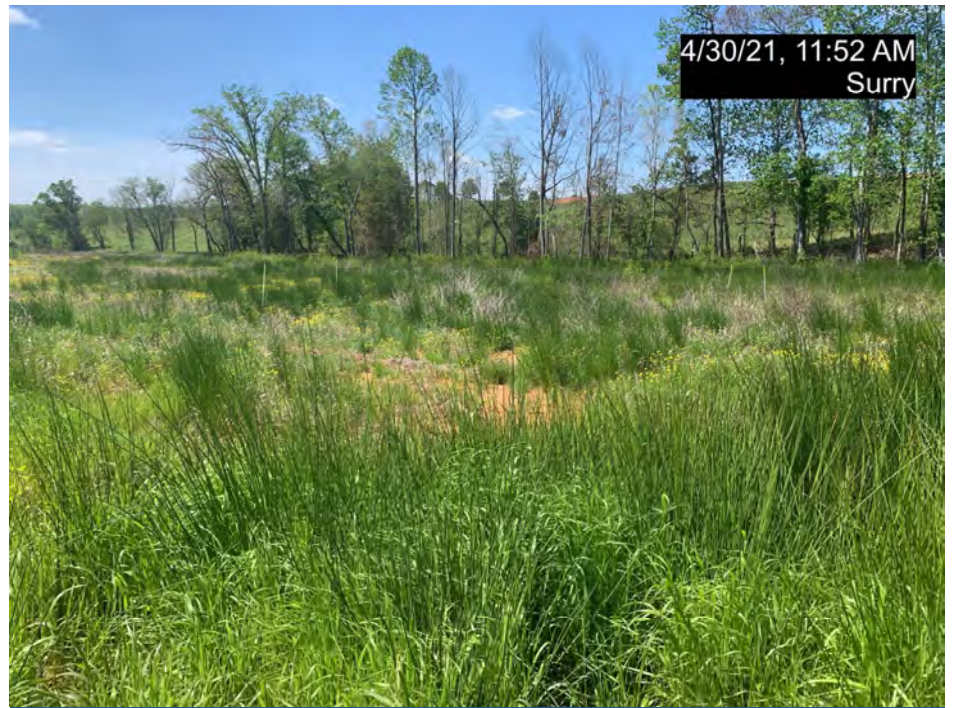
SPA5, R5 Left Floodplain, Minor Erosion (MY-01)

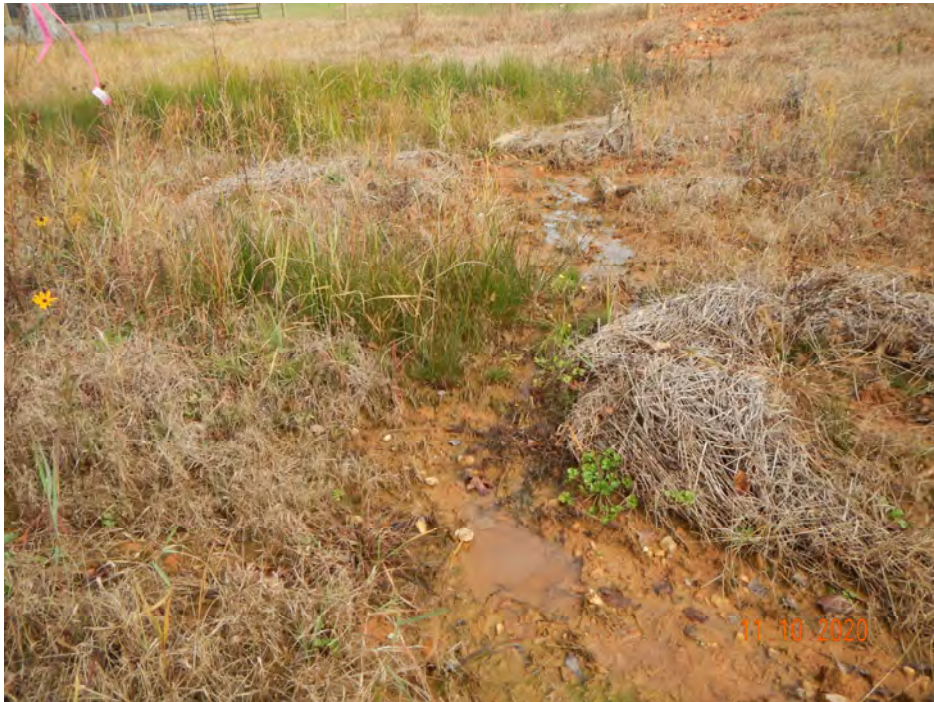
SPA5, R5 Left Floodplain, Minor Erosion (MY-02)

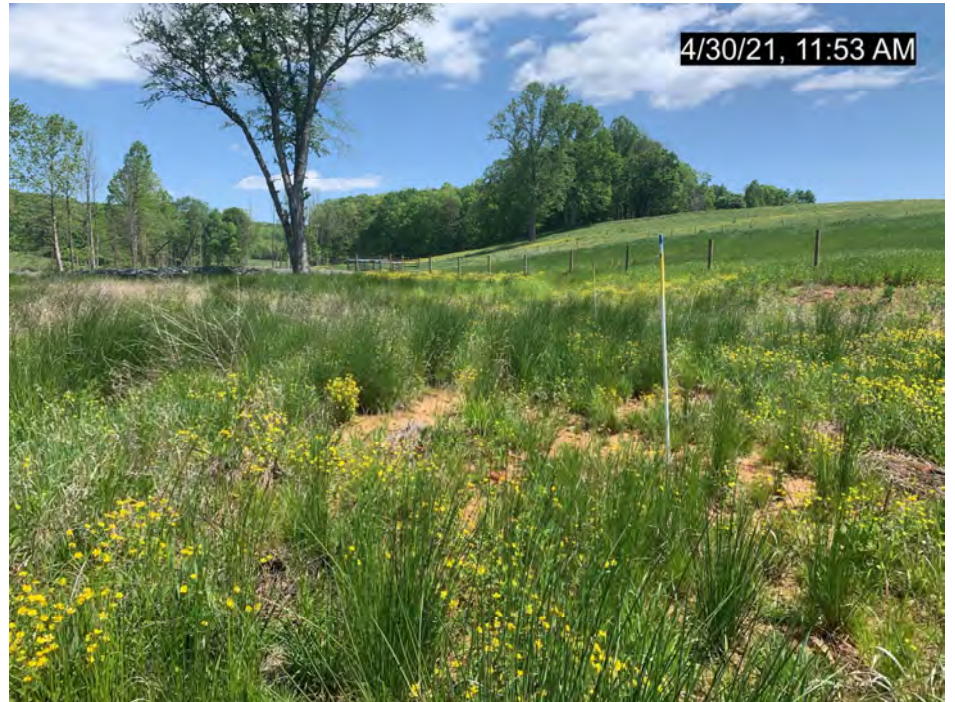
SPA5, R5 Left Floodplain, Minor Erosion (MY-01)

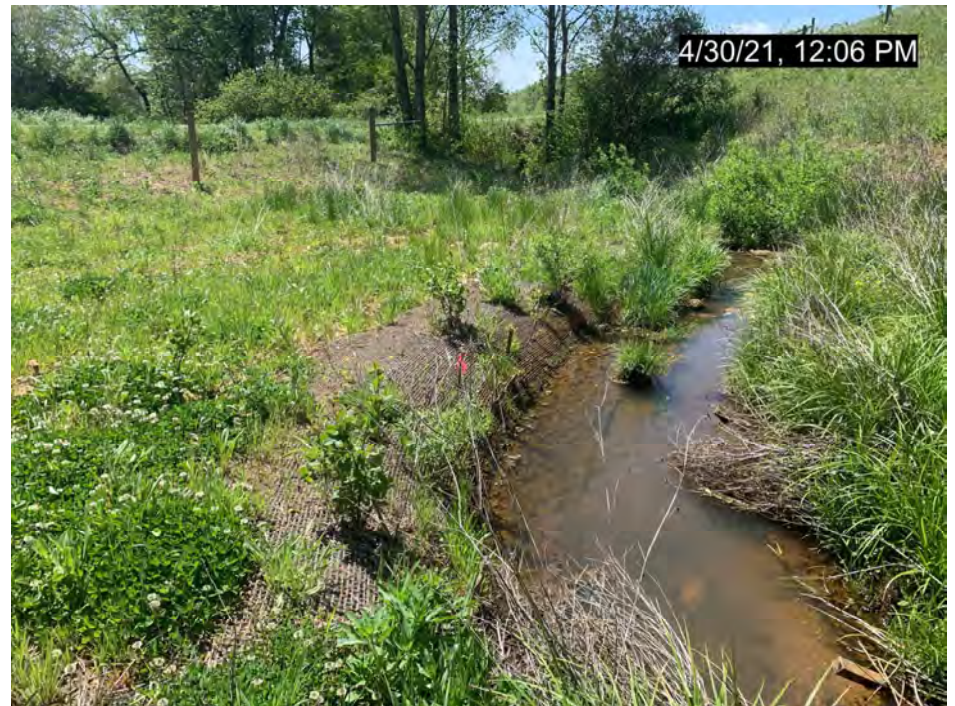
SPA7, R5 Left Bank, Functioning at Risk (MY-01)
