**Jones Creek Mitigation Project
Anson County, North Carolina
DENR-EEP Contract No. D04020-1
FINAL Year 5 Monitoring Report**

April 2011

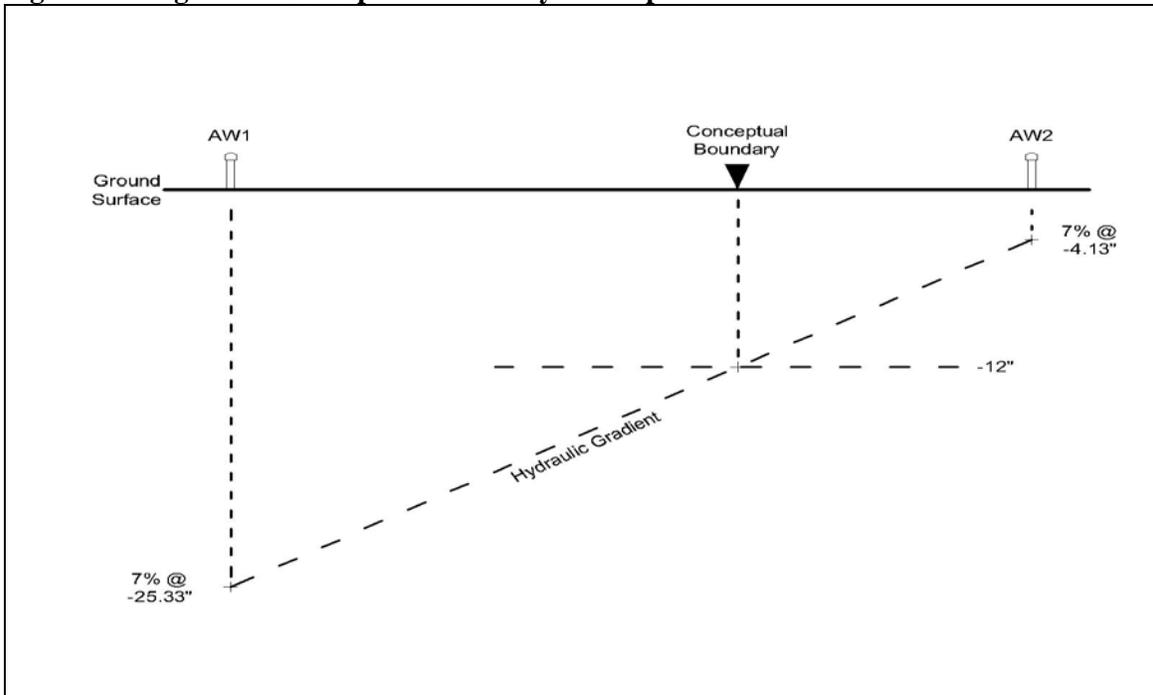
Figure 1. Diagram of Conceptual Boundary Development

For the gauges that failed to meet the 7 percent wetland hydroperiod within 12 inches of the surface a linear hydraulic gradient was developed with an adjacent successful gauge. For example, gauge AW1 had a hydroperiod of 2.6 percent (6 days). The minimum depth at which 7 percent was achieved was -25.33 inches from the surface. Gauge AW2 had a hydroperiod of 27.1 percent (61 days). The minimum depth at which 7 percent was achieved was -4.13 inches below the ground surface. A conceptual boundary was established at the point where the hydraulic gradient between these two gauges crossed below 12 inches from the surface (**Figure 1**).

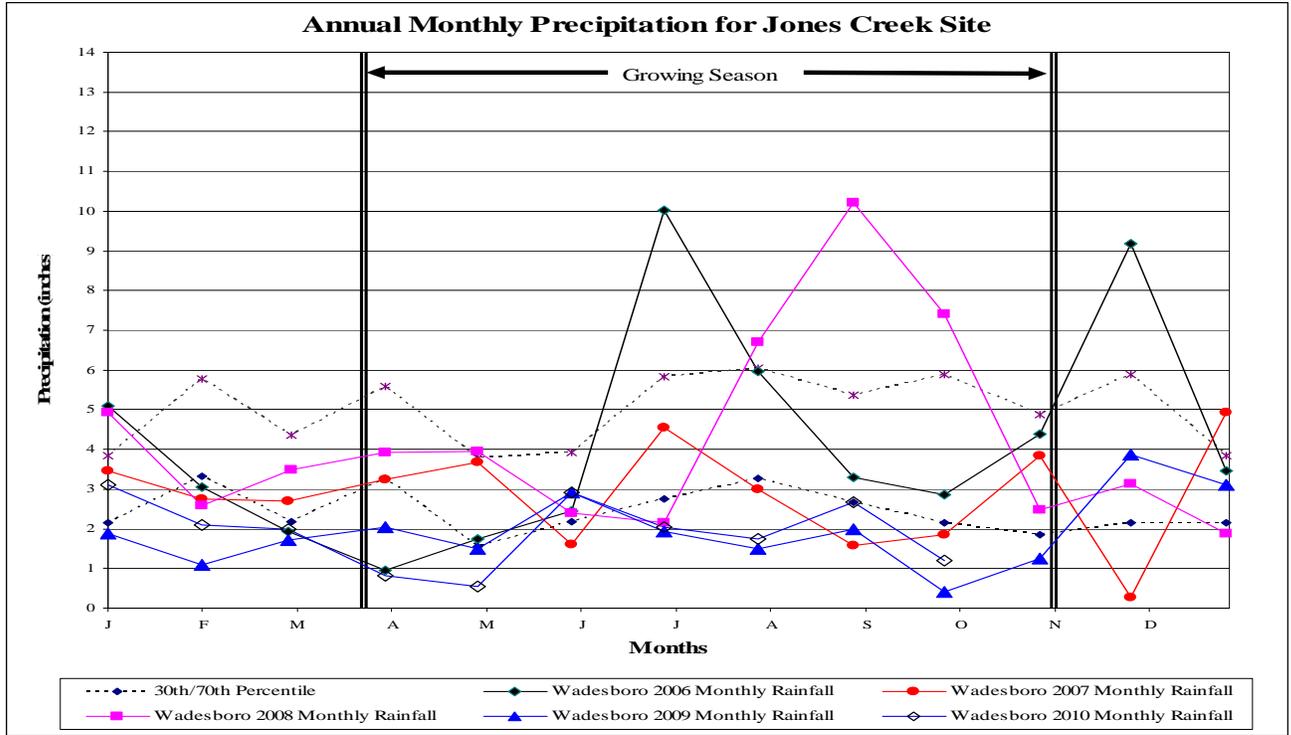
Figure 3. Five-Year Monthly Precipitation for Jones Creek Restoration Site

Annual rainfall during the growing season from 2006 through 2009 has been within the annual normal rainfall amounts except for 2007, which was abnormally dry and most of the state was in a severe drought (**Figure 3** and **Table 3**). The hydroperiod was derived from data recorded during the early part of the growing season and not during the large rain events recorded in August. Rainfall data throughout the monitoring period has exhibited normal to dryer than normal years. Fifty percent of the gauges did not meet the success criteria during 2007. Therefore, the 2007 results are not included in this analysis. During the first year after construction, 2006, many gauges underperformed as the site became saturated and the rainfall for February through April in 2006 was below normal. Despite the drought conditions in 2007, many gauges appeared to maintain similar hydrologic success or in some cases, increased hydroperiods as the site become saturated. The rainfall for 2010 through September indicates a below average rainfall year and possibly below normal.
