**Juniper Bay Wetland Mitigation Site**  
**Robeson County, NC**

**2006 Annual Monitoring Report**  
**Year 1 of 5**

NCEEP Project Number 201

Date: January 2007

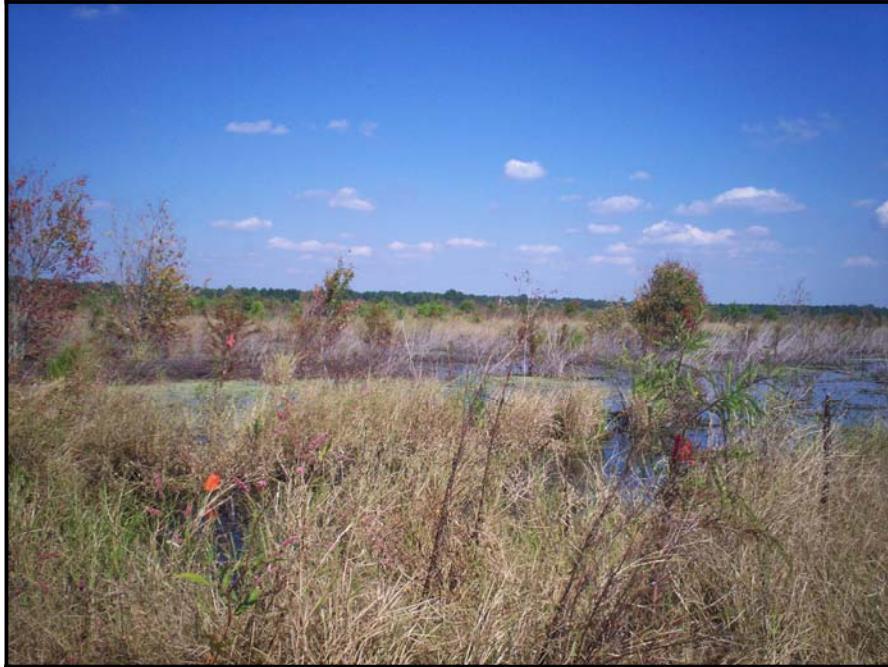
VPA-1

Plot 19

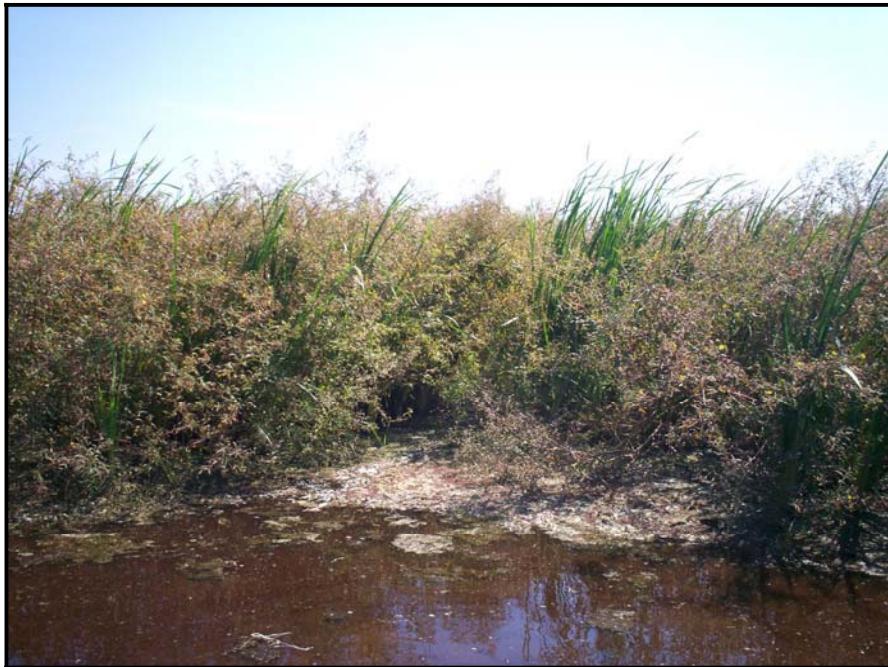
VPA-2

Plot 20

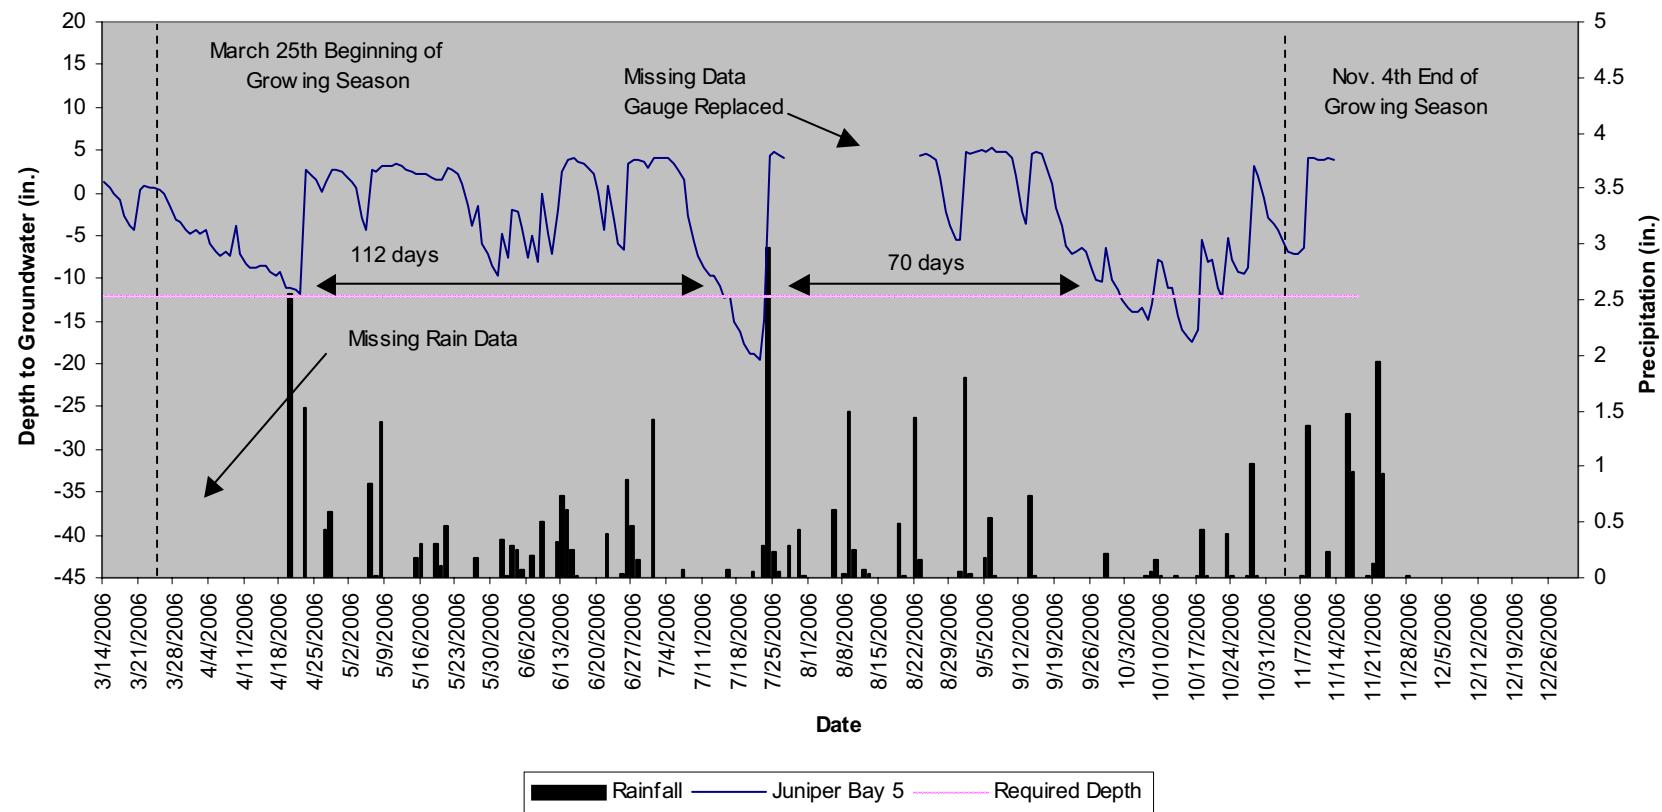
**Juniper Bay**  
**5**  
**40" Groundwater**

Gauges GW-5 and GW-14 malfunctioned for short periods of the growing season and were replaced. These two gauges met the hydrologic success criterion regardless of the periods of missing data. The missing data for Gauge GW-5 does not affect the longest consecutive hydroperiod. Gauge GW-14 recorded 156 consecutive days of jurisdictional hydrology with one data gap. Using adjacent data points to extrapolate missing data, it can be assumed that Gauge GW-14 would have made jurisdictional hydrology for 100% of the growing season.

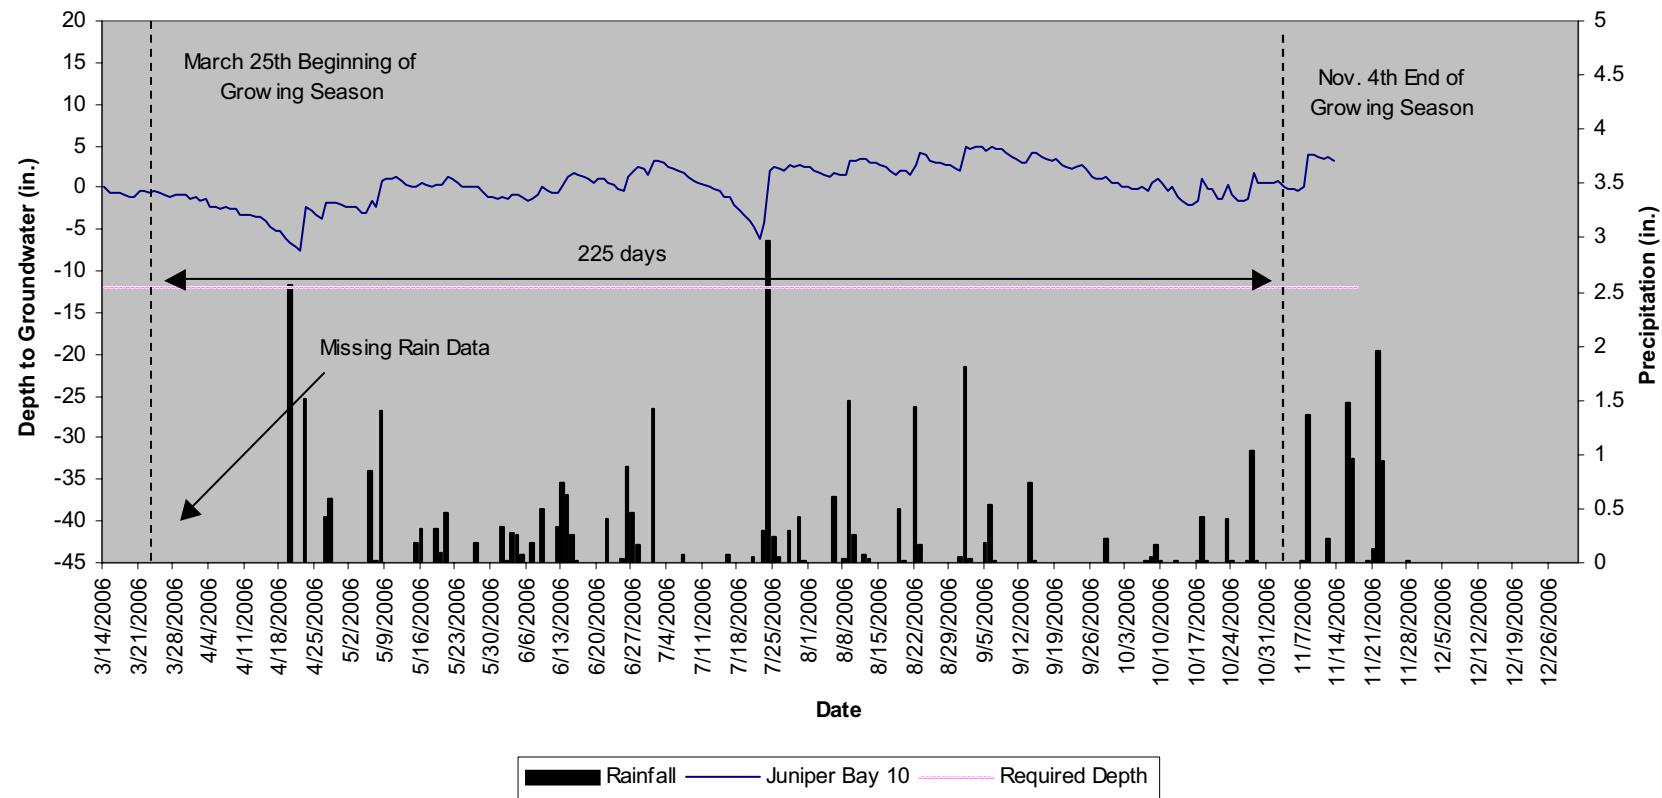
**Juniper Bay**  
**10**  
**40" Groundwater**

Of the 17 remaining gauges in the Pond Pine Woodland/ Bay Forest community, 13 (76.5%) met the hydrological success criterion. Gauges GW-10, GW-34, GW-36, and GW-42 did not meet the hydrologic success criterion. The soils within this community type are sandy with higher infiltration rates than those in the Peatland Atlantic White Cedar Forest/ Bay Forest community. Additionally, the Pond Pine Woodland/ Bay Forest community was designated for areas of the site with higher elevations in the bay. The sandy soils and higher elevations may explain why these gauges did not meet the success criteria, although further observation is warranted.

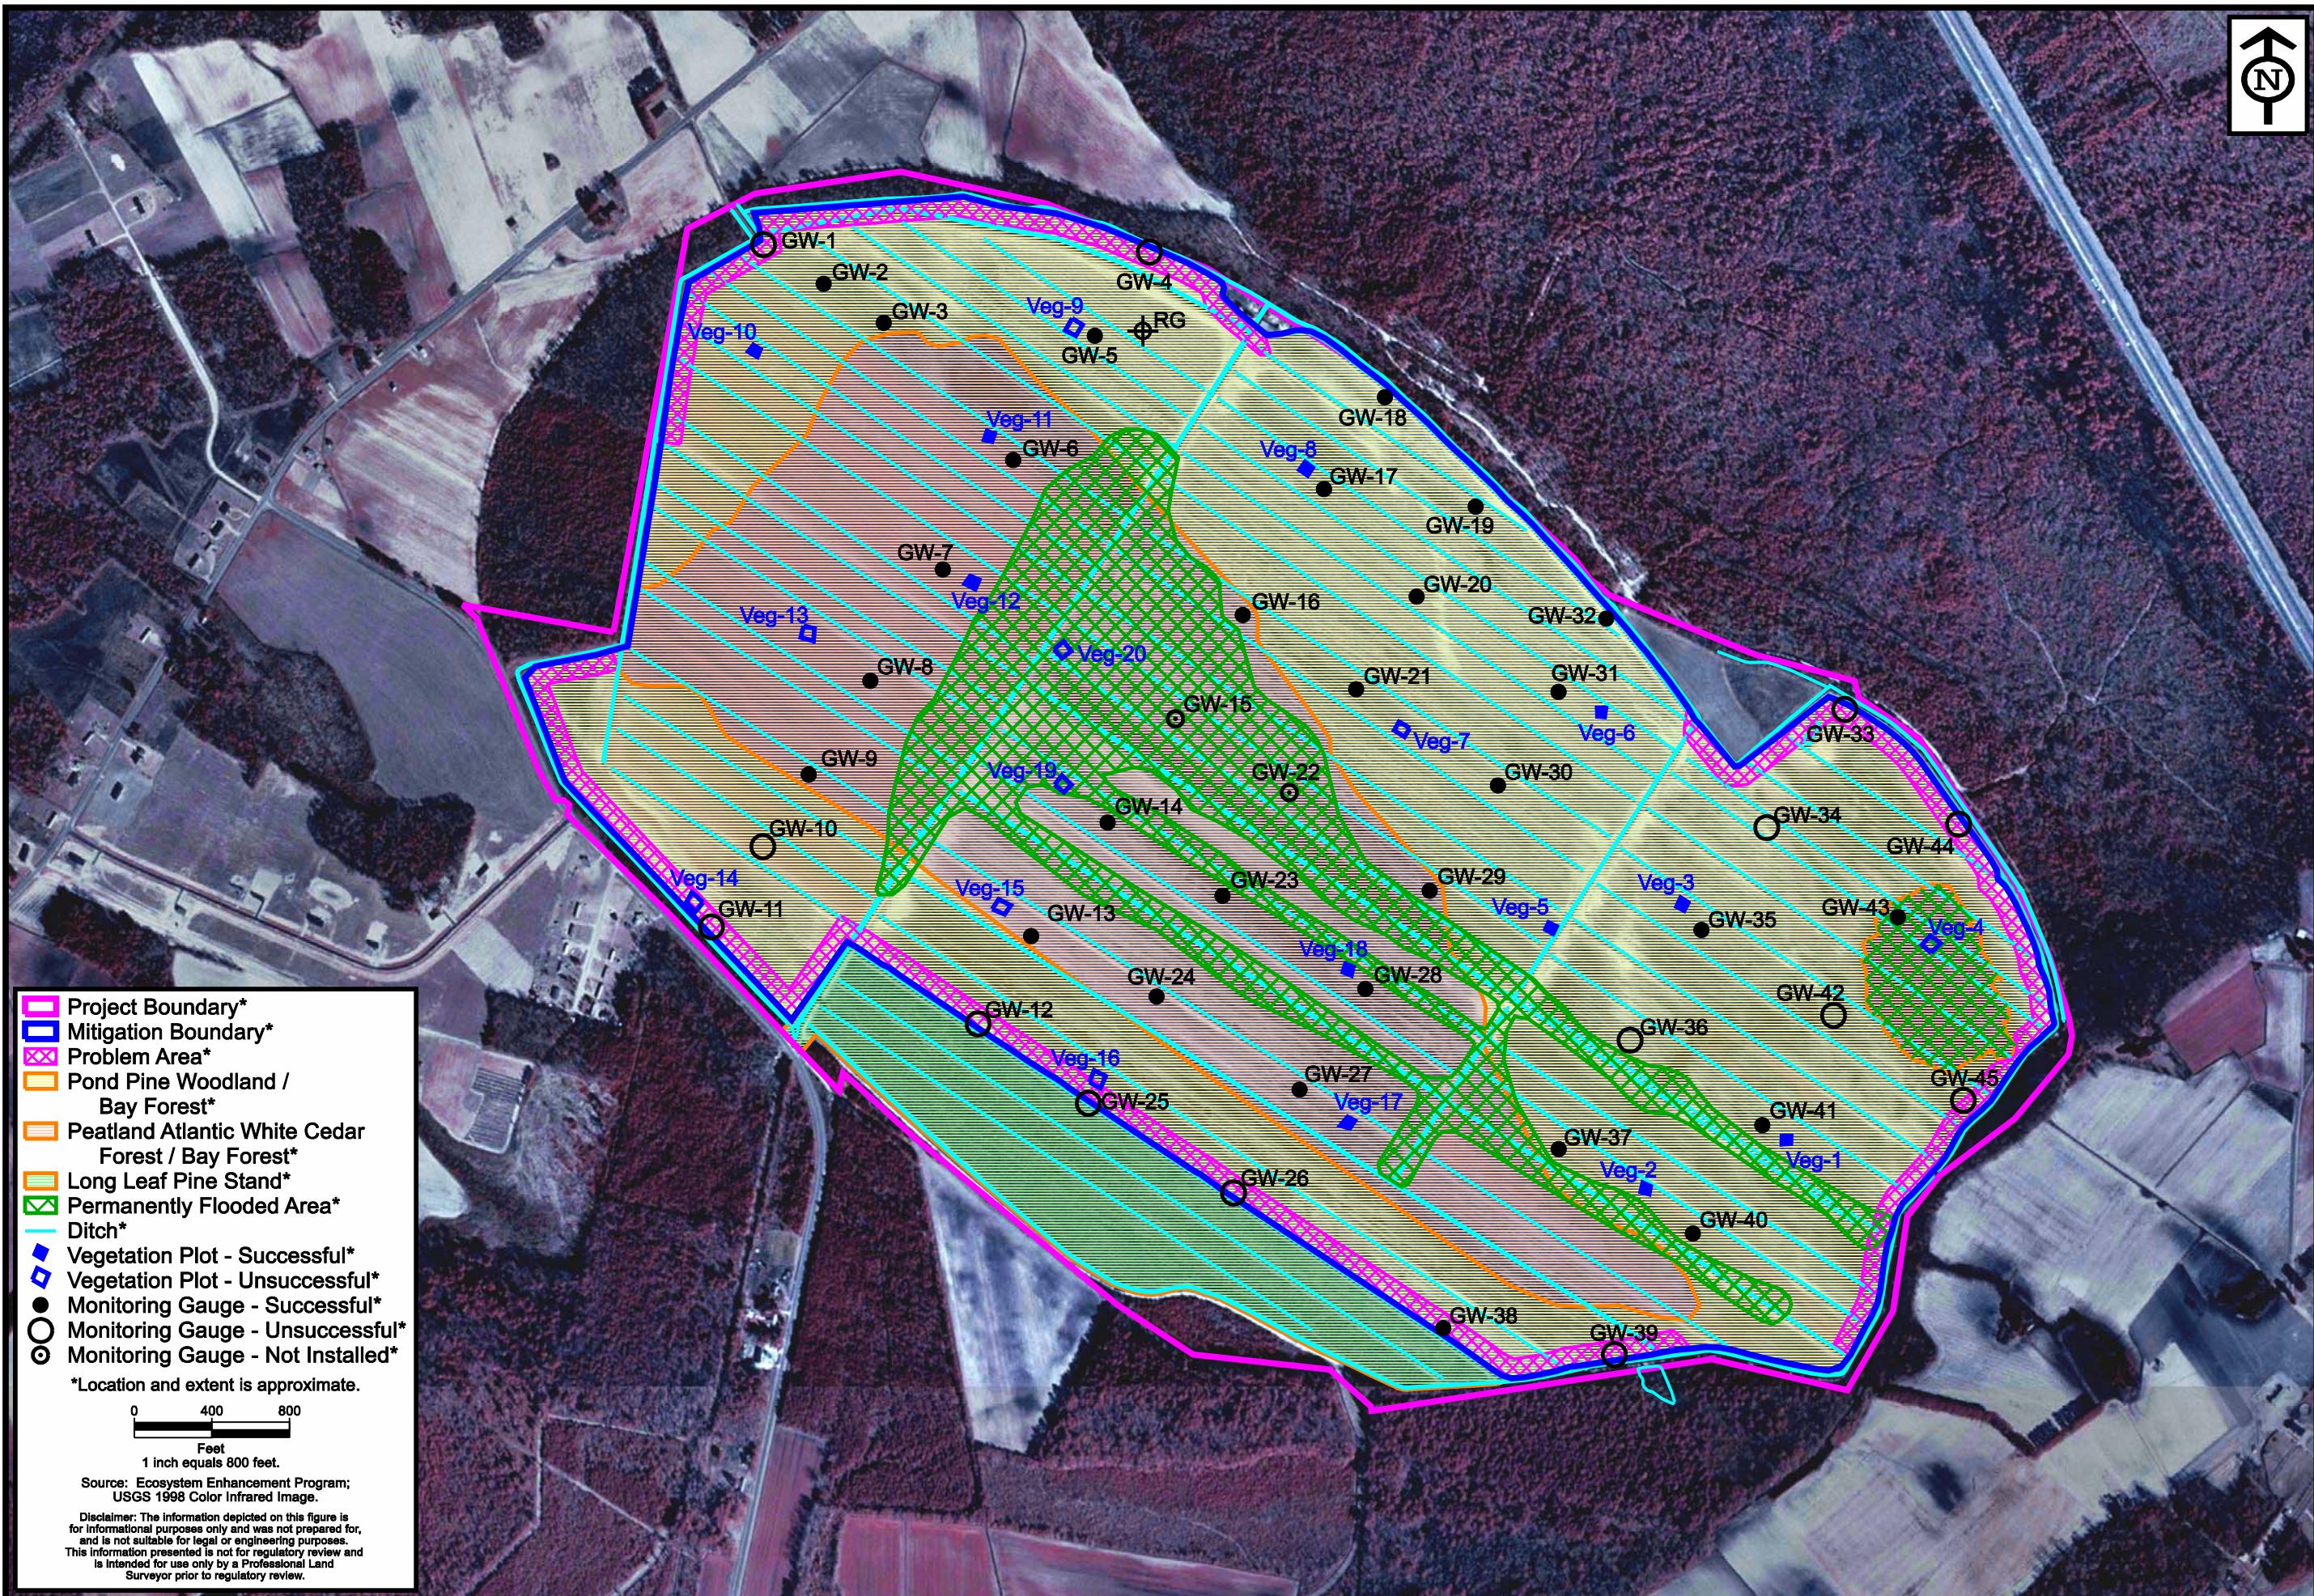
Overall Problem Areas  
**Juniper Bay**  
Robeson County, North Carolina  
Monitoring Report Year 1

Feature/Issue	Plot	Probable Cause	Photo #
Submerged	19	Adjacent to drainage ditch with overtopped bank. >25% of plot submerged > 1 ft.	VPA 1
Submerged	20	Low area in center of site adjacent to drainage ditch. 40% of plot submerged > 1 ft.	VPA 2
Submerged	4	Low area in eastern portion of site. Approximately 1 ft. water across plot.	VPA 3
Herbaceous growth	15	Dense herbaceous midstory.	VPA 4
