## MONITORING YEAR 5 ANNUAL REPORT

### LONE HICKORY MITIGATION SITE

Yadkin County, NC DEQ Contract No. 6897 DMS Project No. 97135 DWR No. 20161044 USACE Action ID No. SAW-2017-00100 Yadkin River Basin HUC 03040101

Data Collection Period: February – November 2023 Draft Submission Date: November 29, 2023 Final Submission Date: January 4, 2024

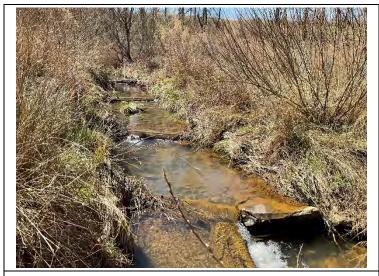
Photo Point 20 – UT1 Reach 3, view upstream (03/07/2023)

Along UT1 Reach 3, some bed scour is present at riffle cross-section 10 and consequently the bank height ratio has increased to 1.4. First noted in MY3, riffle cross-section 28 along UT3 Reach 1 continues to experience some incision. The incision within cross-sections 10 and 28 is isolated and not representative of most riffles within the reach. Refer to section 1.2.5 for further discussion on stream areas of concern.

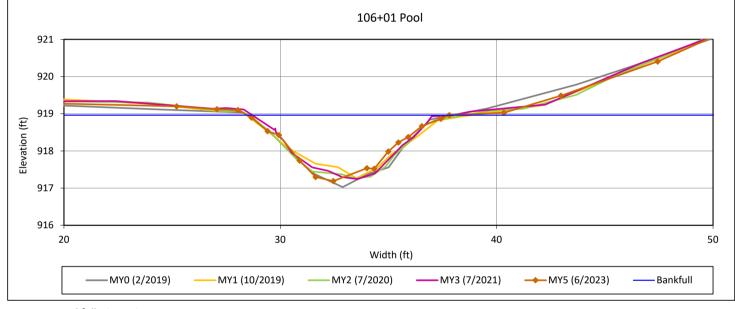
# Cross-Section 1 - UT1 Reach 1

- 8.7 x-section area (ft.sq.) 9.3 width (ft)
- 0.9 mean depth (ft)
- 1.8 max depth (ft)
- 10.2 wetted perimeter (ft)
- hydraulic radius (ft) 0.9
- 10.0 width-depth ratio

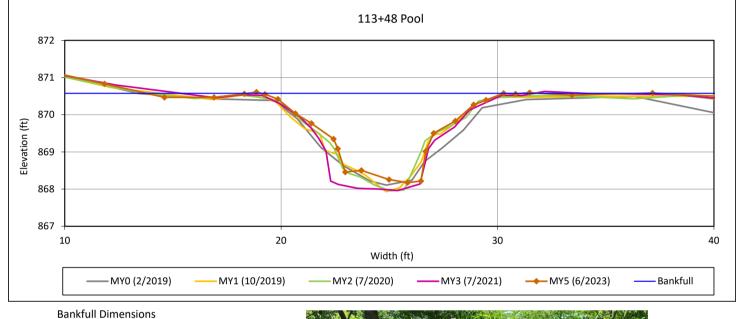
# Cross-Section 3 - UT1 Reach 2A

- 13.1 x-section area (ft.sq.)
- 11.2 width (ft)
- 1.2 mean depth (ft)
- 2.4 max depth (ft)
- 13.0 wetted perimeter (ft)
- hydraulic radius (ft) 1.0
- 9.5 width-depth ratio

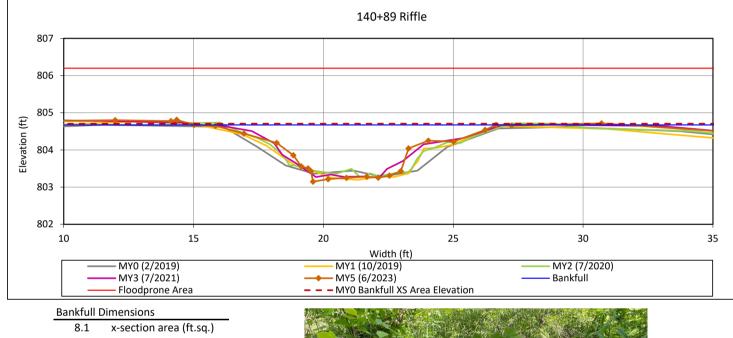
# Cross-Section 9 - UT1 Reach 2B

- 11.6 width (ft)
- 0.7 mean depth (ft)
- 1.5 max depth (ft)
- 12.6 wetted perimeter (ft)
- 0.6 hydraulic radius (ft)
- 16.7 width-depth ratio
- 49.1 W flood prone area (ft)
- 4.2 entrenchment ratio
- 1.0 low bank height ratio

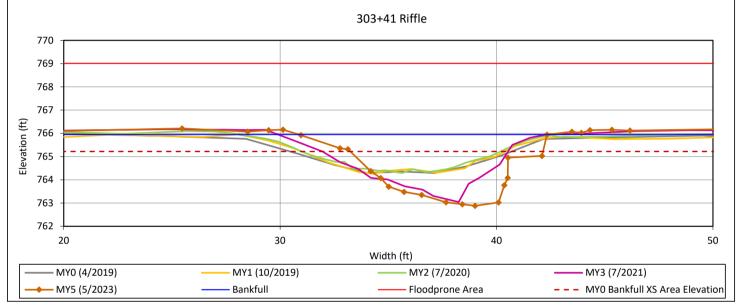
# Cross-Section 28 - UT3 Reach 1

20.2	x-section area (ft.sq.)
11.5	width (ft)
1.8	mean depth (ft)
3.1	max depth (ft)
14.5	wetted perimeter (ft)
1.4	hydraulic radius (ft)
6.5	width-depth ratio
73.3	W flood prone area (ft)
6.4	entrenchment ratio
1.3	low bank height ratio

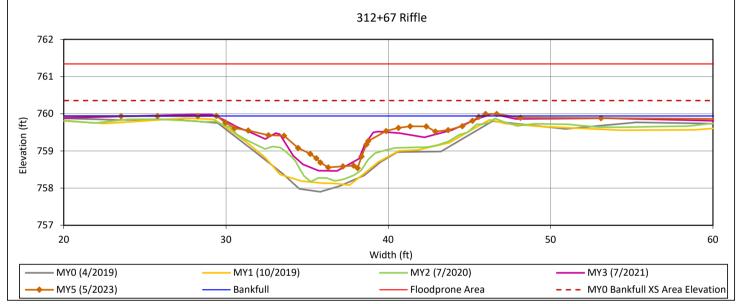
# Cross-Section 29 - UT3 Reach 2

9.6	x-section area (ft.sq.)
16.3	width (ft)
0.6	mean depth (ft)
1.4	max depth (ft)
16.9	wetted perimeter (ft)
0.6	hydraulic radius (ft)
27.5	width-depth ratio
75.6	W flood prone area (ft)
4.6	entrenchment ratio
0.8	low bank height ratio

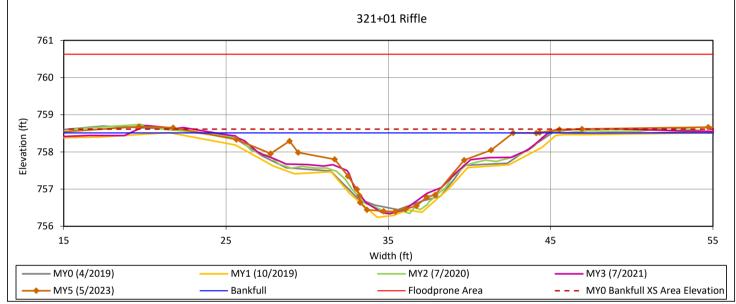
# Cross-Section 31 - UT3 Reach 3

17.5 x-section area (ft.sq.) 19.2 width (ft) 0.9 mean depth (ft) 2.1 max depth (ft) 20.3 wetted perimeter (ft) 0.9 hydraulic radius (ft) 21.1 width-depth ratio 70.7 W flood prone area (ft) 3.7 entrenchment ratio 1.0 low bank height ratio
