McKee Creek Stream Restoration Monitoring Report – Year 5 of 5 FINAL

Contract # 004391 DMS Project # 92573

Cabarrus County, North Carolina

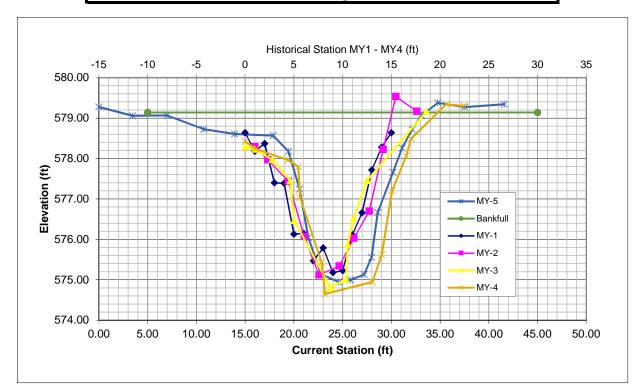
Longitudinal Profile Plot				
River Basin Yadkin Pee-Dee				
Watershed McKee Reach 1				
Station 24+00 - 28+00				
Date 10/26/2016				
Field Crew Richmond/McLaurin

Surveyed elevation data for the enhancement section shows the channel to be approximately in the same profile as prior surveys, with possible evidence of minor aggradation over time, likely the result of natural stabilization. Sediment bars and pools were noted in this area, with consistent pattern and profile, differentiated substrate, and groundwater discharge throughout the reach. The constructed J-hook near Station 27+00 has naturalized and appears to have met intended function.

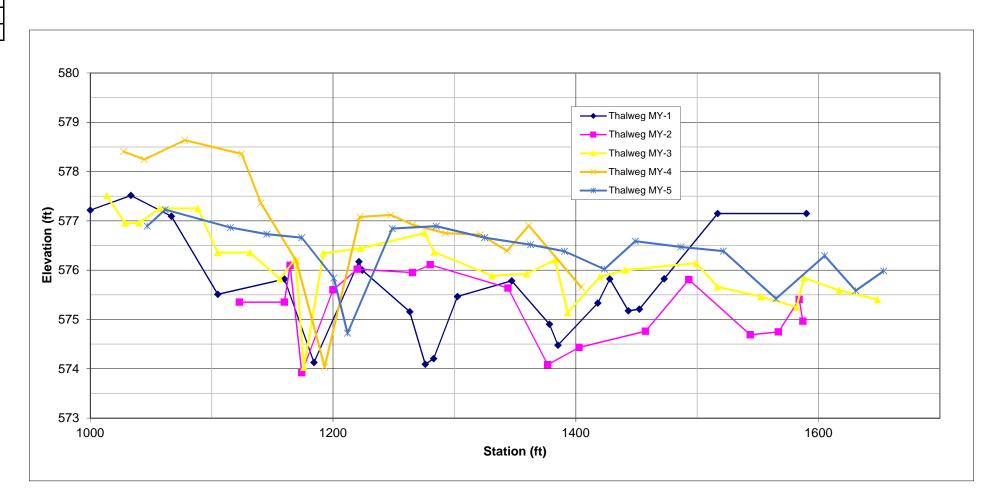
Longitudinal Profile Plot			
River Basin Yadkin Pee-Dee			
Watershed Clear Creek			
Station 11+00 - 28+00			
Date 11/22/2016			
Field Crew Phillips/McLaurin

Between Stations 25+00 and 27+00, there is evidence of channel degradation in the lower reach of the stream, primarily in the form of channel incising and reduced substrate sorting. This area was also impacted during the 2012 tornado, and a majority of the mature hardwood vegetation was lost in the riparian area of this reach.

Structures located approximately between Stations: 23+00 – 27+25 are failing and have significant downcutting. DMS will be implementing project repair on the failing reach of Clear Creek. The repair will include the installation of six (6) constructed ruffles and the removal or repair of existing structures to stabilize and re-establish the channel profile to approximately the original design configuration. The repair will also include minimal supplemental planting and planting of the disturbed areas. The repair work will be completed in February 2017.
