Annual Monitoring Report

Monitoring Year 3 of 5

Middle South Muddy Stream Restoration Site

NCDMS Project No.: 93875

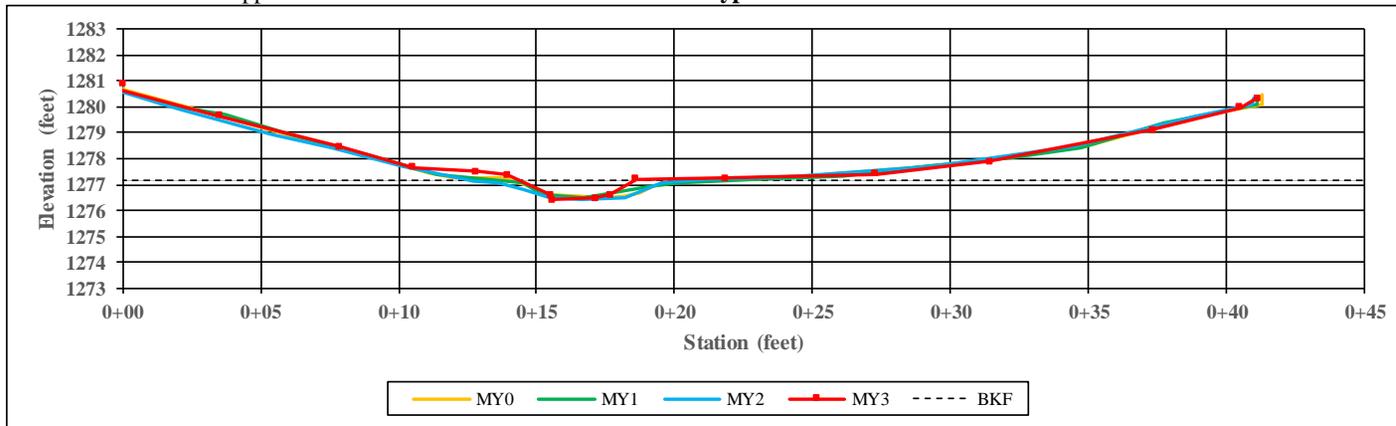
XS Number: 10
XS Type: Riffle

CHANNEL DIMENSIONS SUMMARY	MY0	MY1	MY2	MY3	MY4	MY5	MY6	MY7
Bankful Width (ft)	5.3	5.6	5.8	4.2	-	-	-	-
Floodprone Width (ft)	17.0	17.0	17.0	17.0	-	-	-	-
Bankfull Mean Depth (ft)	0.4	0.3	0.4	0.5	-	-	-	-
Bankfull Max Depth (ft)	0.6	0.6	0.6	0.8	-	-	-	-
Bankfull Cross-Sectional Area (ft ²)	2.1	1.9	2.5	2.1	-	-	-	-
Width/Depth Ratio	13.3	16.7	13.3	8.4	-	-	-	-
Entrenchment Ratio	3.2	3.0	3.0	4.0	-	-	-	-
Bank Height Ratio	1.0	1.0	1.0	1.0	-	-	-	-
Low Top of Bank Depth (ft)	-	-	-	0.8	-	-	-	-

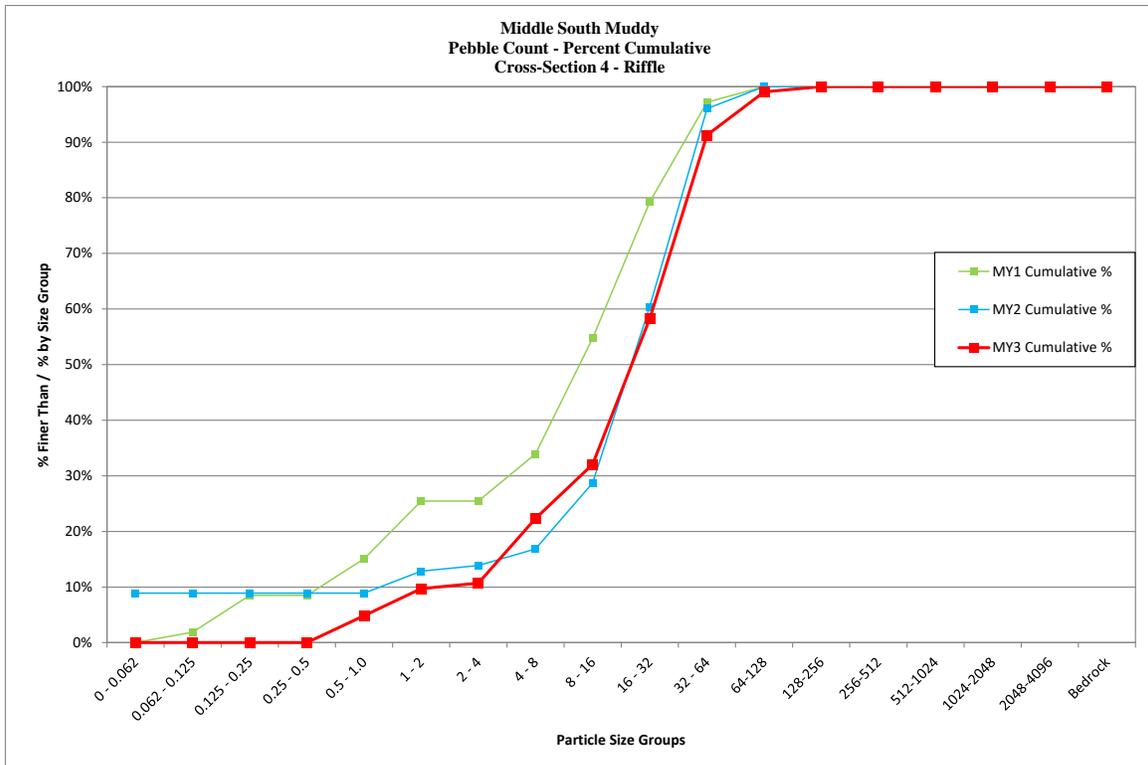
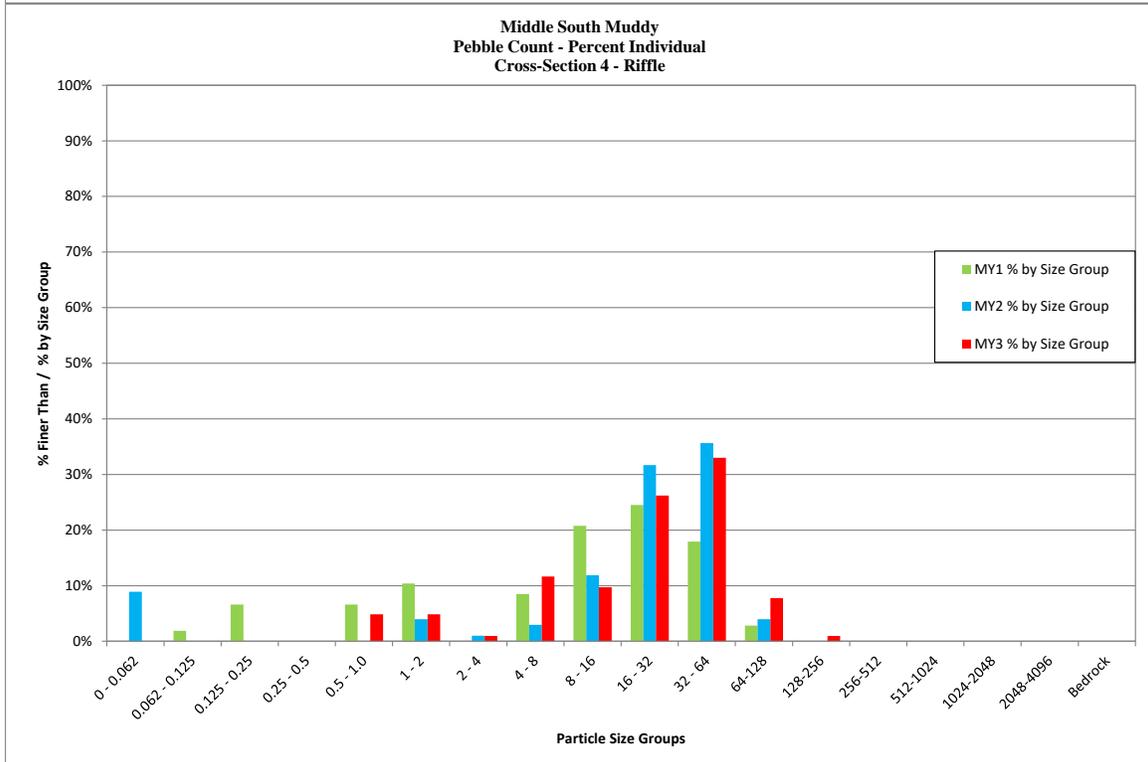
Middle South Muddy			
Cross Section 4 - Riffle			
Monitoring Year - 2018; MY3			
Bed Surface Material Particle Size Class (mm)	Number	% Individual	% Cumulative
0 - 0.062	0	0.0%	0%
0.062 - 0.125	0	0.0%	0%
0.125 - 0.25	0	0.0%	0%
0.25 - 0.5	0	0.0%	0%
0.5 - 1.0	5	4.9%	5%
1 - 2	5	4.9%	10%
2 - 4	1	1.0%	11%
4 - 8	12	11.7%	22%
8 - 16	10	9.7%	32%
16 - 32	27	26.2%	58%
32 - 64	34	33.0%	91%
64-128	8	7.8%	99%
128-256	1	1.0%	100%
256-512	0	0.0%	100%
512-1024	0	0.0%	100%
1024-2048	0	0.0%	100%
2048-4096	0	0.0%	100%
Bedrock	0	0.0%	100%
Total	103	100%	100%
		Summary Data	
		D50	27
		D84	52
		D95	83

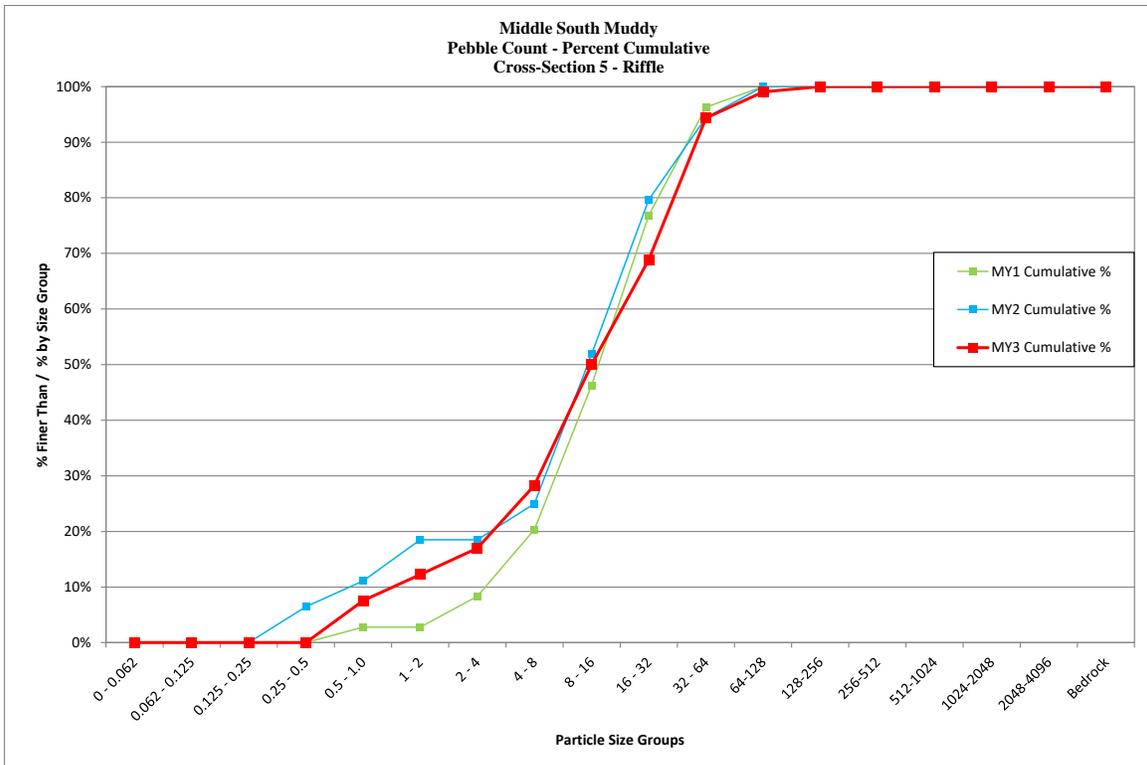
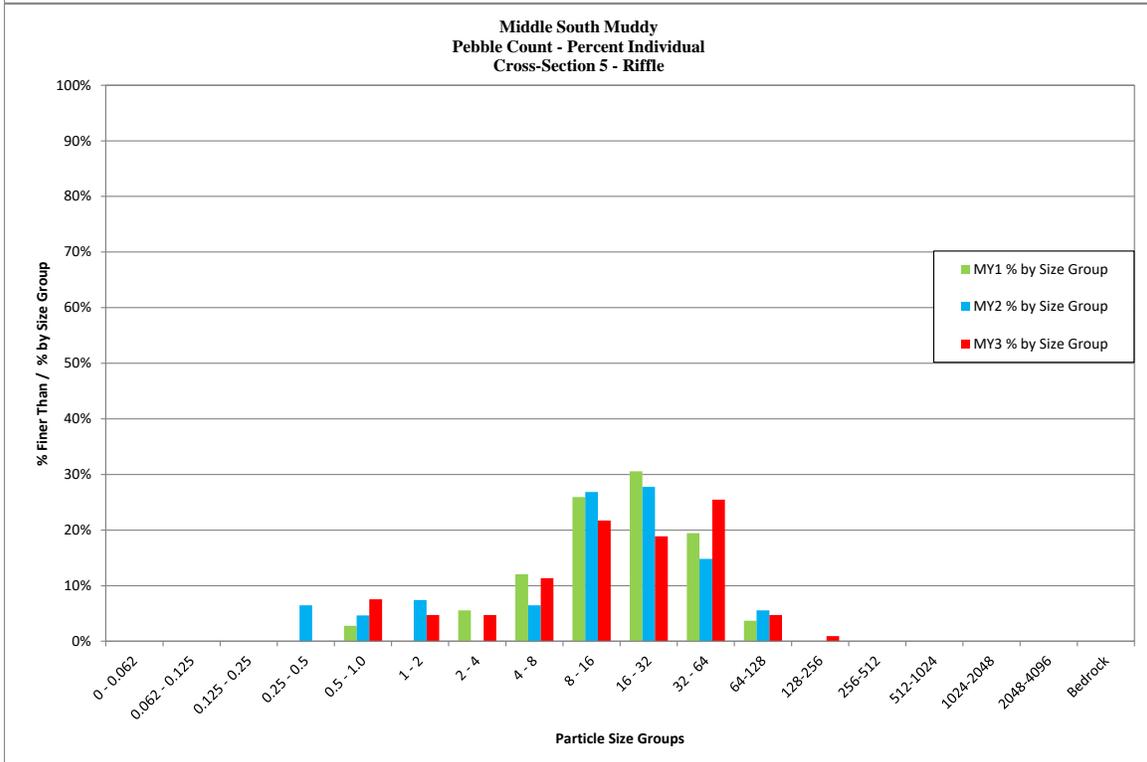
Middle South Muddy			
Cross Section 5 - Riffle			
Monitoring Year - 2018; MY3			
Bed Surface Material Particle Size Class (mm)	Number	% Individual	% Cumulative
0 - 0.062	0	0.0%	0%
0.062 - 0.125	0	0.0%	0%
0.125 - 0.25	0	0.0%	0%
0.25 - 0.5	0	0.0%	0%
0.5 - 1.0	8	7.5%	8%
1 - 2	5	4.7%	12%
2 - 4	5	4.7%	17%
4 - 8	12	11.3%	28%
8 - 16	23	21.7%	50%
16 - 32	20	18.9%	69%
32 - 64	27	25.5%	94%
64-128	5	4.7%	99%
128-256	1	0.9%	100%
256-512	0	0.0%	100%
512-1024	0	0.0%	100%
1024-2048	0	0.0%	100%
2048-4096	0	0.0%	100%
Bedrock	0	0.0%	100%
Total	106	100%	100%
		Summary Data	
		D50	16
		D84	48
		D95	68

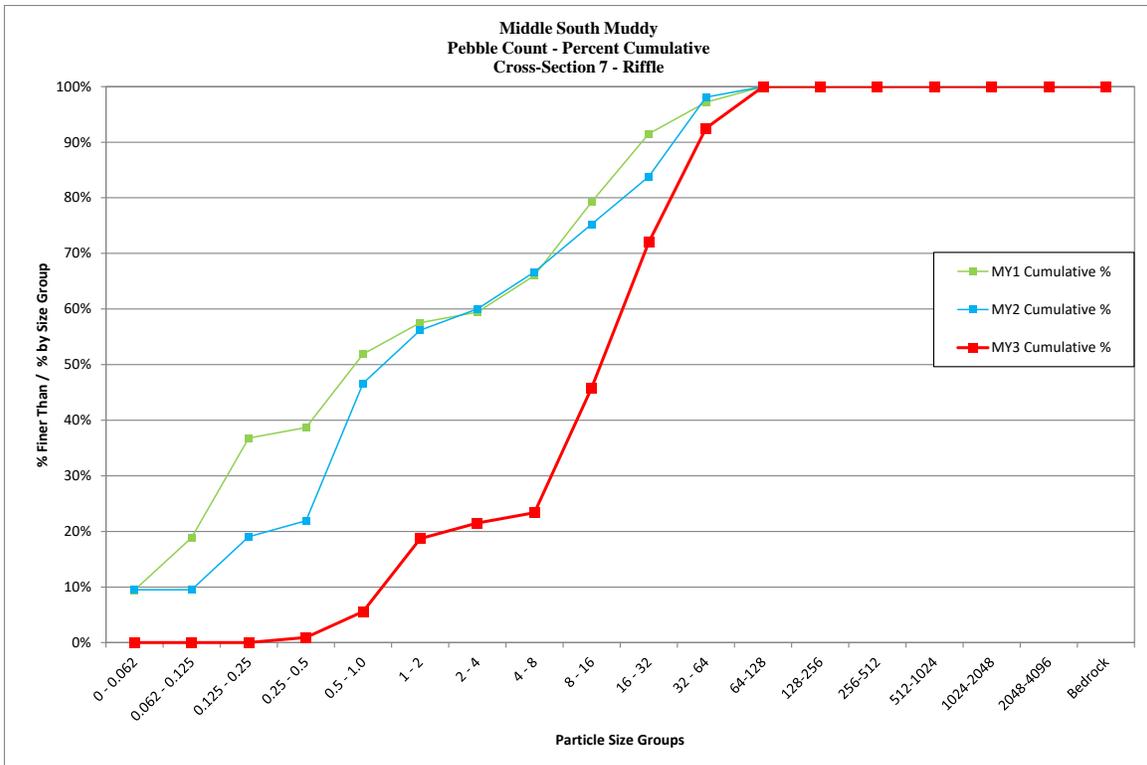
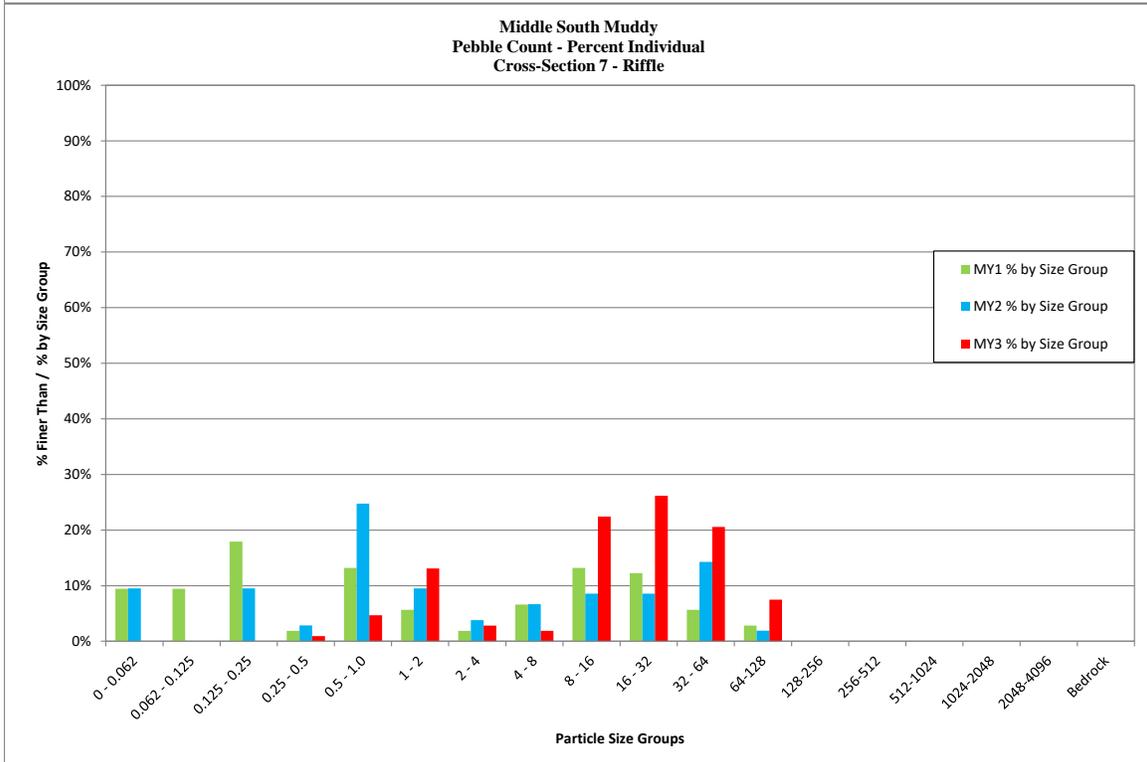
Middle South Muddy			
Cross Section 7 - Riffle			
Monitoring Year - 2018; MY3			
Bed Surface Material Particle Size Class (mm)	Number	% Individual	% Cumulative
0 - 0.062	0	0.0%	0%
0.062 - 0.125	0	0.0%	0%
0.125 - 0.25	0	0.0%	0%
0.25 - 0.5	1	0.9%	1%
0.5 - 1.0	5	4.7%	6%
1 - 2	14	13.1%	19%
2 - 4	3	2.8%	21%
4 - 8	2	1.9%	23%
8 - 16	24	22.4%	46%
16 - 32	28	26.2%	72%
32 - 64	22	20.6%	93%
64-128	8	7.5%	100%
128-256	0	0.0%	100%
256-512	0	0.0%	100%
512-1024	0	0.0%	100%
1024-2048	0	0.0%	100%
2048-4096	0	0.0%	100%
Bedrock	0	0.0%	100%
Total	107	100%	100%
		Summary Data	
		D50	18
		D84	46
		D95	80
