## MORGAN CREEK FLOODPLAIN RESTORATION SITE #258 Mason Farm Biological Reserve – UNC-Chapel Hill – Orange/Durham Co. Cape Fear River HUC# 03030002-060080

### MY-5 (2015) ANNUAL MONITORING REPORT (Final)

#### North Carolina Department of Environmental Quality Division of Mitigation Services (DEQ-DMS) -- Contract # 16-005217

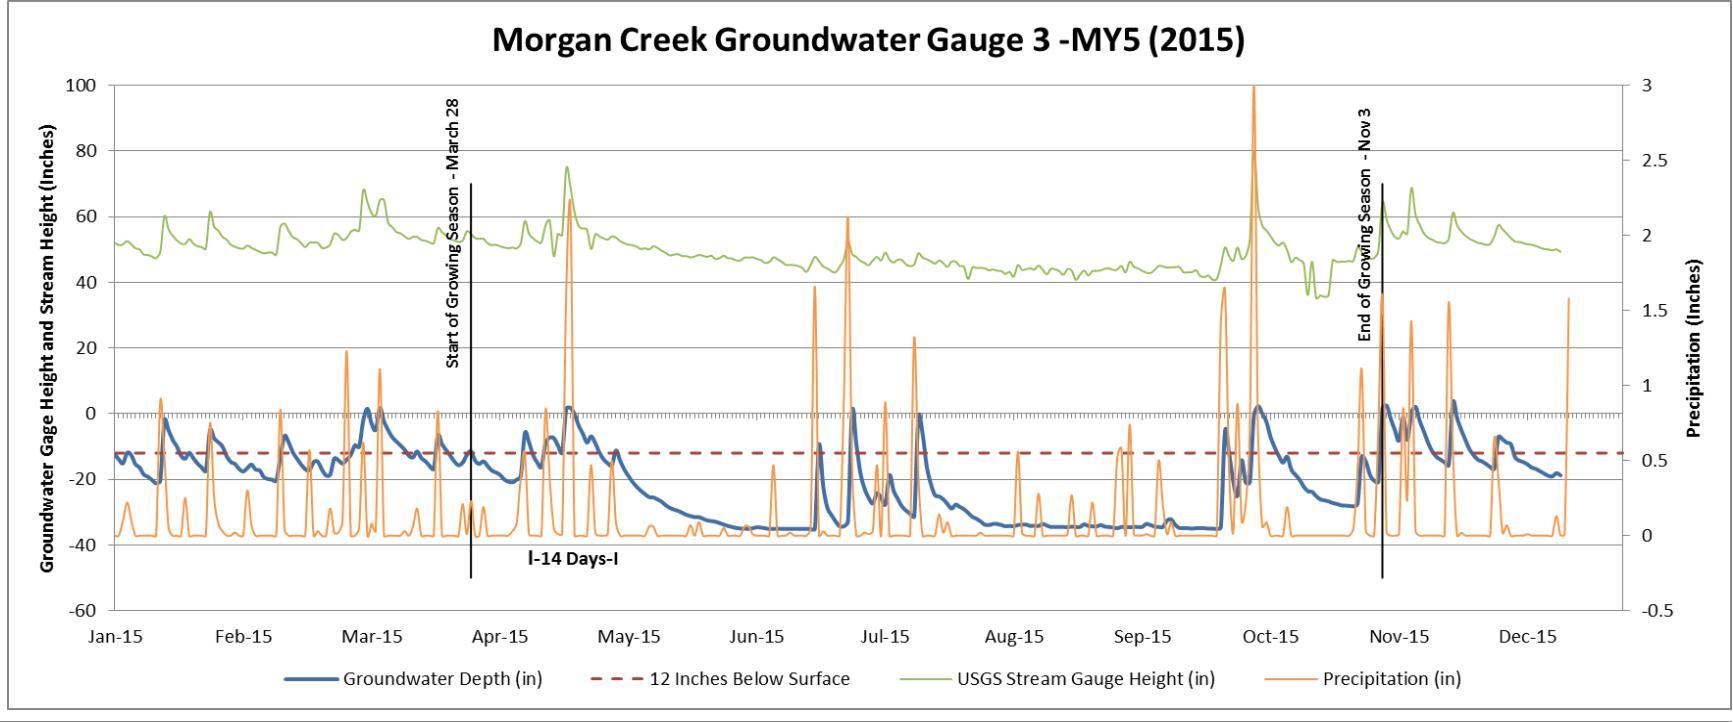
Figure 4.1. Groundwater Wells and Daily Precipitation Data, 2015 (MY5): Morgan Cr Floodplain Site #258.

Nine of the ten groundwater wells met their respective wetland hydrology success criteria in 2015 (Table 9). Only well #4 did not meet its criterion, missing the goal by only 2 days). Over the five year monitoring period (2011 to 2015), four of the five wells in Soil Unit #1 met their 27-day saturation criterion during 3 or more years. Of the five wells in Soil Unit #2 (11-day saturation criterion), well #3 succeeded during only 1 year, well #9 succeeded every year, and the new wells A, B, C all succeeded during their one year of monitoring. Daily precipitation data for 2015 were compiled from CoCoRaHS gauge # NC-DH-33 located at Meadowmont about one mile northeast of the project site.

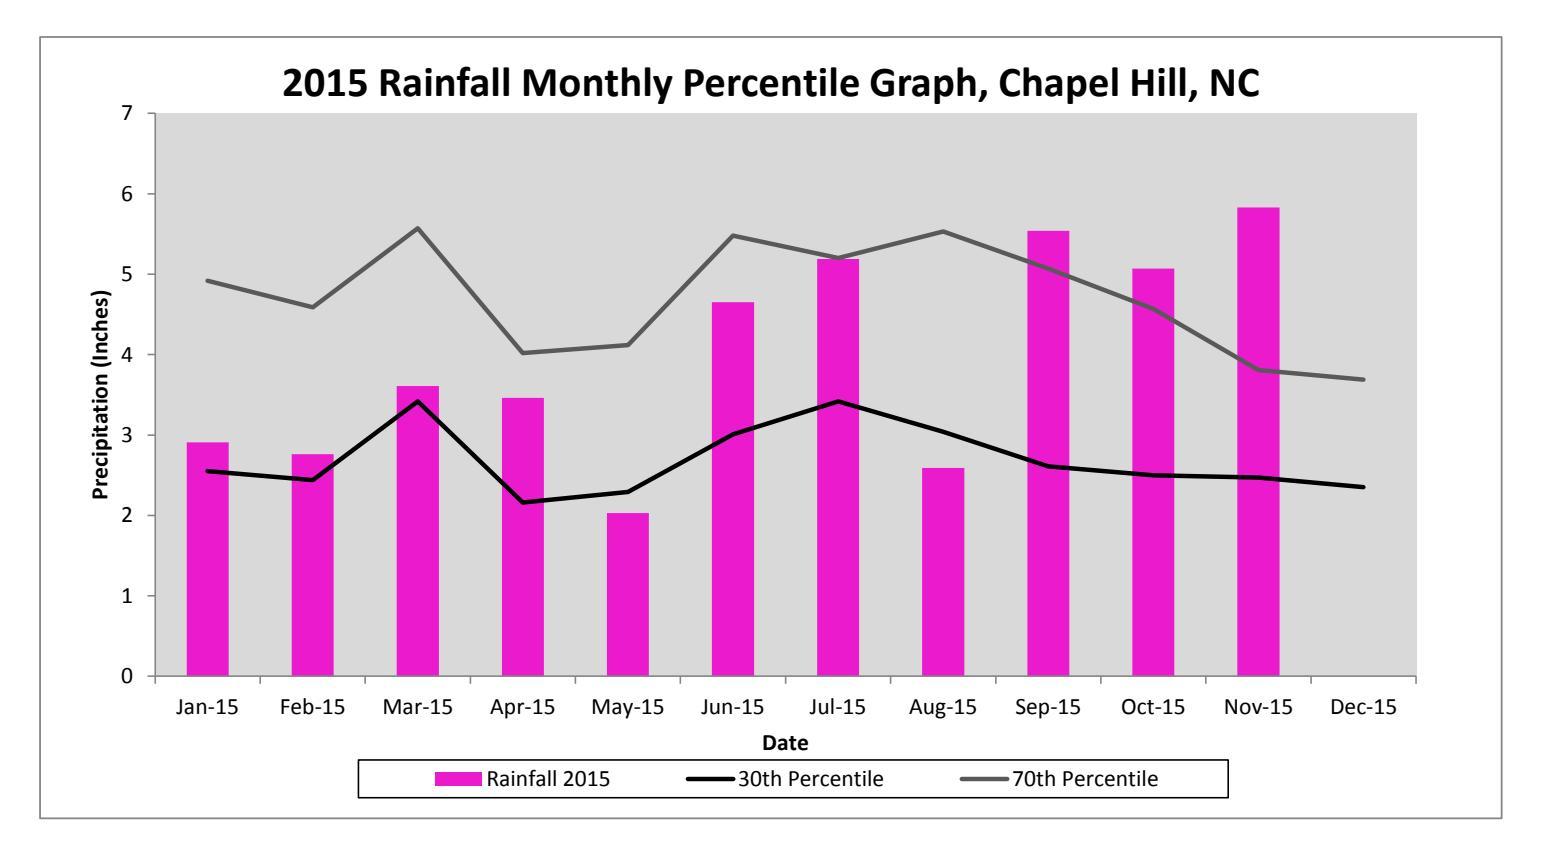
Figure 5. Monthly Rainfall Totals for 2015, with 30th and 70th Percentile Climate Normals, Chapel Hill, NC

Monthly rainfall totals at Third Fork Creek, USGS Gauge# 355511078570745 (4 miles ENE of project site) Monthly Climate values are based on the 30 year period from 1981 to 2010 at Williams Airport, Orange Co.
