# **Year 1 Monitoring Report**

## **Hatchet's Grove Stream Restoration**

**April 2006**

**EEP Project No. 289**

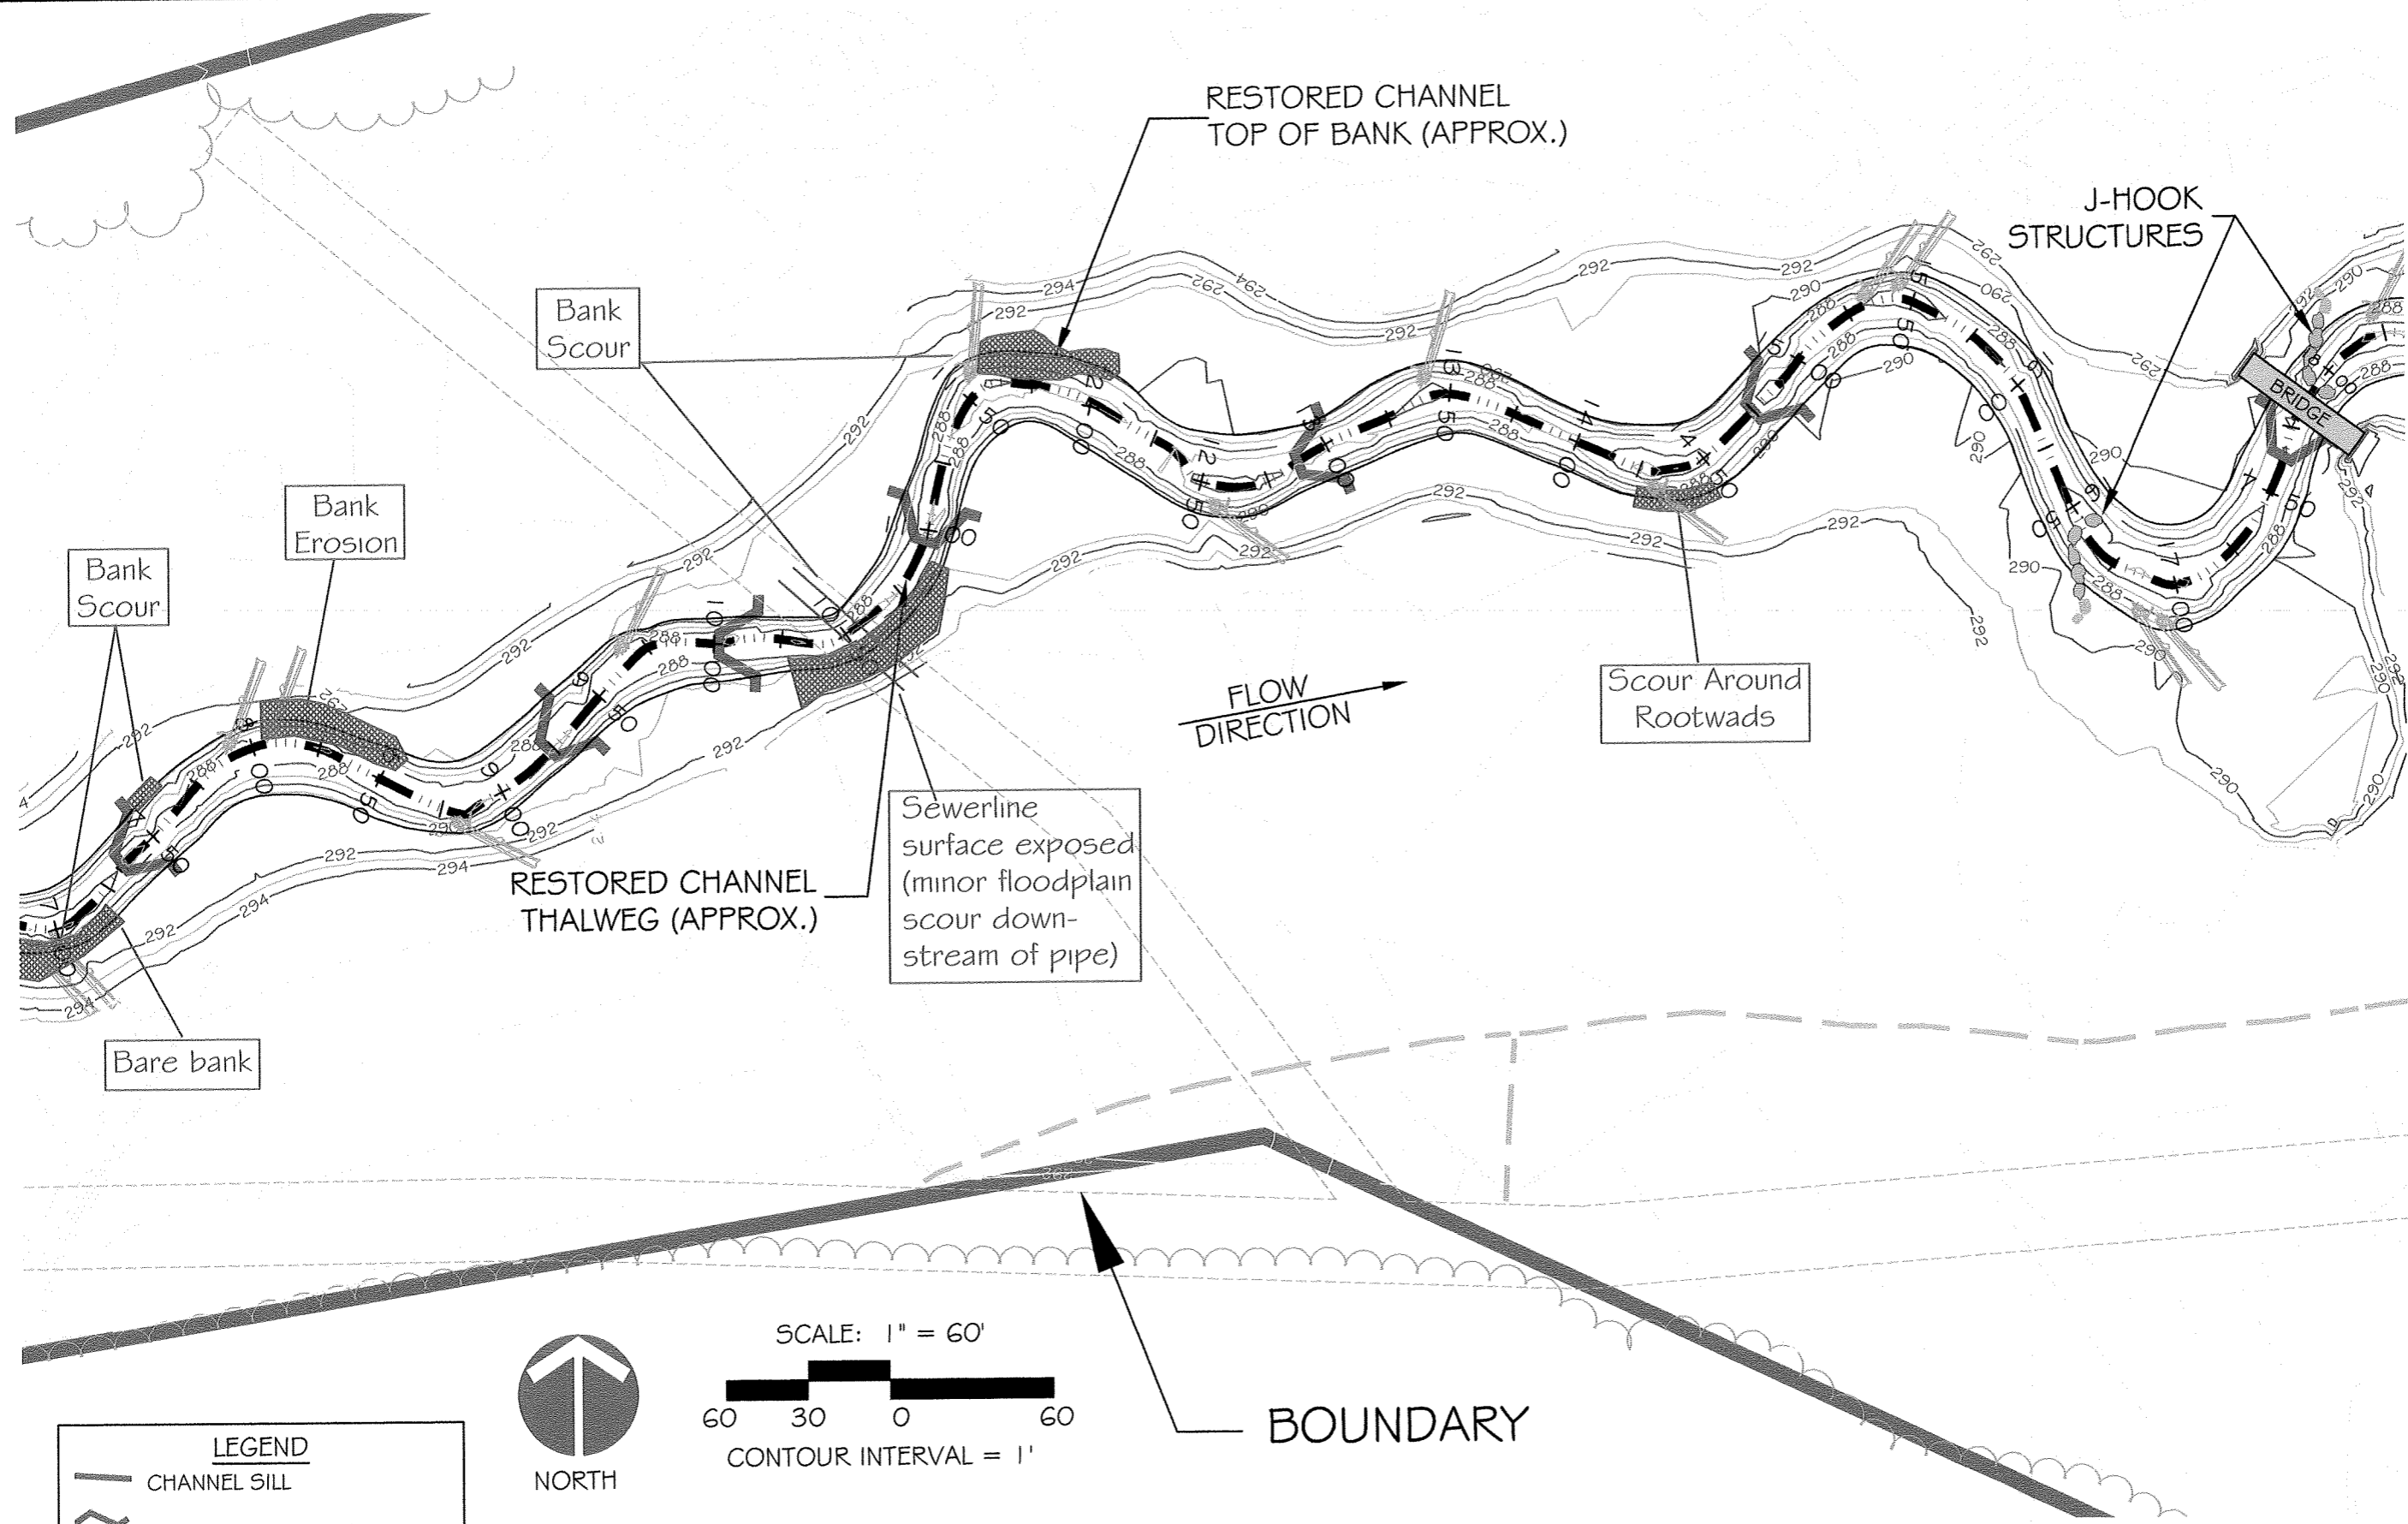
An assessment of the stability of the channel was performed on September 17, 2005, by S&EC. Several areas of concern were observed and documented including localized bank scour, overbank scour, and several failing structures. These problem areas are shown on Sheets 7 through 10 – Problem Area Plan Views E through H.

<b>Feature Issues</b>	<b>Station numbers</b>	<b>Suspected Cause</b>	<b>Photo number</b>
Bank Scour	0+50 to 1+00	high velocity/excess shear	Stream Problem Areas 1-2
	2+75	high velocity/excess shear	
	4+80 to 5+60	high velocity/excess shear	
	6+50 to 7+25	high velocity/excess shear	
	7+50	high velocity/excess shear	
	8+00 to 8+50	high velocity/excess shear	
	10+25 to 11+00	high velocity /excess shear	
	11+50 to 12+00	high velocity/excess shear	
	18+50 to 19+00	high velocity/excess shear	
	23+50 to 24+00	high velocity /excess shear	
	31+00 to 31+75	high velocity/excess shear	
Overbank Scour	3+25	floodplain drainage/stormwater outfall	N/A
	6+00	floodplain drainage/stormwater outfall	
	10+50	downstream of sewer pipe	
	25+00	floodplain drainage/stormwater outfall

28+50	floodplain drainage/stormwater outfall	
Failing Structures	3+25 to 3+50	rootwad scour	Stream Problem Areas 3-4
	5+25	rock shift on arm	
	6+50	collapsed sill	
	14+50	rootwad scour	
	18+50	scour at arm	
	22+75	arms of crossvane failed	
	25+25	rootwad scour	
	26+25	rootwad scour	
	31+25	rootwad scour	
	31+75	rock shift at apex of vane	
	32+50	footer rock shift (left arm)	
	14+50	rootwad scour	
	18+50	scour at arm	
	22+75	arms of crossvane failed	
	25+25	rootwad scour	
	26+25	rootwad scour	
	31+25	rootwad scour	
	31+75	rock shift at apex of vane	
	32+50	footer rock shift (left arm)

And while the channel is generally stable these areas of concern should be considered for repair or stabilization to ensure the future success of the project.
