**Prestonwood Golf Course  
(Hatchet's Grove)  
Stream Restoration Monitoring Report  
EEP Project # 289  
Monitoring Year – 05  
2009**

**December 2009**

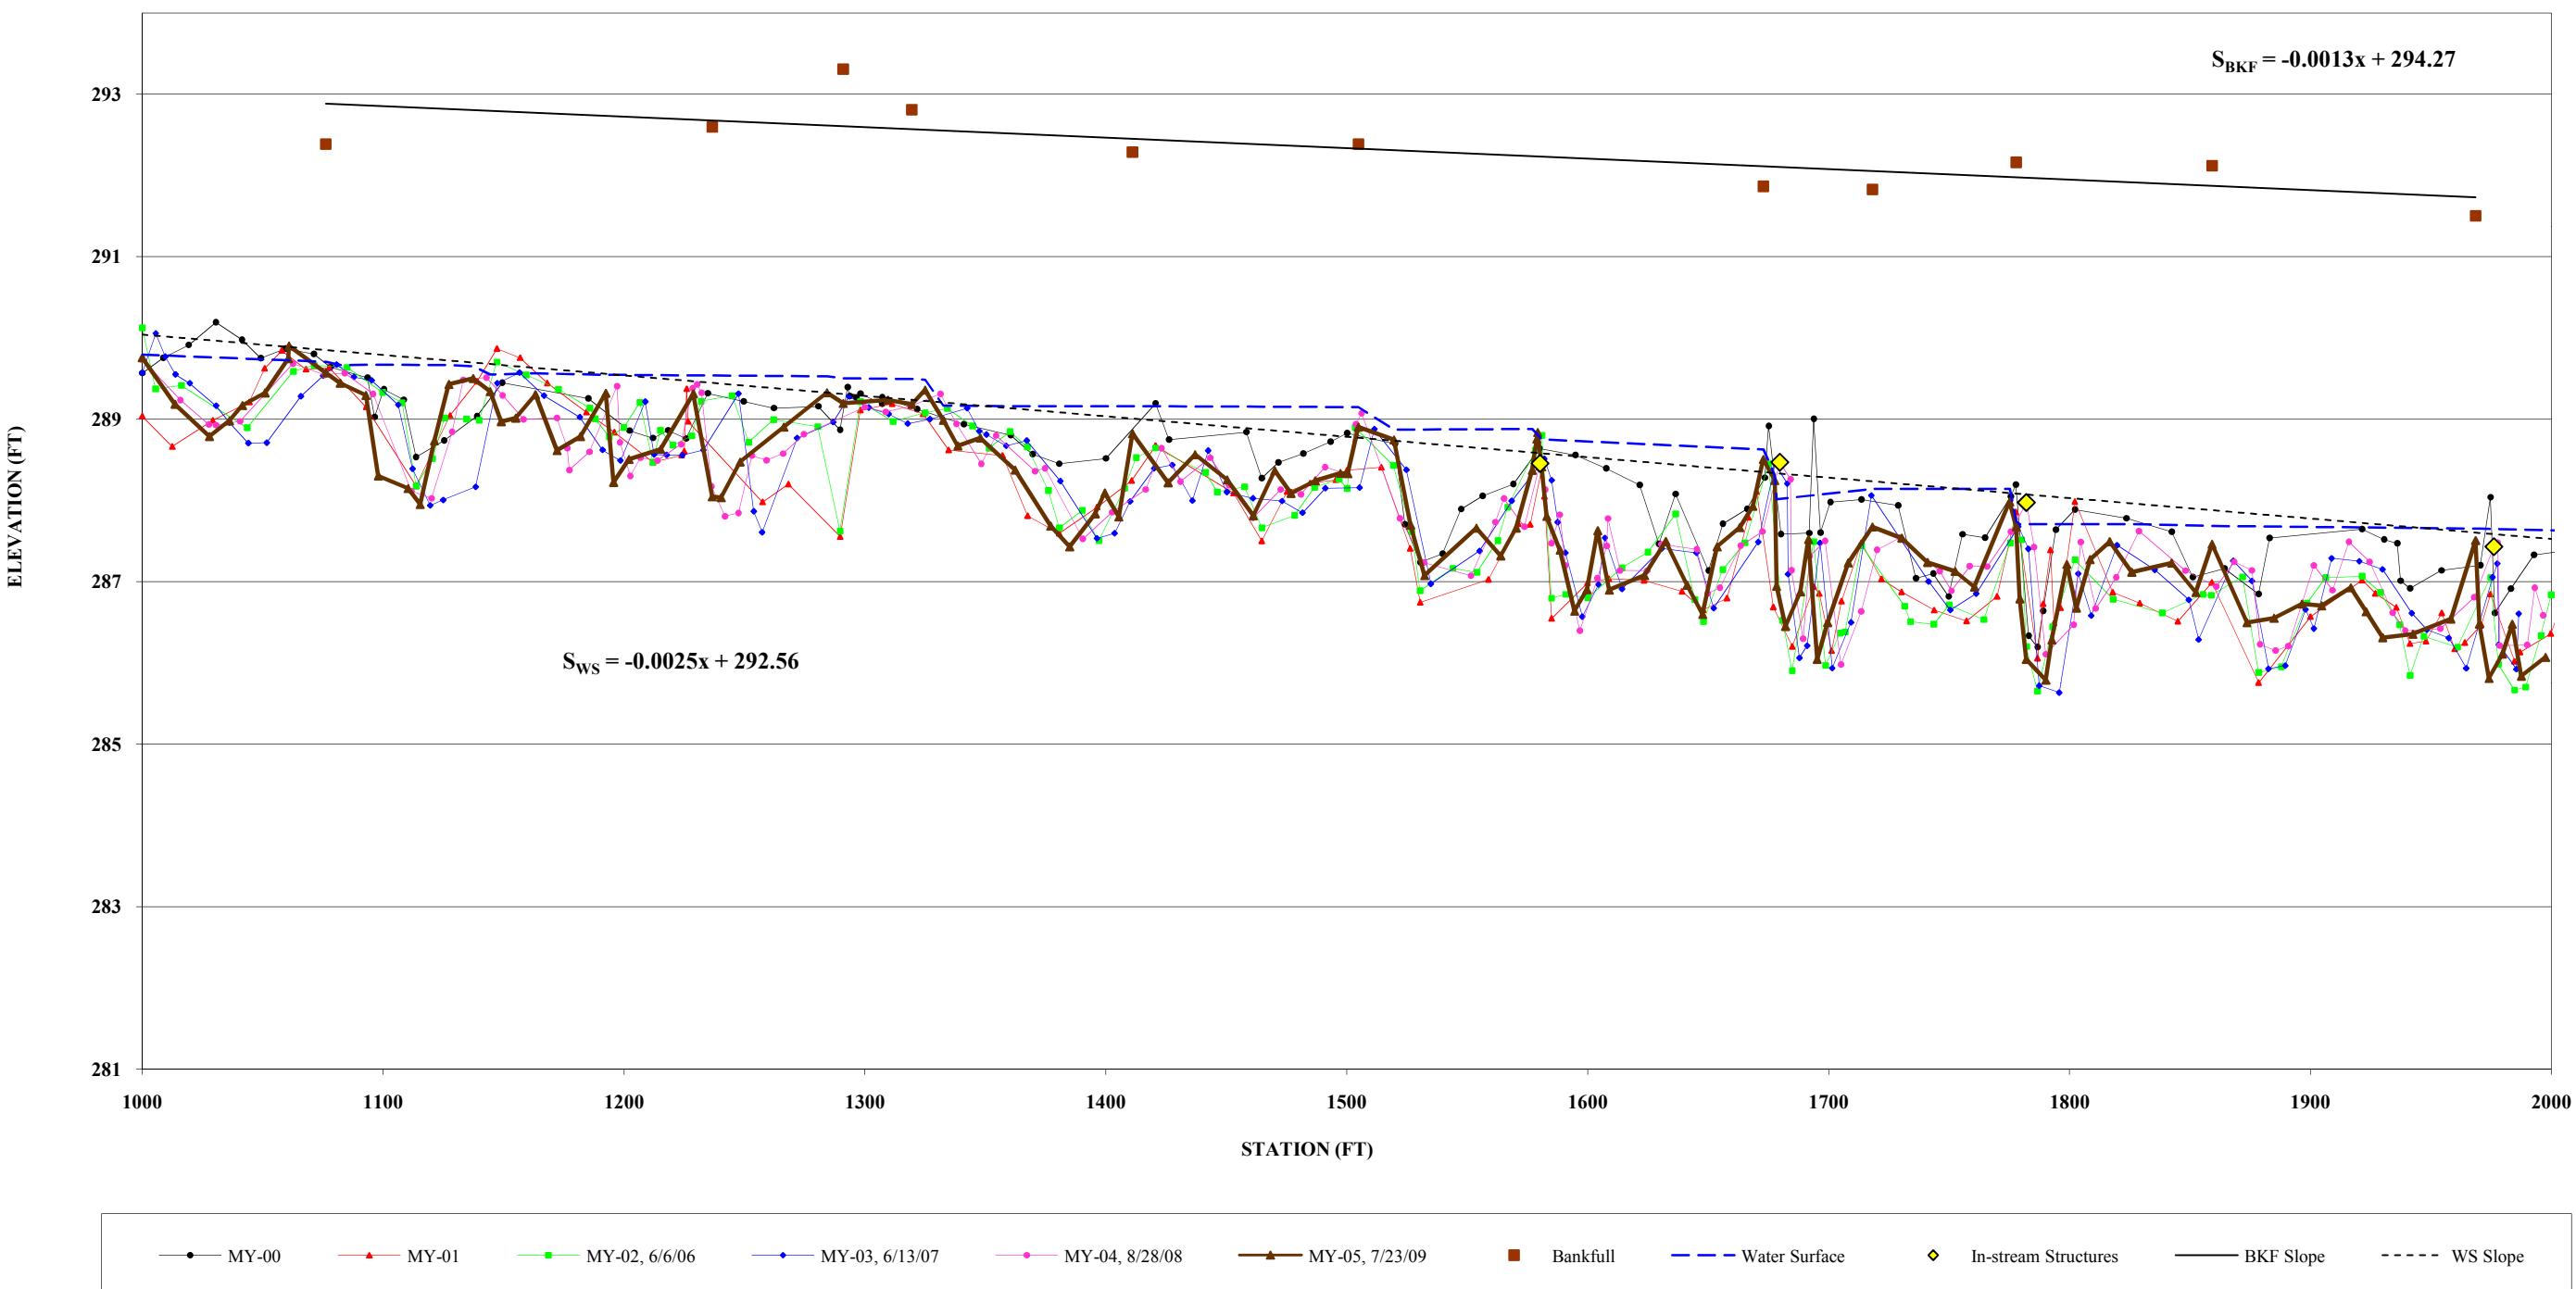
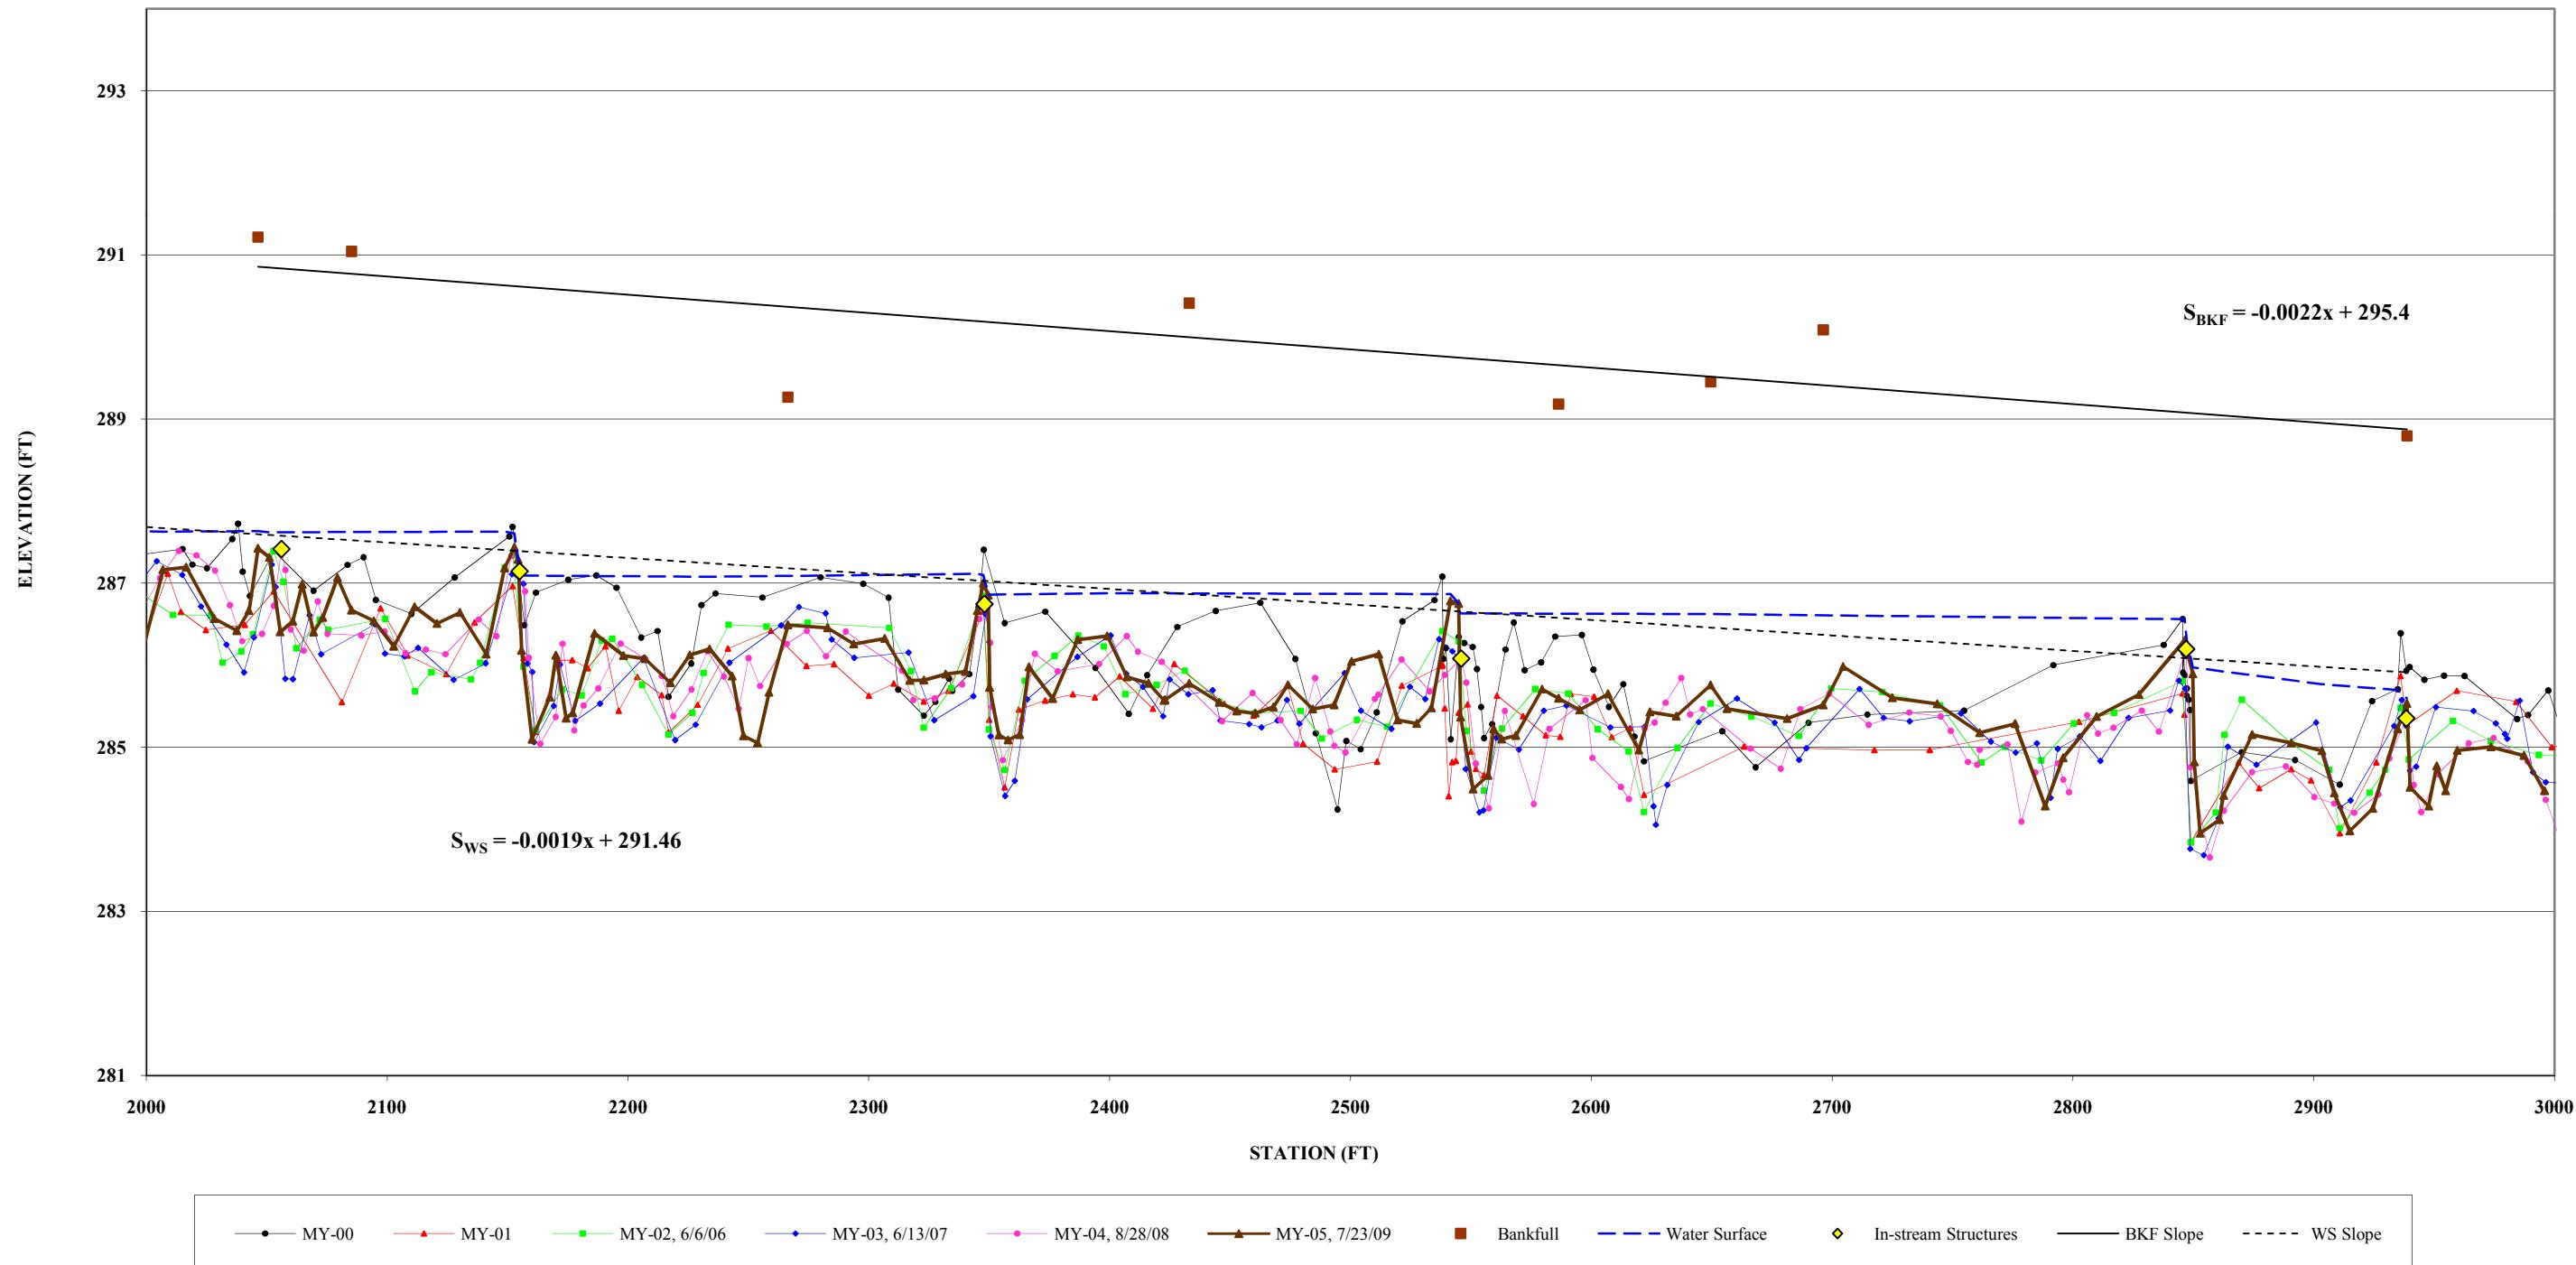
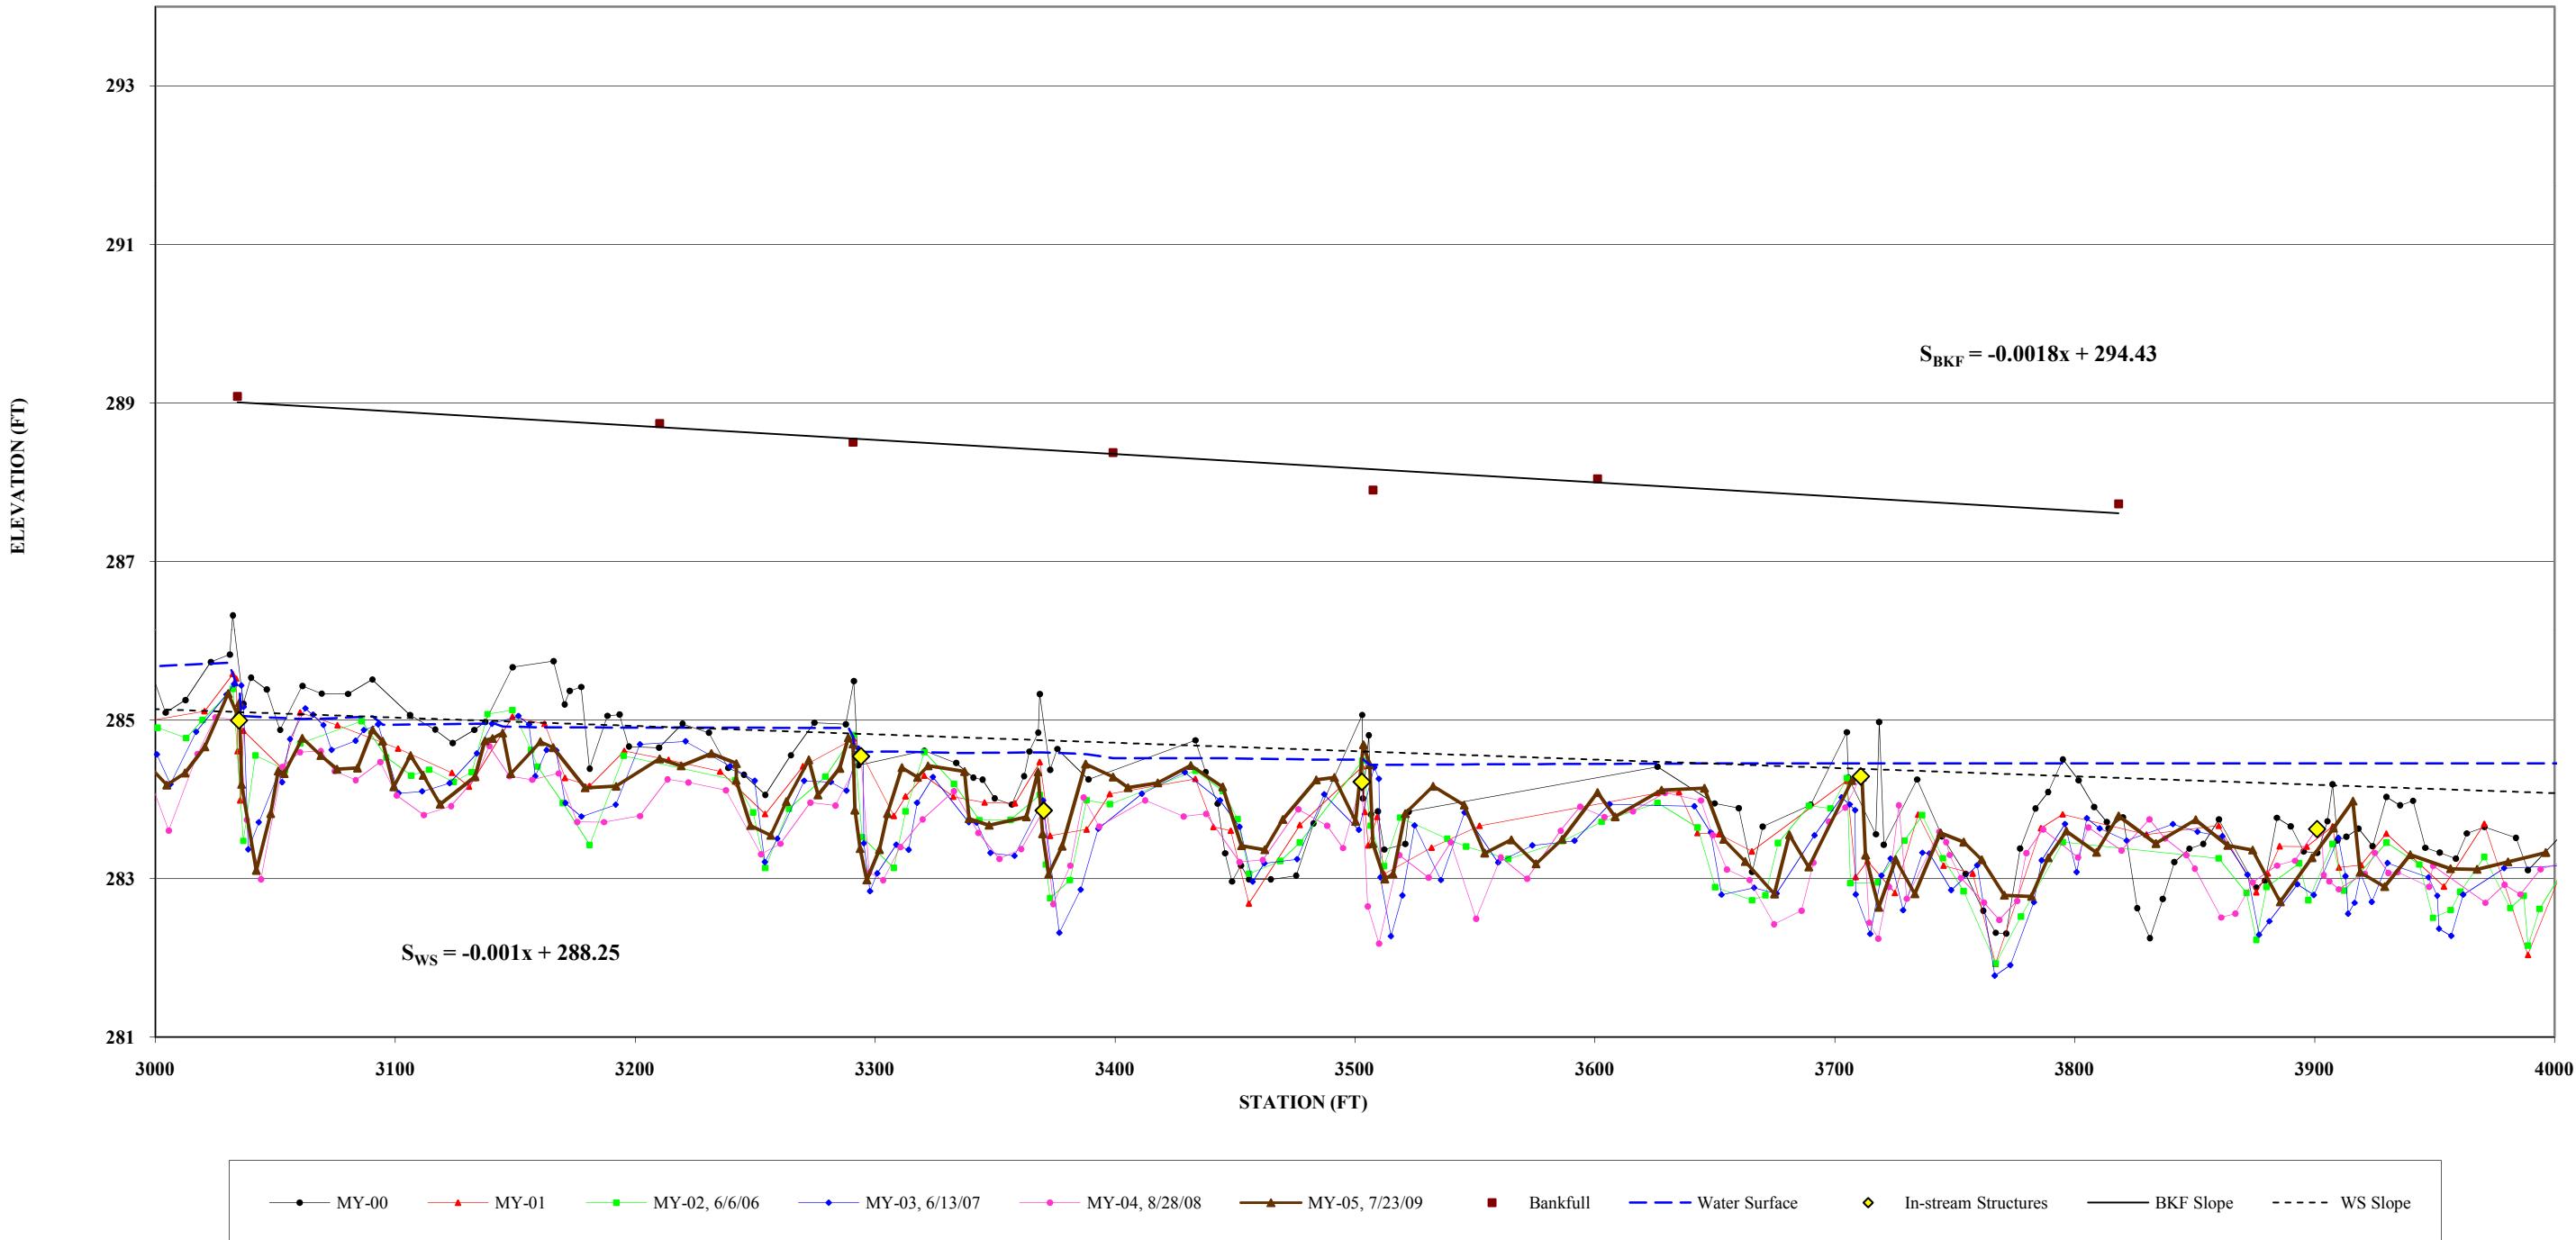
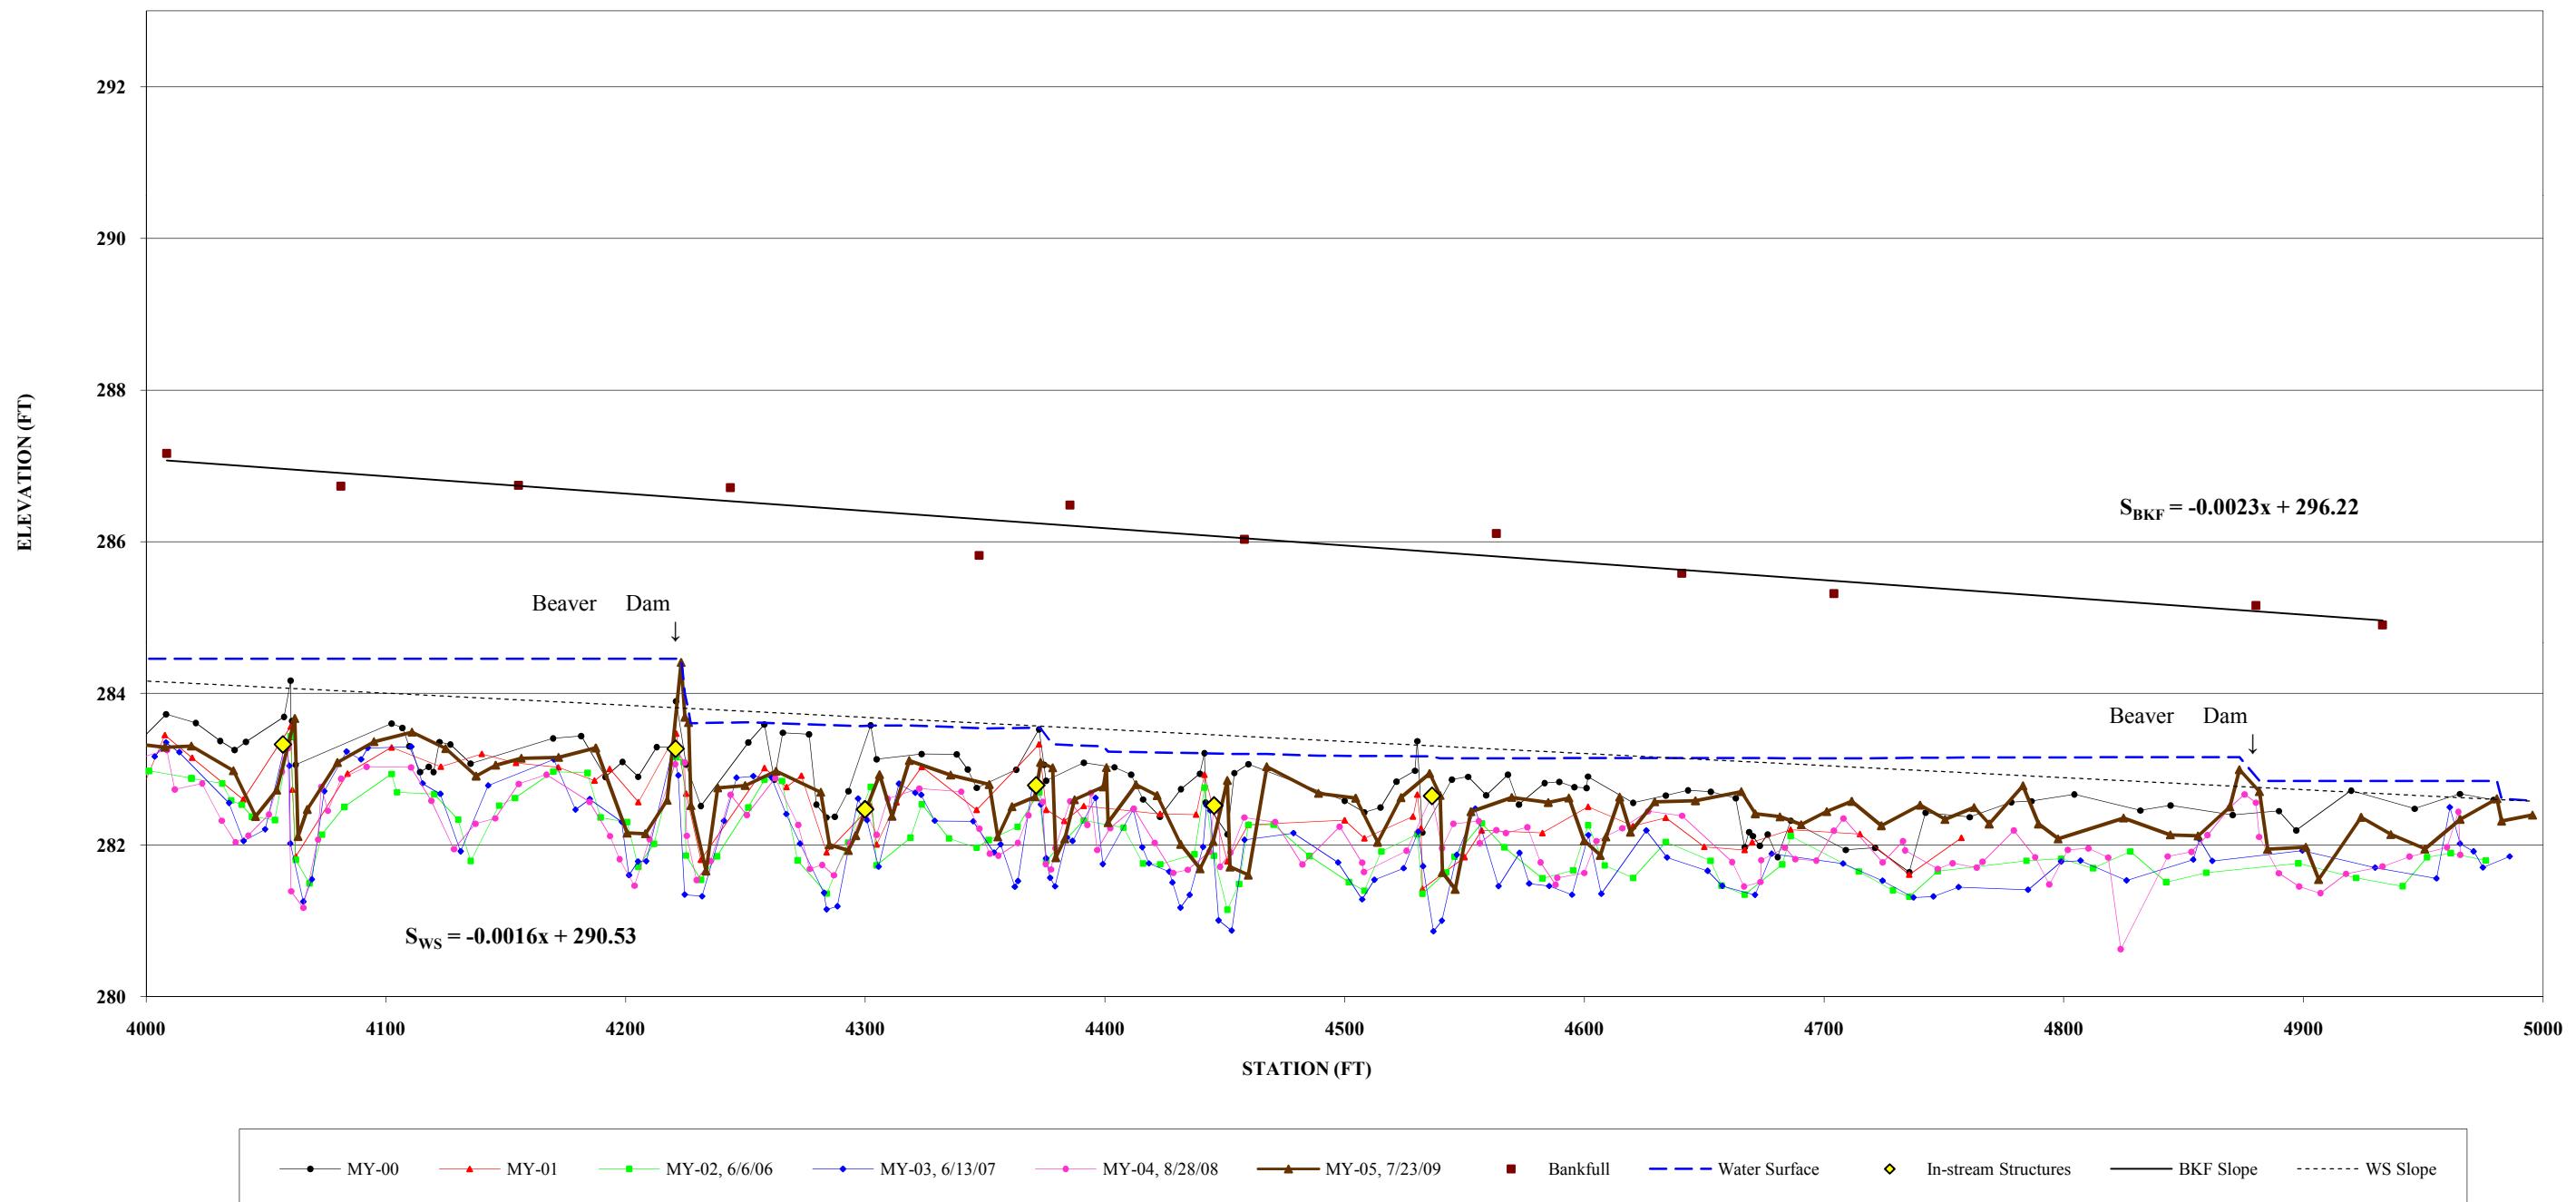
influence of beaver dams in the lower part of the project. All of these dams have been removed since the longitudinal profile survey was completed. In November 2009, there was only one dam at the site, which is near Station 10+75. The golf course has an agreement with the EEP to remove these dams. Monitoring Year 5 has found that the stream is generally functioning, but the erosion indicates the stream is susceptible to change and should be closely monitored following additional bankfull events to determine if the signs of stabilization after these adjustments continue to progress.
