Purlear Creek Phase II Monitoring Report

Year 0 of 5 (2006)

Wilkes County, North Carolina

Project ID No. 010559701

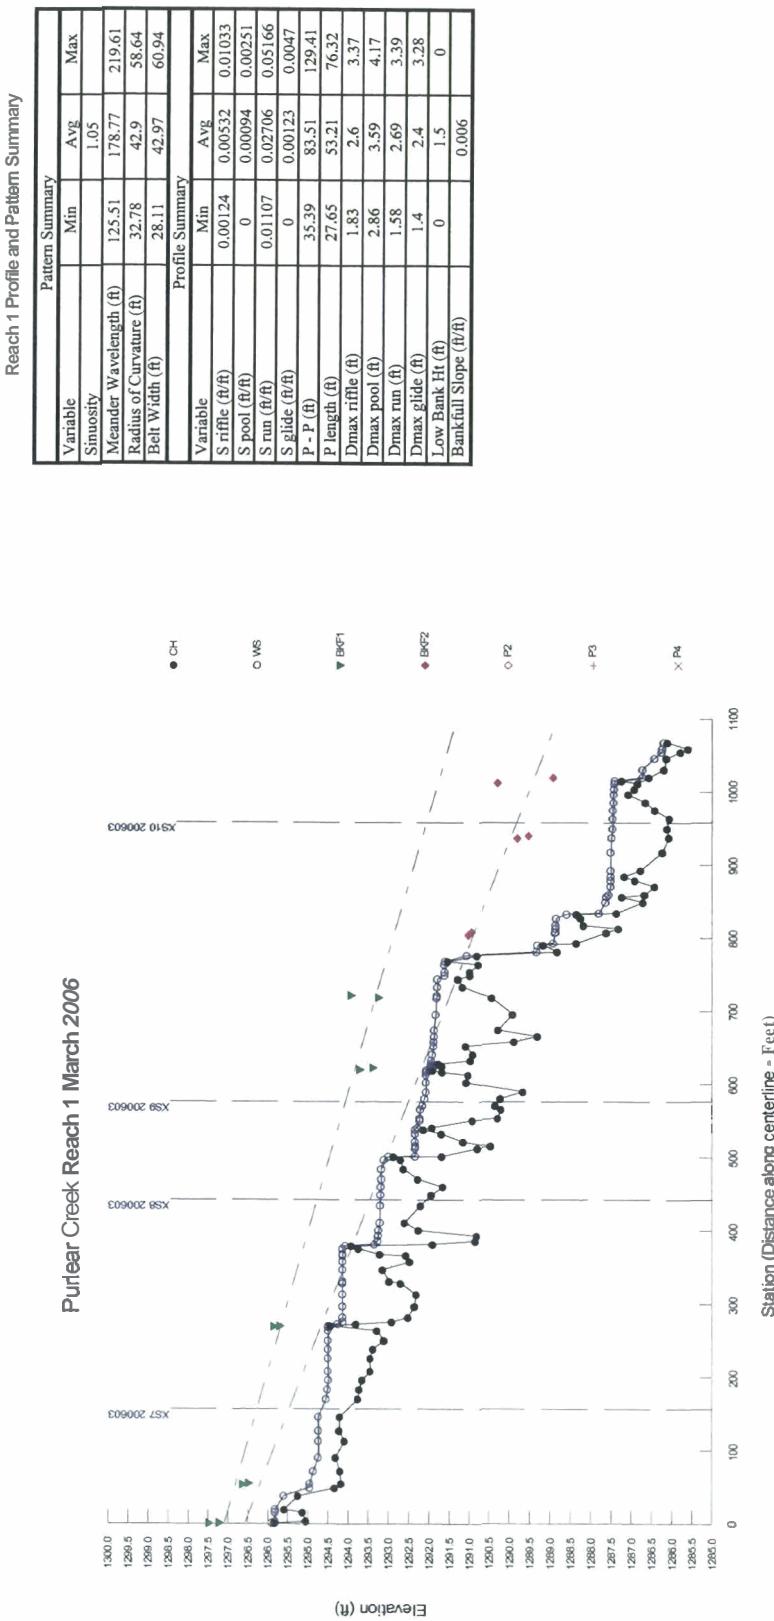
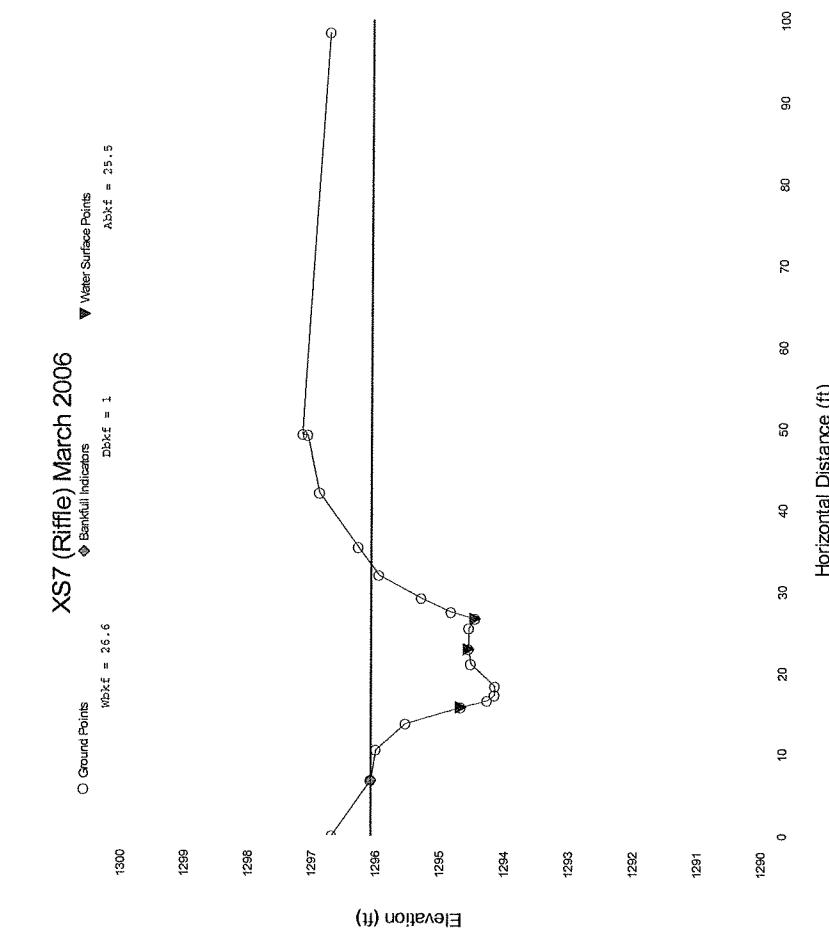
Cross Section Geometry	
Floodprone Elevation (ft)	1298.02
Bankfull Elevation (ft)	1296.08
Floodprone Width (ft)	98.46
Bankfull Width (ft)	26.61
Entrenchment Ratio	3.7
Mean Depth (ft)	0.96
Maximum Depth (ft)	1.94
Width/Depth Ratio	27.72
Bankfull Area (sq ft)	25.54
Wetted Perimeter (ft)	27.18
Hydraulic Radius (ft)	0.94
Classification	C

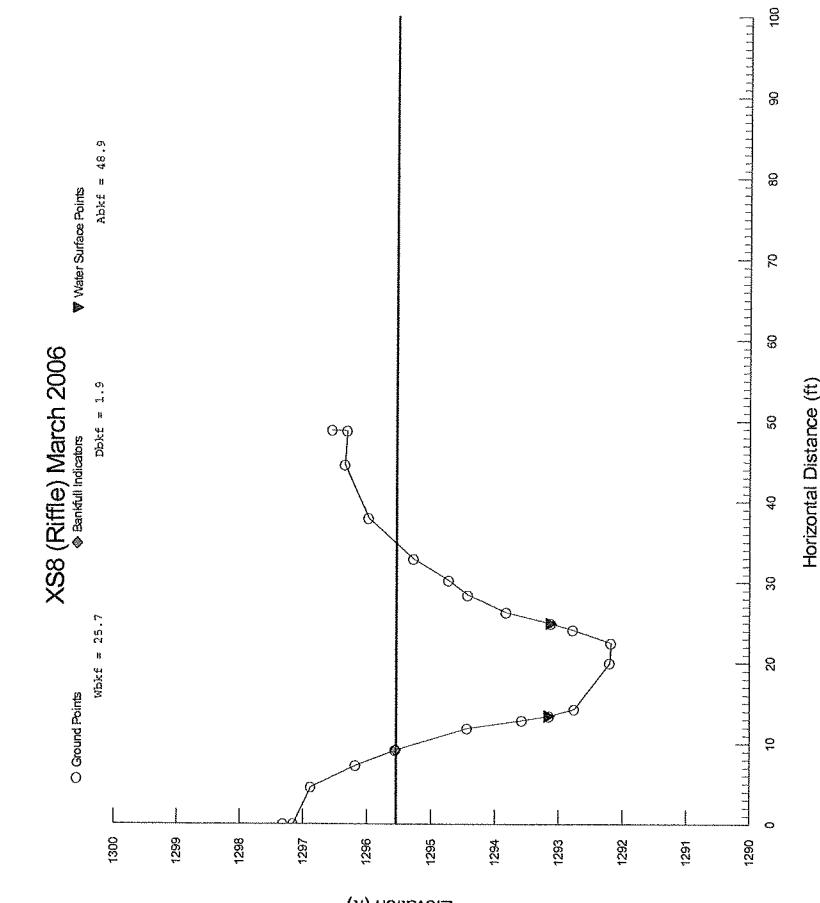
Cross Section Geometry	
Floodprone Elevation (ft)	1298.92
Bankfull Elevation (ft)	1295.55
Floodprone Width (ft)	48.86
Bankfull Width (ft)	25.72
Entrenchment Ratio	1.9
Mean Depth (ft)	1.9
Maximum Depth (ft)	3.37
Width/Depth Ratio	13.54
Bankfull Area (sq ft)	48.85
Wetted Perimeter (ft)	27.05
Hydraulic Radius (ft)	1.81
Classification	B

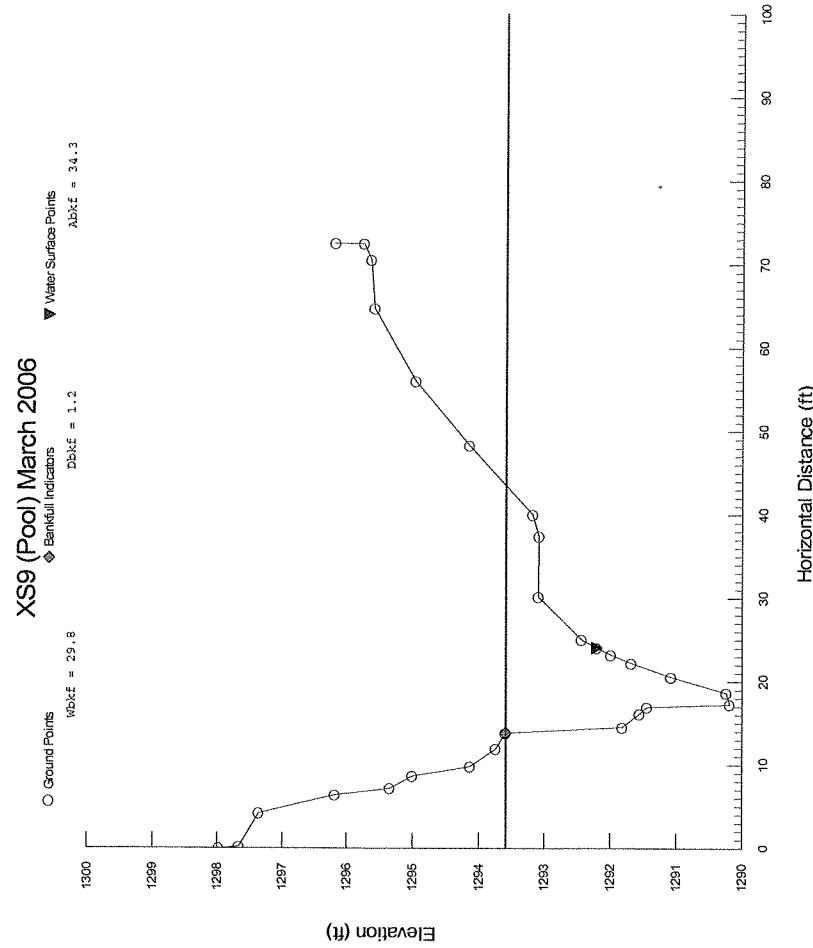
Cross Section Geometry	
Floodprone Elevation (ft)	1297
Bankfull Elevation (ft)	1293.59
Floodprone Width (ft)	67.71
Bankfull Width (ft)	29.78
Entrenchment Ratio	2.27
Mean Depth (ft)	1.15
Maximum Depth (ft)	3.41
Width/Depth Ratio	25.84
Bankfull Area (sq ft)	34.33
Wetted Perimeter (ft)	32.46
Hydraulic Radius (ft)	1.06
Classification

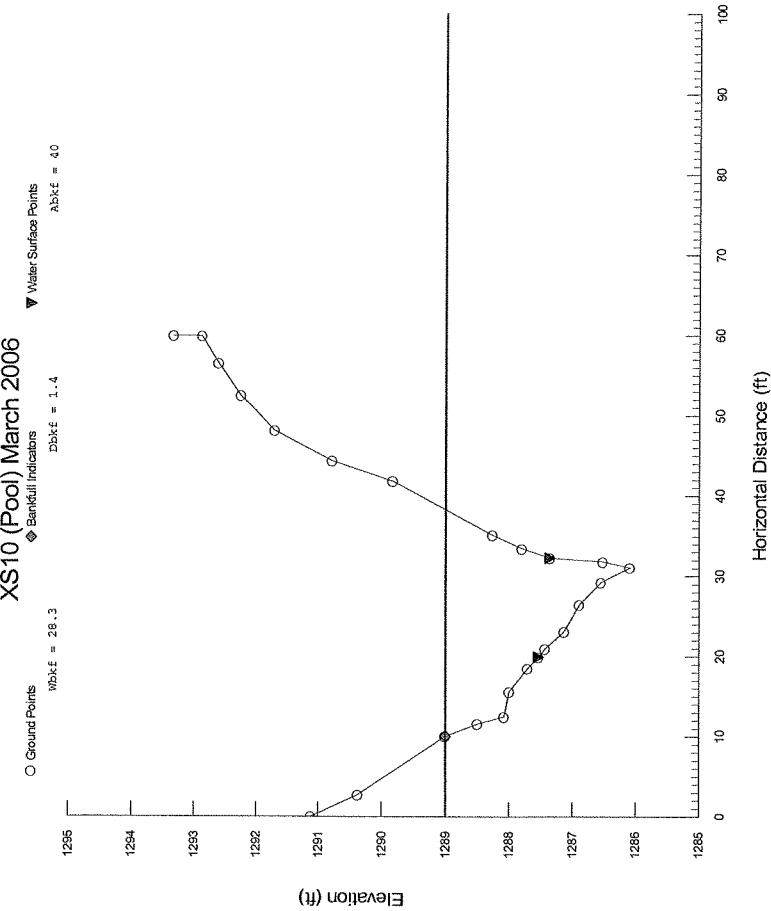
Cross Section Geometry	
Floodprone Elevation (ft)	1291.91
Bankfull Elevation (ft)	1289
Floodprone Width (ft)	49.85
Bankfull Width (ft)	28.25
Entrenchment Ratio	1.76
Mean Depth (ft)	1.42
Maximum Depth (ft)	2.91
Width/Depth Ratio	19.96
Bankfull Area (sq ft)	39.98
Wetted Perimeter (ft)	29.4
Hydraulic Radius (ft)	1.36
Classification
