**RACEY MITIGATION SITE ON LAXON CREEK,
WATAUGA COUNTY**

Year 5 Monitoring Report

Period Covered: July 31, 2005 - June 27, 2006

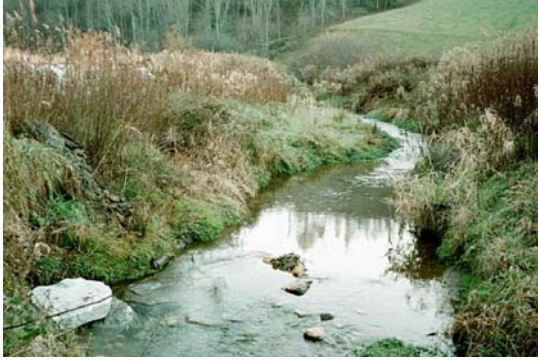
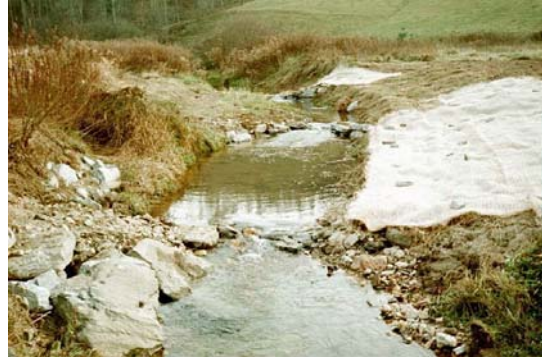
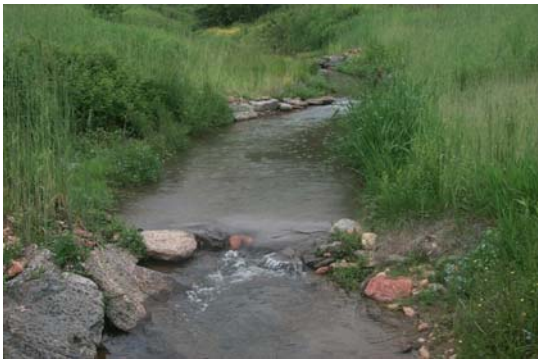
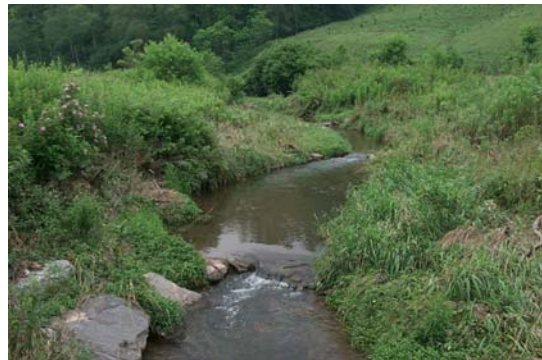
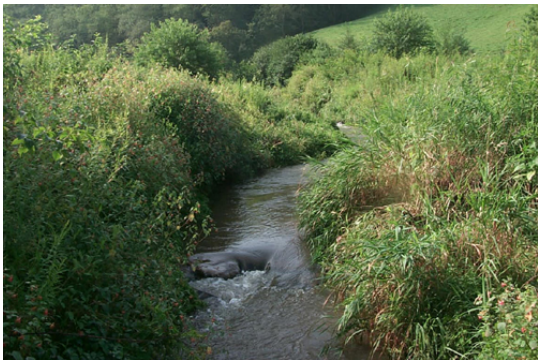
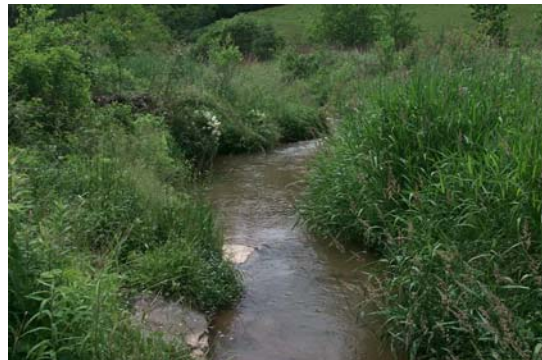
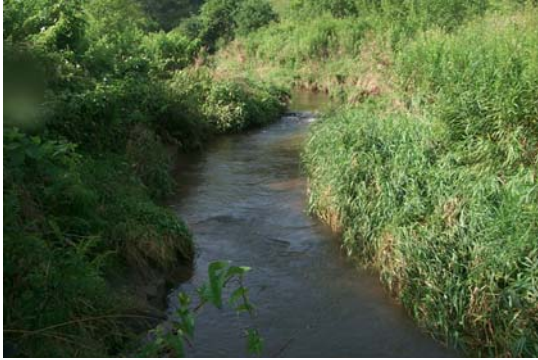
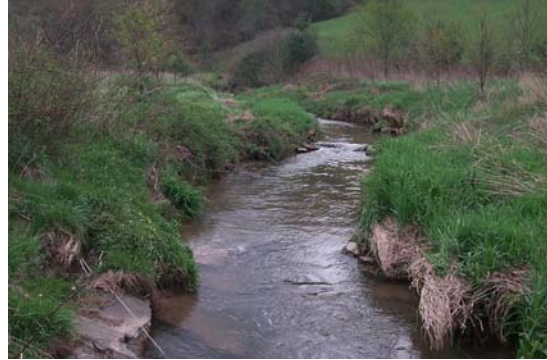
Appendix 1: Photographic log of the Racey mitigation site looking upstream at cross-section 1+88, Laxon Creek, Watauga County, October 2000-July 2005.

Since construction was completed on November 3, 2000, all disturbed banks have become well vegetated (Appendices 1-3). A total of 412 stems comprised of live stakes and bare-rooted plants were planted within 0.67 acres of disturbed streambanks in 2001 and 2002 (Table 2). A total of 179 stems were counted in 2006 (43% survival) (Table 2). The density of stems in the disturbed areas planted is 267/acre (179 stems/0.67 acres), which is above the 260 stems/acre required for woody species planted at mitigation sites through year five of monitoring (USACE 2003). It should be noted that the stem counts and survival calculations did not include seven black cherry *Prunus serotina*, 14 white pine *Pinus strobes*, and 18 black walnut *Juglans nigra* planted by the landowner in 2001.

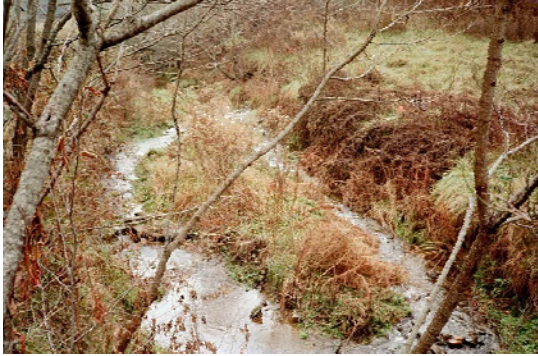
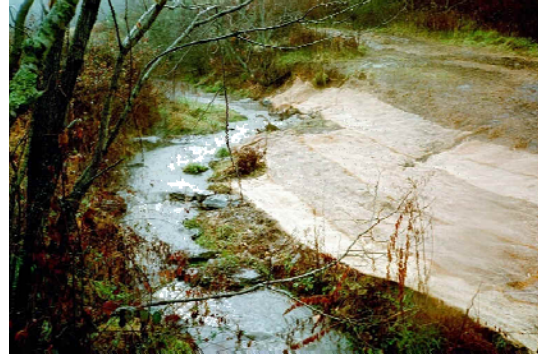
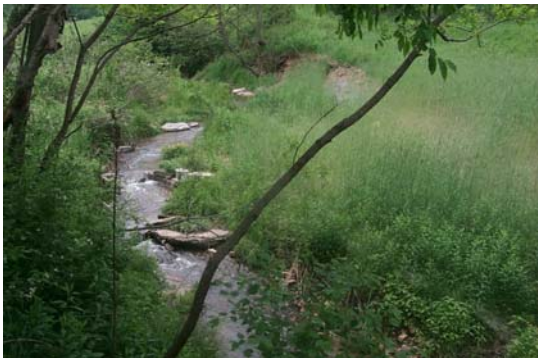
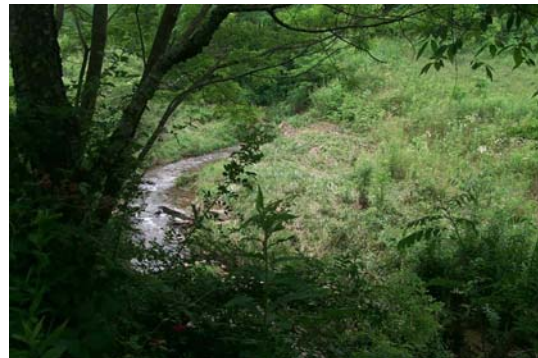
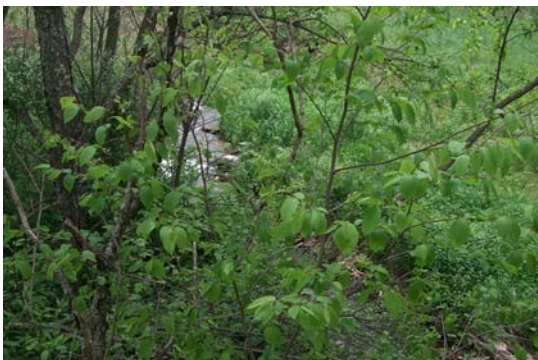
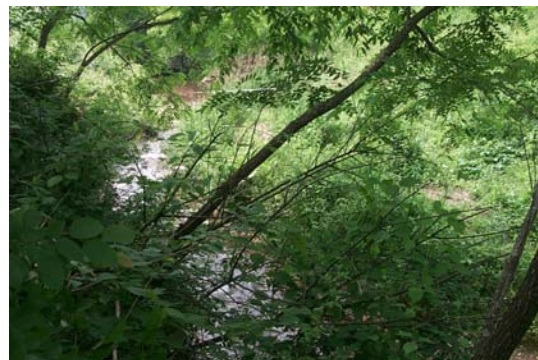
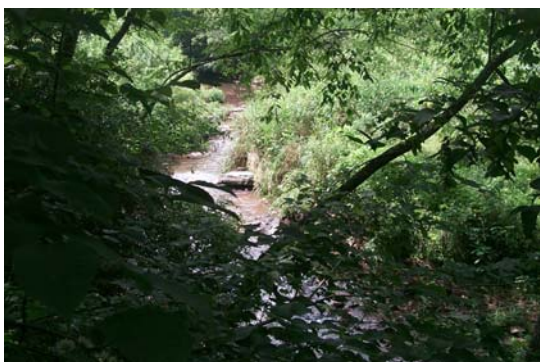
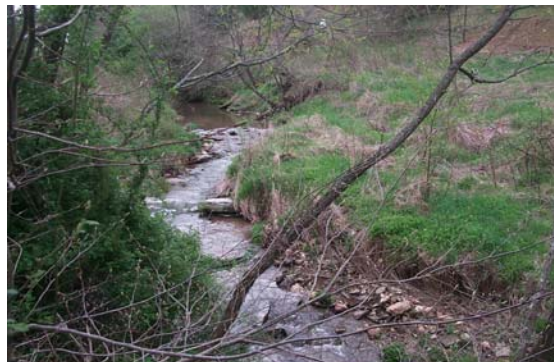
APPENDIX 2: Photographic log of the Racey mitigation site looking upstream at cross-section 7+13, Watauga County, October 2000-July 2005.

The steep right bank at cross-section 7+13 and the central bar below cross-section 8+40 should be monitored annually for bank erosion problems. The interpretation of the five years of monitoring data, the fact that there have been no major failures to the structures or streambanks, and the continuing growth of the dense riparian vegetation suggests that the stream reach at the Racey site is stable, and needs no further detailed monitoring. It is our recommendation that this site be considered stabilized and released from further monitoring. Furthermore, we recommend NCDOT be awarded 1,160 mitigation credits (1:1 ratio) for this site as approved by NCDWQ (NCDWQ letter to the NCWRC dated November 6, 2000).
