**Year 2 Monitoring Report for Stream Mitigation of South Muddy Creek
Tributaries
(Queen Property)**

South Muddy Creek Tributaries
McDowell County, NC
SCO # D04006-01

Submitted: January 2008

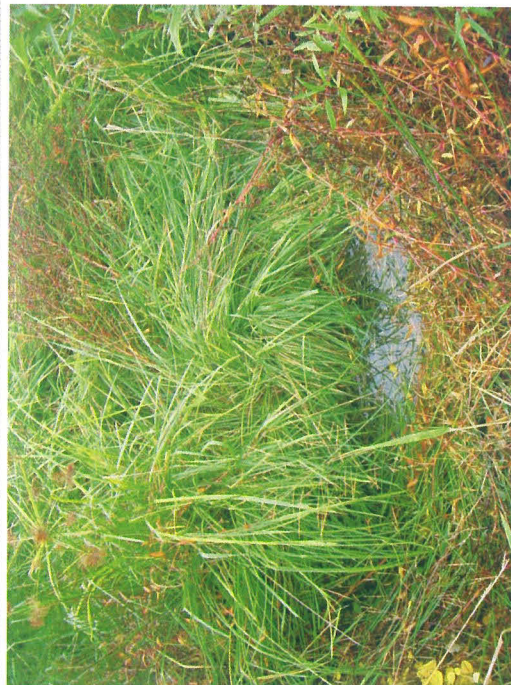
CROSS SECTION: 8+39

**Cross-section photo – looking across stream.
 Channel is obscured by vegetation.**

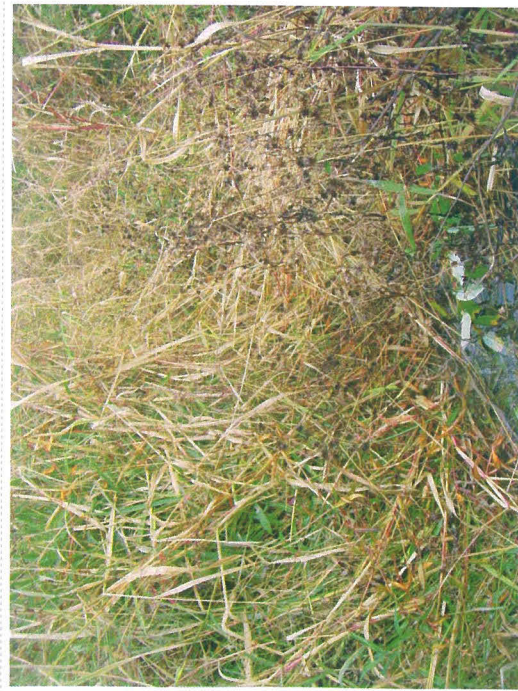
CROSS SECTION: 5+00
FEATURE: Riffle

Cross-section photo – looking downstream
 Channel obscured by vegetation.

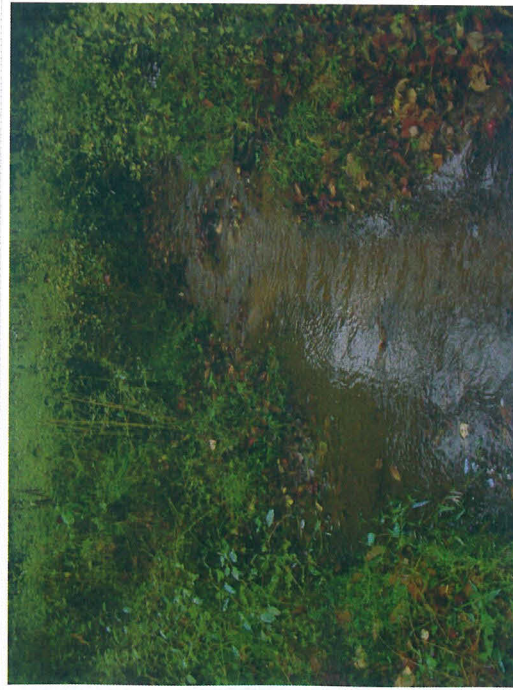
CROSS SECTION: 8+57

**Cross-section photo – looking upstream
 Downstream photos were blurry and obscured.**
