Monitoring Year 2 FINAL Monitoring Report
Stewarts Creek Tributaries Stream Restoration Project
Surry County, North Carolina
Yadkin River Basin, Hydrologic Unit Code (HUC) 03040101

Data Collection Period:
September 2021 – November 2021

Submission Date:
December 2021

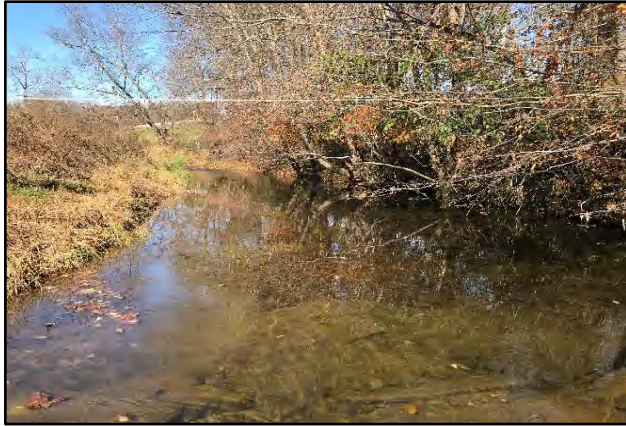
XS2 looking upstream

- Cross-section 2 on Moores Fork Reach 1 Enhancement shows an increase in bank-height-ratio. It is our professional judgement that this will fluctuate through the monitoring years and will not cut down any further due to it currently being cut down to bedrock.
- Cross-sections 4 and 5 are in the lower reaches of Moores Fork that show bank instability that will require maintenance/ repair. This will be addressed in the 2022 AMP.
