FINAL MY2 (2023) MONITORING REPORT

SWAMP GRAPE STREAM AND WETLAND MITIGATION SITE

Robeson County, North Carolina Lumber River Basin Cataloging Unit 03040204

DMS Project No. 100115
Full Delivery Contract No. 7869
DMS RFP No. 16-007705
USACE Action ID No. SAW-2019-00904
DWR Project No. 2019-0675

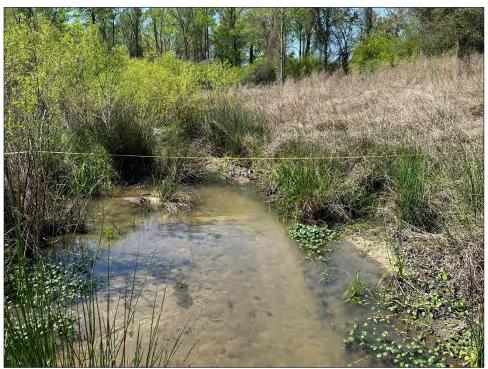
UT2 Cross Section 14 (pool) - 03/30/2023

While conducting a quarterly site assessment walkthrough in May of Swamp Grape, Axiom Environmental Inc. (Axiom) noted that the upper reach of UT 2 has received excess sediment deposition. The aggregation begins above the UT2 vented-ford crossing, located outside the Site's conservation easement, and continues downstream through cross sections 14 (pool) and 13 (riffle). Minimal observance of aggregation was documented in cross-section 12 (riffle), and none was observed in cross-section 11 (pool).

Once the deposition was noted, Axiom conducted surveys of cross-sections 11-14 to ascertain the degree of aggradation. Cross sections are plotted in Figure 1, attached with photo documentation.

We believe that a combination of these causes resulted in the observed aggregation, with the lack of flushing flows being the main contributor. No aggregation/excess sediment deposition was observed on UT1 or UT3. Restoration Systems is aware of the aggradation and wanted to ensure DMS and the IRT know about this development prior to the July 12th IRT Site walkthrough. Please feel free to contact me to discuss this at your convenience.

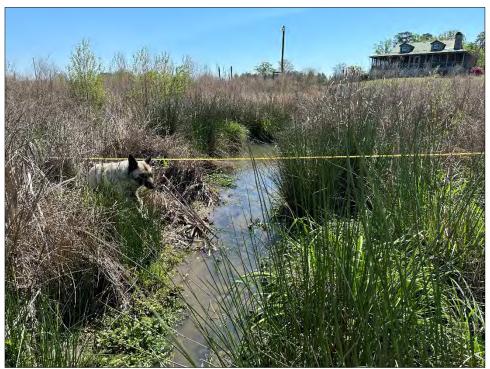
UT2 Cross Section 12 (riffle) - 03/30/2023

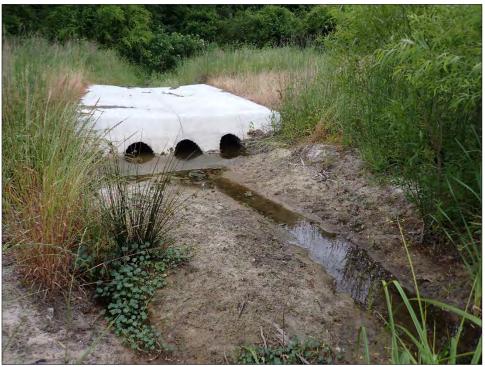
UT2 Vented Ford Crossing - 05/17/2023

- The UT1 and UT2 crossings are performing as expected.
 - The IRT noted that the height of the vented ford crossing on UT2 may be a contributing factor to sediment deposition above and below the crossing.

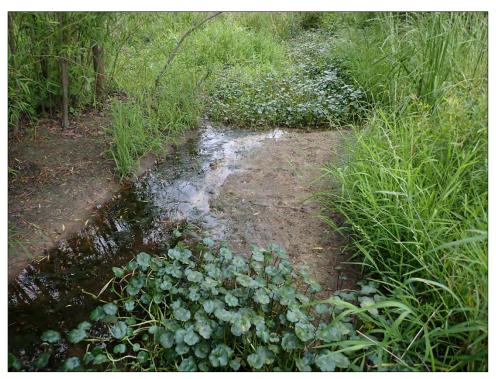
UT2 below the Vented Ford Crossing - 05/17/2023

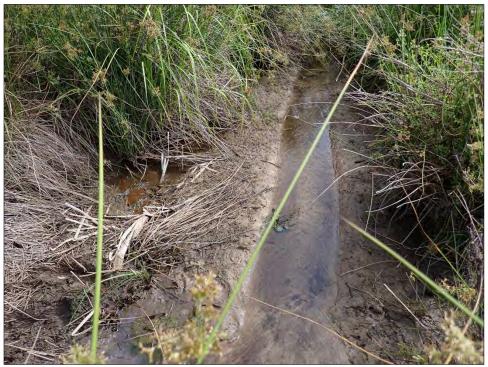
UT2 upstream of cross section 14 - 05/17/2023

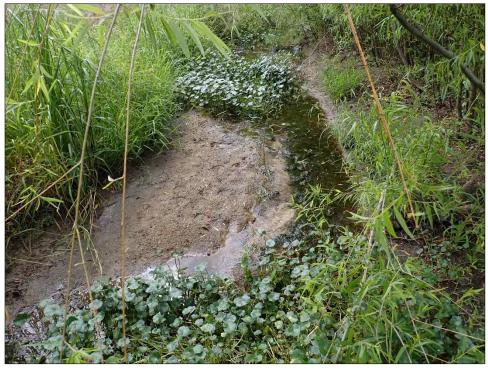
UT2 upstream between cross sections 13 and 12 - 05/17/2023

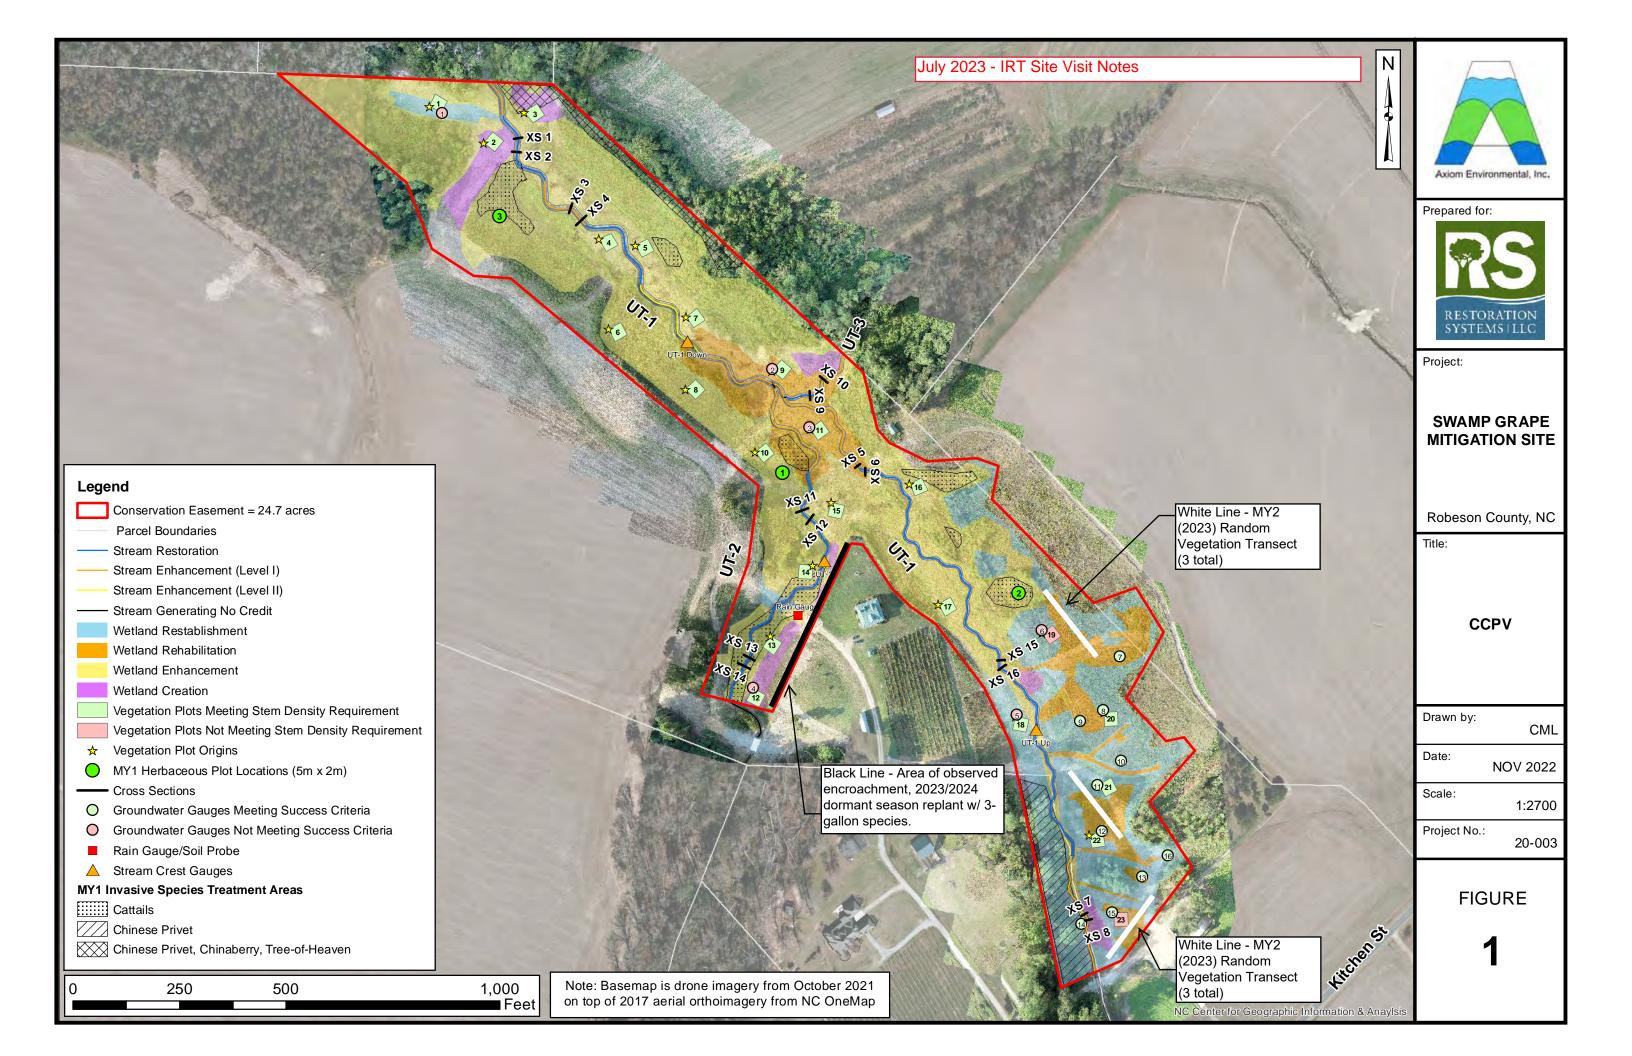
- MY 1 (2022) CCPV with Site Visit Notes

- RS and the IRT reviewed the observed area of encroachment along UT2's right easement boundary (shown in the attached figure). RS will replant this area with 3-gallon upland containerized species from the approved Site Mitigation Plan during the dormant season of 2023/2024. The approved mitigation plan planting list is provided below for reference.
- RS will install additional treated fence post corners along this boundary line and add additional signage.
