Subject: Year 5 Monitoring Report for Stream Mitigation of Thompsons Fork and UT; McDowell County, NC; SCO# D06030-A

# Year 5 Monitoring Report for Stream Restoration of Thompsons Fork and Unnamed Tributary

McDowell County, NC SCO # D06030-A

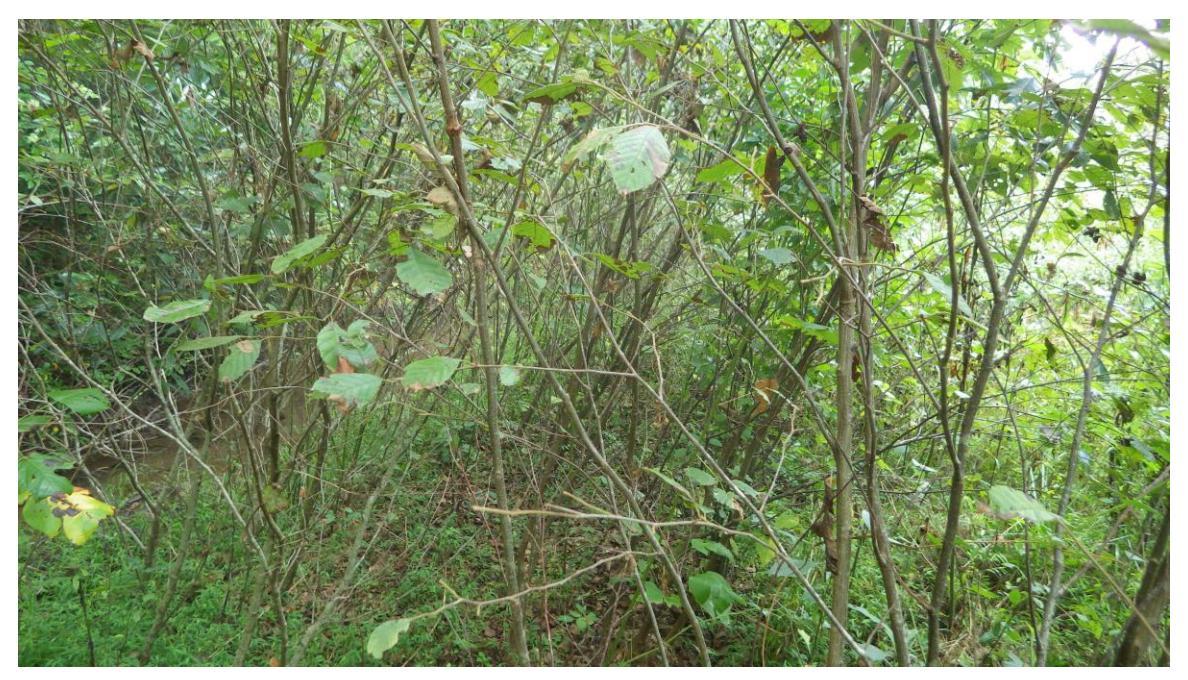
Fixed Station 1 Overview of valley along UT1 near the upstream terminus of the project, approximately Station 4+00, facing downstream. (EMH&T, 9/11/13)

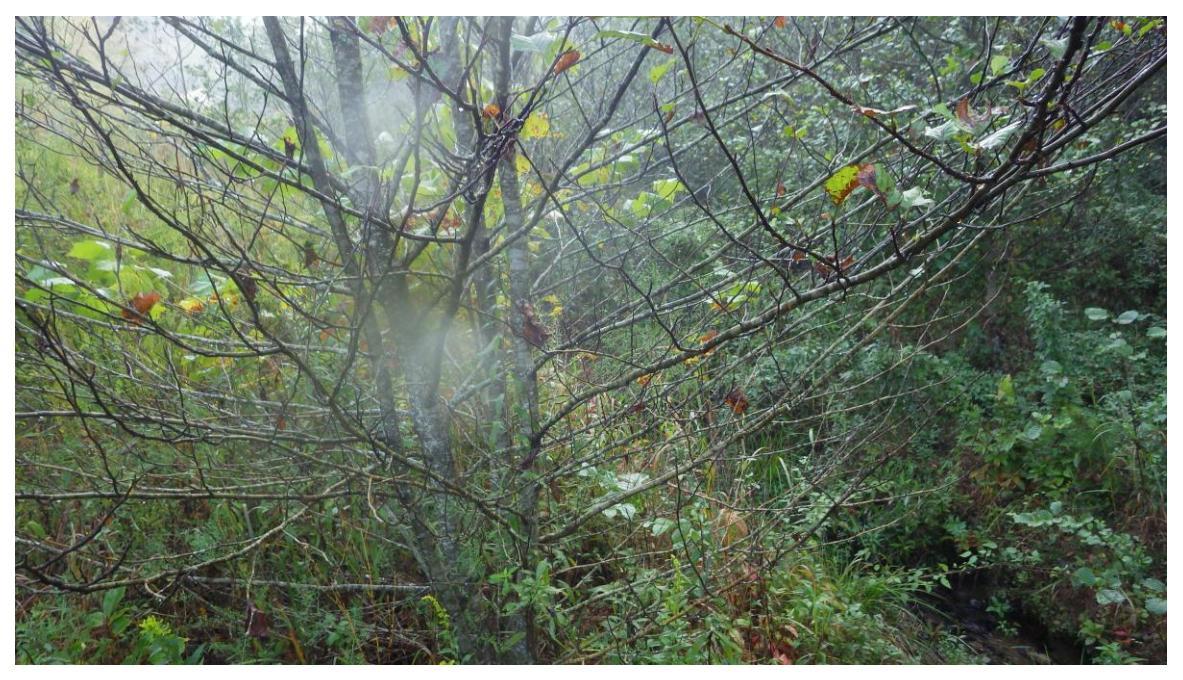
Fixed Station 2 Overview of valley along UT1 near the midpoint of the project, approximately Station 10+75, facing upstream. (EMH&T, 9/11/13)

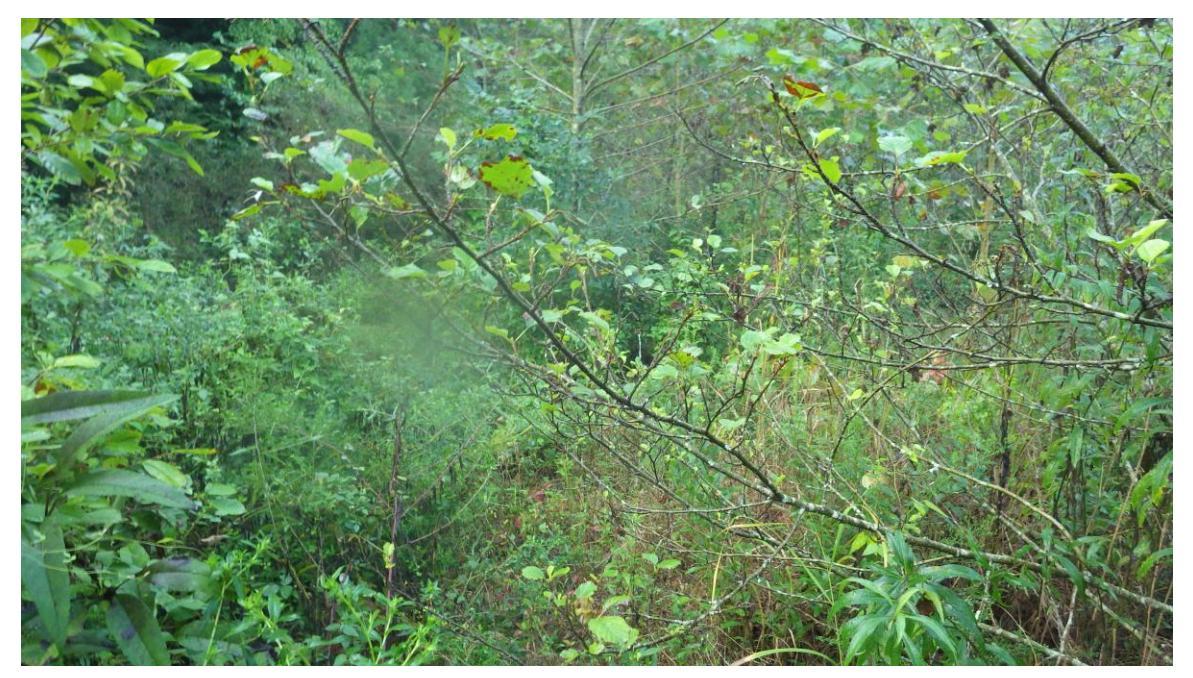
Fixed Station 3 Overview of valley along UT1 near the midpoint of the project, approximately Station 10+75, facing downstream. (EMH&T, 9/11/13)

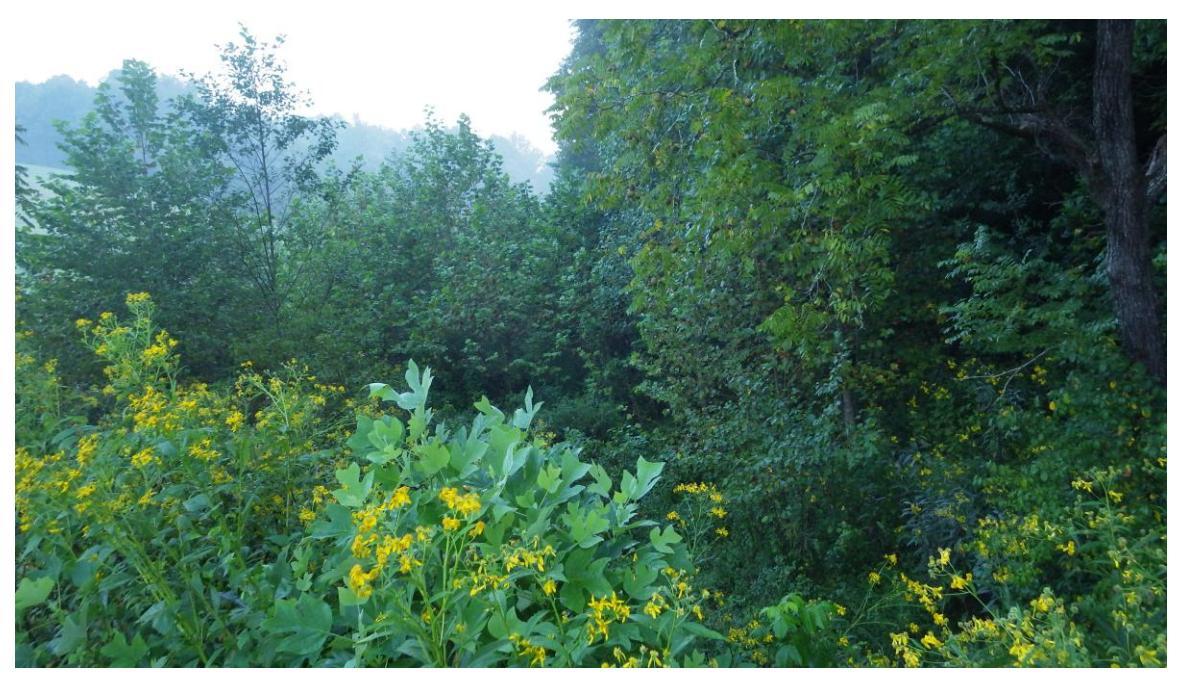
Fixed Station 4 Overview of valley along UT1 near the downstream terminus of the project, just north of South Creek Road, facing upstream. (EMH&T, 9/11/13)

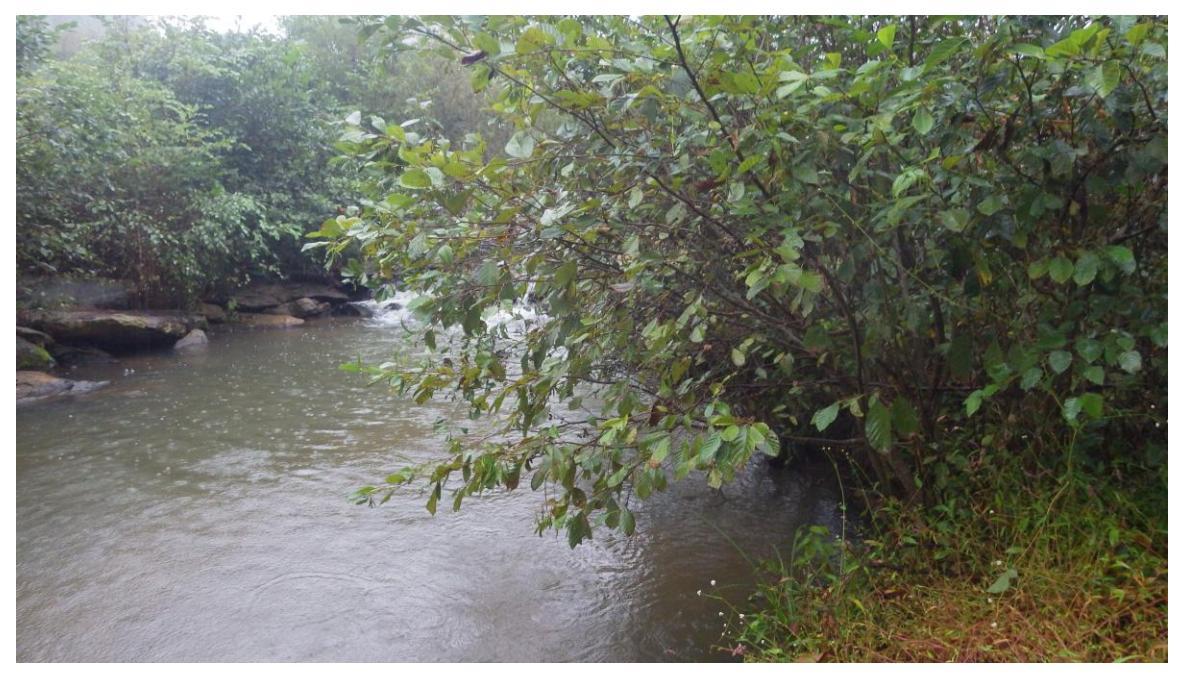
Fixed Station 5 Overview of valley along UT1 at the downstream terminus of the project, facing upstream. (EMH&T, 9/25/13)

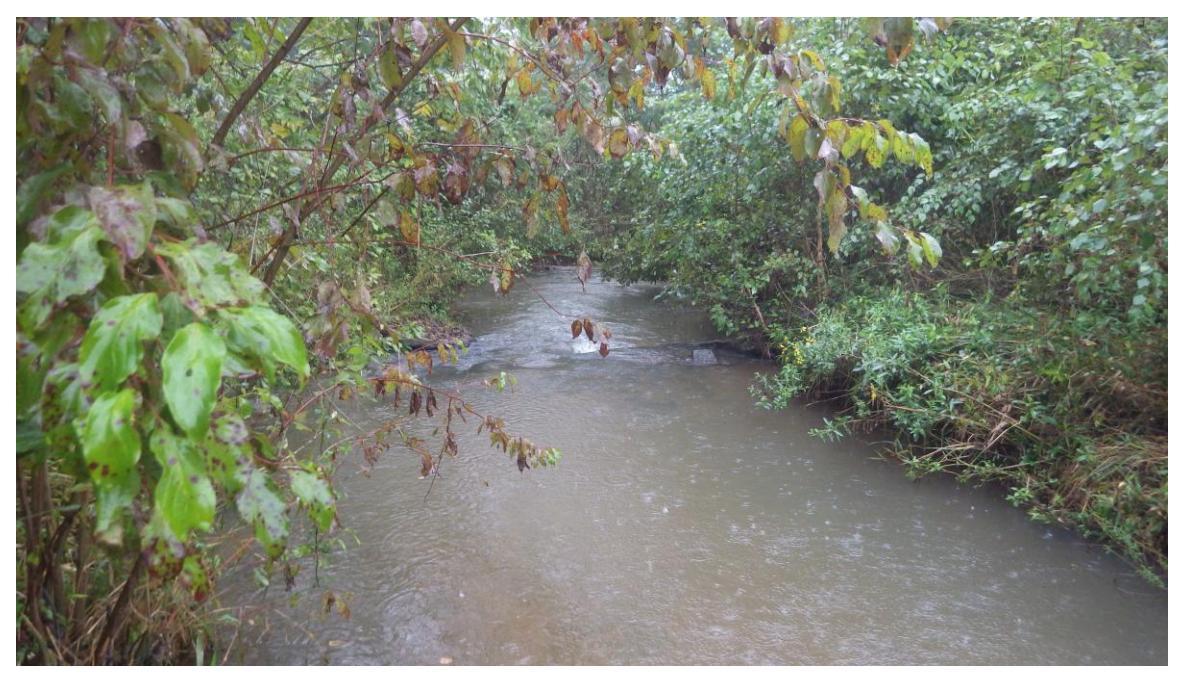
Fixed Station 6 Overview of valley along the mainstem near the downstream terminus of the project, facing upstream. (EMH&T, 9/25/13)

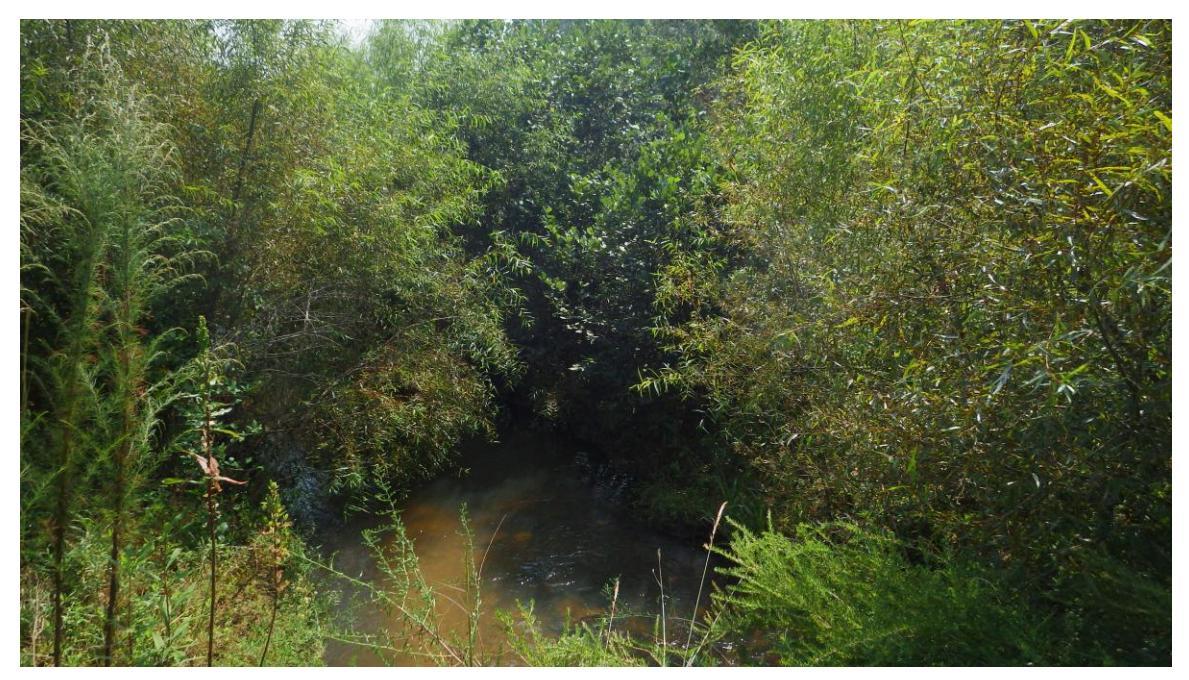
Fixed Station 7 Overview of valley along the mainstem near the midpoint of the project, approximately Station 12+00, facing downstream. (EMH&T, 9/11/13)

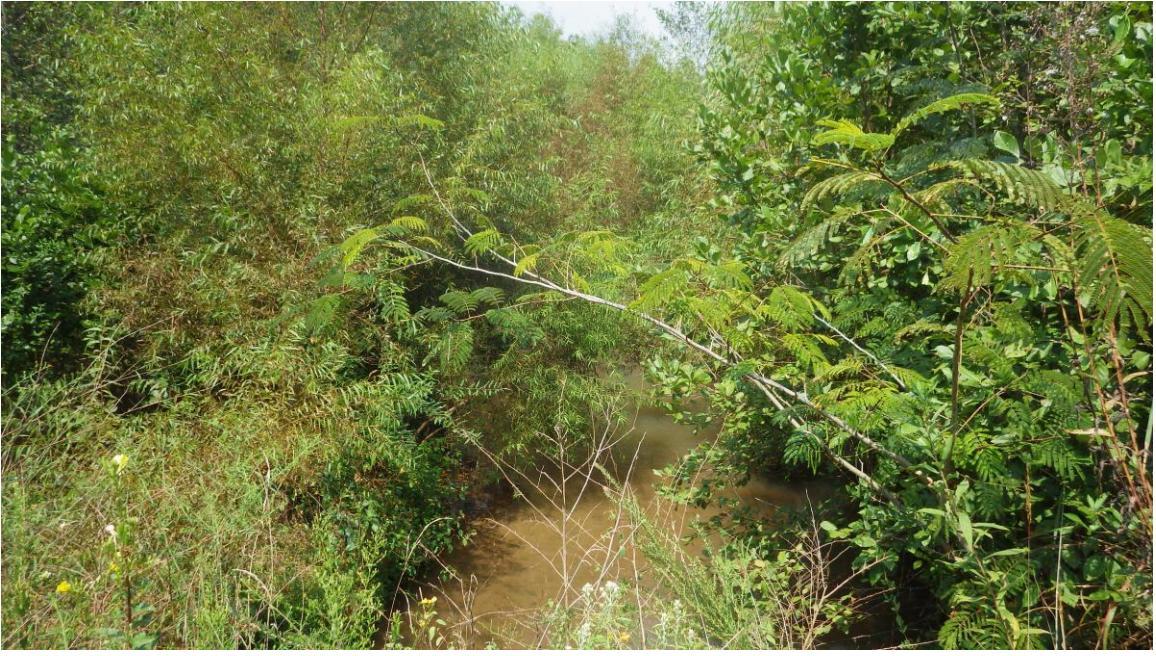
Fixed Station 8 Overview of valley along the mainstem near the midpoint of the project, approximately Station 11+50, facing upstream. (EMH&T, 9/11/13)

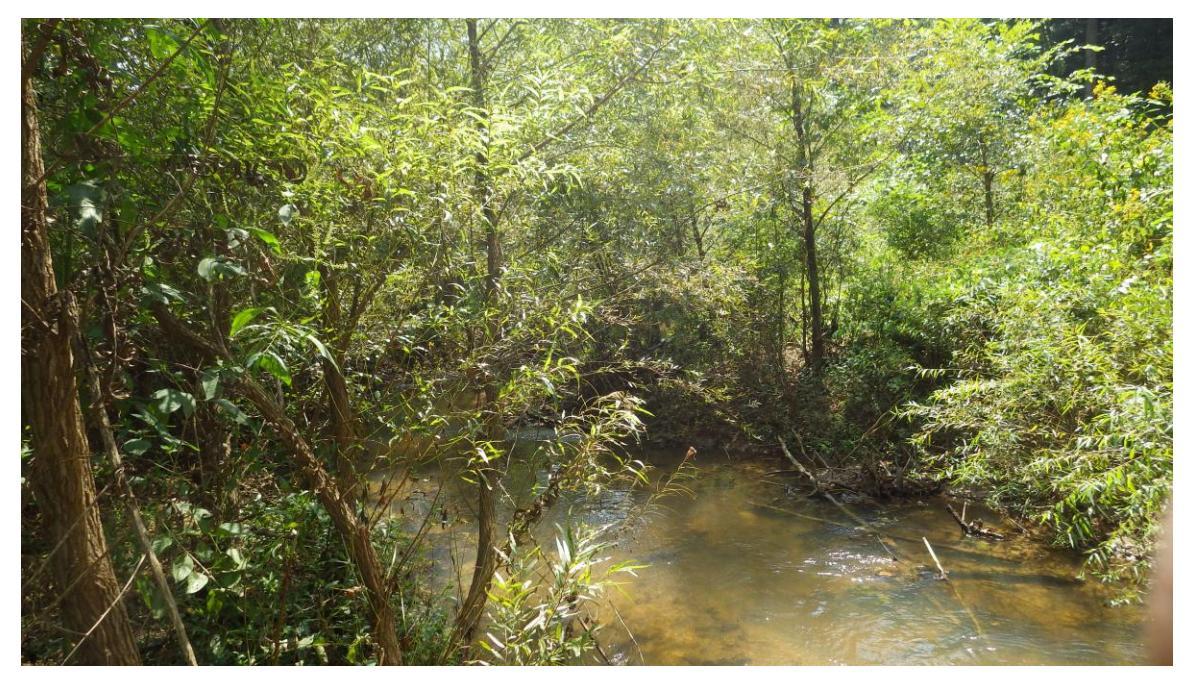
Fixed Station 9 Overview of valley along the mainstem near the upstream terminus of the project, facing downstream. (EMH&T, 9/11/13)

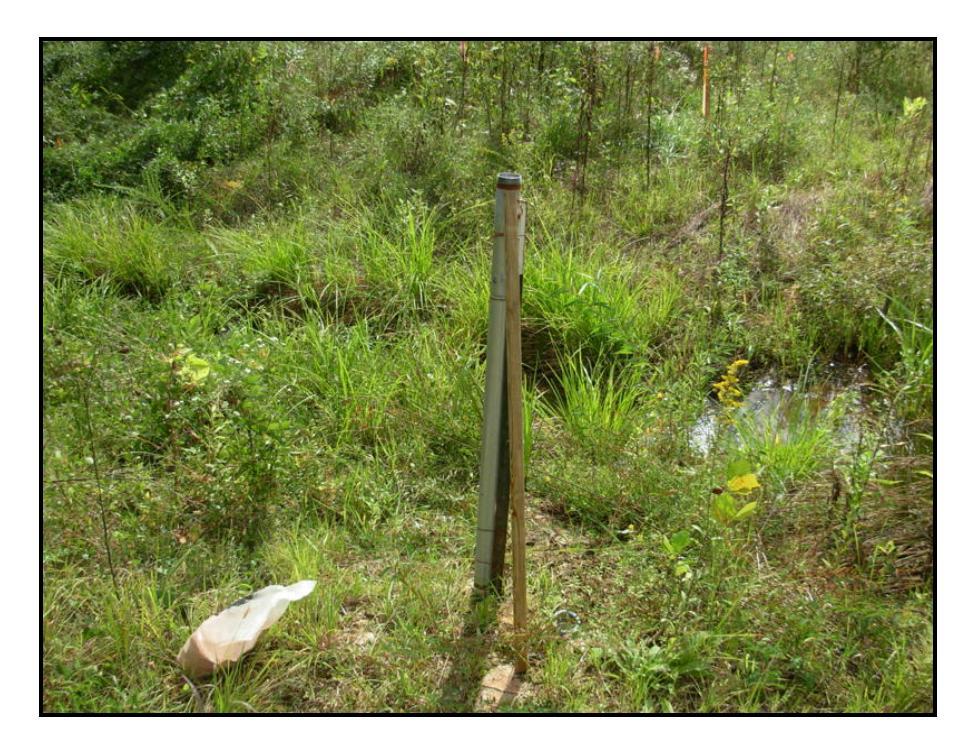
BF 1 Crest Gage at XS-6 on UT (Year 1). (EMH&T, 9/21/09)

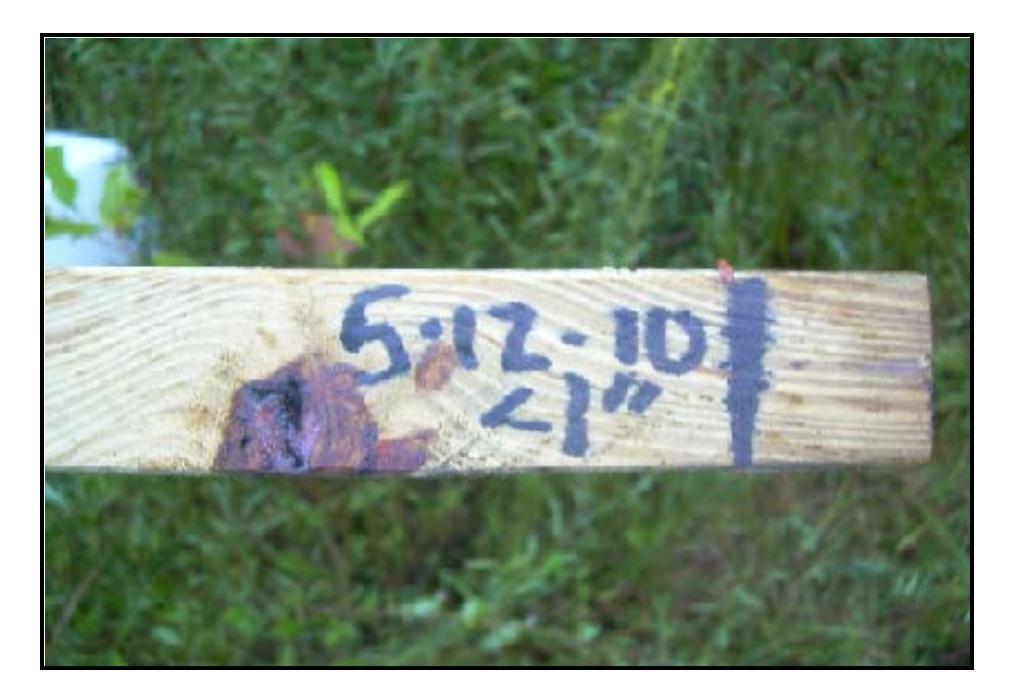
BF 2 Crest Gage at XS-6 on UT (Year 2). (EMH&T, 5/12/10)

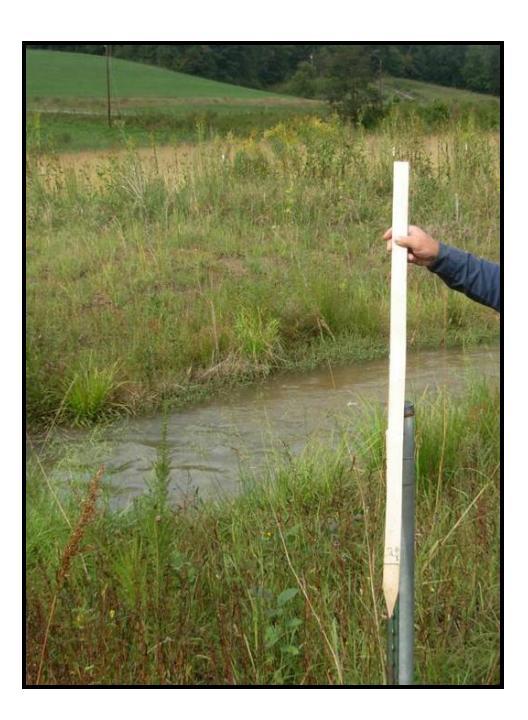
BF 4 Crest Gage at XS-7 on Mainstem (Year 1). (EMH&T, 9/21/09)

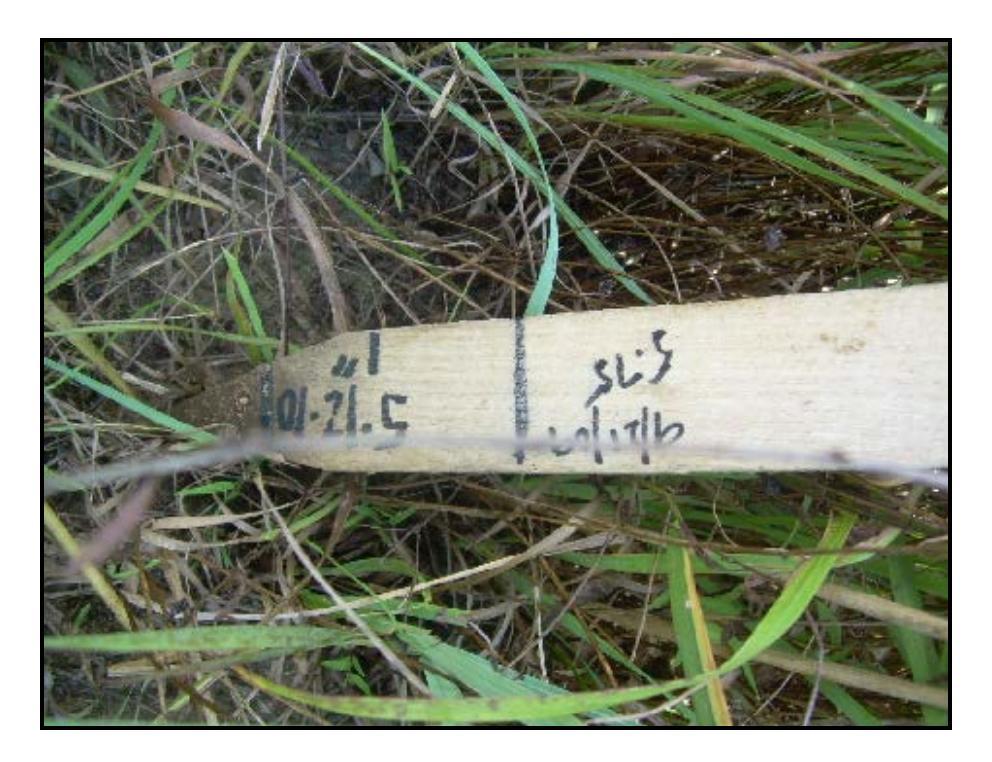
BF 5 Crest Gage at XS-7 on Mainstem (Year 2). (EMH&T, 5/12/10)
