Monitoring Year 5 (2016) Report

FINAL

Upper South Hominy Mitigation Site, South Hominy Creek, French Broad River Basin, Buncombe County, North Carolina

DMS Project Number: 92632

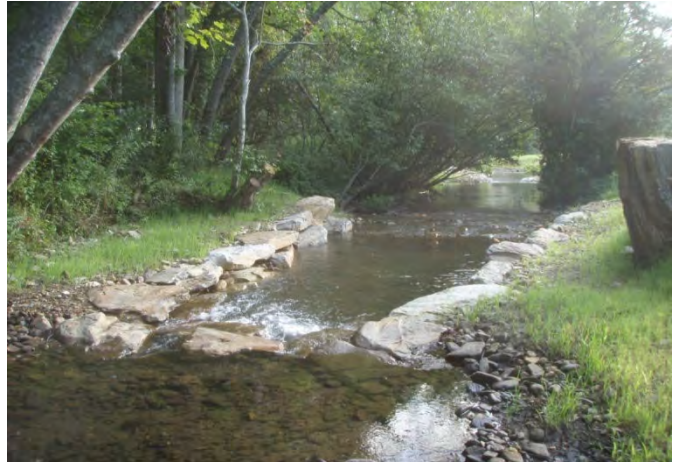
Cross vane, sta. 0+50, facing downstream, 14 August 2011.

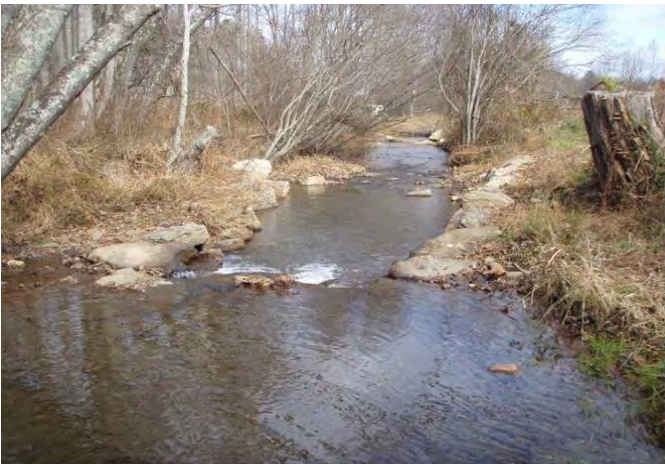
Cross vane, sta. 0+50, facing downstream, 20 November 2012.

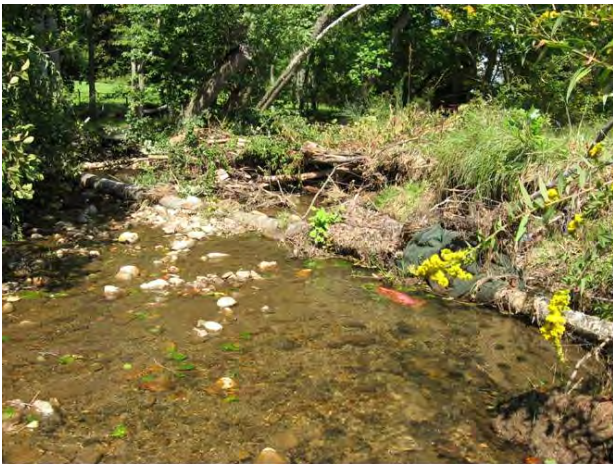
Channel blockage, sta.2+50, facing downstream, pre-construction, 30 September 2008.

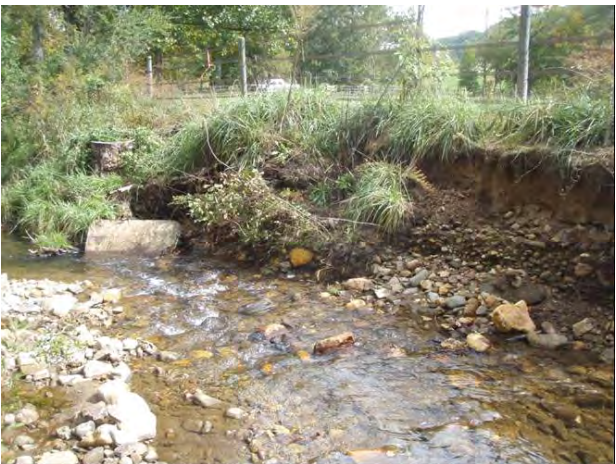
Right bank erosion, sta. 5+50, pre-construction, 30 September 2008.

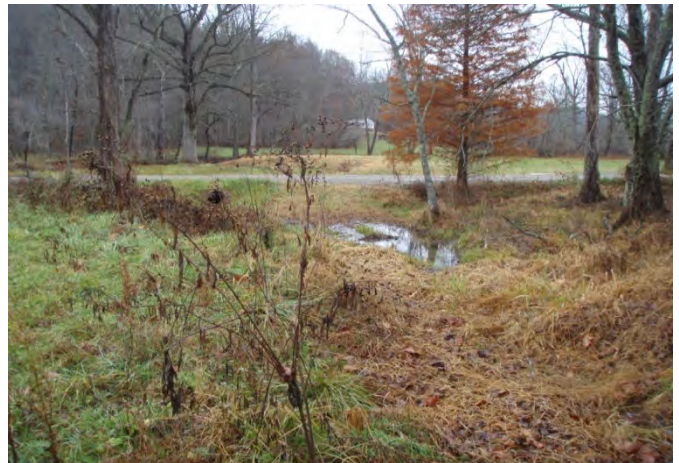
UT2 re-connected under Canterfield Lane to abandoned channel, sta. 0+00 to 0+50, 5 December 2011.

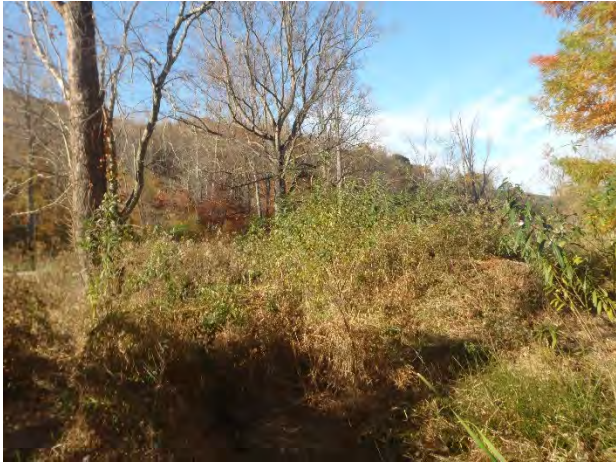
UT2 re-connected under Canterfield Lane to abandoned channel, sta. 0+00 to 0+50, 12 November 2014.

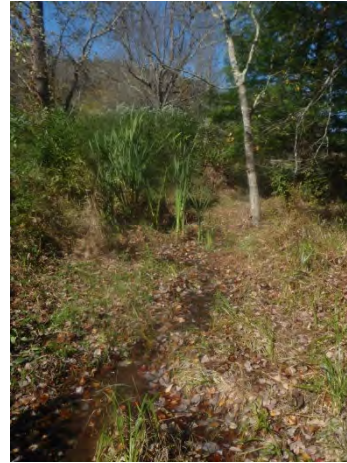
UT2 re-connected under Canterfield Lane to abandoned channel, sta. 0+00 to 0+50, 15 October 2015.

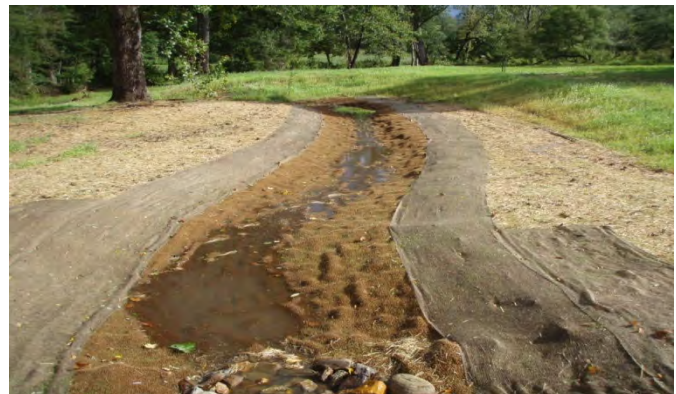
UT2 restored portion, east of Canterfield Lane, 5 September 2011.

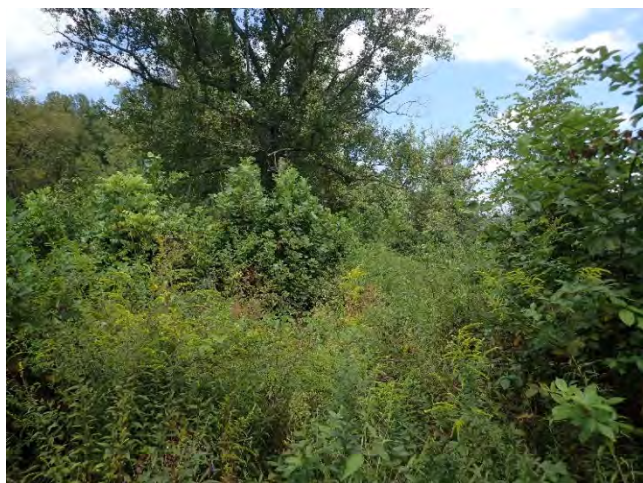
UT2 restored portion, east of Canterfield Lane, 15 September 2016.

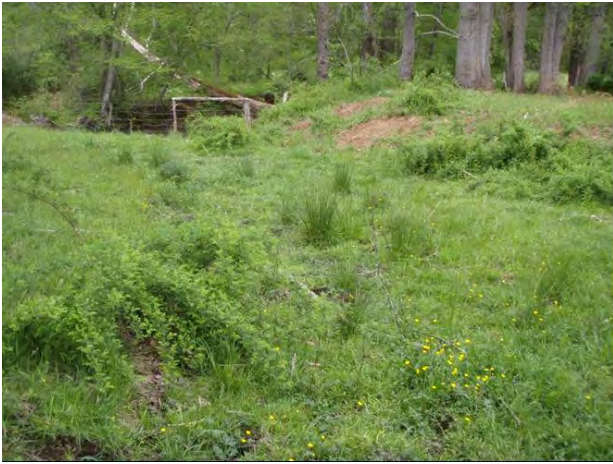
Lower portion of UT2 abandoned channel at confluence with SHC, Pre-construction, facing downstream, 26 April 2010.

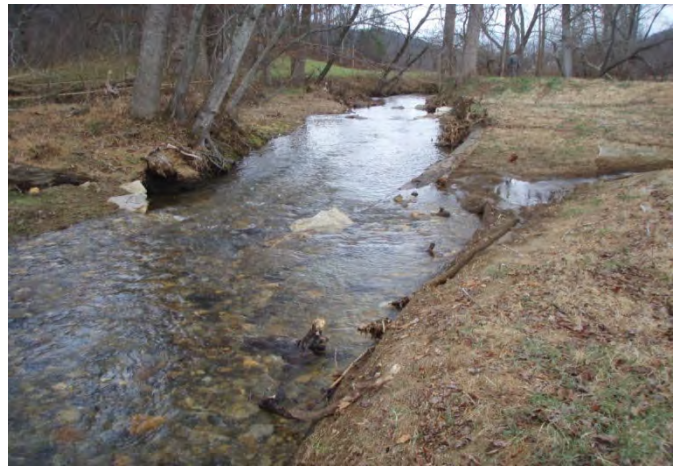
Log vane sta. 1+00 to 1+50, facing downstream

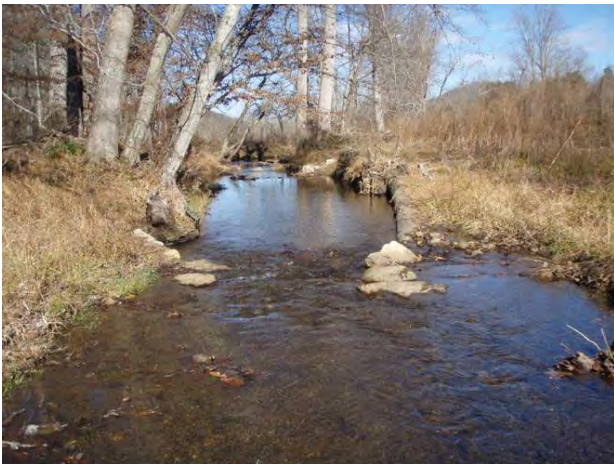
Log vane sta. 1+00 to 1+50, facing downstream, 20 November 2012.

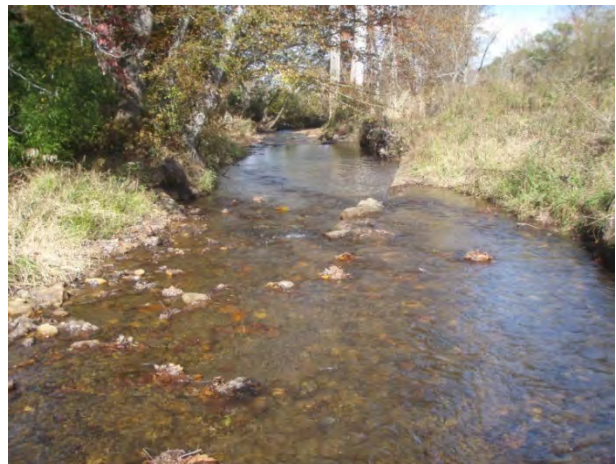
Log vane sta. 1+00 to 1+50, facing downstream, 29 October 2013.

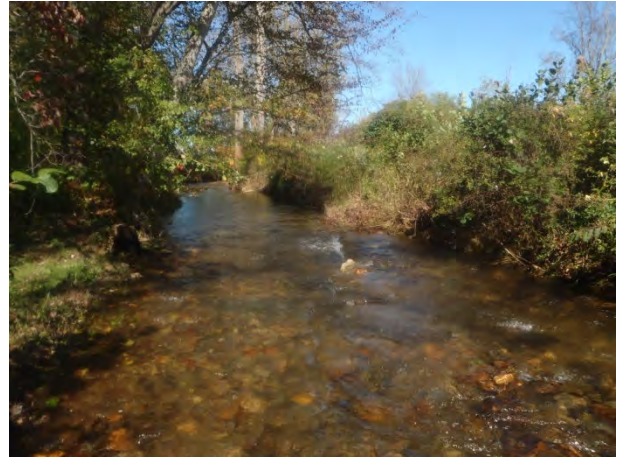
Log vane sta. 1+00 to 1+50, facing downstream, 14 October 2015.

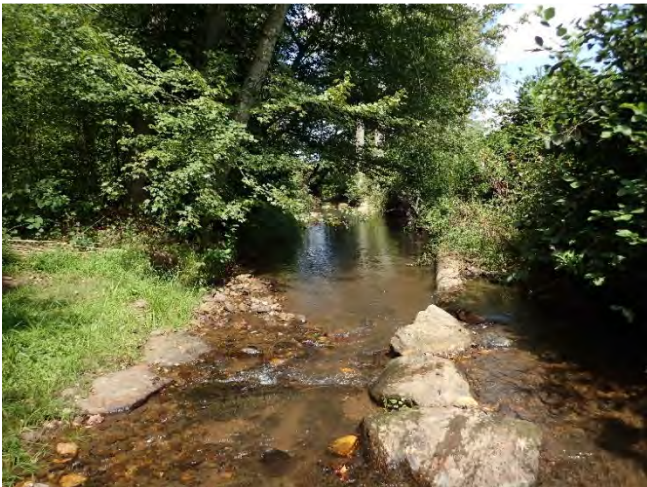
Log vane sta. 1+00 to 1+50, facing downstream, 15 September 2016.

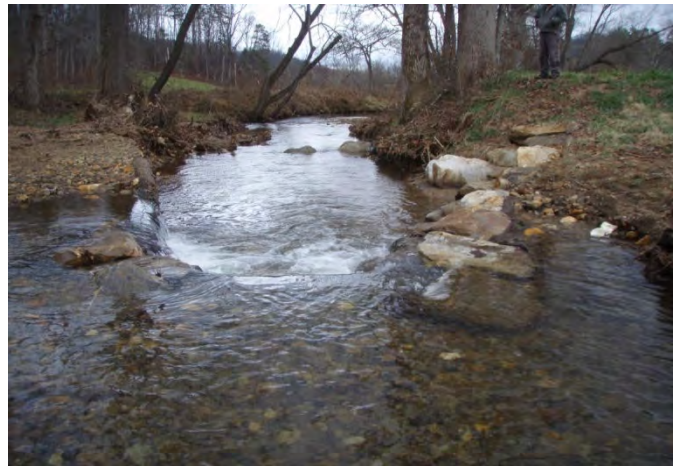
Log vane at sta. 1+50 to 2+50, facing downstream, 5 December 2011.

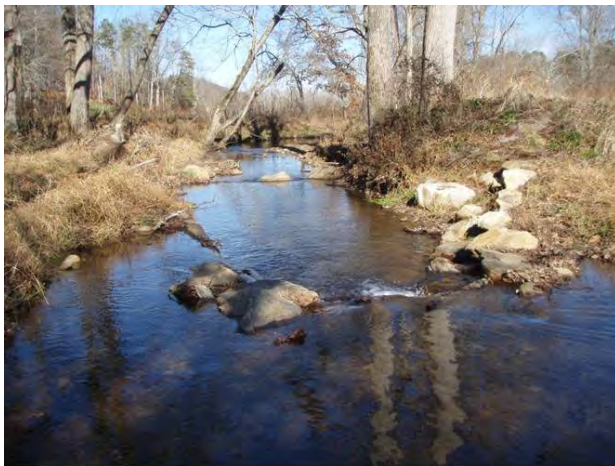
Log vane sta. 1+50 to 2+50, facing downstream, 20 November 2012.

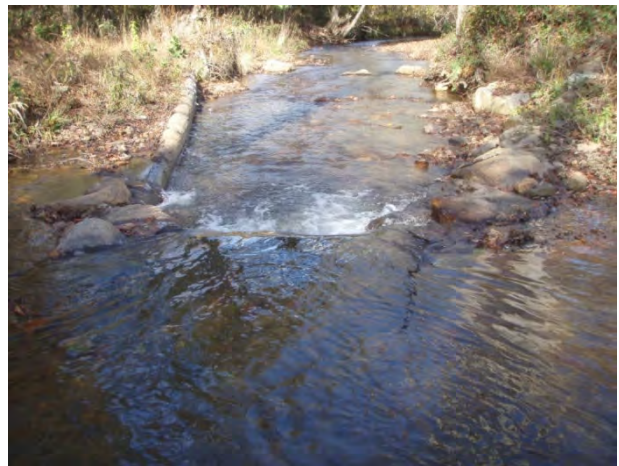
Log vane sta. 1+50 to 2+50, facing downstream, 29 October 2013.

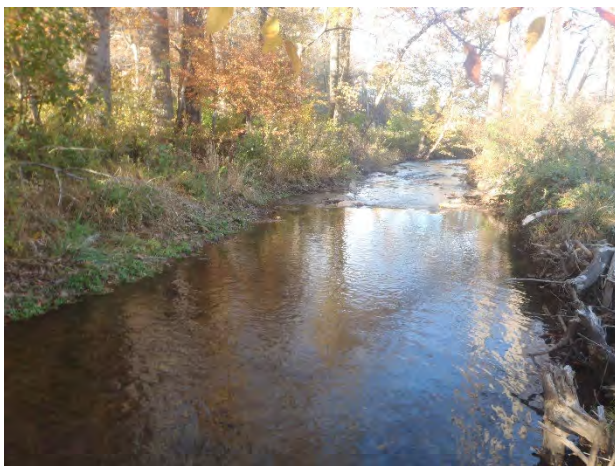
Log vane sta. 1+50 to 2+50, facing downstream, 12 November 2014.

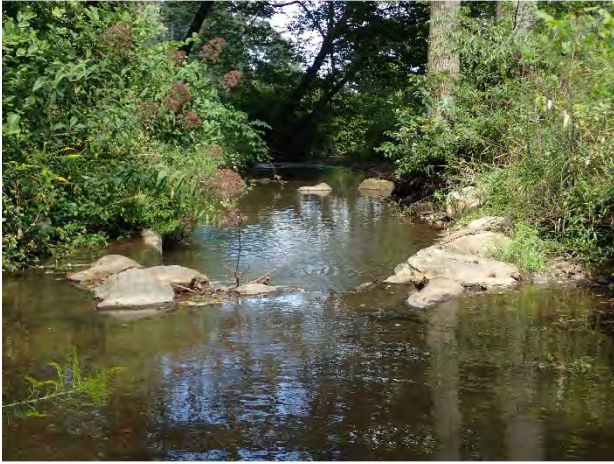
Log vane sta. 1+50 to 2+50, facing downstream, 15 September 2016.

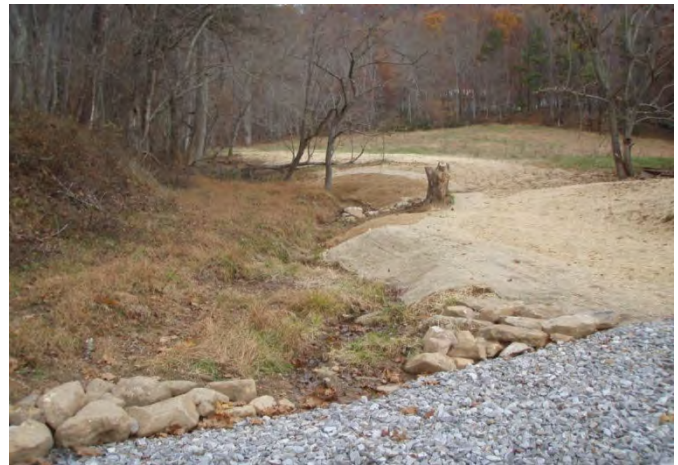
UT3 above ford, invasive removal, cattle exclusion, and bank shaping, facing upstream, 9 November 2011.

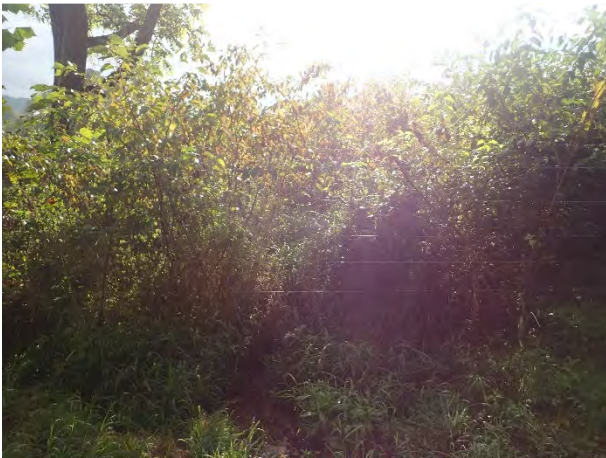
UT3 above ford, invasive removal, cattle exclusion, and bank shaping, facing upstream, 15 September 2016.

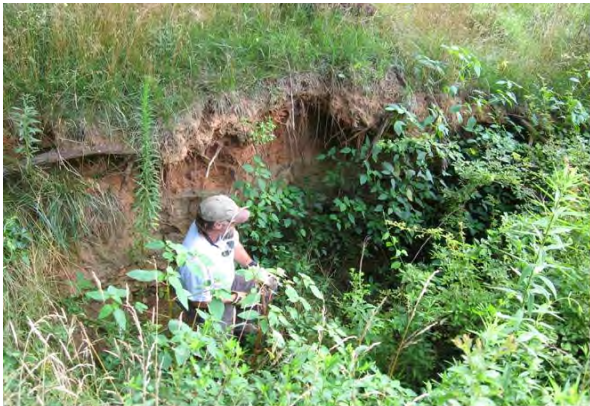
Photo Station 25

UT3 below ford, severe entrenchment and head cutting, 25 July 2008.

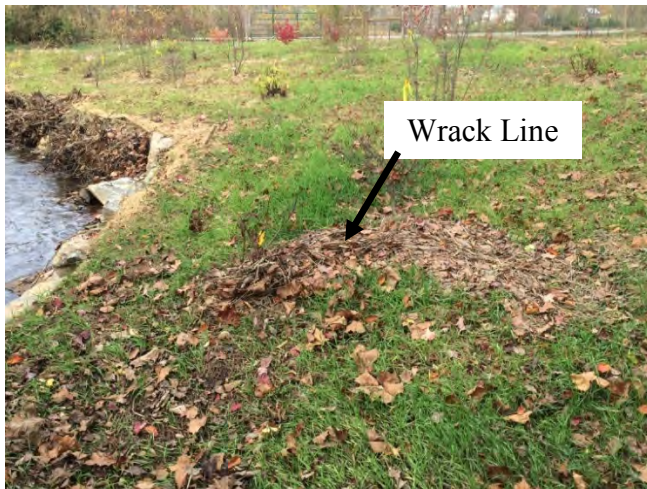
Photo 7 bankfull event on SHC, right bank Robertson property, sta.12+00 facing downstream on 28 October 2014.

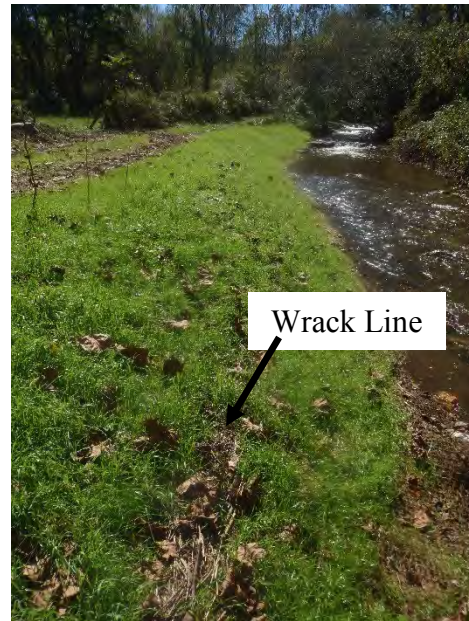
Photo 8 bankfull event on SHC, right bank Bianculli property, sta.12+00 facing downstream on 14 October 2015.

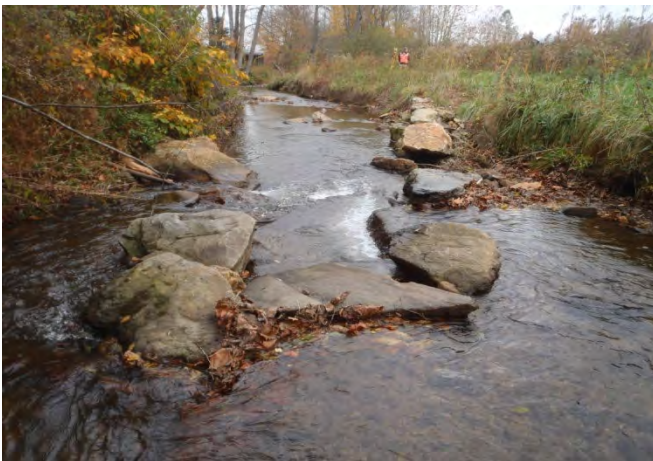
Rock vane, sta 1+50 facing downstream, 28 October 2014

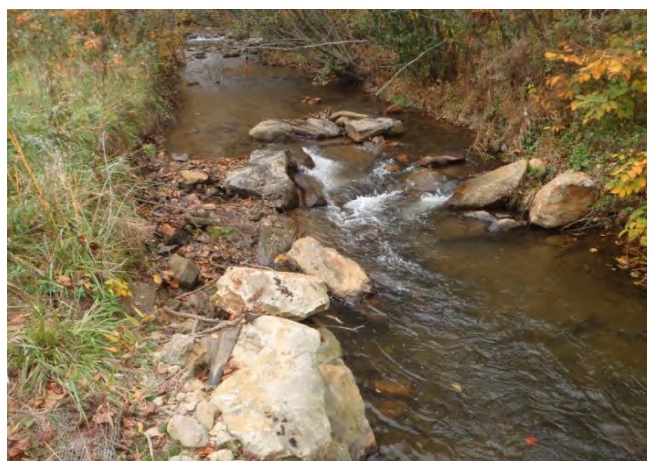
Rock vane, sta 1+50 facing upstream, 28 October 2014

Repaired rock vane, sta 1+50 facing downstream 14 October 2015
No longer considered a problem during MY4 (2015) field surveys.

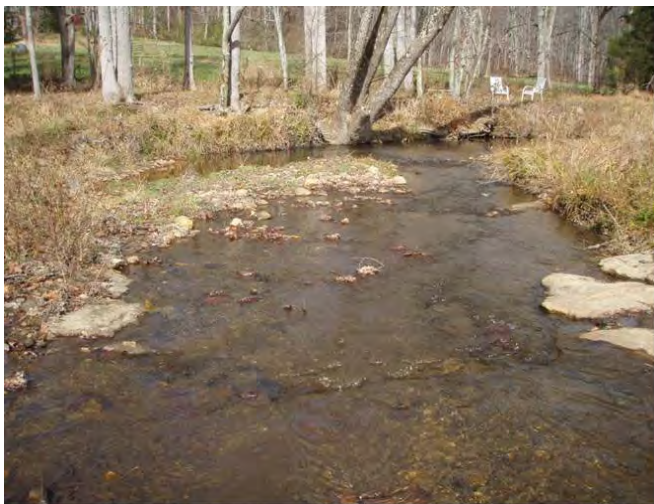
Aggradation and bar formation in meander below J-hook, sta. 2+50, facing downstream, 20 November 2012.

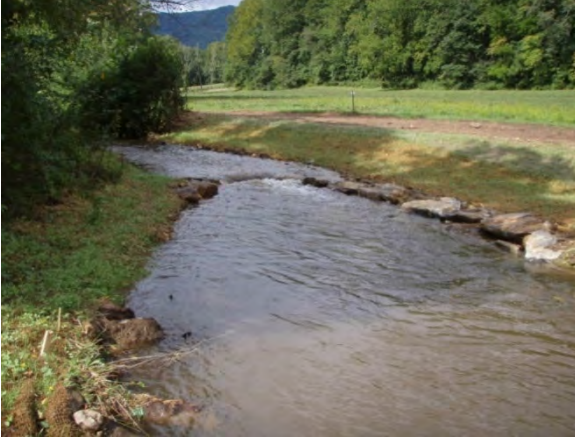
Problem Area 4

J-hook vane after construction, sta. 9+25, facing upstream, 5 September 2011.

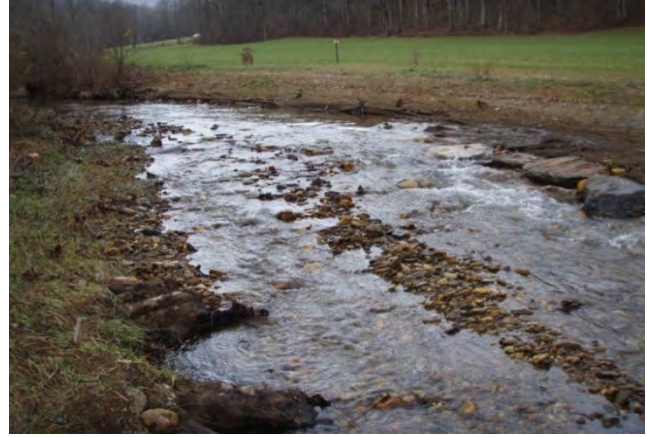
Aggradation and bar formation below J-hook, sta. 9+25 to 9+50, after flood event, facing upstream, 5 December 2011.

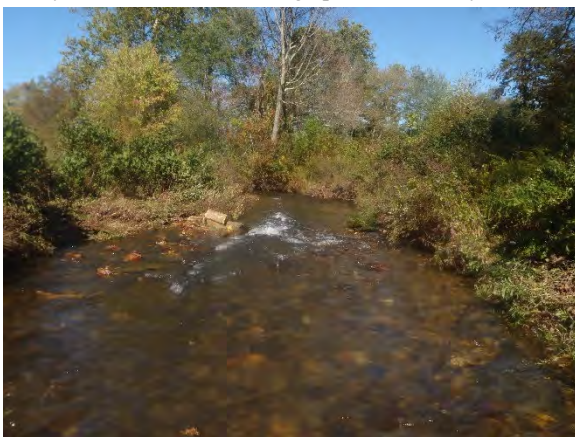
Aggradation and bar formation below J-hook, sta. 9+25 to 9+50, following 5 May 2013 flood event, facing downstream, 14 October 2015.

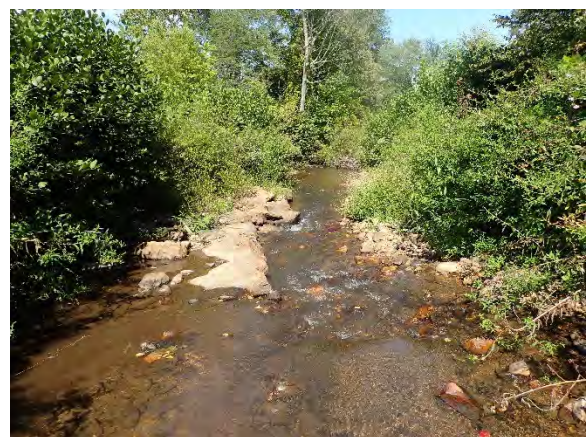
Aggradation and bar formation below J-hook, sta. 9+25 to 9+50, following 5 May 2013 flood event, facing downstream, 12 September 2016.

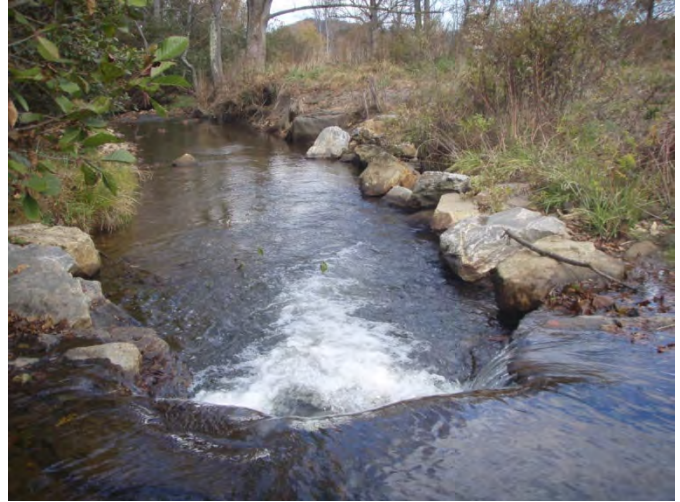
Problem Area 6

J-hook arm collapse during 5 May 2013 flood event, sta. 5+75, facing downstream, 29 October 2013.

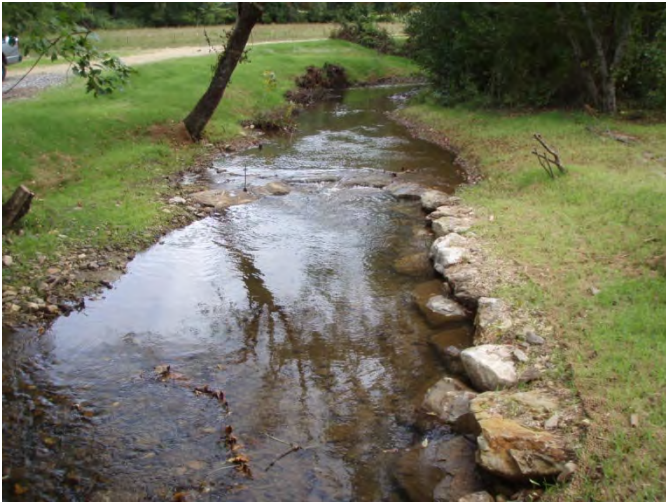
Problem Area 7

J-hook, sta. 12+75, after construction, facing upstream, 22 Sept 2011.

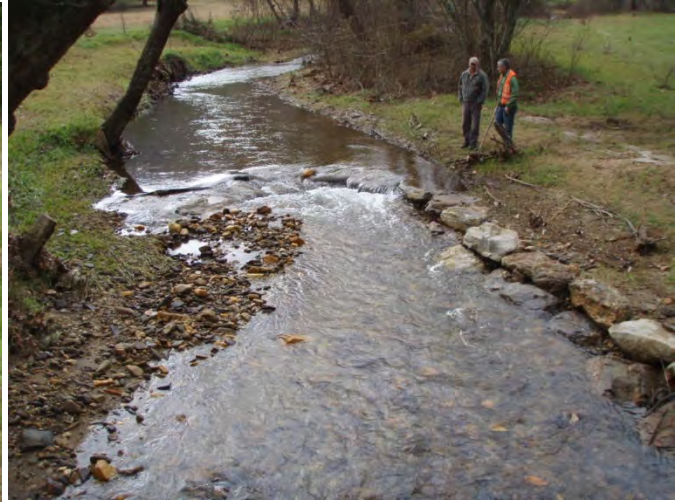
J-hook after 28 Nov 2011 flood event, aggradation in pool below J-hook, 5 December 2011.

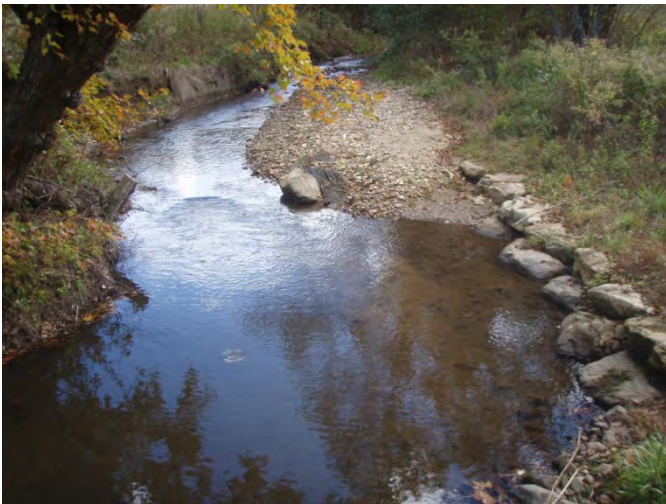
J-hook after 5 May 2013 flood event, aggradation above J-hook and scour pool below, 29 October 2013.

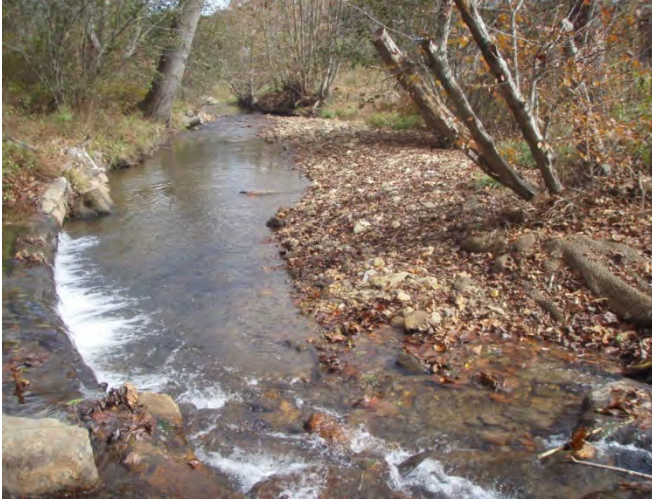
Problem Area 8

Aggradation below J-hook, sta. 4+00 to 4+50, following 5 May 2013 flood event, facing downstream, 29 October 2013.

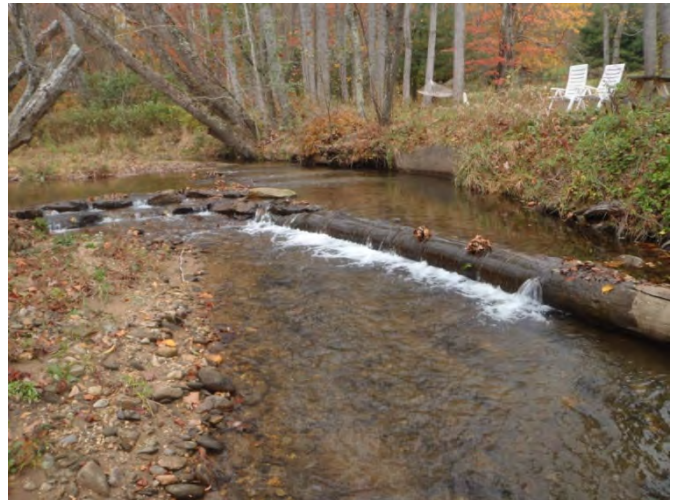
Aggradation below J-hook, sta 4+00 to 4+50, facing upstream, 28 October 2014

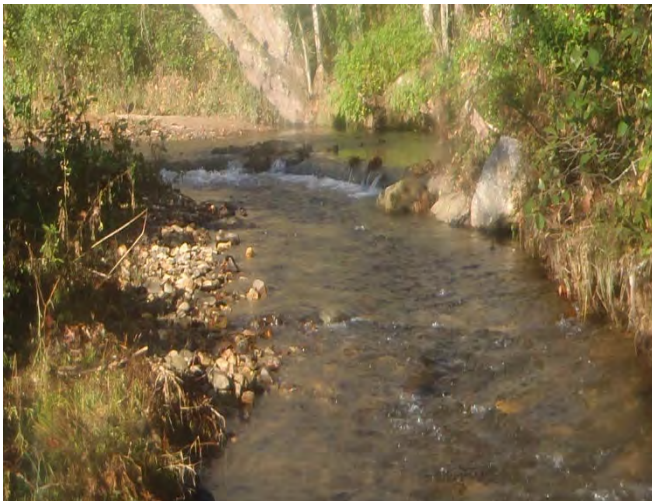
Area below J-hook, sta. 4+00 to 4+50, facing upstream, 15 October 2015. No longer considered a problem during MY4 (2015) field surveys.

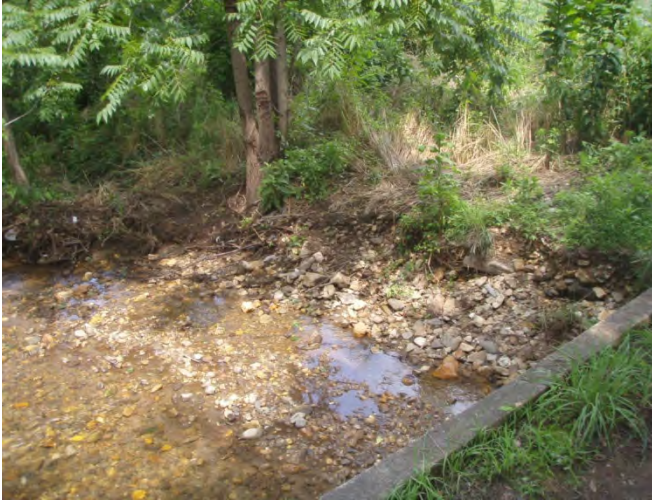
Problem Area 9

Right bank scour during 5 May 2013 flood event, sta. 0+00 to 0+20, facing downstream, 18 July 2013.

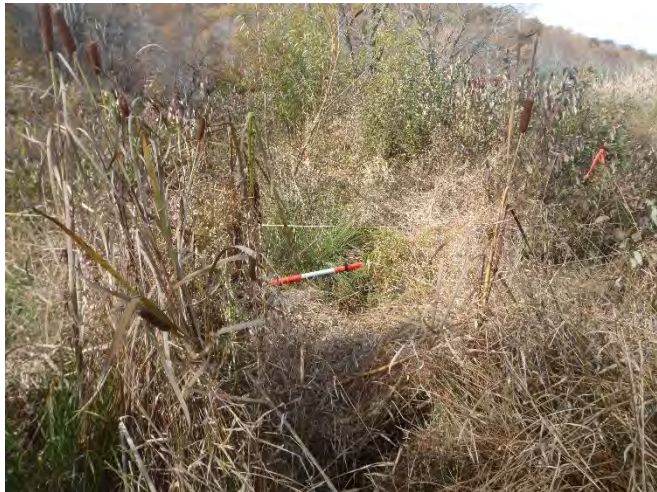
Problem Area 10

Aggradation due to low flow velocity and dense herbaceous vegetation, sta. 0+00 to 2+00 UT-3 Upper Davis Reach, facing upstream, 28 October 2014.

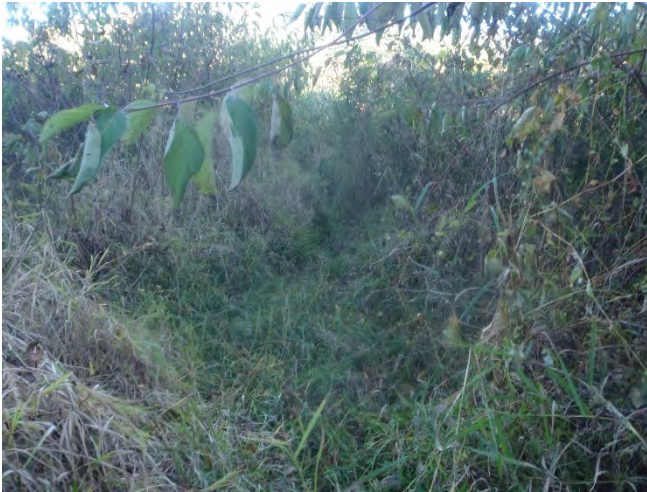
Aggradation due to low flow velocity and dense herbaceous vegetation, sta. 0+00 to 2+00 UT-3 Upper Davis Reach, facing downstream, 15 October 2015.

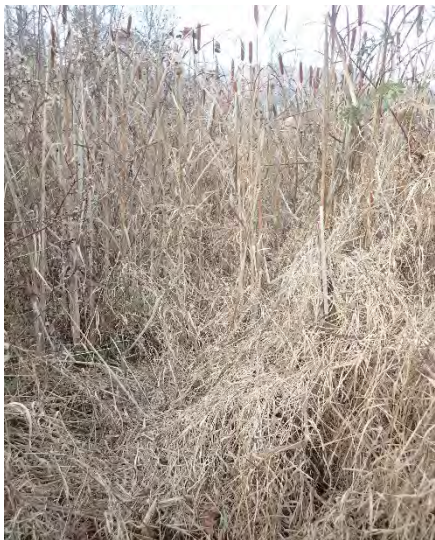
Aggradation due to low flow velocity and dense herbaceous vegetation, sta. 0+00 to 2+00 UT-3 Upper Davis Reach, facing upstream, 14 November 2016.

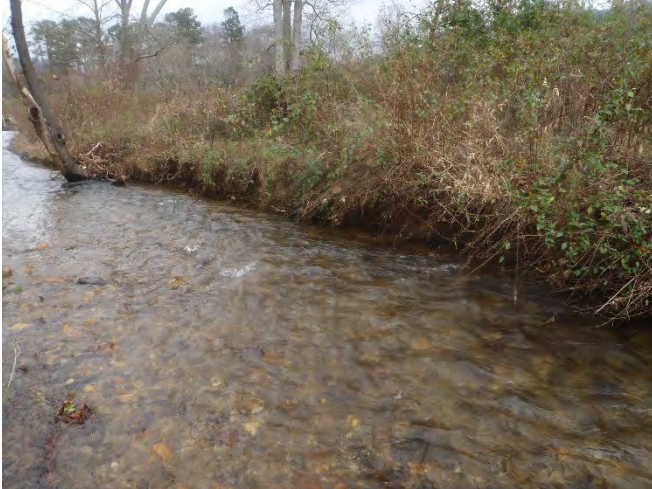
Problem Area 11

Right bank erosion due to high flow events, sta. 5+05 to 6+10 facing downstream, 17 November 2015.

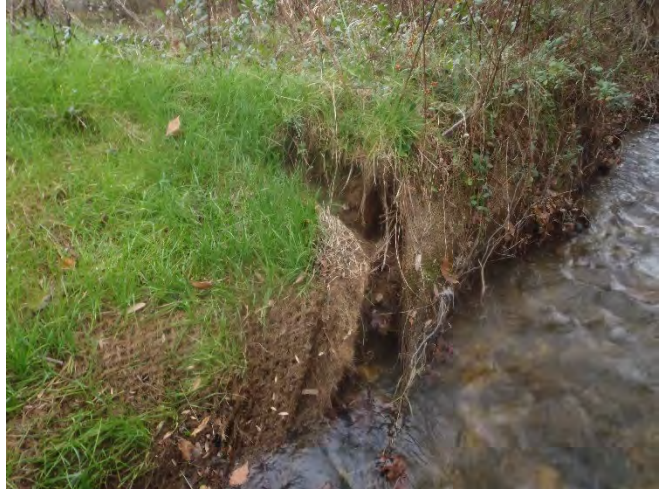
Right bank erosion due to high flow events, sta. 5+05 to 6+10 facing upstream, 17 November 2015

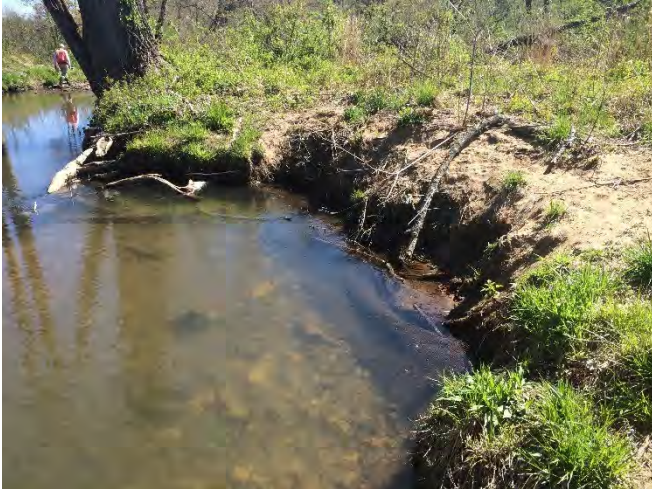
Problem Area 12

Right bank erosion due to high flow events, sta. 3+45 to 3+70 facing downstream, 18 April 2016.
