FINAL
ANNUAL MONITORING REPORT
YEAR 3 (2014)
UT TO BALD STREAM/WETLAND RESTORATION SITE
YANCEY COUNTY, NORTH CAROLINA
(EEP Project No. 92596, Contract No. 4997)
Construction Completed December 2011

March 2015

Prepared by:
Axiom Environmental, Inc.
218 Snow Avenue
Raleigh, North Carolina 27603

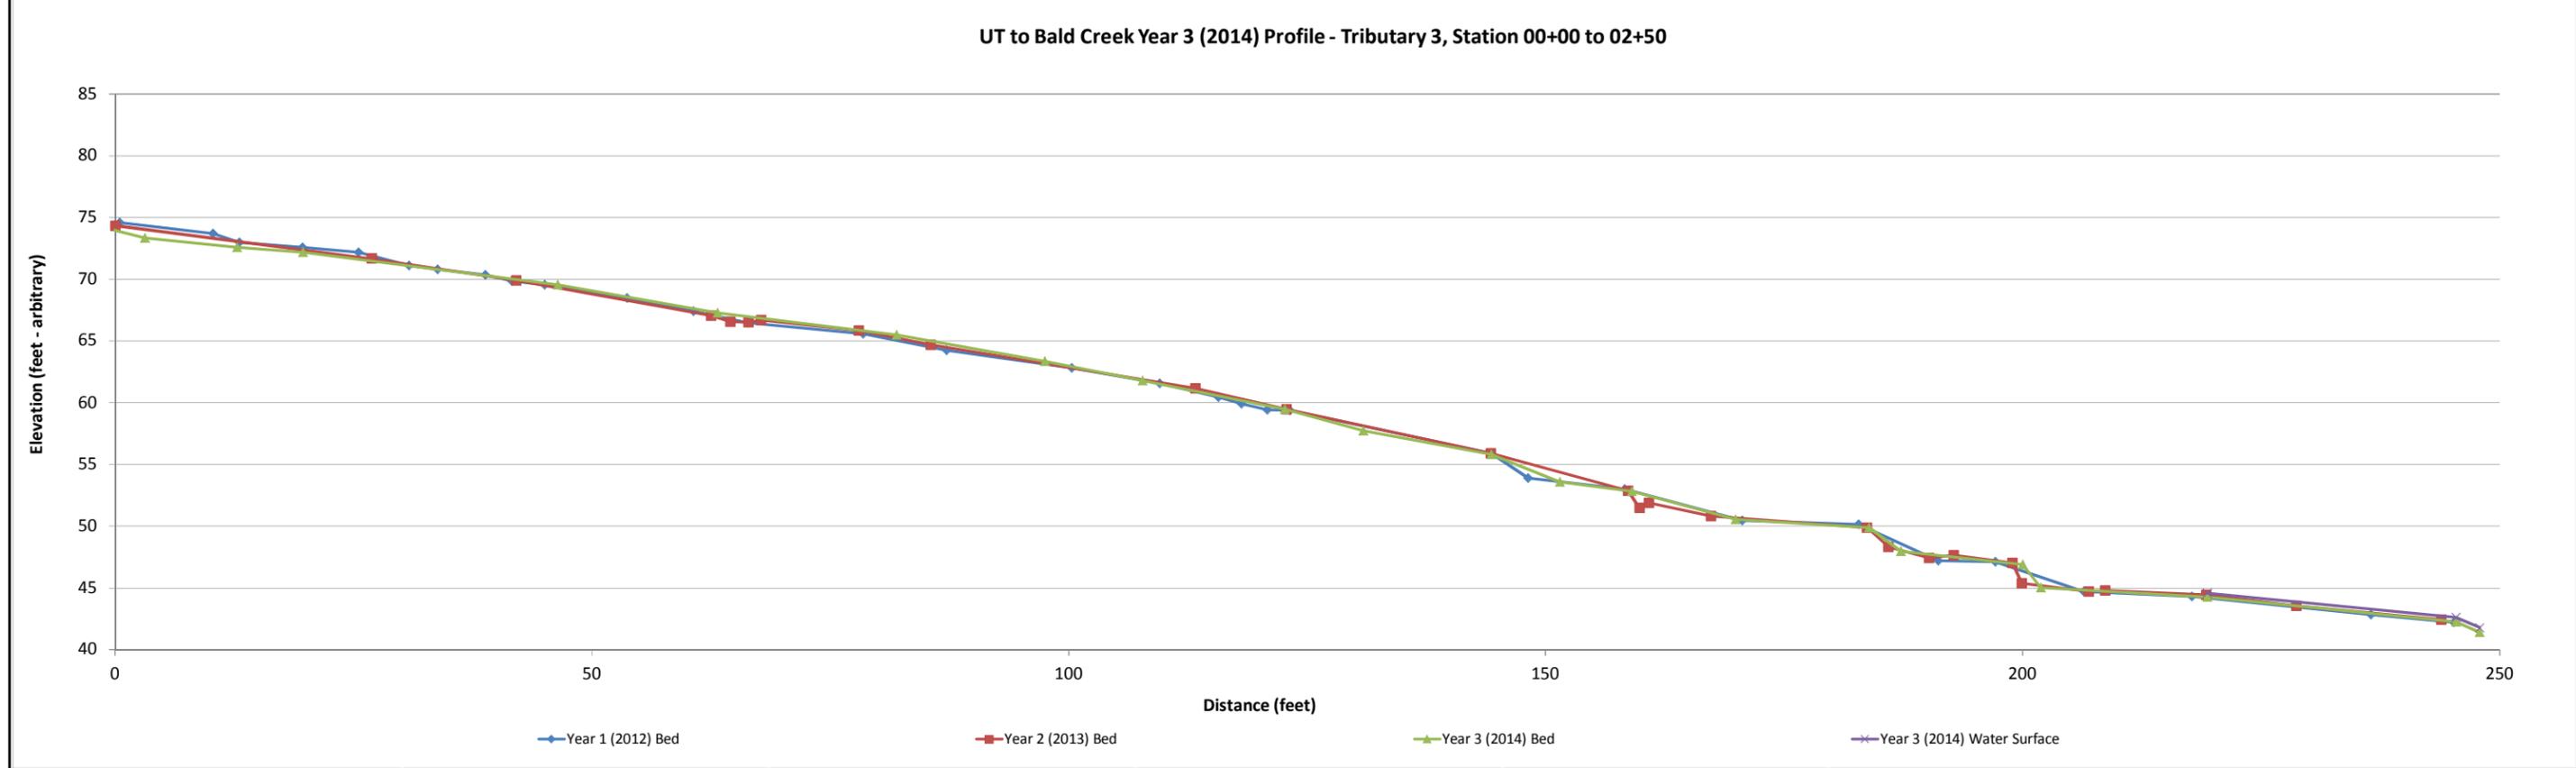
Project Name	UT to Bald Creek - Profile
Reach	Tributary 3 Station 00+00 - 02+50
Feature	Profile
Date	2/16/15
Crew	Perkinson, Jernigan

2012	2013	2014	2015	2016
Avg. Water Surface Slope	NA*	NA*	NA*		
Riffle Length	25	44	33		
Avg. Riffle Slope	NA*	NA*	NA*		
Pool Length	18	7	10		
Pool to Pool Spacing	28	45	25

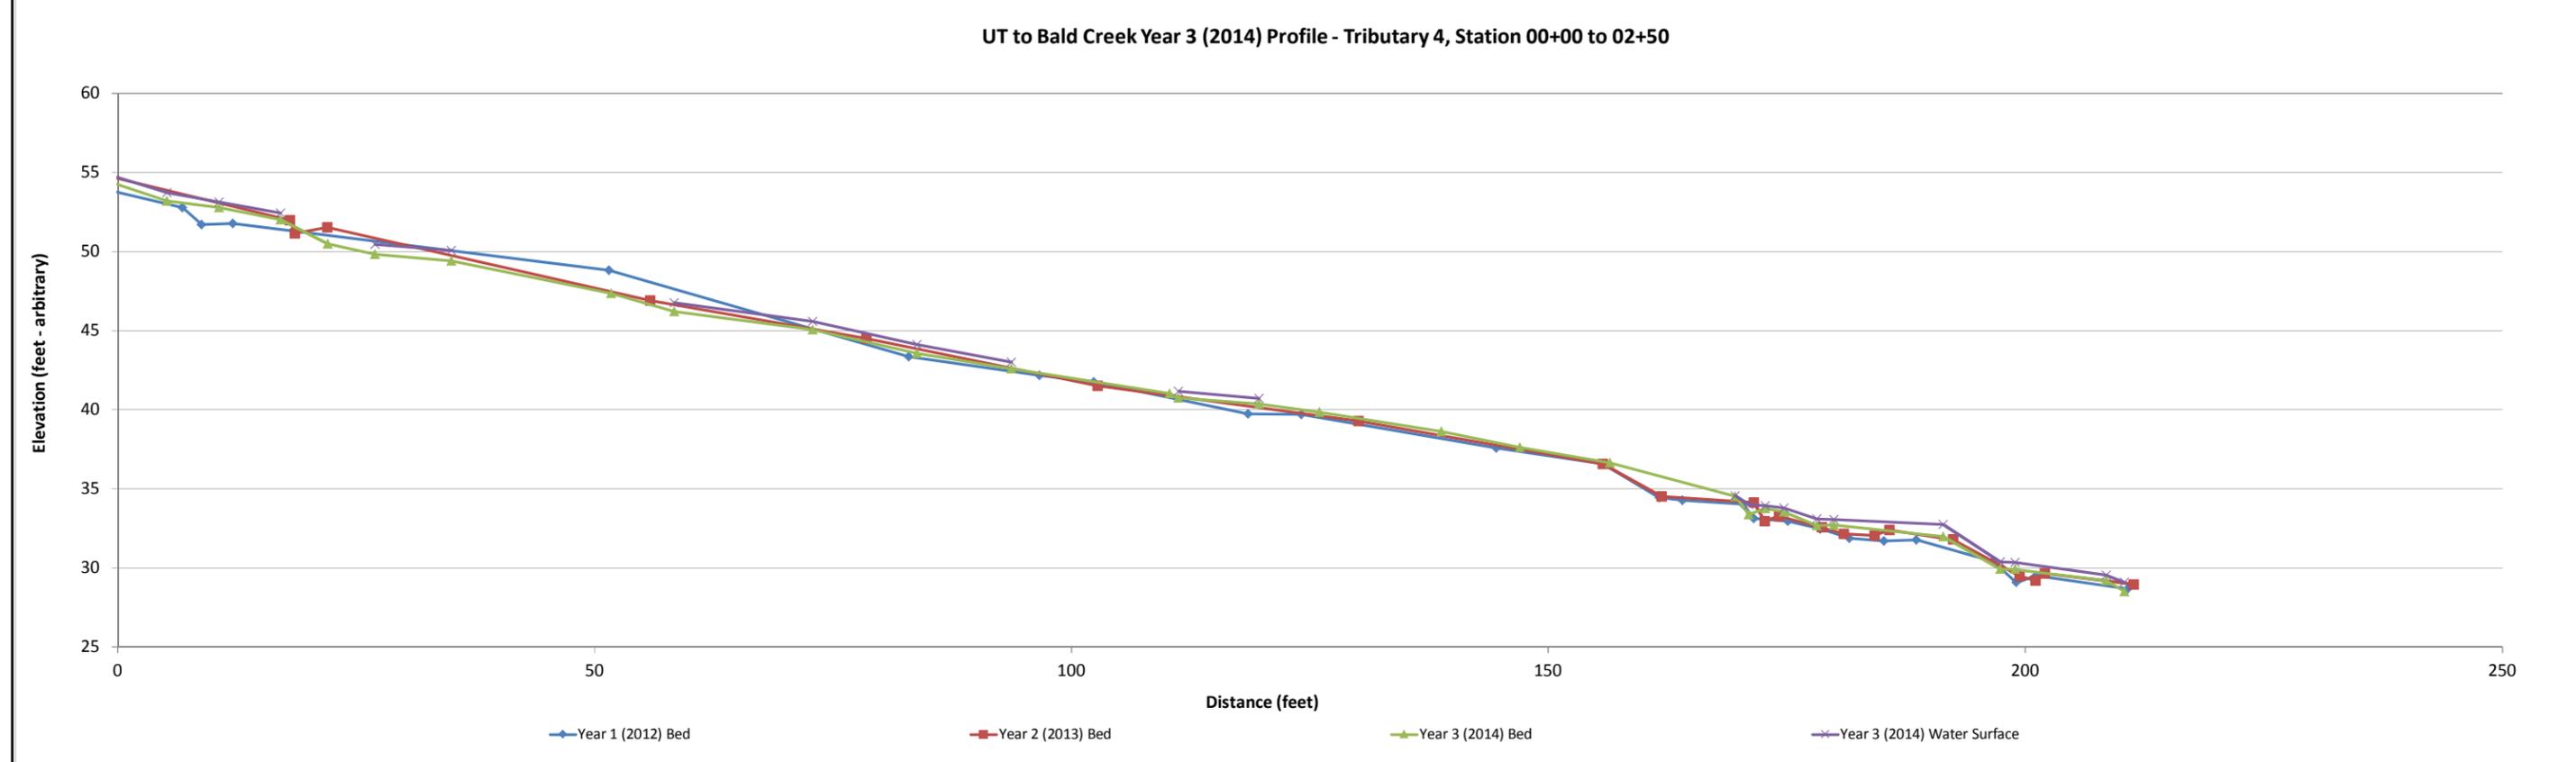
Project Name	UT to Bald Creek - Profile
Reach	Tributary 4 Station 00+00 - 02+50
Feature	Profile
Date	2/16/15
Crew	Perkinson, Jernigan

Avg. Water Surface Slope	2012	2013	2014	2015	2016
Riffle Length	0.0074	0.1228	0.1147		
Avg. Riffle Slope	23	22	11		
Pool Length	0.0118	0.1118	0.0814		
Pool to Pool Spacing	34	6	5		
	57	13	13
