**UT Barnes Stream and Wetland
Restoration Project
Montgomery County
North Carolina**

**CU: 03040103
SCO# 040614201A
EEP Project No. 397**

**2nd Year Final Monitoring Report
March 1, 2008**

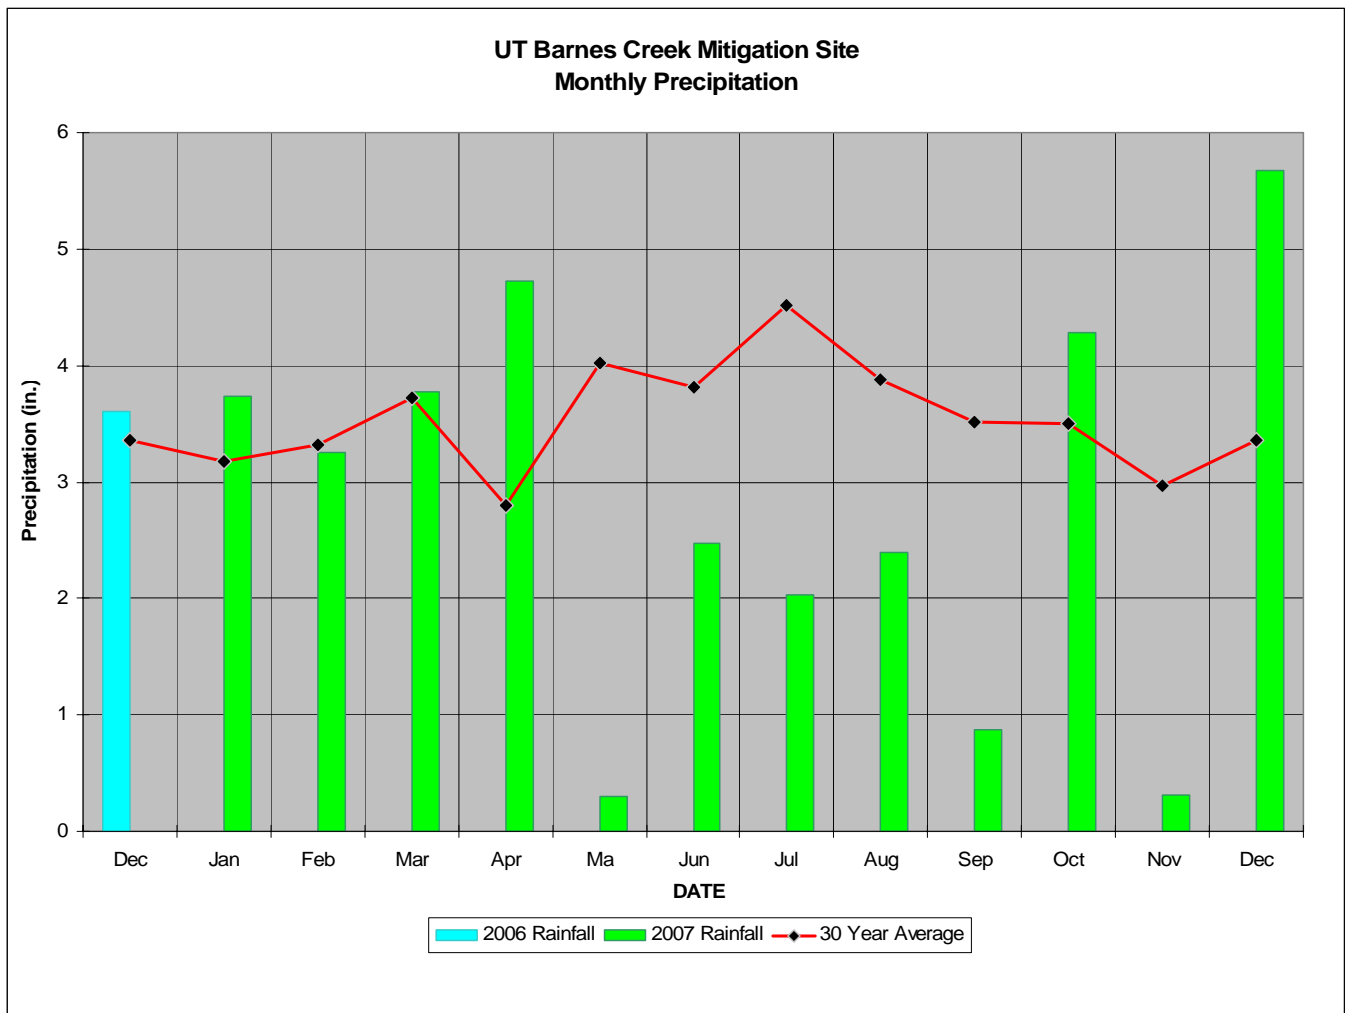
Figure 4. Historic Average vs. Observed Rainfall

Weather station data from the NUWH - Uwharrie (Troy, NC) were used in conjunction with a manual rain gauge located on the site to document precipitation amounts. The manual gauge is used to validate observations made at the automated station. The year 2007 experienced rainfall totals below average resulting drought conditions for the monitoring period.

Month	Average	Observed 2007 Precipitation
April 2007	2.8	4.73
May 2007	4.02	0.3
June 2007	3.81	2.47
July 2007	4.51	2.03
August 2007	3.88	2.4
September 2007	3.52	0.87
October 2007	3.5	4.28
November 2007	2.97	0.31
December 2007	3.36	5.67
